## Assessing the resurgent irrigation development program of the Philippines: National irrigation systems component

PIDS Discussion Paper Series, No. 2020-01

# Assessing the Resurgent Irrigation Development Program of the Philippines – National Irrigation Systems Component

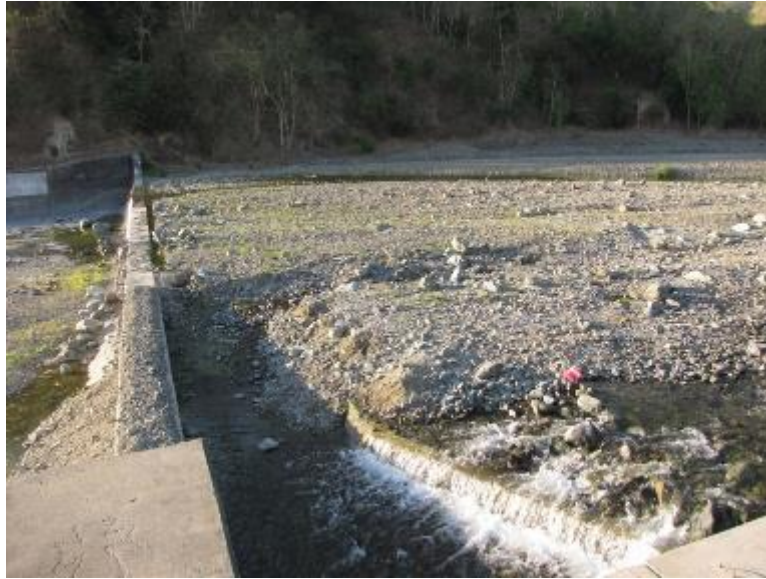
As part of the design, siltation of the dam can be controlled by opening the sluice gates during high river flow. But opening the sluice gates can only control siltation at a certain extent. On the other hand, canal siltation can be controlled by regular maintenance. Silt control in silted canals can be implemented through dredging or through the use of structures (i.e silt ejector of PDRIS and Marbel #1 RIS – in Annex C, by-pass canals). The lack of canal maintenance was mentioned during FGDs (as reason for canal siltation) by Mapamasa IA in Division 4 of UPRIS, Muhara IA in Solana PIS, Zigiran IA in Magapit PIS, Carsan IA in Ambayoan-Dipalo RIS, and Gamot Bolo Nicolas IA in Caguray RIS, among others. Siltation depth was measured in PDRIS (see Annex C) and was found to range from 6 cm midstream to 37 cm downstream. This indicates that flows have reduced considerably from the upper to lower sections of the main canal which is consistent with the increase in siltation depth from midstream to downstream.

Photo 1. Silted diversion dam of Dipalo RIS

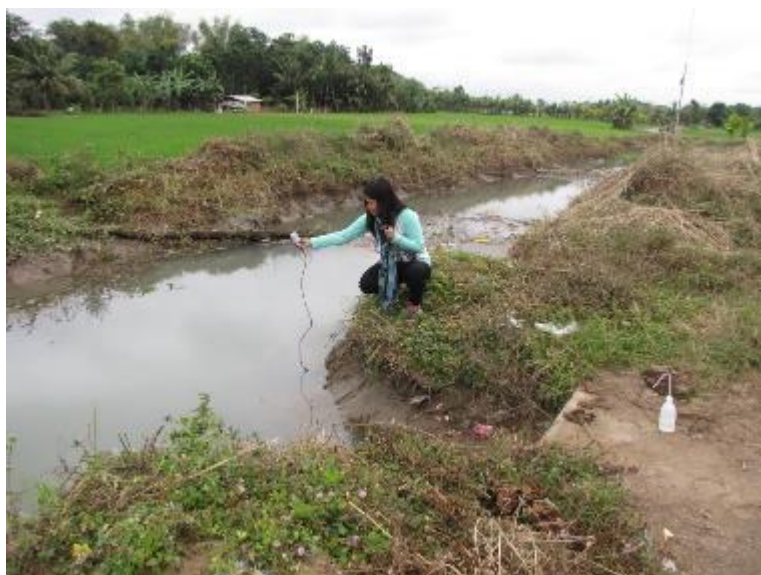
Photo 3. Damaged canal end section of Lateral D2-D2, Div. 4, MARIIS. Pile of sediments could be observed in both embankments of the canal

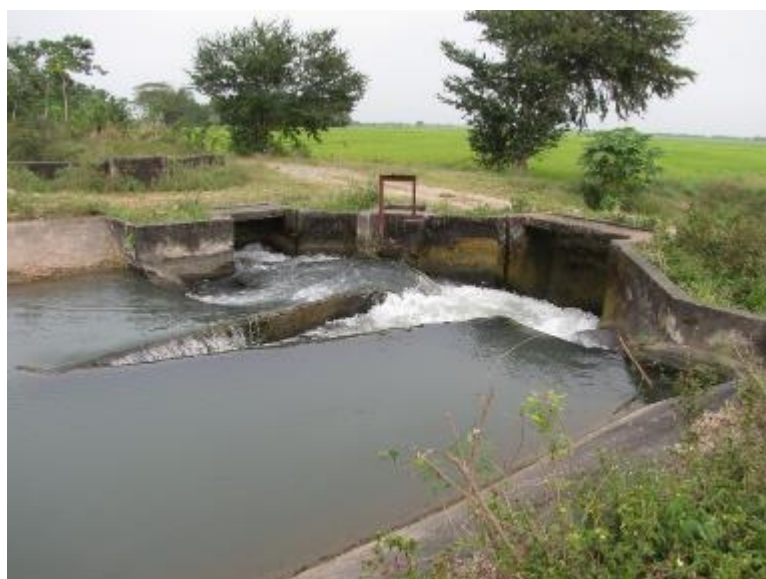
During design stage, system performance considered was based from the design standards that all canals were lined, and canal structures were in place. However, after construction, most of the NIS in the country were actually completed if compared to the original design. Most of the deviations were unlined canal and reduced area covered. Thus, it will result in the deviation between designed service area and actual irrigated area. Moreover, there were no interactions between design and O&M engineers of irrigation system (David, 2004). Problems related to design during operations were not properly conveyed to the designers. This is evident of the problems encountered by the NIS designed in the 1970s and designed in the early 2000s encountered the same operational problems as canal seepage, siltation and lack of structures.

Photo 4. Control and division structures along Lateral B, Div. 2, MARIIS

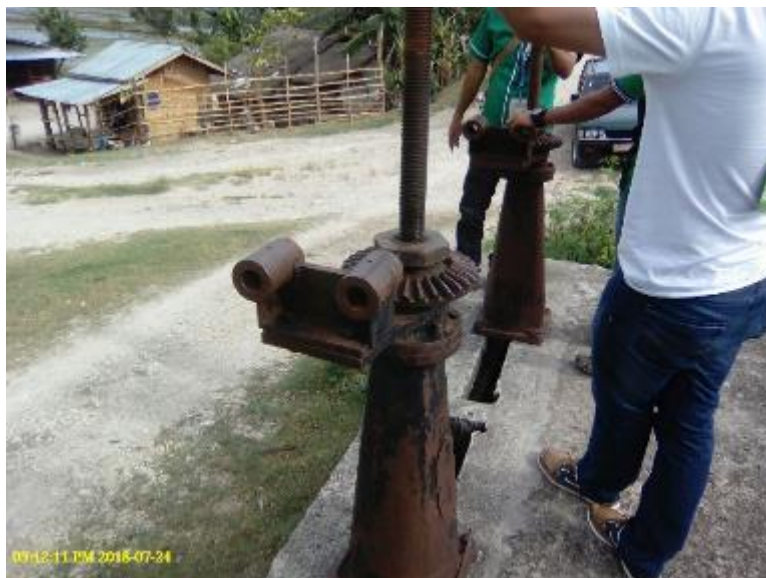
Photo 5. Missing gates in MalMar 2 RIS.

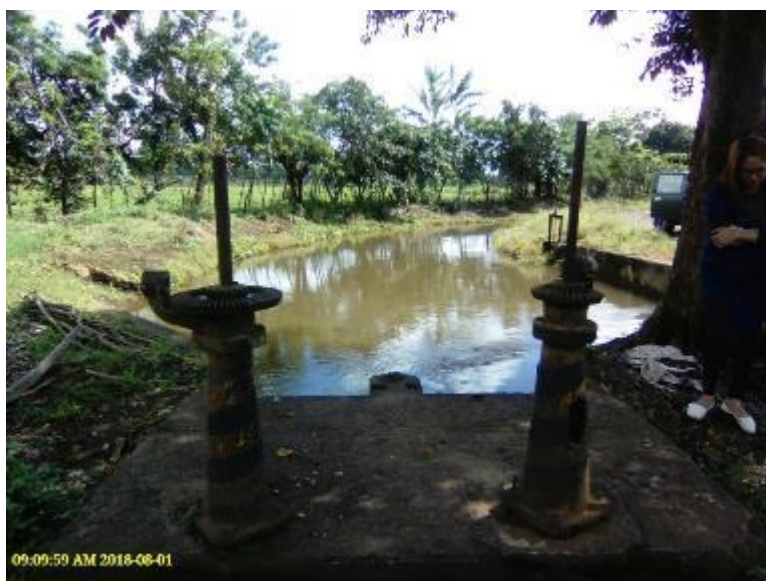
Photo 6. Damaged headgates control lever of Lateral A of Manupali RIS.

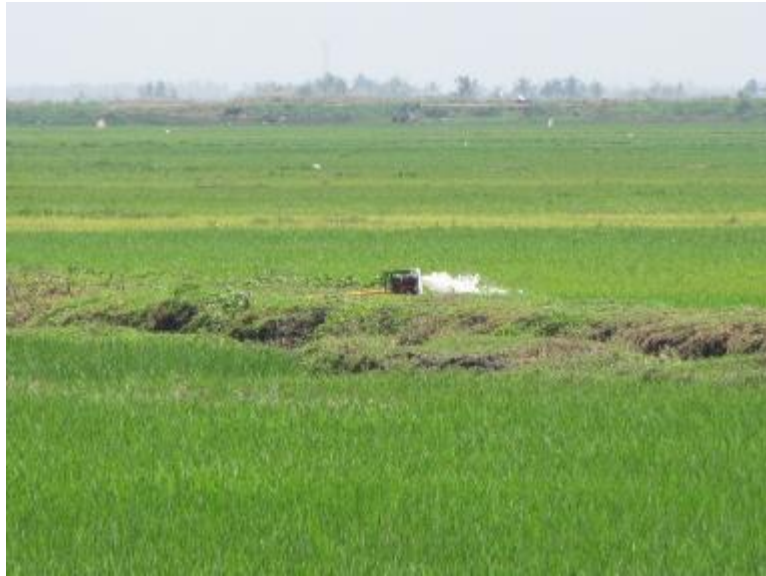
Photo 9. A pump set extracting water from drainage canals in Magapit PIS

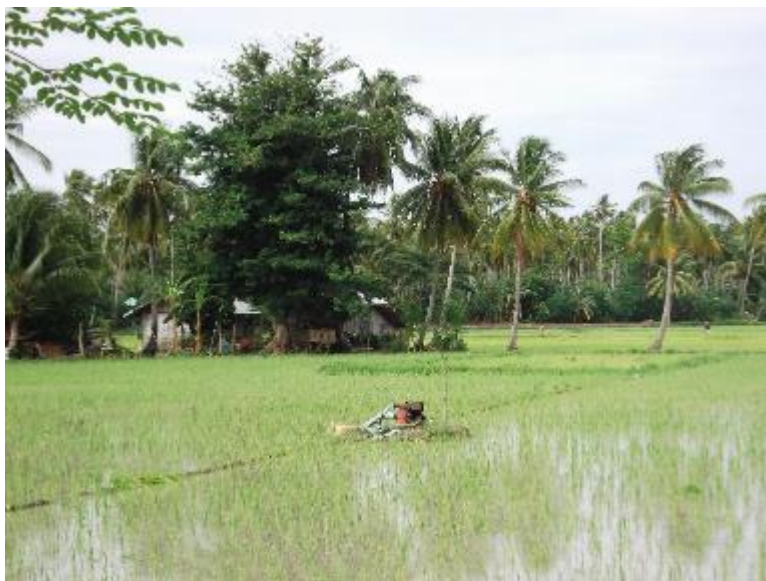
Photo 12. A pumpset installed in the service area of Padada RIS.

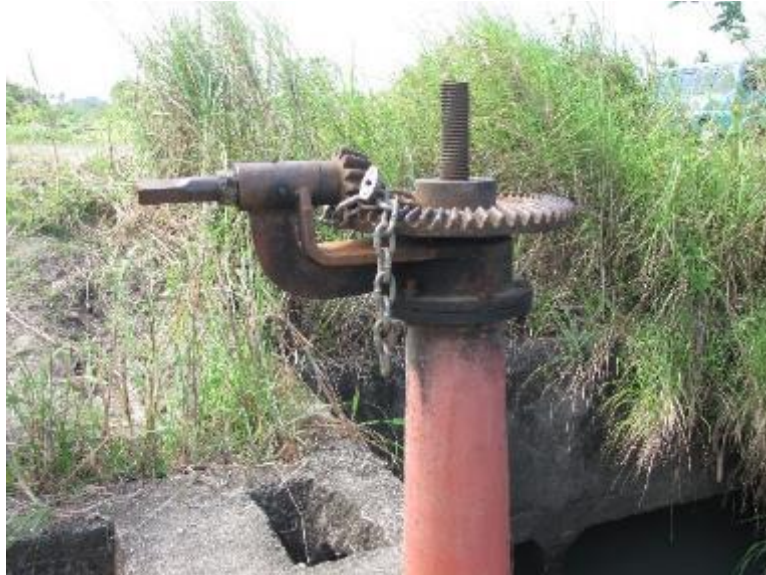
Some IAs encountered illegal opening and closing of gates. This could be observed in the field wherein locks and security gates were installed to prevent illegal gate control (see sample in Photos 17 and 18).

Photo 17. Check gate with padlocks in Libmanan-Cabusao PIS

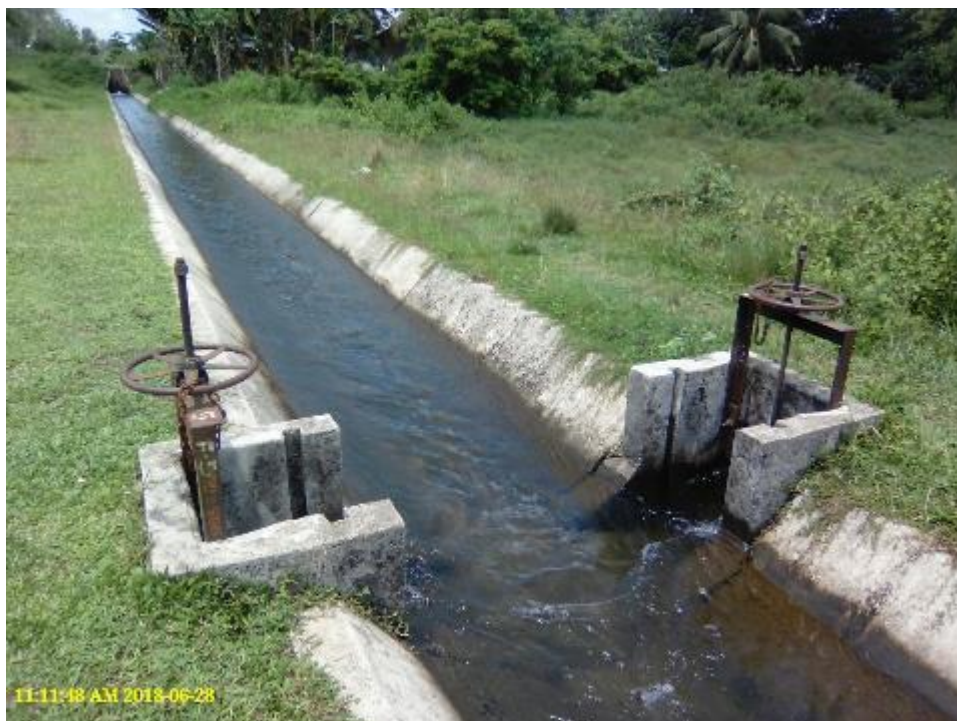
Photo 18. Section of Lateral C of Bayongan IS.  
Take note of the chains with padlock on the turning mechanism of the gates.

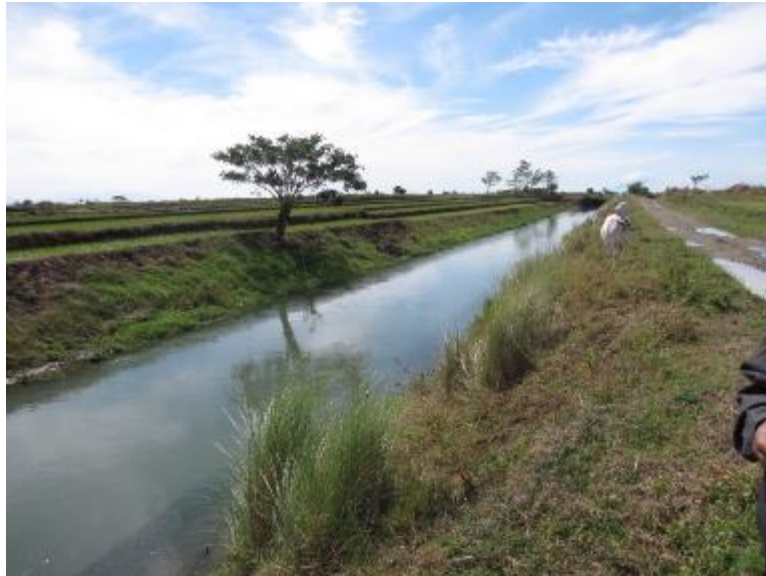
Three divisions of UPRIIS (2, 3 and 4) were visited. Siltation problems (see Photo 22) exist across all sections of the canal network which again points to the technical deficiency in the maintenance of the canal network. This is even worst in unlined canals which are eroded and damaged by uncontrolled animals frequenting the sides of the canals. As observed in other NIS, similar concerns exist such as lack of staff gauges to measure flow, siltation of canal up to lateral level, illegal pumping, garbage dumping in canals due to illegal settlers (Photo 23) and lack of maintenance were also observed in UPRIIS. Water shortage is expected to occur during El Nino this year. Another major issue is the collapse of LTRIS dam (see Photo 24) due to typhoon Mario in 2014.

Photo 22. Silted MC of LTRIS, Division 2, UPRIIS

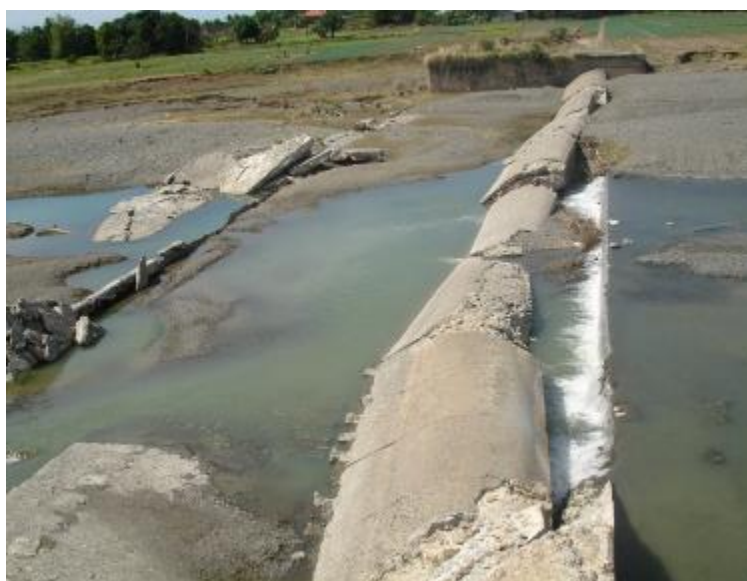
Photo 24. LTRIS dam damaged due to Typhoon Mario

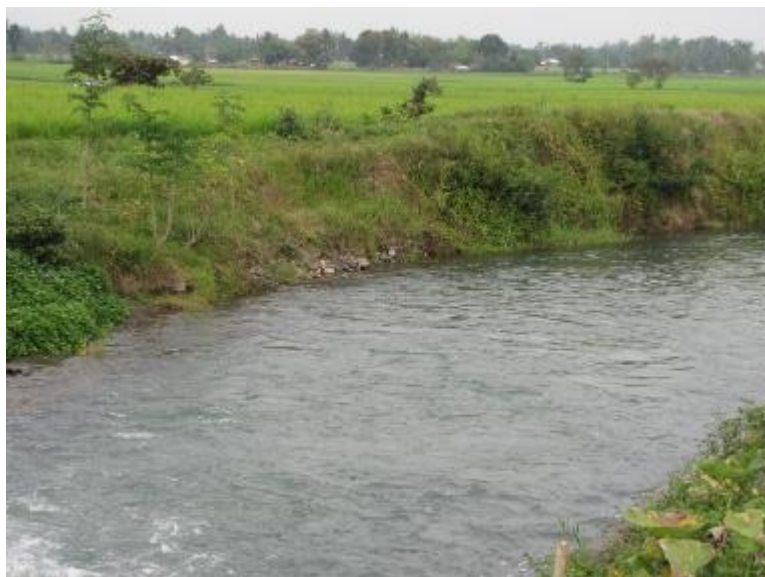
Photo 26. Unlined section of Lateral B, Div. 2, MARIIS with damages from erosion

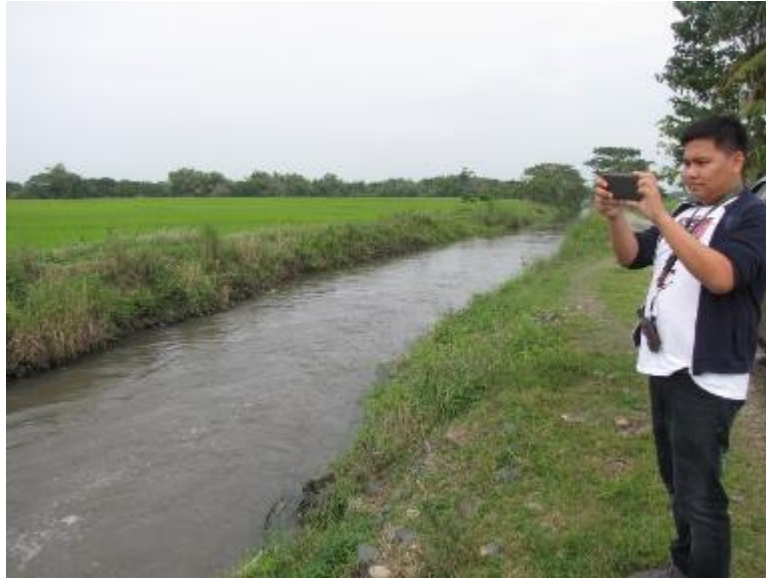
Photo 27. Unlined canal of Lateral B, Division II, MARIIS

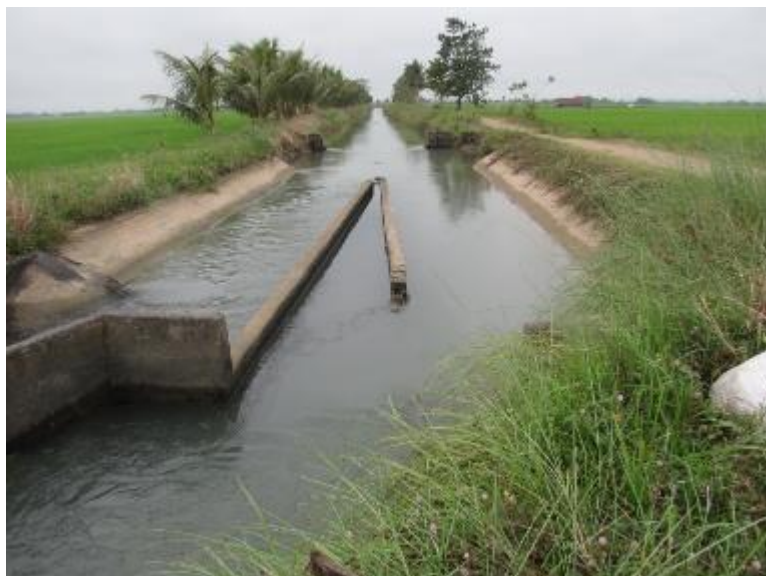
Photo 28. Damaged structures along Lateral D2, Div.4, MARIIS

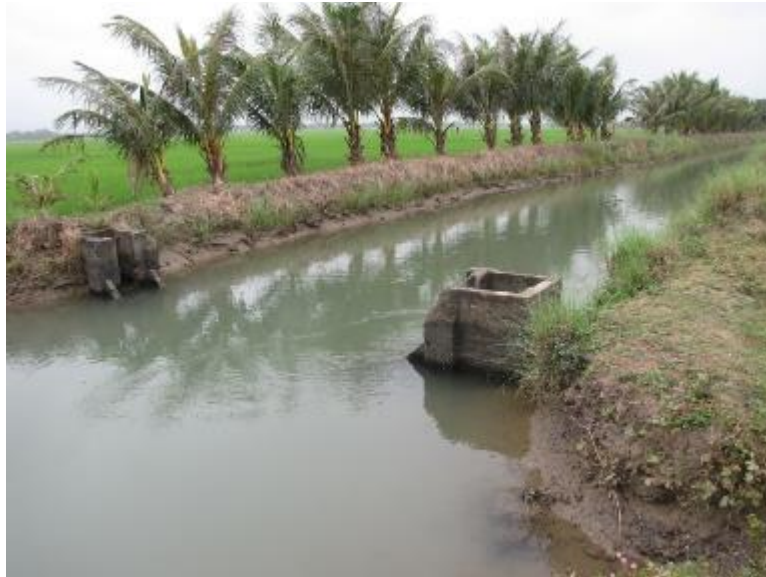
Photo 29. Damaged canal and turnout in a section Lateral Dw-D, Div.4, MARIIS.  
Take note that the Lateral was unlined

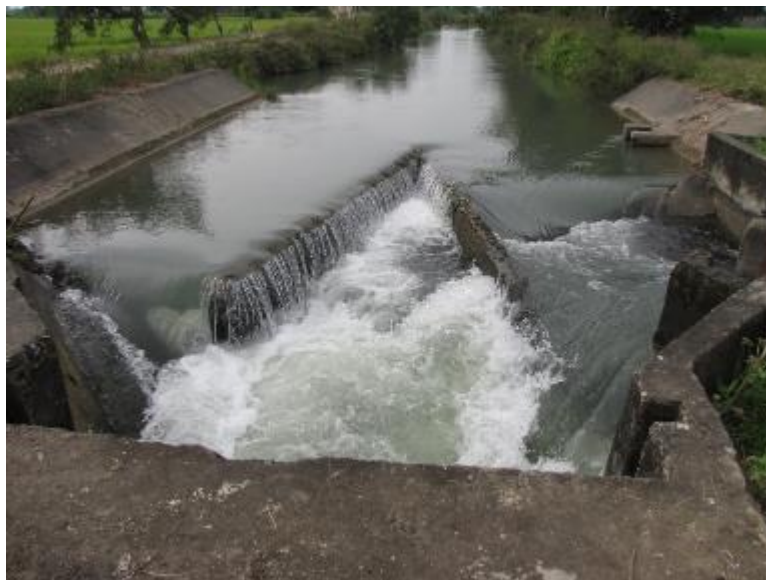
Photo 30. Control and division structures along Lateral B, Div.2, MARIIS.  
Take note of the damages and condition of the canal and structures.

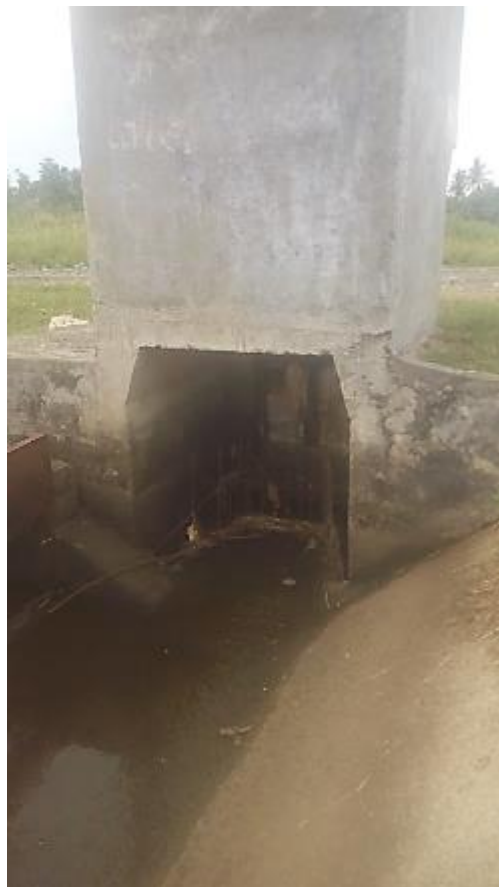
and turn outs (Photo 40). There were also several damaged structures, one can be seen in Photo 41.

Photo 41. Damaged structure in Malinao IS.

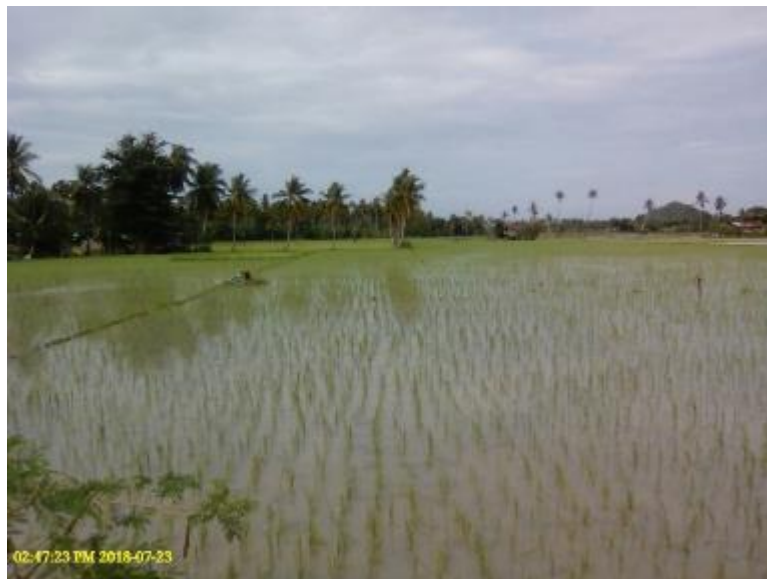
Photo 71. Take note of the standby STW as water source during dry spells.

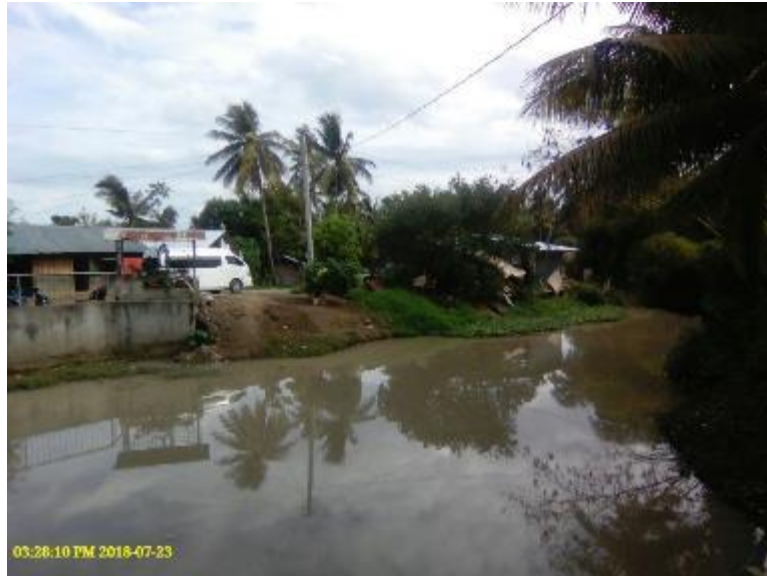
Photo 72. Illegal settlers along the drainage.

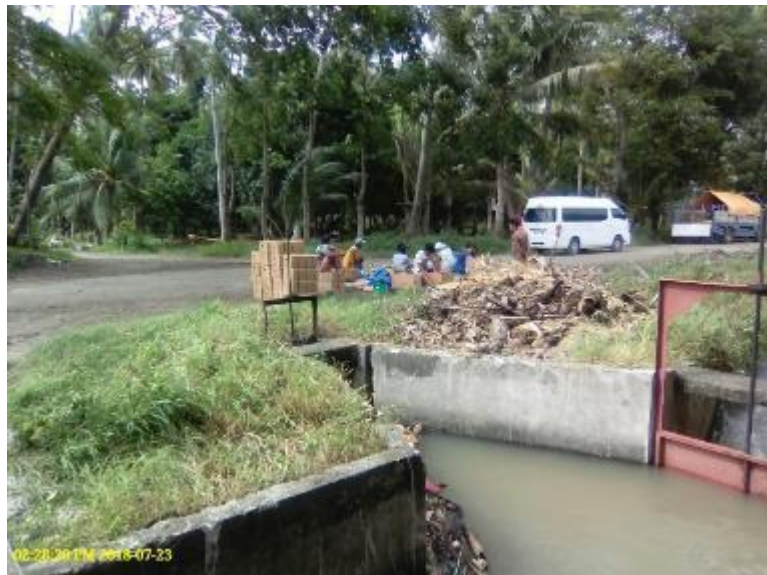
During the field visit in Padada RIS, we observed some odd structures. The headwater of Lateral A has two checkgates (Photos 73 and 74). Additional gate was installed to increase water intake into the Lateral. On the other hand, the silt ejector opposite the headgate of Lateral B was converted into farm turn out (Photo 75).

Photo 73. First intake gate of Lateral A.

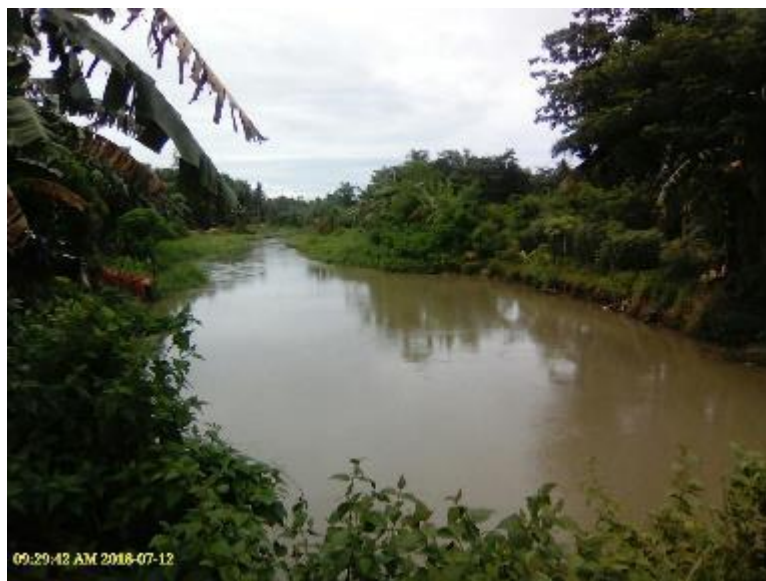
Photo 92. Section of Main Canal, Jalaur Proper RIS that meander.
