Assessing the resurgent irrigation development program of the Philippines: Communal irrigation systems component

PIDS Discussion Paper Series, No. 2020-02

Assessing the Resurgent Irrigation Development Program of the Philippines – Communal Irrigation Systems Component

March 2020

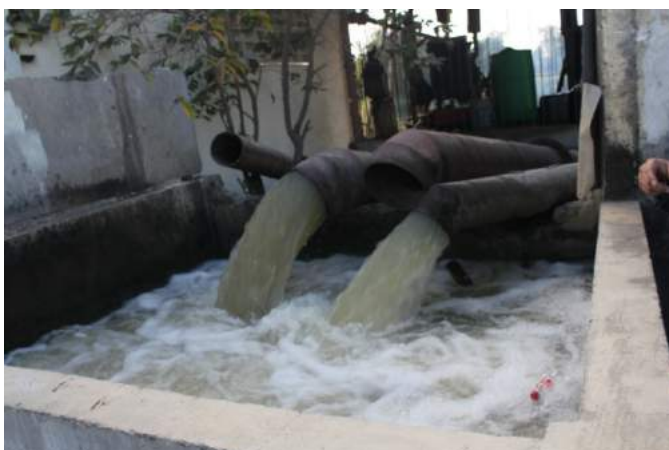
Figure 1A-4. The concrete sump where the discharge pipes of the 3 pumps empties before distribution to the main canal; the middle pump is being repaired; the water is sediment laden

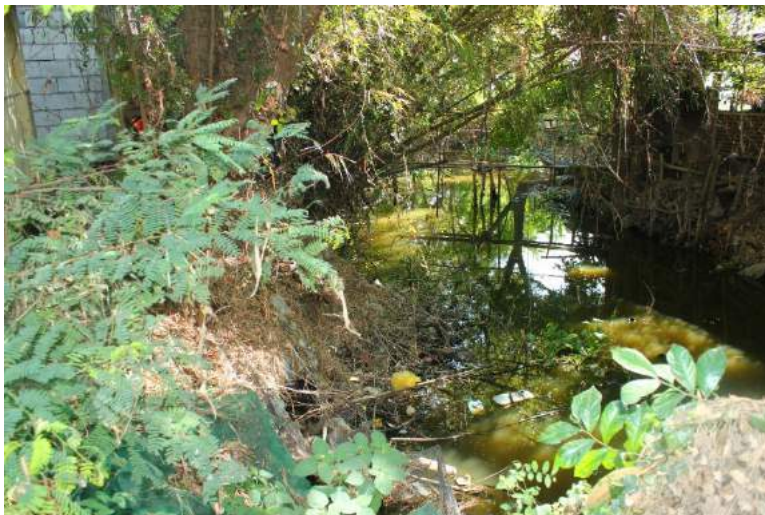
Figure 1A-9. The Minalin Creek where the Sapa-San Vicente PIS gets its water for irrigation; in some instances, saltwater from the Pampanga River delta intrudes into this creek damaging the crops

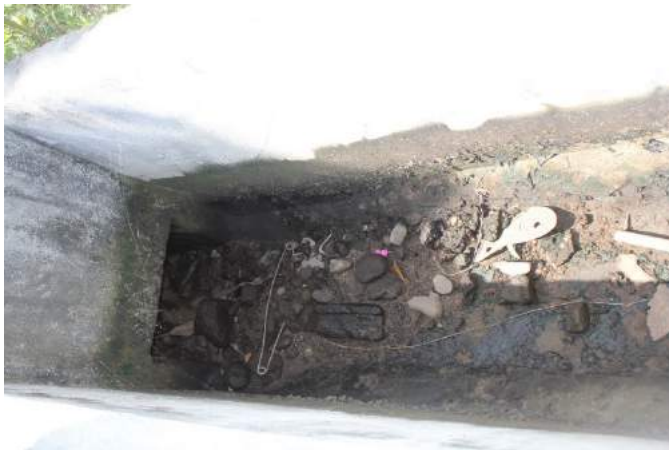
Figure 1A-11. Siltation and garbage observed from the portion of the main canal near the pump

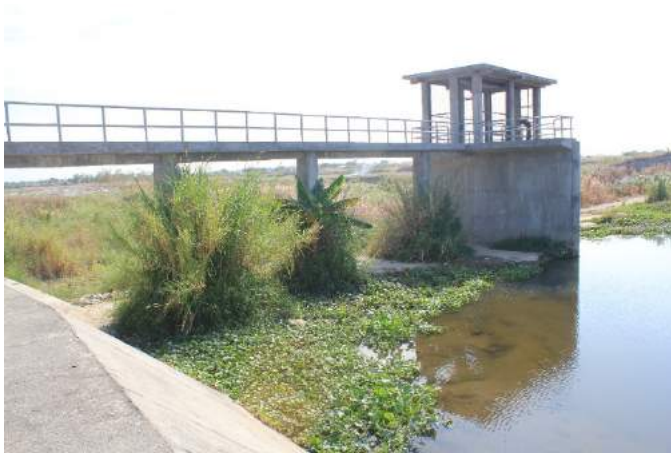
Figure 1A-13. Front view of the Anao CIS showing the heavily silted upstream portion of the dam

To help improve their system, the IA requested for financial assistance for lining of the 3.5 kilometer unlined canal and replacement of deteriorated steel gate of the 1st cross regulator. It is advised that major repairs be made on the dam particularly to arrest underground scouring by construction (or repair) of upstream and downstream cutoff walls, to lengthen and add permanent support to the downstream apron, not just gabions, and to dredge the river bed upstream of the dam to increase storage capacity.

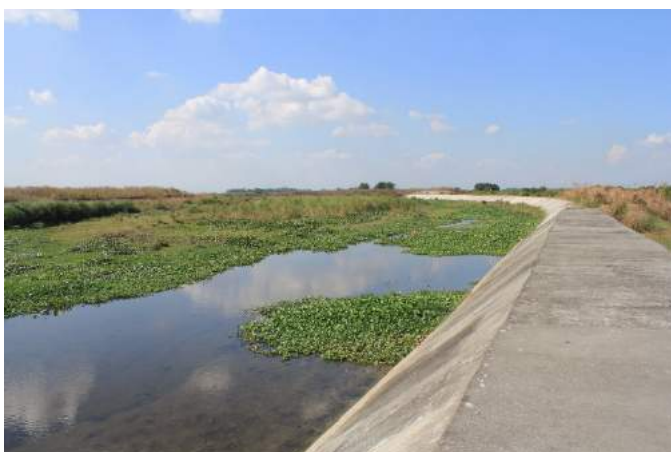
Figure 1A-15. The concrete embankment at the approach to the dam, again showing heavy siltation

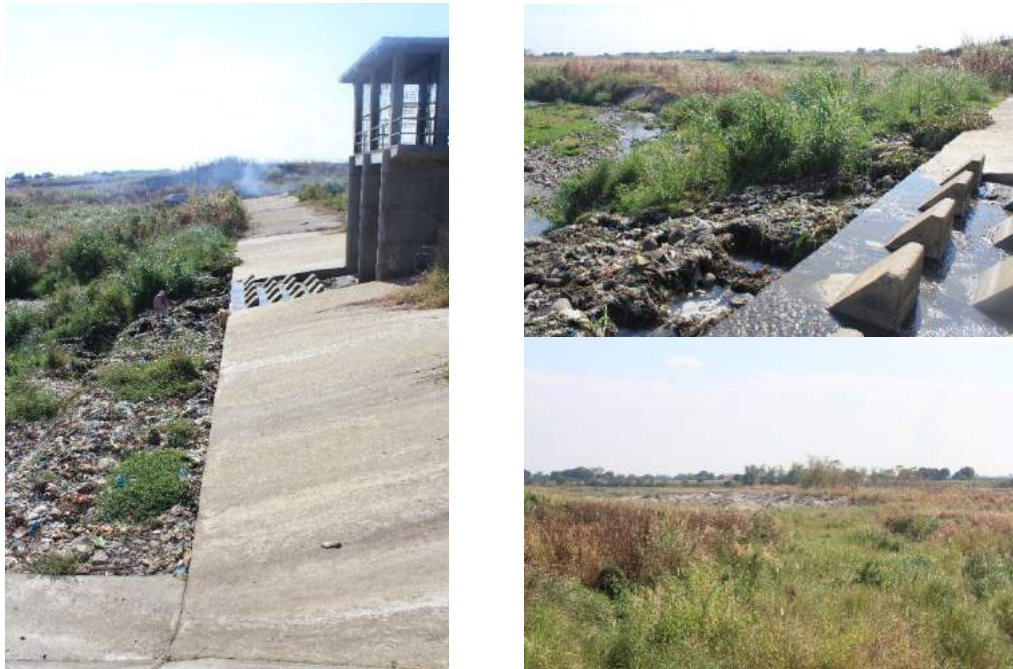
Figure 1A-16. Clockwise from left: (a) scouring at the downstream apron, the sluice gates and intake structures are seen at the middle of the dam; (b) the gabions are damaged and accumulating garbage; (c) the quarry operations just downstream of the dam location

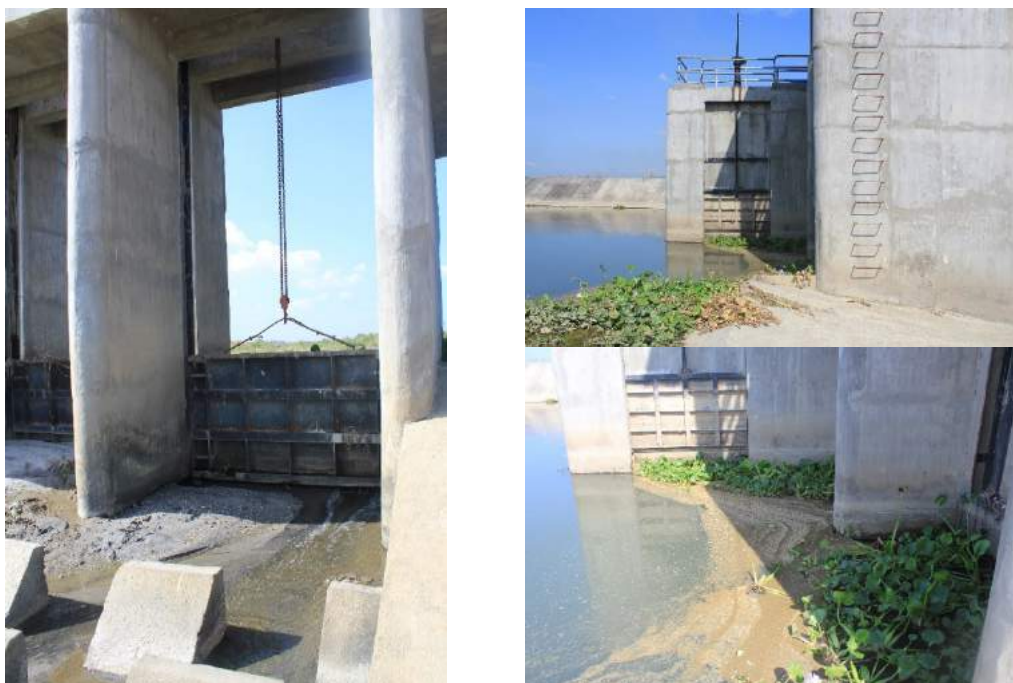
Figure 1A-17. Clockwise from left: (a) the two sluice gates showing some siltation and leakage, also shown are the baffle blocks; (b) The intake structure was designed to be near the middle of the river, the intake gates are still functional; (c) the approach to the sluice gates and intake gates are heavily silted

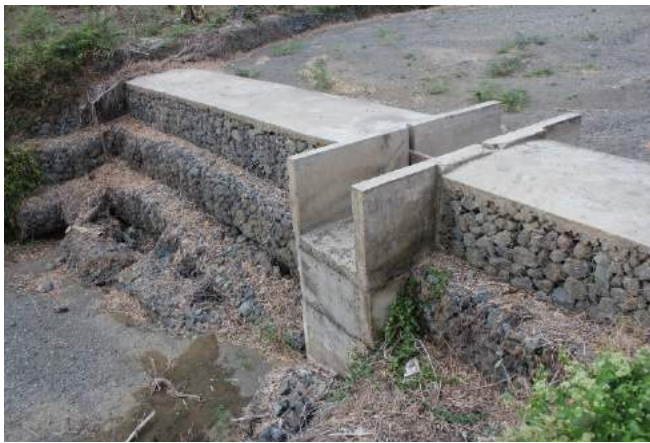
Figure 1A-22. The Cordero CIS dam along Arimal creek is made up of gabions and plastered with cement at the crest; shown at the left side are the damaged gabions where water seeped underneath the dam

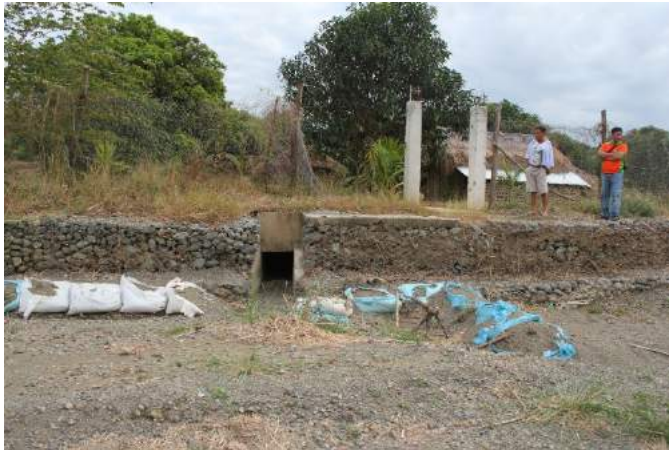
Figure 1A-24. The intake gate upstream of the dam use wooden slabs as gates; the gabions serving as side embankments of the dam are damaged; sand bags used to divert the depleting water last cropping are also shown

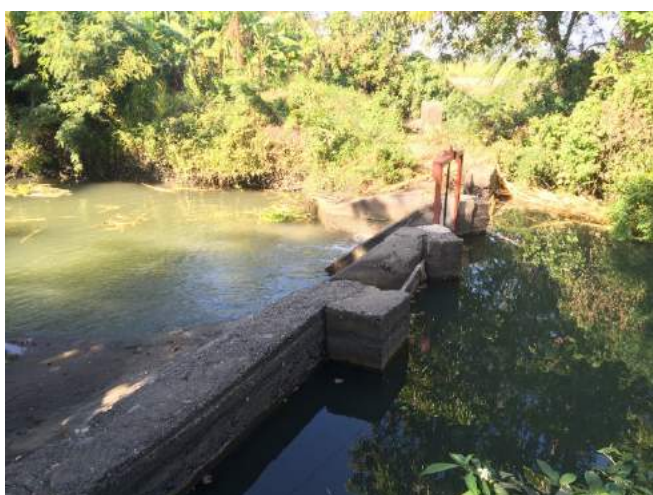
Figure 1A-60. A check gate with one steel gate damaged and replaced with wooden plank

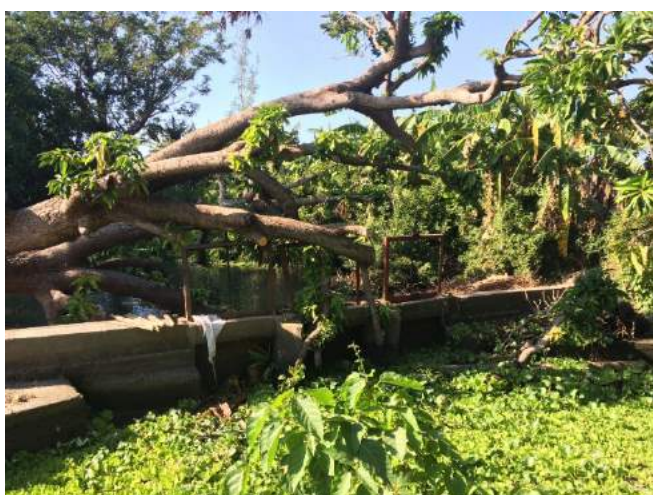
Figure 1A-61. Damaged and non-operational gates due to a tree falling on it during the typhoon Mario in 2014.

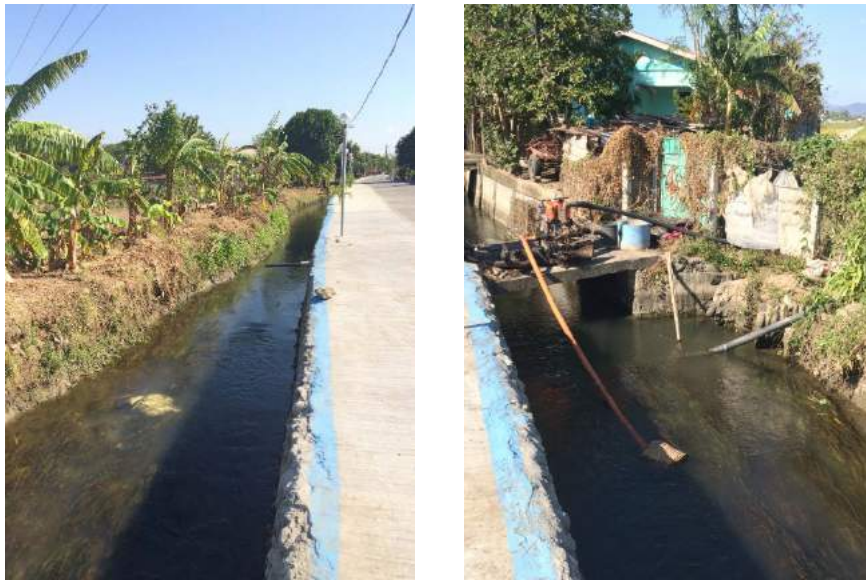
Figure 1A-62. Lateral canals: Left – grasses are growing at the channel bottom; Right – a low-lift pump (LLP) extracting water from the canal (according to the farmer interviewed, the owner of this pump is not a member of the IA).

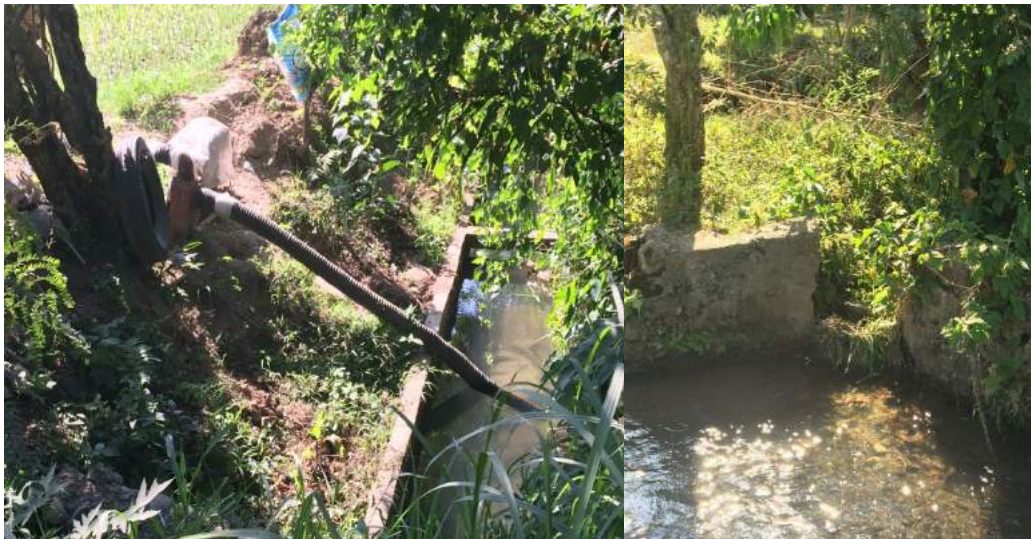
Figure 1A-75. Portions of the main canal with illegal pumps (left) and improvised lateral turnouts (right)

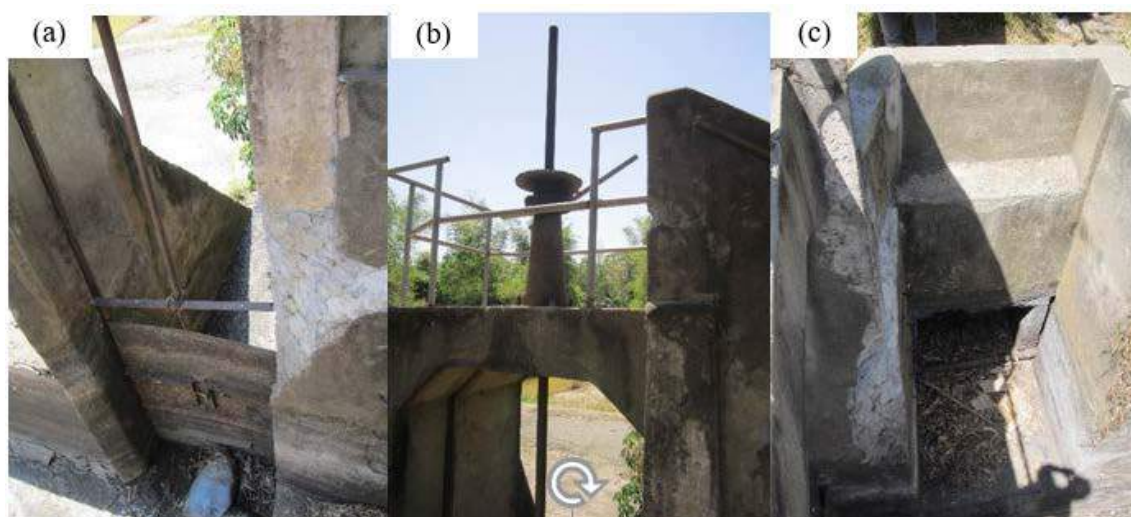
Figure 1A-95. (a) The wooden sluiceway gate; (b) the operating screw of the sluiceway gate; (c) the intake gate with broken regulator

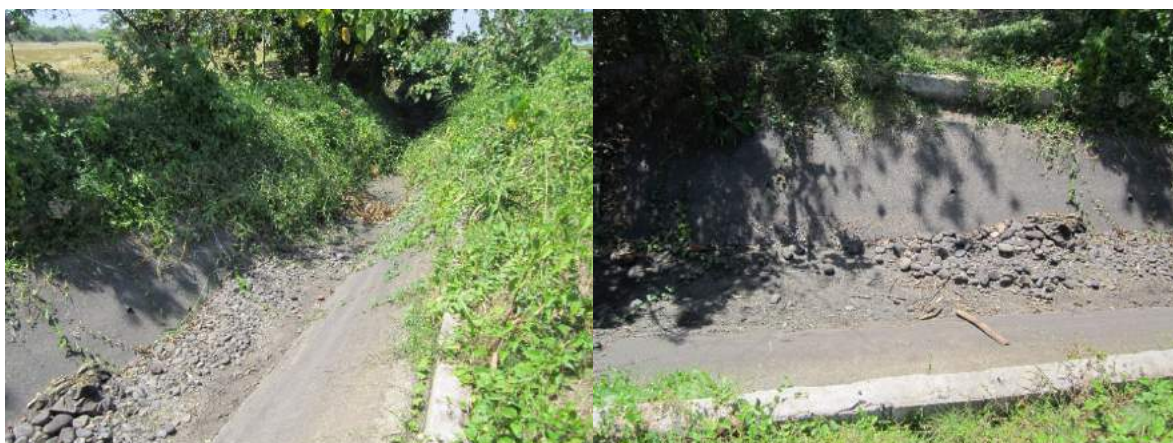
Figure 1A-96. The trapezoidal lined main canal, shown with some sediments at the bottom

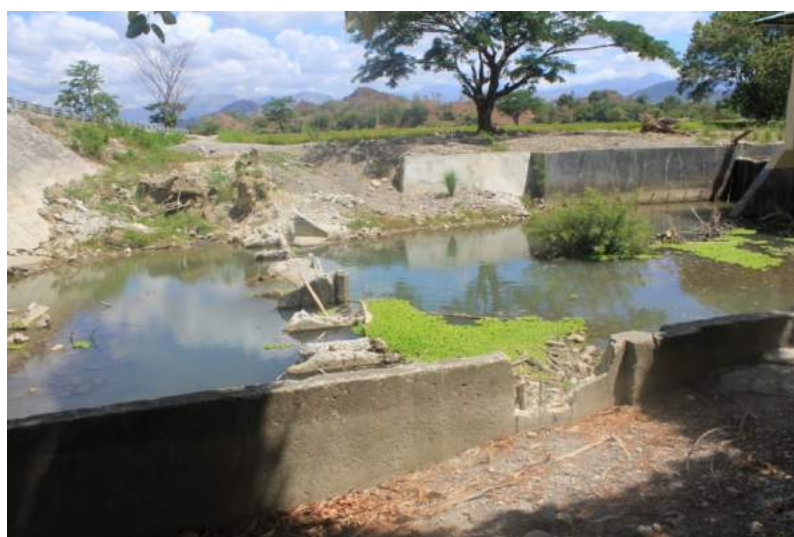
Figure 1A-115. The former Batasan CIS dam that was broken
Source: Author's capture

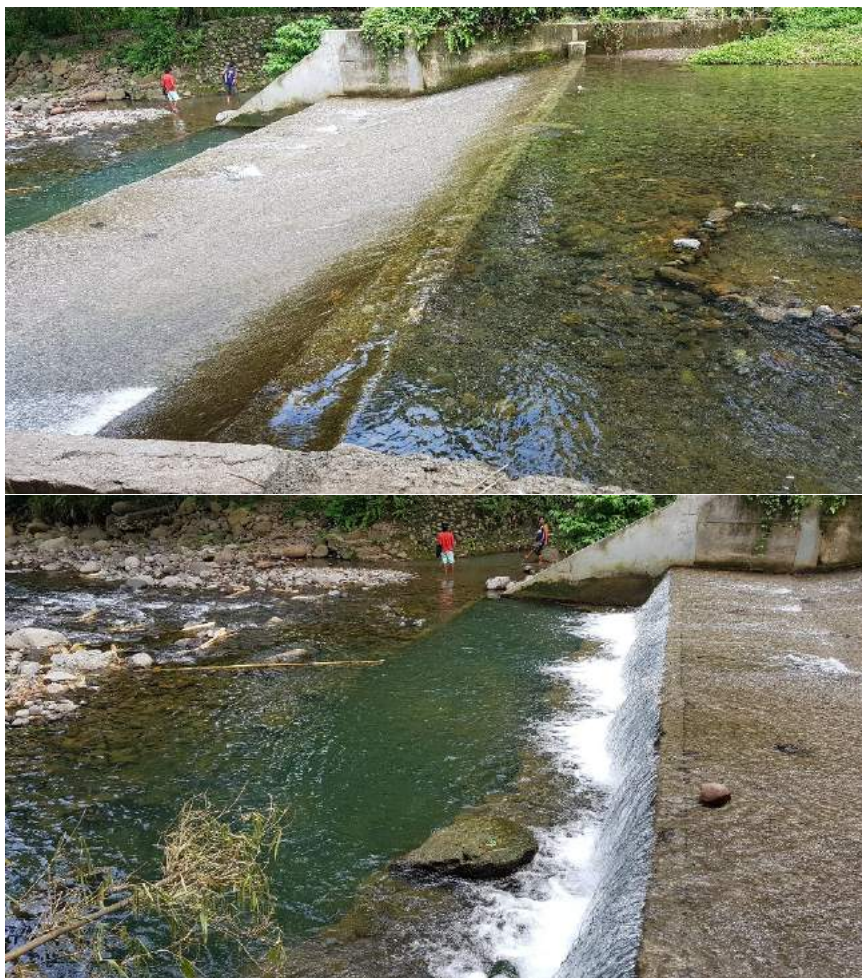
Figure 1C-1. Marapangi Dam of Unifarm CIS showing sedimentation and damaged downstream apron of the dam

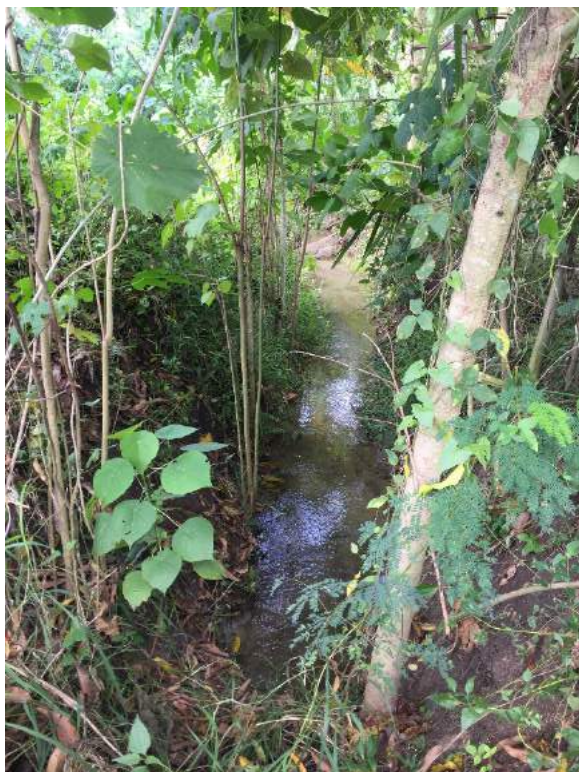
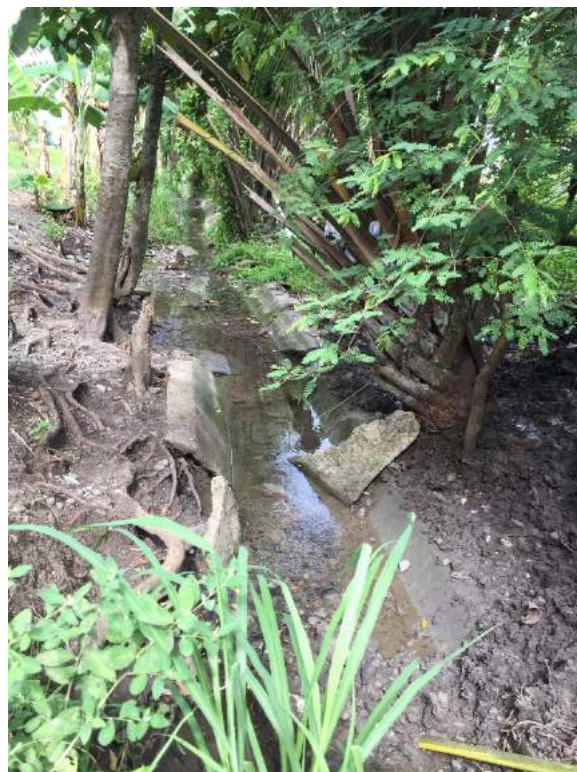
Figure 1C-6. The unlined and broken portions of the main canal

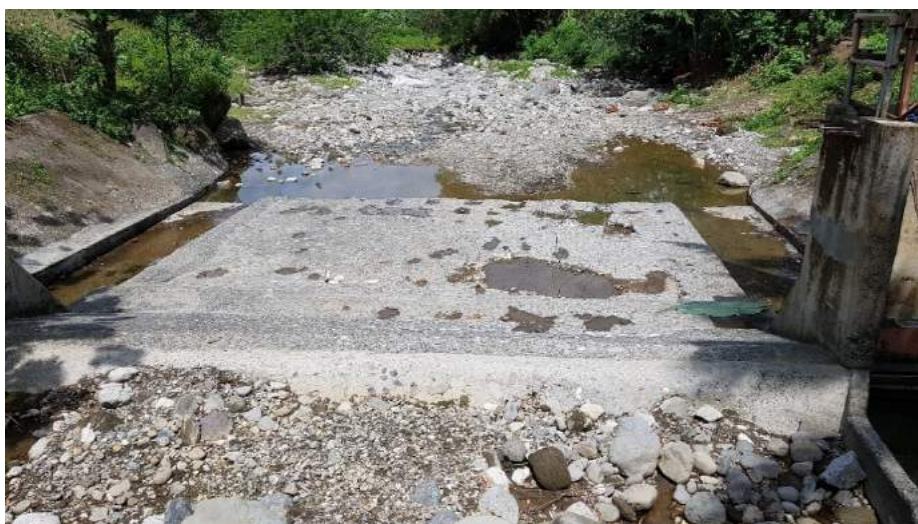
Figure 1C-33. The damaged downstream apron of the dam
