Assessing the resurgent irrigation development program of the Philippines: Communal irrigation systems component

PIDS Discussion Paper Series, No. 2020-02

Assessing the Resurgent Irrigation Development Program of the Philippines – Communal Irrigation Systems Component

Roger A. Luyun Jr. and Dulce D. Elazegui

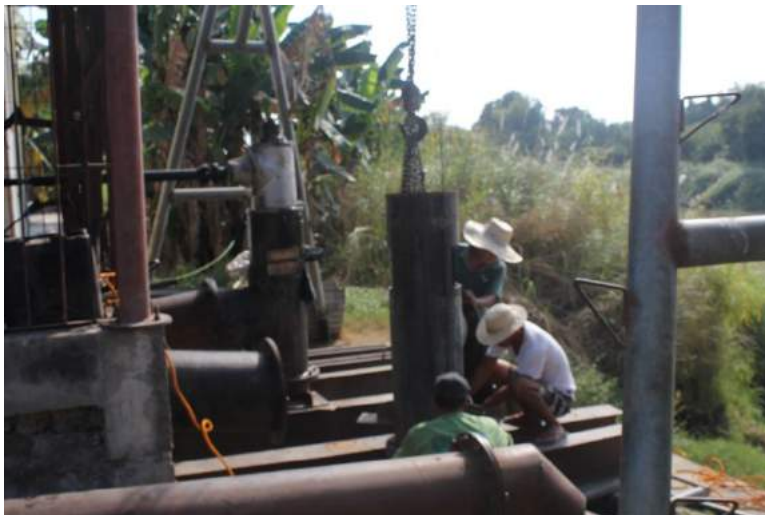
Figure 1A-1. The two 16" dia. mixed flow pumps (one is being repaired); at the foreground is the 10" dia. pipe of the submersible pump

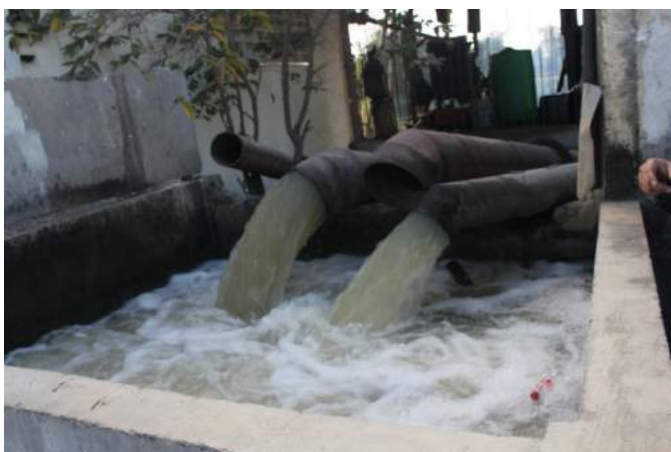
Figure 1A-4. The concrete sump where the discharge pipes of the 3 pumps empty before distribution to the main canal; the middle pump is being repaired; the water is sediment laden

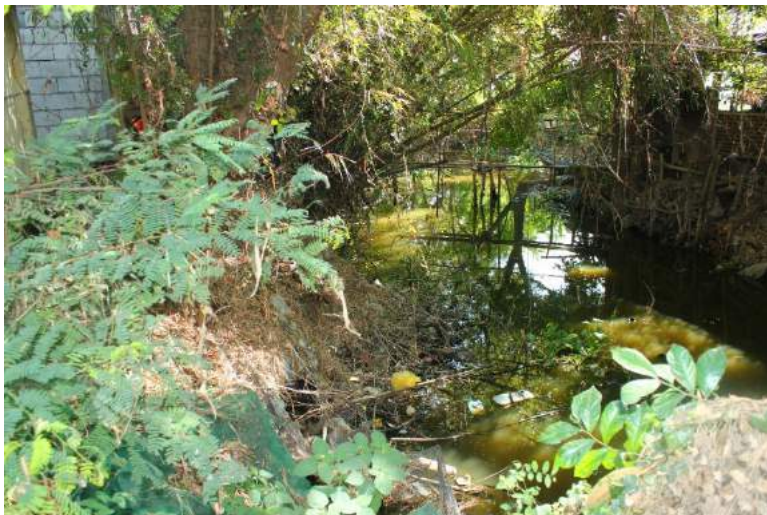
Figure 1A-9. The Minalin Creek where the Sapa-San Vicente PIS gets its water for irrigation; in some instances, saltwater from the Pampanga River delta intrudes into this creek damaging the crops

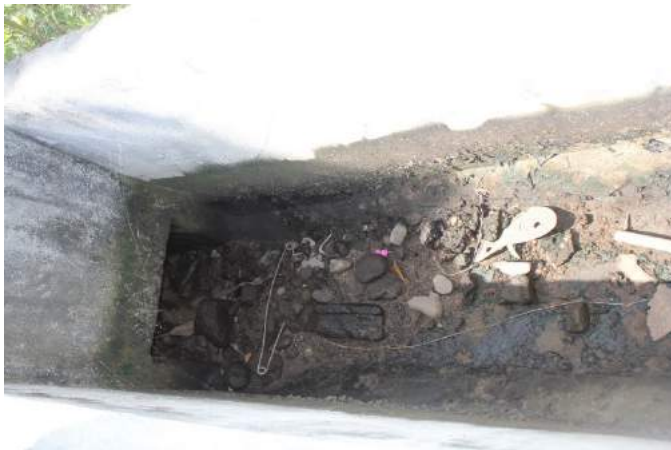
Figure 1A-11. Siltation and garbage observed from the portion of the main canal near the pump

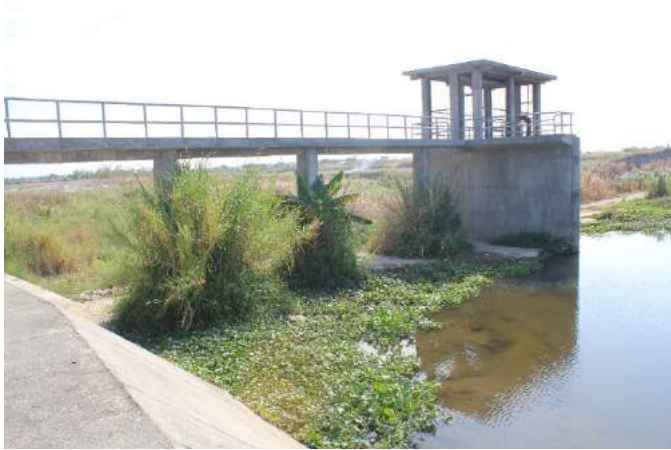
Figure 1A-13. Front view of the Anao CIS showing the heavily silted upstream portion of the dam

To help improve their system, the IA requested for financial assistance for lining of the 3.5 kilometer unlined canal and replacement of deteriorated steel gate of the 1st cross regulator. It is advised that major repairs be made on the dam particularly to arrest underground scouring by construction (or repair) of upstream and downstream cutoff walls, to lengthen and add permanent support to the downstream apron, not just gabions, and to dredge the river bed upstream of the dam to increase storage capacity.

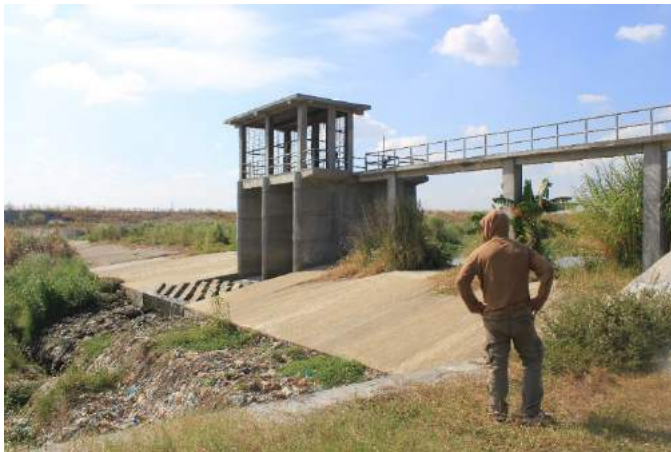
Figure 1A-14. Rear view of the Anao CIS showing the wide dam crest and the damaged and garbage-filled gabion support downstream of the dam

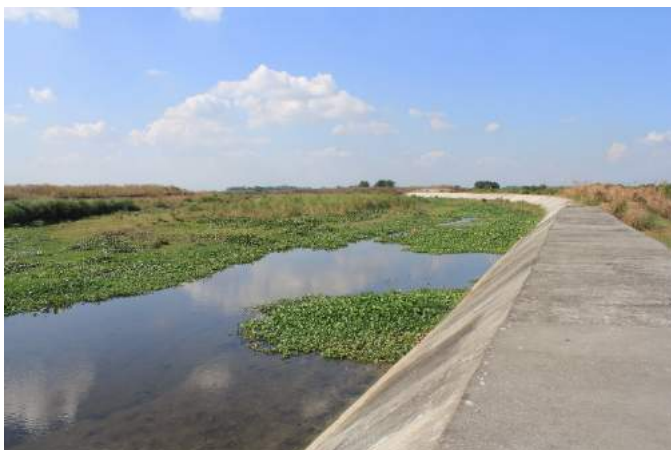
Figure 1A-15. The concrete embankment at the approach to the dam, again showing heavy siltation

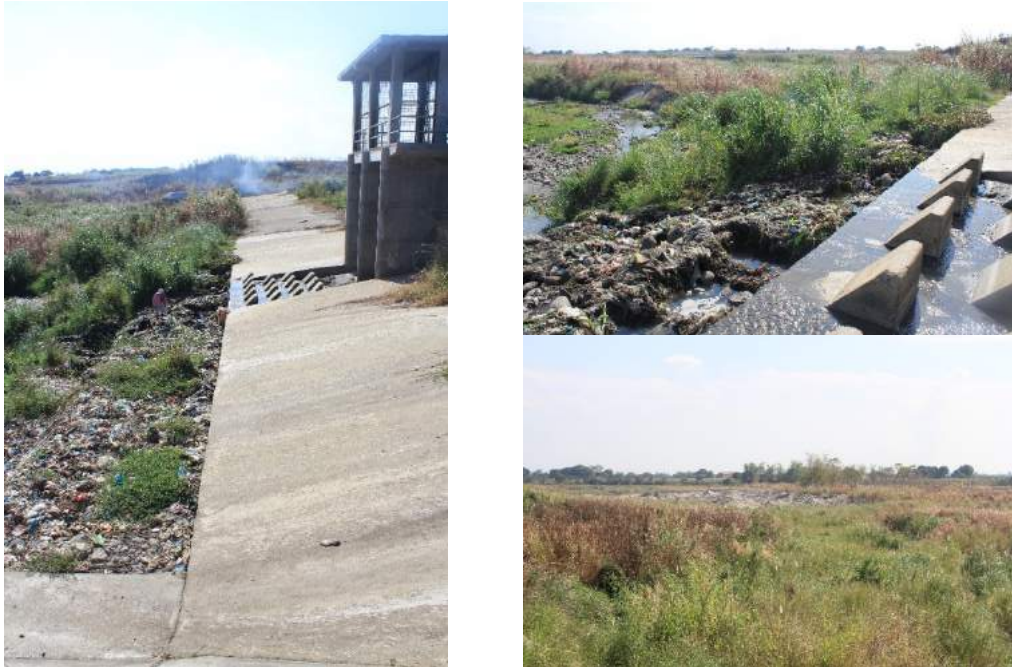
Figure 1A-16. Clockwise from left: (a) scouring at the downstream apron, the sluice gates and intake structures are seen at the middle of the dam; (b) the gabions are damaged and accumulating garbage; (c) the quarry operations just downstream of the dam location

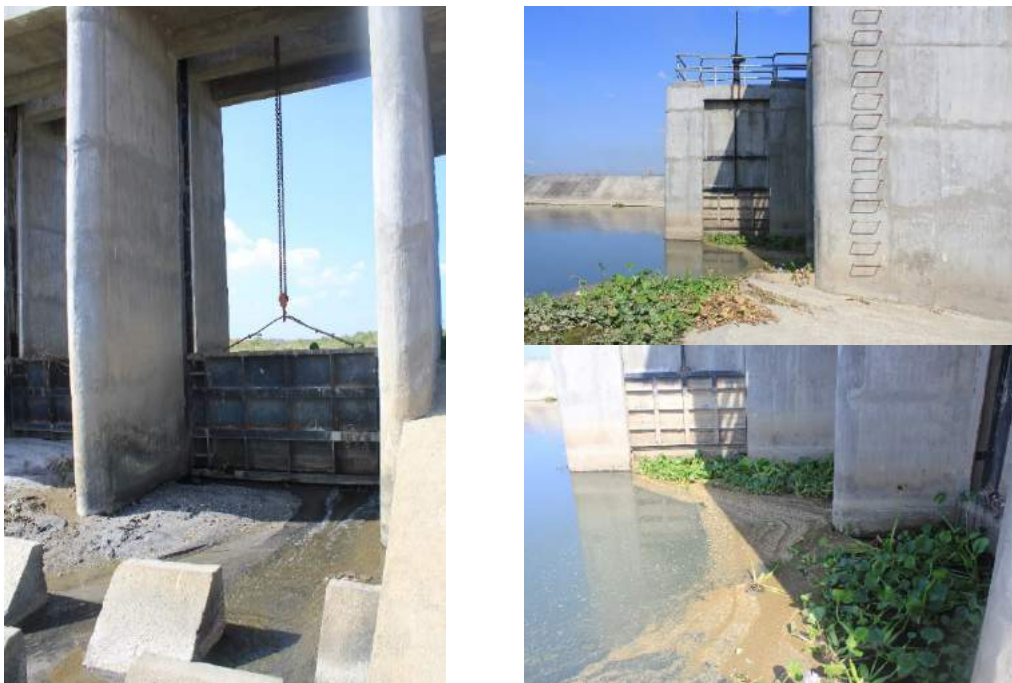
Figure 1A-17. Clockwise from left: (a) the two sluice gates showing some siltation and leakage, also shown are the baffle blocks; (b) The intake structure was designed to be near the middle of the river, the intake gates are still functional; (c) the approach to the sluice gates and intake gates are heavily silted

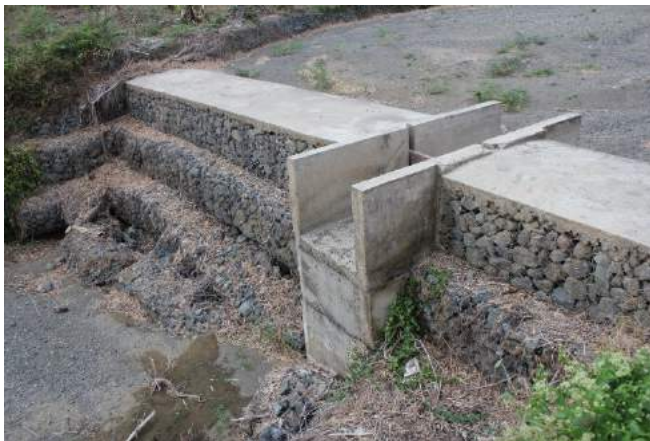
Figure 1A-22. The Cordero CIS dam along Arimal creek is made up of gabions and plastered with cement at the crest; shown at the left side are the damaged gabions where water seeped underneath the dam

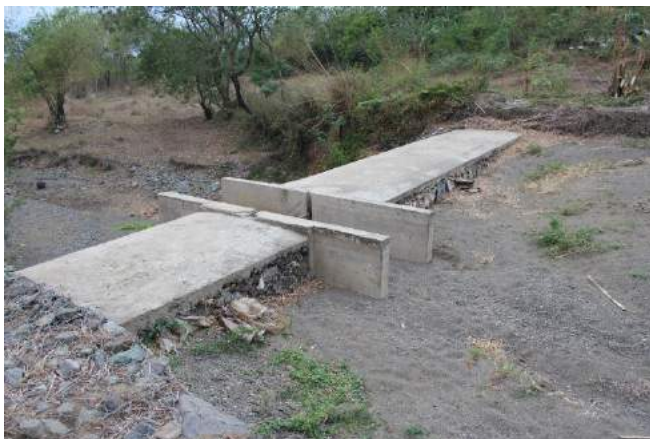
Figure 1A-23. There is no water in the creek during the time of visit and the sediments are almost up to the dam crest

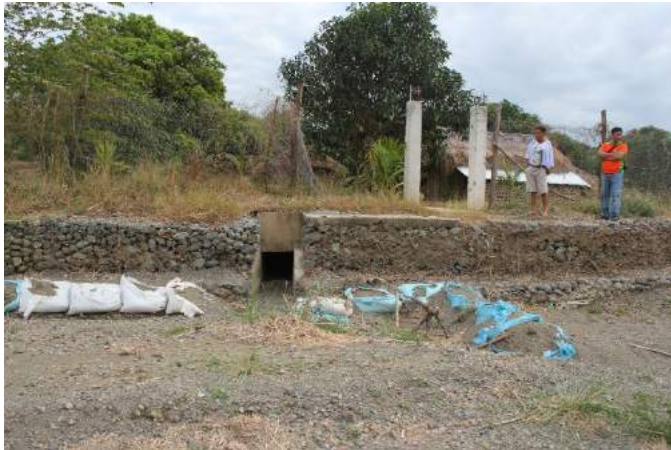
Figure 1A-24. The intake gate upstream of the dam use wooden slabs as gates; the gabions serving as side embankments of the dam are damaged; sand bags used to divert the depleting water last cropping are also shown

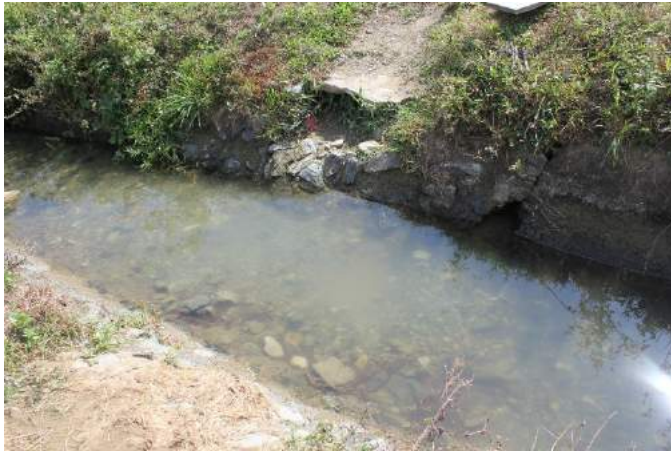
Figure 1A-34. Some portion of the main canal near the highway with damaged side walls and rock laden canal bottom

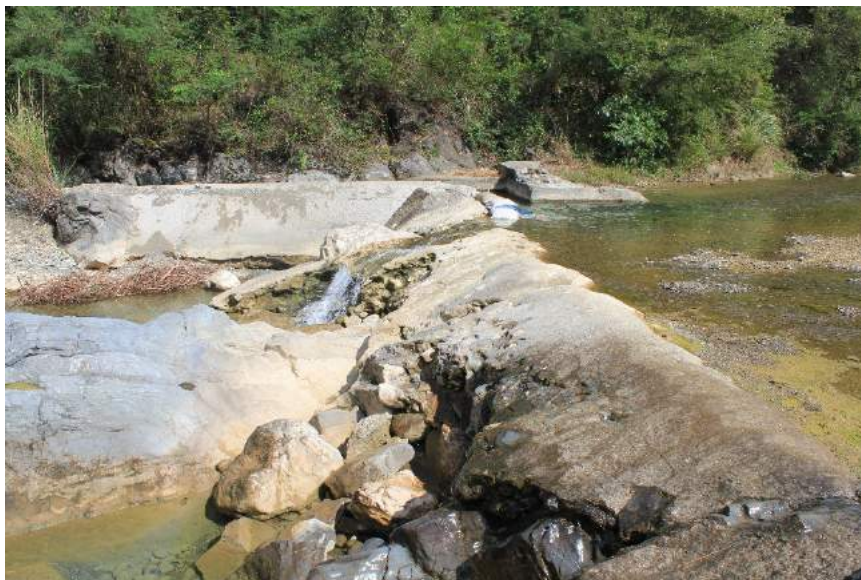
The dam is currently in under disrepair with damaged ogee spillway and downstream apron (Figure 1A-36). The core of rocks and boulders are already exposed and the sediments are almost at crest level. The sluice gate is now made up of piled rocks, woods and sand bags (Figure 1A-37). But enough water is still entering the intake structure (Figure 1A-38) at the time of the survey. The intake structure channels water through an intake channel that lines one side of the river, which then leads into the main canal (Figure 1A-39). Flow to the main canal is controlled by a check gate and the excess water is reverted back to the river through another check gate (Figure 1A-40). The main canal is fairly well maintained with minor siltation and at the time of the survey, the discharge was measured at (Figure 1A-41). Part of the water flowing on the main canal is diverted across the river through an inverted siphon (Figure 1A-42) to irrigate farms in that area. This siphon has been repaired and unclogged once before and still functional during the visit. The IA wants to have an additional siphon to prevent disruption of operation and also to line their unlined canal to increase efficiency of the system.

Figure 1A-36. The Parang-Bugnan CIS dam; the damage at the ogee spillway exposes the dam core made of rocks and boulders; the sediments are almost at the dam crest level

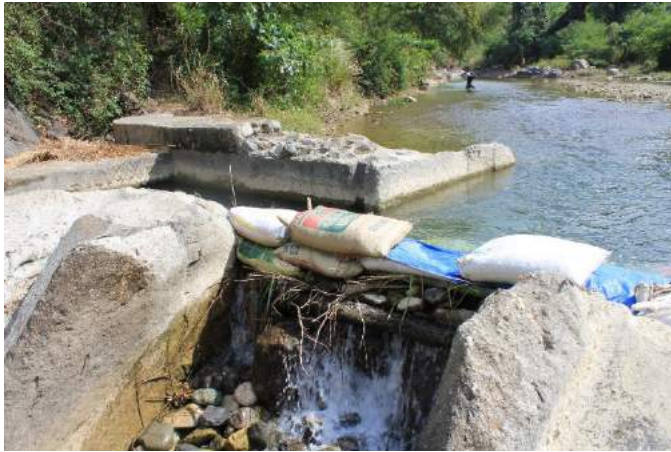
Figure 1A-37. The damaged sluice gate now made up of piled wood, rocks and sand bags
Source: Author's capture

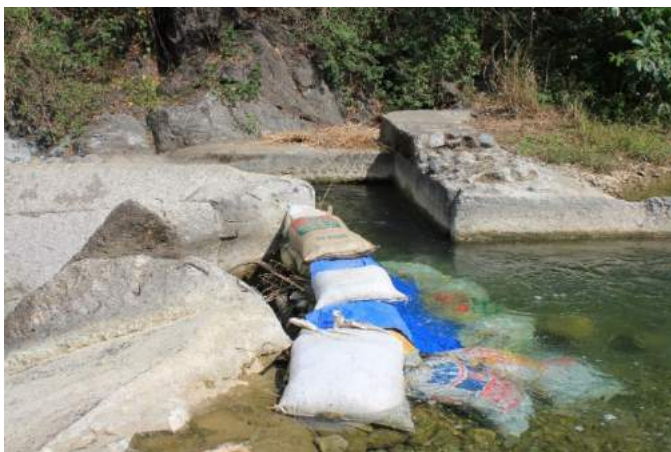
Figure 1A-38. The intake structure showing damaged concrete parts where water flow is guided to the inlet by piles of sand bags
Source: Author's capture

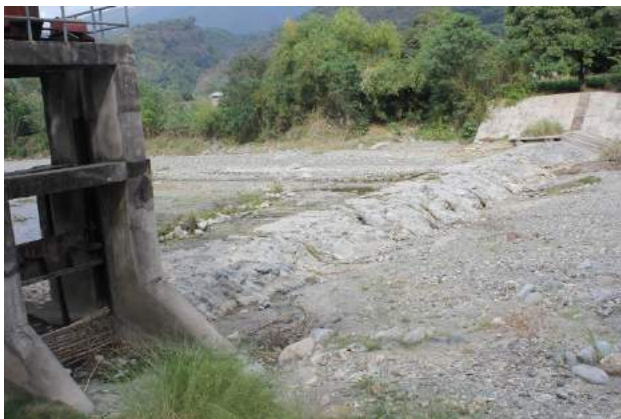
The Ngayao-ngaoan CIS is located at Sison, Pangasinan. It gets water from the Aloragat River. The ogee dam is already damaged and completely filled with sediments (Figure 1A-50), but the concrete embankments and structure for the sluice gate is still in good condition (Figures 1A-50 to 1A-51). The sluice gate however is broken so they use bamboo and sandbags just to divert water into the intake gate. The intake has no check gate, only a steel grill to prevent large debris and stones from entering into the main canal (Figure 1A-52). There are several lined canals and control structures and some have ripraps but most are unlined (Figure 1A-53). The canals are heavily silted and the IA reported several illegal offtakes.

Figure 1A-50. The Ngayao-ngaoan CIS dam showing damaged ogee spillway and silts up to the dam crest; also shown is the sluice gate now made of bamboo

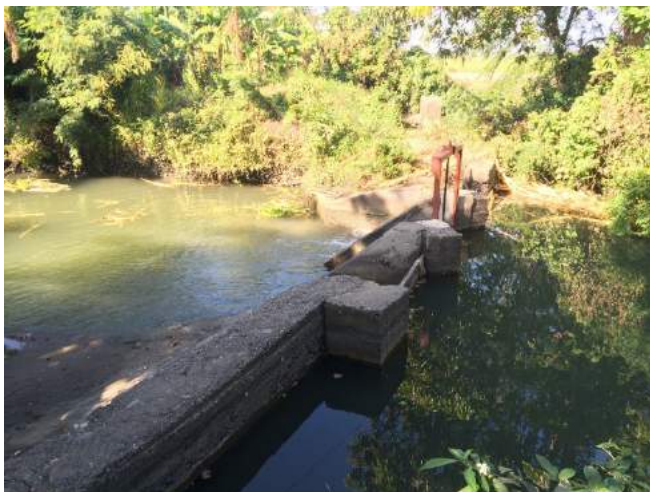
Figure 1A-60. A check gate with one steel gate damaged and replaced with wooden plank

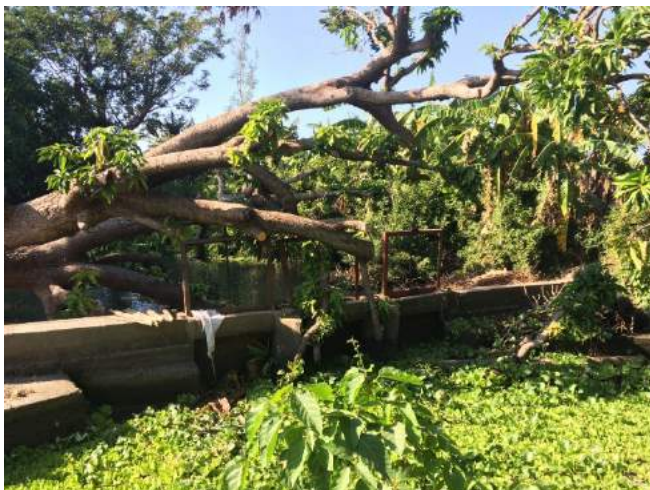
Figure 1A-61. Damaged and non-operational gates due to a tree falling on it during the typhoon Mario in 2014.

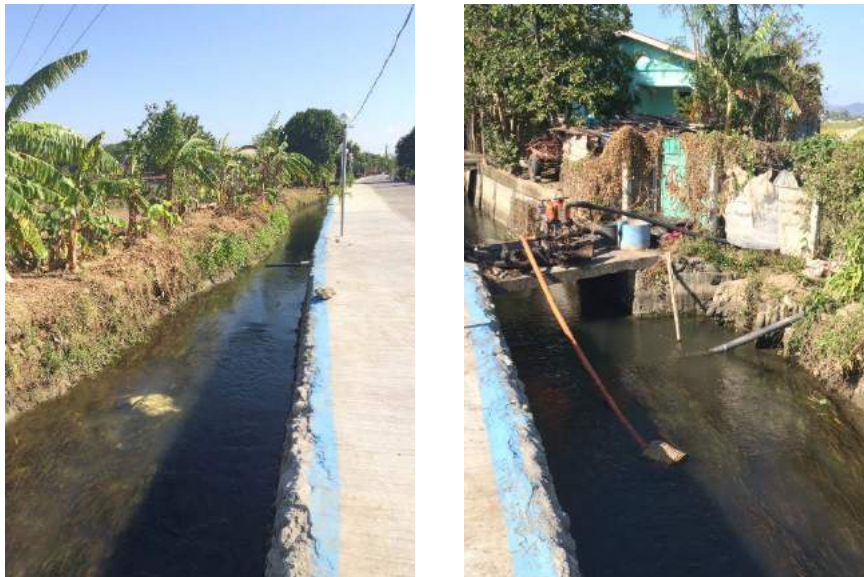
Figure 1A-62. Lateral canals: Left – grasses are growing at the channel bottom; Right – a low-lift pump (LLP) extracting water from the canal (according to the farmer interviewed, the owner of this pump is not a member of the IA).

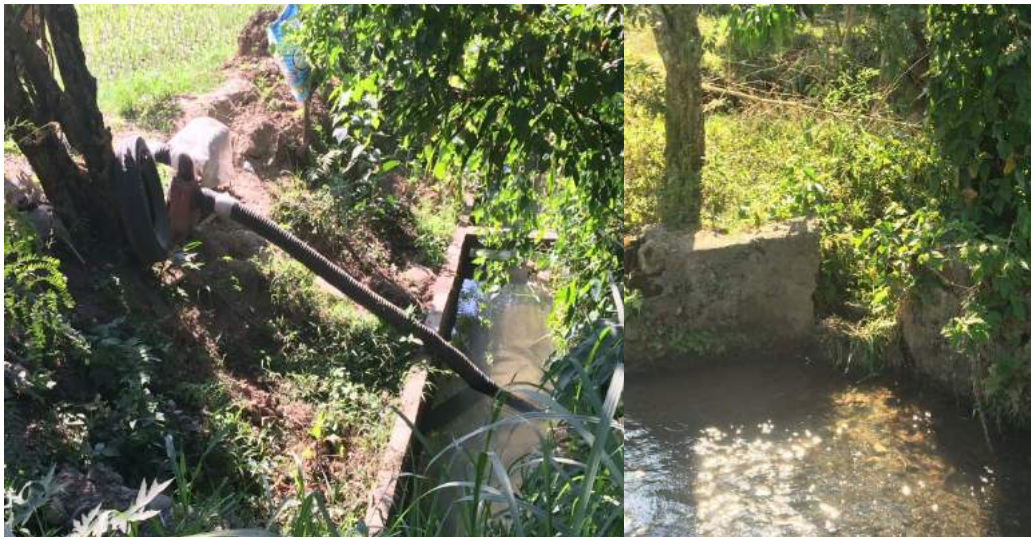
Figure 1A-75. Portions of the main canal with illegal pumps (left) and improvised lateral turnouts (right)

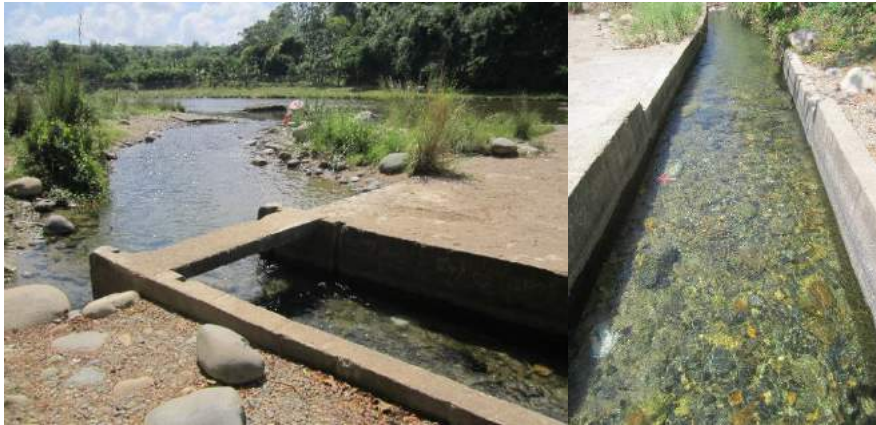
Figure 1A-88. The intake at the side of the dam has no screens and are filled with sediments

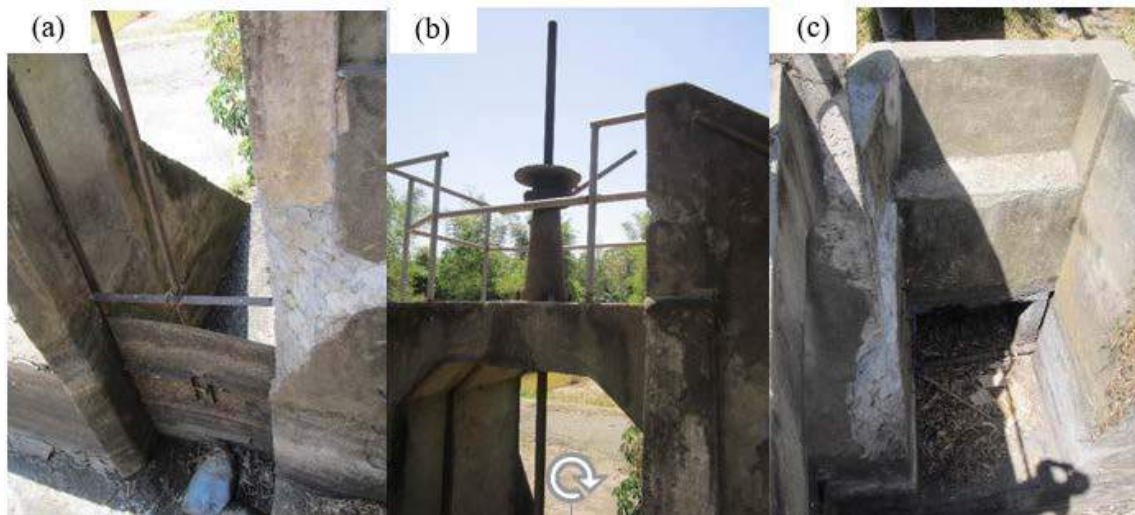
Figure 1A-95. (a) The wooden sluiceway gate; (b) the operating screw of the sluiceway gate; (c) the intake gate with broken regulator

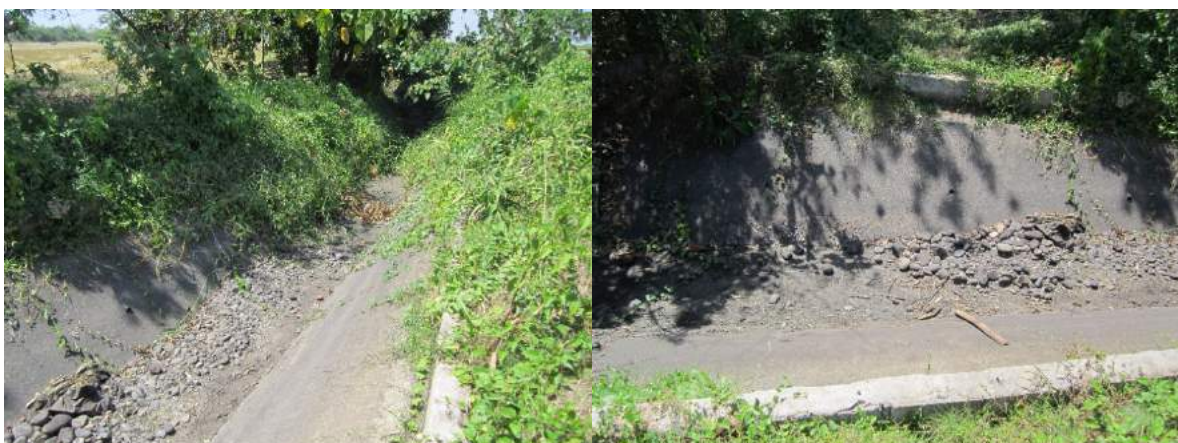
Figure 1A-96. The trapezoidal lined main canal, shown with some sediments at the bottom

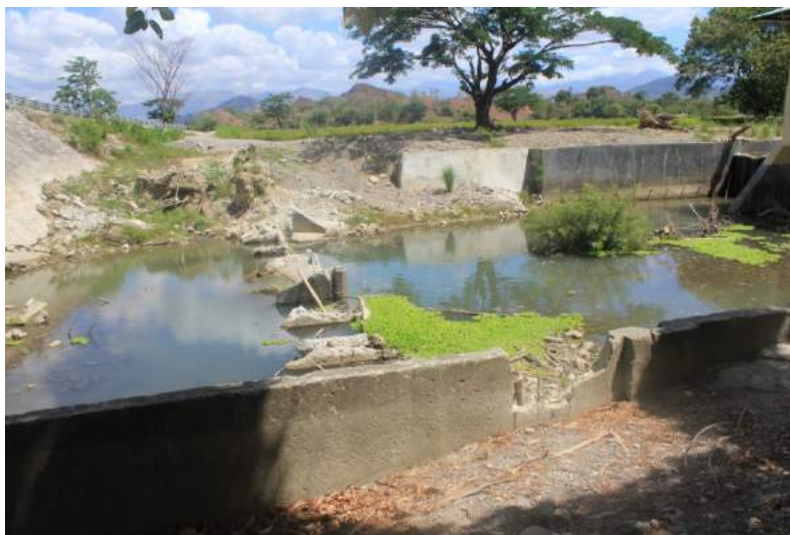
Figure 1A-115. The former Batasan CIS dam that was broken
Source: Author's capture

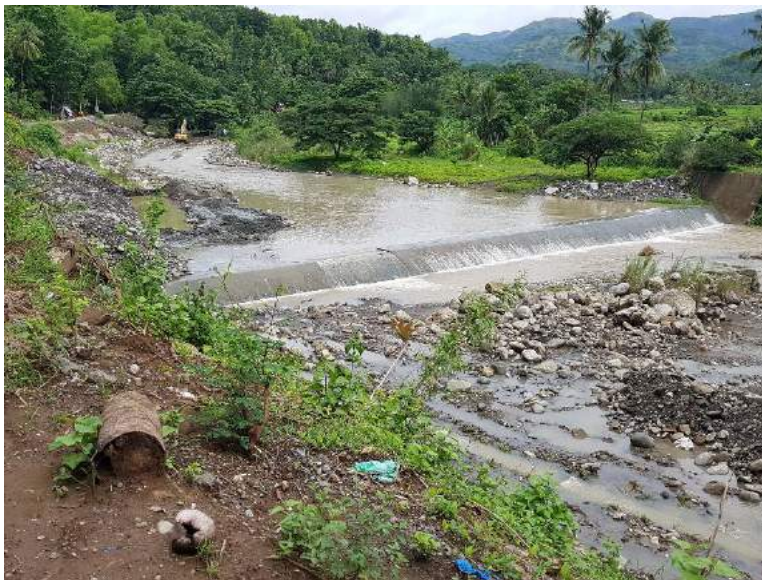
Figure 1B- 24. The Tumagboc CIS dam affected by a road construction on the left
Source: Author's capture

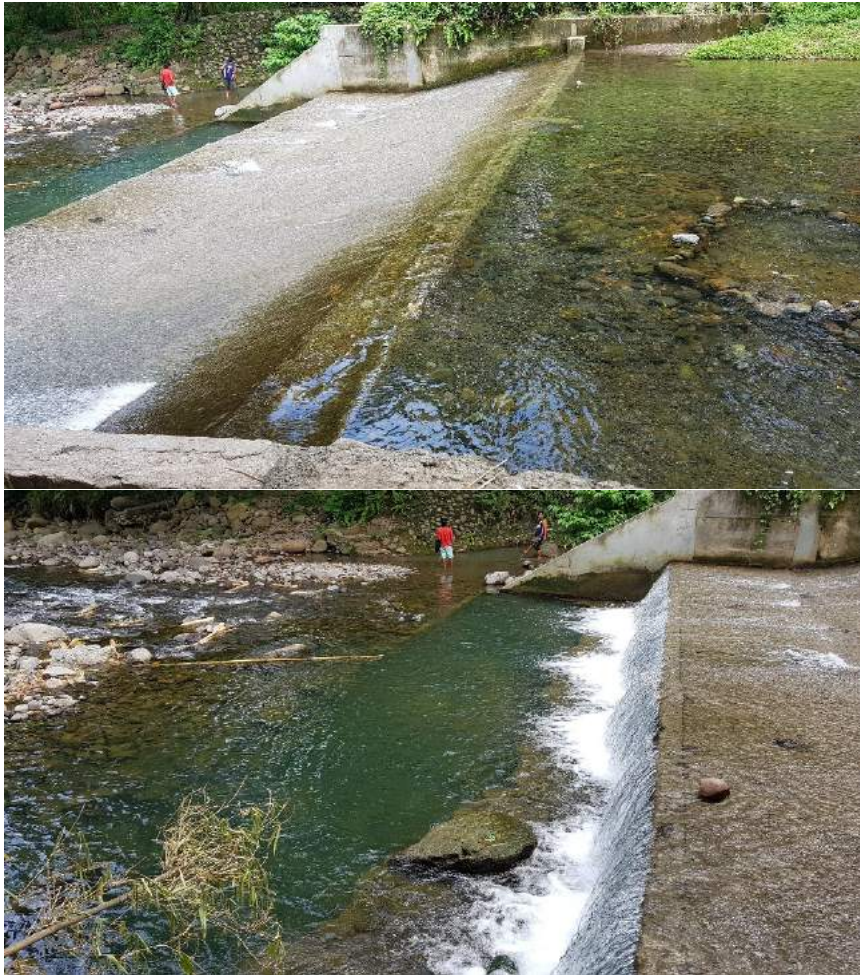
Figure 1C-1. Marapangi Dam of Unifarm CIS showing sedimentation and damaged downstream apron of the dam

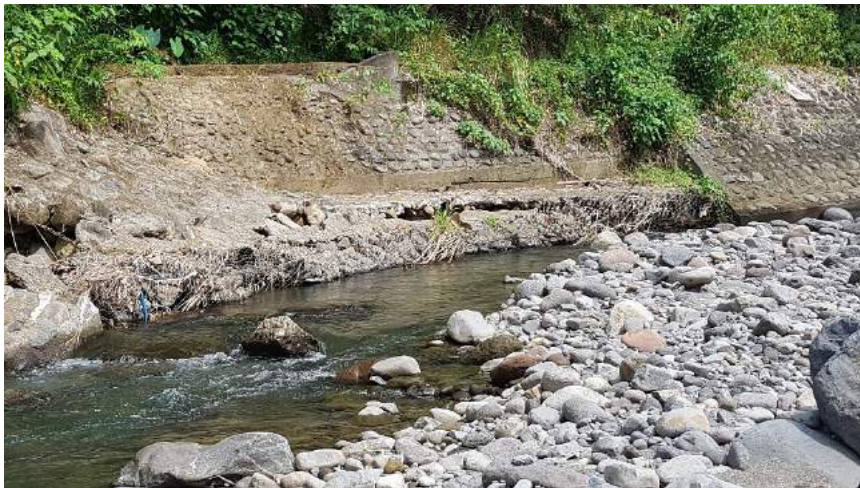
Figure 1C-4. Riprap of bench flume damaged by floods

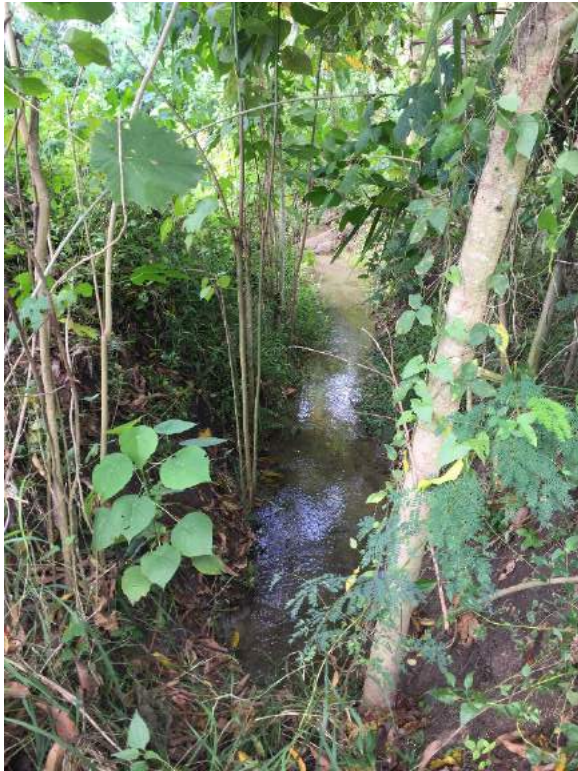
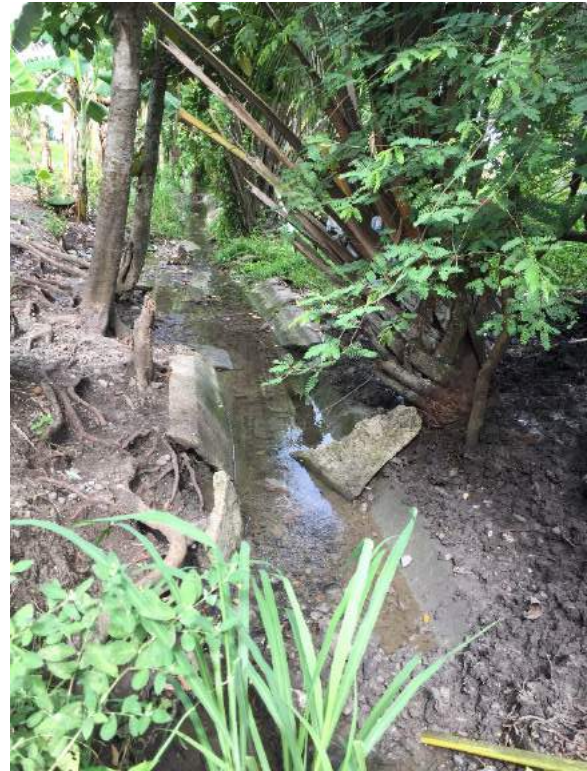
Figure 1C-6. The unlined and broken portions of the main canal

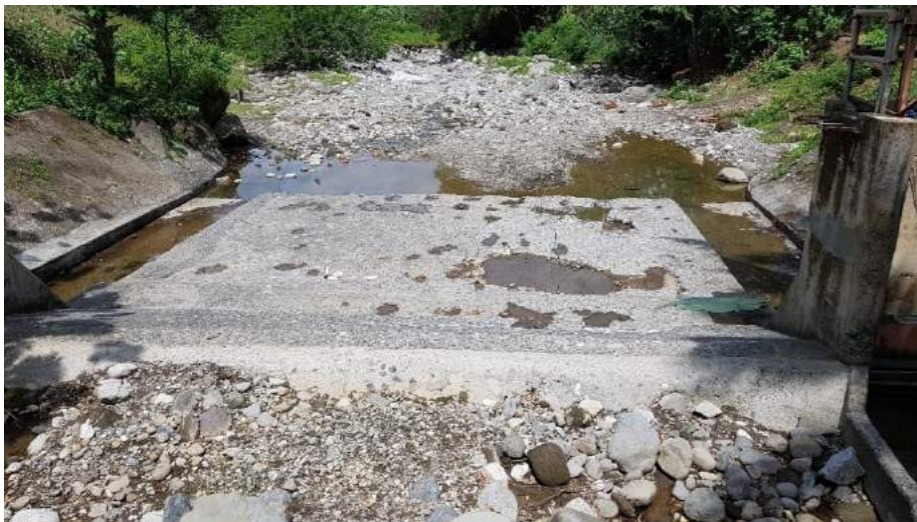
Figure 1C-33. The damaged downstream apron of the dam

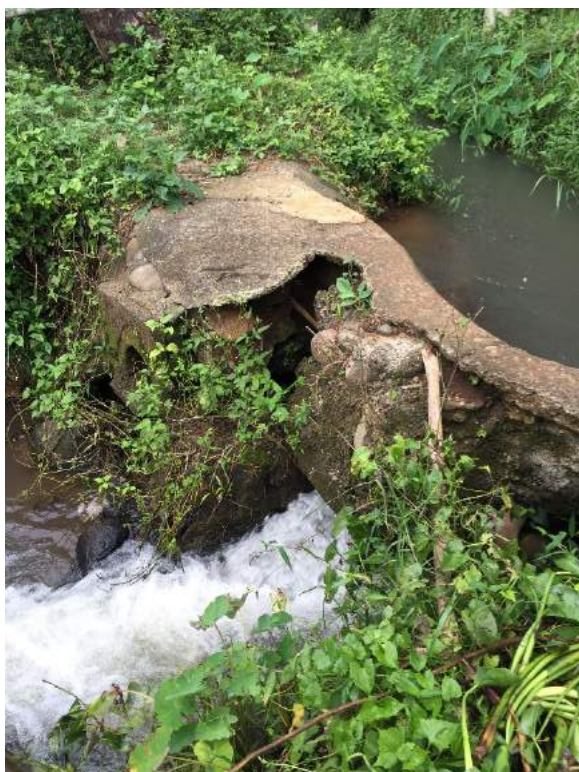
Figure 1C-43. Lateral canal which is broken and no controls
