Conference Paper

54th Congress of the European Regional Science Association: "Regional development & globalisation: Best practices", 26-29 August 2014, St. Petersburg, Russia

URBAN CONSERVATION POLICY- THE CASE OF HAMAMÖNÜ- ANKARA-TURKEY

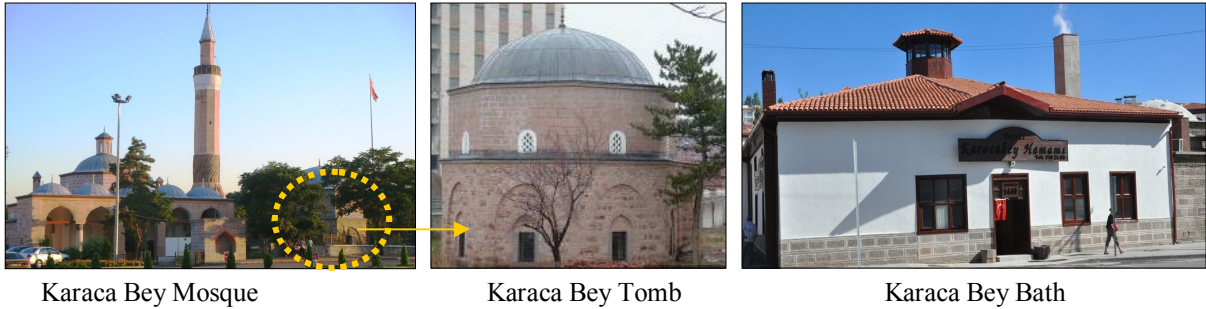
Photo 3.1. Karaca Bey Mosque and Karaca Bey Bath in Hamamönü

Around the religious buildings at Hamamönü, the fabric formed by mansions and usually modest-scale housing structures, dating back to the end of the 19th century, reflects the settlement scheme of the Ottoman Period Anatolian City. Built in 1427, Karaca Bey Mosque is the single example of a mosque with iwans –*eyvanlı*³– in Ankara (Photo 3.1). Following the earthquake of 1892, the five-vaulted worship section of the mosque was covered with a wooden ceiling. Karaca Bey Bath (Photo 3.1) was built in 1440 on an indoor space of two thousand square meters, in the form of a double bath (Aslanoğlu, 1988; Tüfekçioğlu, 2000). The tombs to its west and Tacettin Mosque (Photo 3.2) with a minaret to its northwest were built by Bayramiye Celvetiye Şeyhi Tacettin-i Veli and his community in the 7th century. In 1826, Sultan Abdülmecit had the mosque repaired, and built the Tomb for Tacettin-i Veli, a dervish convent –*dergah evi*–, a drinking fountain and a cemetery. To the east of the Sarı Kadı Mosque (Photo 3.2), built in the 18th century, lies the cemetery –*hazire*–, and to its west, the madrasah –*medrese*– (Mübarek, 1996; Konyalı, 1978; Öney, 1971).

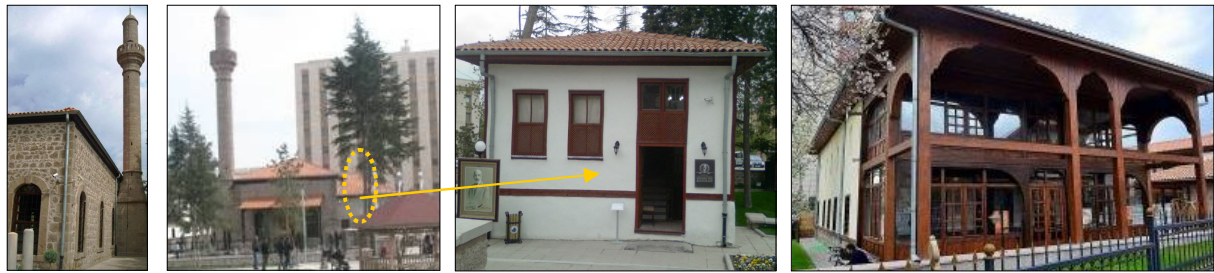
Photo 3.2. Tacettin Mosque, Mehmet Akif Ersoy House, Sarı Kadı Mosque in Hamamönü

The house on the corner of Tacettin Mosque, which was allotted by Şeyh Tacettin to Mehmet Akif Ersoy while he was composing the National Anthem, was transformed into a museum as a dedication with the name of Mehmet Akif Ersoy House in 1949 (Photo 3.2). This building and the other modest-scale housing buildings in the area are usually situated in small parcels (100-150 m²), with a 45-65 m² base area and a plan of basement + two storeys'; they are adjacent and they open up to the street directly (Photo 3.5) . In the U Type Courtyard Plan scheme, three sides of the courtyard are surrounded by rooms and one of the courtyard walls look onto the street; in the L Type Plan scheme, two sides of the courtyard are surrounded by rooms and in front of the other walls is the garden. In small parcels, houses with rooms surrounding all the four sides of the courtyard are also common. The ground floors of the houses are where mohair benches were situated. The buildings are structured on a stone base with wooden bearing walls and brick or stone filling in between, while roofs are brick covered over wooden bearing.

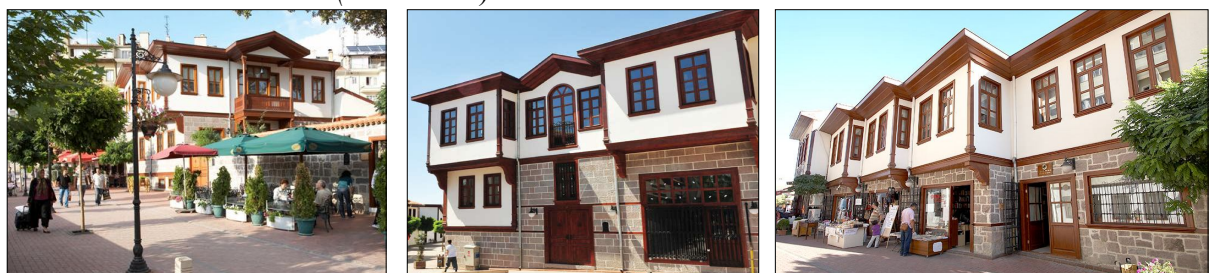
Photo 3.3. The Mansions (*Konak-lar*) in Hamamönü

The mansions –*konak*– in the area, dating back to the 19th century, were witnesses to the founding of the Republic. These relatively larger residences are detached and provide access to the street via a garden-courtyard wall. Beynamlızâde Mansion is where Beynamlızâde Hacı Mustafa Efendi lived as the Member of Parliament of Turkish Republic from Ankara (1923-1935). Kamil Paşa Mansion was built by the honorable Mavi Ağa in the 19th century; it was utilized by Kamil Paşa, the Headquarters Commander of Ankara, until 1918 and by his brother until the 1970s. The notable Kabakçı family bought the Kabakçı Mansion, built in the 1900s, in 1930 and lived there until the 1970s (Aslan, 2012) (Photo 3.3). All of the mansions were leased out until the beginning of the 1980s, yet in the 1990s, they turned into ruins.

- *Street Rehabilitation Project for Mehmet Akif Ersoy and Hamamönü Streets*, encompassing Fırın and İnanlı Streets, was prepared and ratified in 2007 and completed in 2009. Reconstruction was applied to all of the buildings between Hamamönü Street (Photo 3.3, 3.4) and İnanlı Street (Photo 3.5), and others were restored.

- *Street Rehabilitation Project for Sarı Kadı (Kadın)⁴ Street* was prepared and ratified in 2007 and completed in 2009 (Photo 3.3, 3.5). Within the scope of the project, of the 38 buildings in total (11 of which are registered), excluding Tacettin Mosque and Sarı Kadı Mosque, 4 were restored by the estate owners, 1 by HU, and the others, along with the technical infrastructure, by the Municipality.

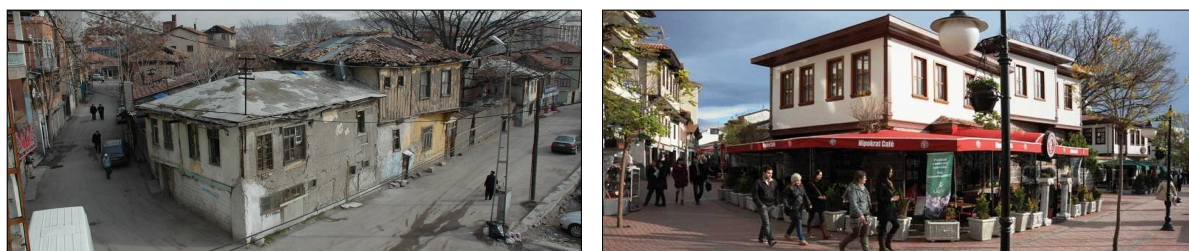
Photo 3.4. Hamamönü Street-Corner / before and after reconstruction

In all these implementations, except for face-lifting and/or refurbishment, tourism and trade focused function changes were applied, as buildings' base areas and inner walls were torn down in order to enlarge the rooms and, as such, the authentic spatial organization has been altered. On the façade, window norms and forms have been deteriorated and non-authentic façade elements (such as doorposts, fringes and frontals) have been added.

- Additional and illegal formation contradicting the pattern has been extracted and authentic vacancy / repletion rates were re-formed.
- The area has been formed into tourism and trade zone through changes in function (Figure 4.3); authentic characteristics in traditional housing and its fabric have been distorted or lost; a new (imitative) traditional fabric has been created. Original spatial organization has been deteriorated in accordance with the demands of function change realized through reconstruction and restoration. Sign posts and street invasions, required by the new function; have hampered the perception of the streets and the buildings (Photo 3.4, 3.5).

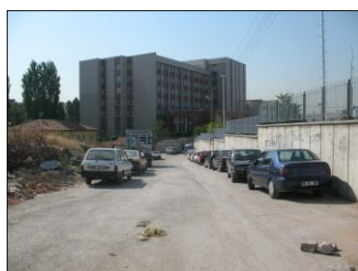
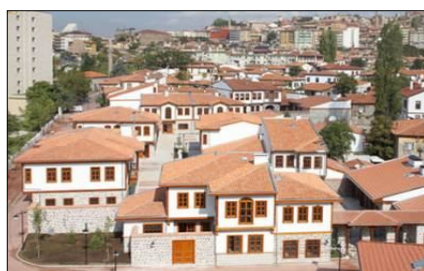
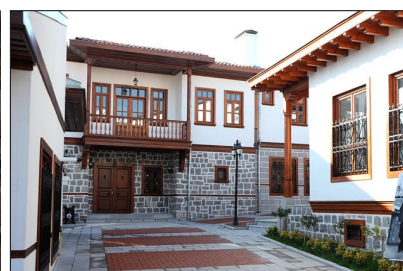
Photo 3.6. Hamamönü -Art Street- Exhibition Hall and Handcrafts Center

Hamamönü -Art Street- Exhibition Hall and Handcrafts Center: This project in which 9 parcels between Sarı Kadı and Mehmet Akif Ersoy Streets belonging to HU were combined and 26 new buildings were realized in an approximately 1000 m² area through a build-manage-turn over model for 10 years (Aslan, 2012), was prepared by the Municipality, it was approved in 2009 and its implementation was completed in 2010. This interference is a technique of urban conservation as defined infill development (Photo 3.6).

2009- Before new construction
Source: Aslan, 2012.

2010- The Exhibition Hall-Crafts Center

2014-View to courtyard

- Through reconstruction implementations, the new buildings (such as Exhibition Hall and Handcrafts Center, Art and Culture Centers and Art Street) providing for the non-authentic functions were built by imitating the traditional residential architecture, thereby transmitting to the present and the future misinformation on immovable cultural heritage (Photo 3.6, 3.7).

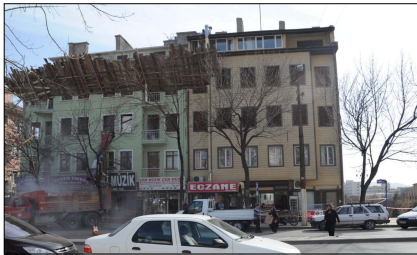
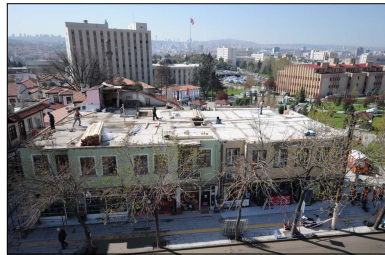
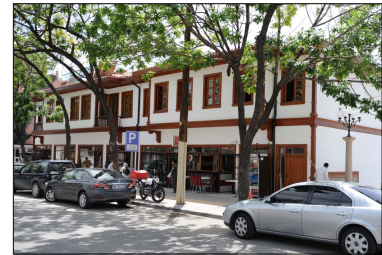
Photo 3.8. The façades of Talat Paşa Boulevard apartment buildings from 2012 to today.

The upper floors of apartment buildings built on Talat Paşa Boulevard in the 1960s were demolished by Altındağ Municipality in 2013. In the same year, the façades of these buildings were renovated according to the traditional fabric (Photo 3.8).

2012- The multi-storey apartments buildings.

2013- When the upper floors demolished

2014- The renovated facades of these buildings

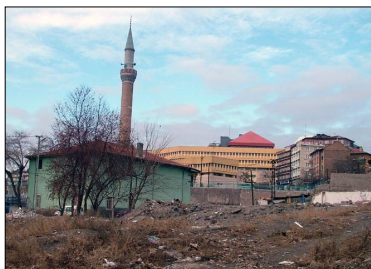
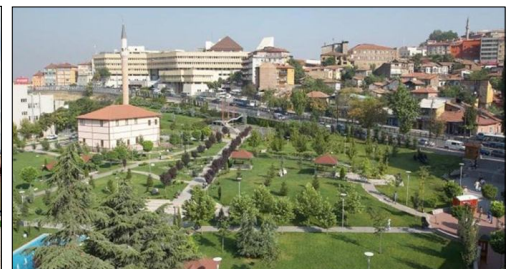
Photo 3.9. Mehmet Akif Ersoy Park and there Hacı Musa Mosque

Mehmet Akif Ersoy Park; The Park was built by the Municipality in 2008 at an approximately 2 acre area starting at Talat Paşa Boulevard and ending at Hacettepe University Campus (Photo 3.9). The restoration of Hacı Musa Mosque which was rendered dysfunctional and meaningless within the park was carried out by the Directorate General of Foundations concurrently with the park.

2007- The traditional houses around mosque were destroyed

The park and the mosque view from Hamamönü Street

- Built after the traditional housing buildings were torn down despite the conservation efforts, the park area is an outdoor location in complete contrast with the original characteristic of the pattern (Photo 3.9).

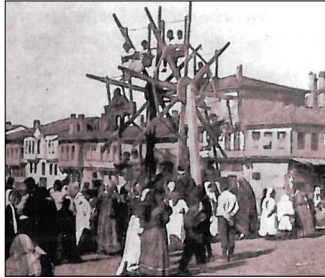
Photo 3.10. The Fair (Panayır) Square from past to today.

The Fair (Panayır) Square; Illegal stores in the old fair area in front of the Karaca Bey Bath were demolished in 2004 and the area was organized as the Fair Square by the Municipality in 2008 (Photo 3.10).

1920s- Fair (Panayır) Square

1990s- The Occupied Square

2004- The Demolished Shops

2014- The squared non-original clock tower

The Fair Square arrangement does reflect the spatial structure of the authentic fabric, yet non-authentic accessories (such as street lamps and clock tower) are engrossing from the perspective of conservation. The fact that Mehmet Akif Ersoy Park was built simultaneously as the traditional housing structures in this area were being torn down and rebuilt is contradictory to the effort of preserving the past.

- The fact that new street furniture (such as sculptures, flower pots, sitting benches and waste baskets, Photo 3.10/2014) has been used instead of authentic street elements (such as alms stone and mounting block) is a kitsch condition.

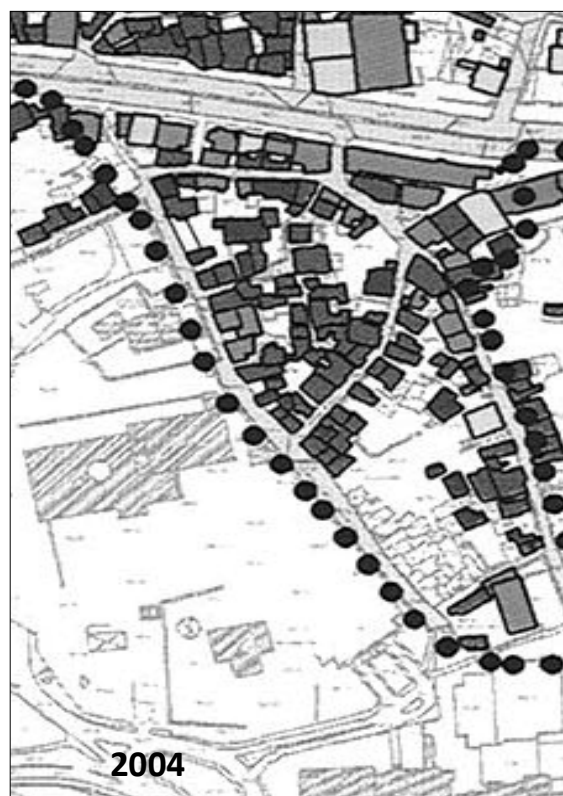
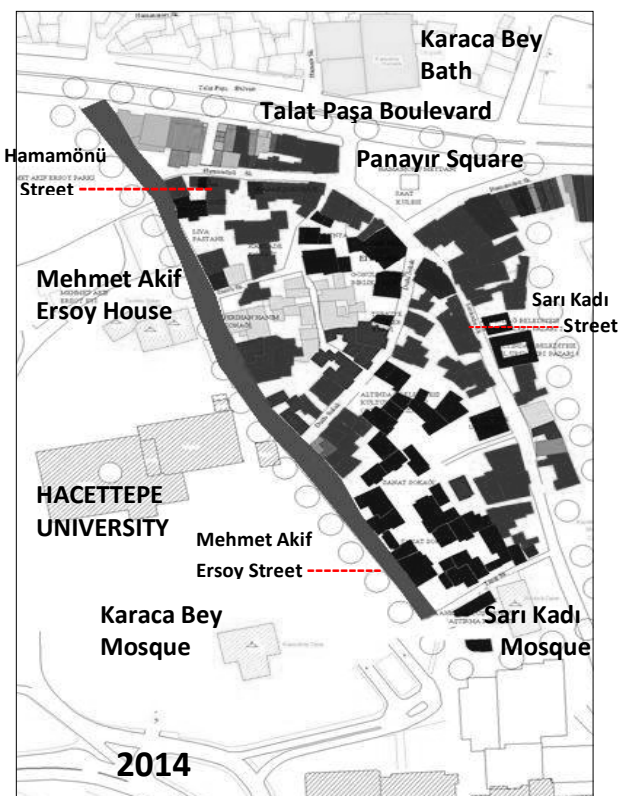
Figure 4.1. The land-use of 1st Upgrading Renewal Zone

As of 2011, applications of rehabilitation were completed and all streets also building have been used (Figure 4.1).

Directorate General of Foundations carried out restoration implementations for the monumental religious buildings of Tacettin Mosque, Hacı Musa and Sarı Kadı Mosque and, the museum of Mehmet Akif Ersoy House. The mostly modest-scale housing structures have been restored by mostly new owners (Figure 4.1).

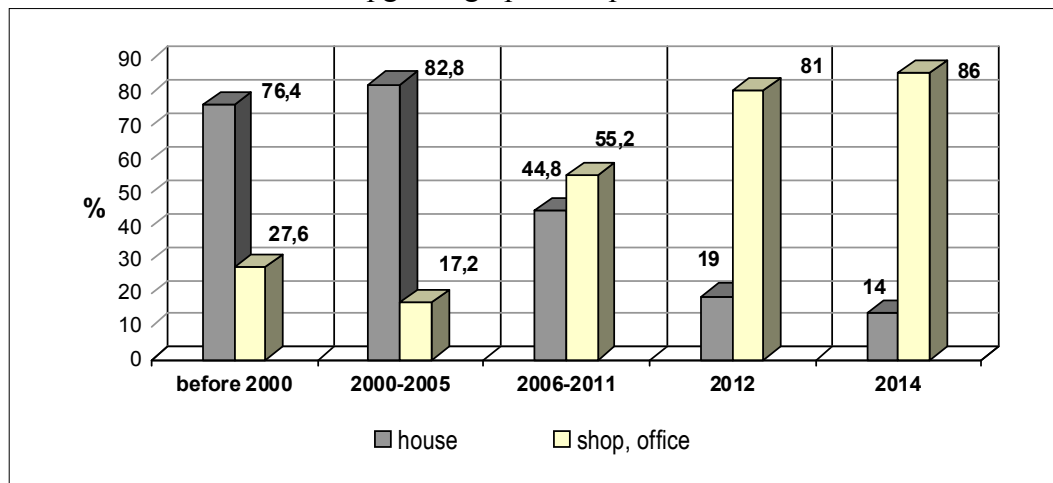
Figure 4.3. Function change at Hamamönü 1st Upgrading Renewal Zone from prior to rehabilitation-upgrading up to the present

- With the widening of the buildings' base areas, addition of basements, transformation of basements and ground floors into stores, reformation of garden-courtyard walls through reconstruction and restoration, the street-parcel-building relation has been destroyed, and hence, the original construction style has been transformed. Instead of plain façade formation and esthetics in face-lifting and/or refurbishment applications, exaggerated ornamentation elements (such as doorposts, fringes, frontals and shades, Photo 3.4, 3.5), not authentic to the fabric or the building, were utilized for the purpose of creating a décor that would be attractive for the new functions and this is completely misleading.

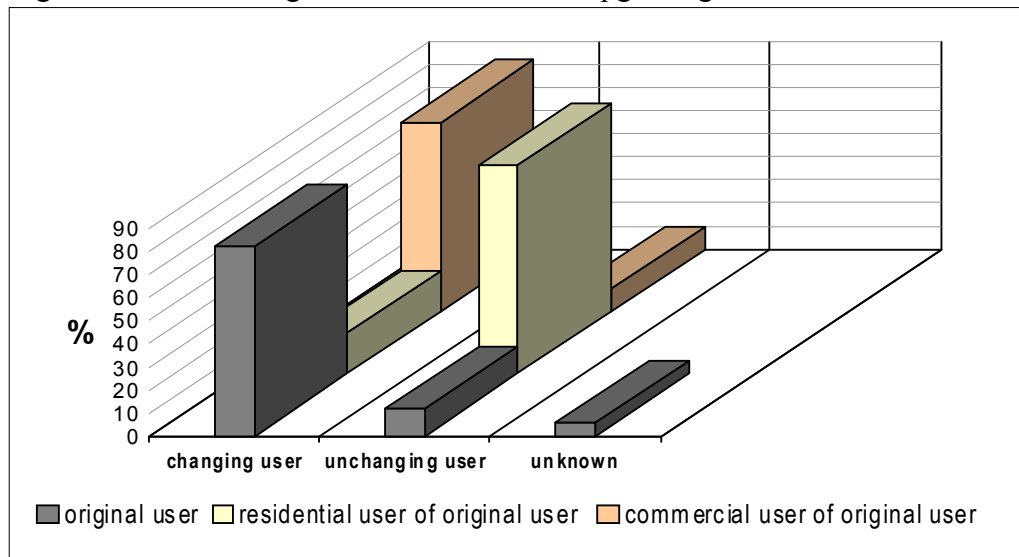
Figure 4.4. User changes after rehabilitation-upgrading in Hamamönü - 2014

- The residents who have been living in this area, deserted by the property-owners for the purpose of living in the modern city, since the 1950s were forced to leave after the gentrification. As such, by the end of interventions in preserving immovable cultural heritage, partner participation has not been provided and ennoblement has been applied. User-change has been achieved over real estate. New property owners (82%) have leased out their immovables to brand restaurants and cafés at high prices or they themselves are utilizing them for commercial purposes. The majority (88%) of those who were residing here in the past (12%) are using the estates in their original function as residence, and only one tailor and one grocer continue to operate at ground floors (Figure 4.4).
