Sequential disaster forensics: An application to floods in the city of Grimma

UFZ Discussion Paper, No. 3/2018

Sequential Disaster Forensics: An Application to Floods in the City of Grimma

Marina Mendoza, Reimund Schwarze

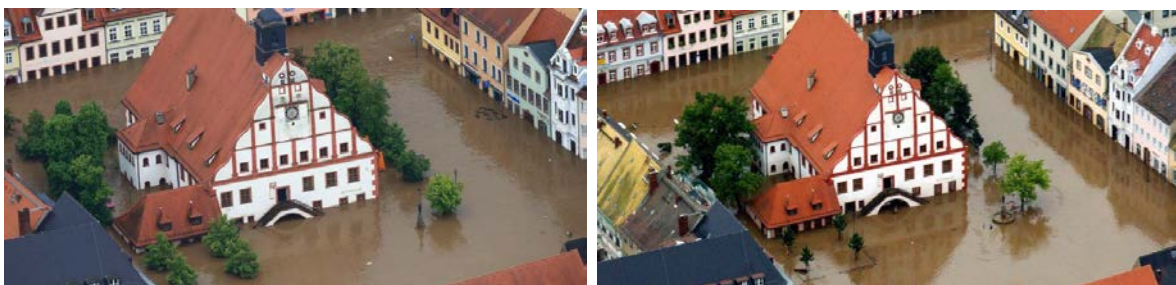
Figure 5 Grimma city hall during the flood in 2013 (Welt.de, dpa / Jens Wolf). Figure 4 Grimma city hall during flood in 2002 (Welt.de, dpa).

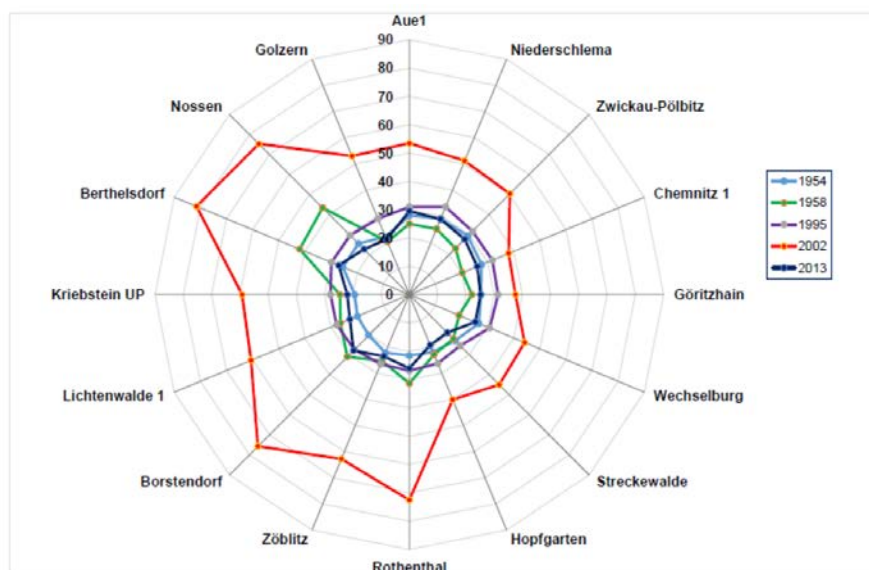
Concerning precipitation, all the indicators (i.e. 6 hours, 12 hours, 24 hours and 48 hours maximum precipitations) show that the 2002 event was much more severe than the event of 2013. Furthermore, when compared to other important historical events, the precipitation in the 2002 flood always stands out, in all the pluviometers of the Mulde catchment in the Saxony State, for all the indicators and historical events. An example is provided in Figure 20 for the 6-hours maximum precipitation (the 12-hours, 24-hours and 48-hours maximum precipitation provide similar graphs).

Figure 8 6-hour precipitation [mm] in pluviometers in Saxony in the Mulde catchment for historical events (Schumann et al., 2016)

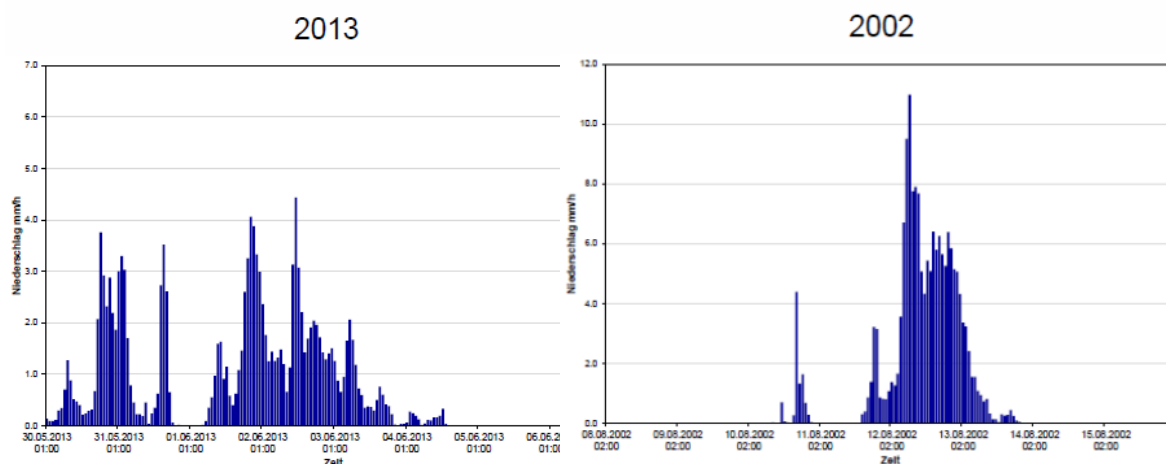
A further difference in the precipitation between the 2002 and 2013 events is found in the precipitation pattern. In 2013, rainfall can be divided into two-time sections (May 30, 05:00 to 31 May, 18:00 and June 1, 07:00 to 3 June, 8:00 pm), as seen in Figure 21 (Schumann et al., 2016). Consequently, runoff increased until late hours of May 31st, with a temporary drop in the amount of rainfall, and then started to increase again, stronger and more prolonged than before, when rain resumed in the morning of June 1st and lasted until June 2nd and 3rd, depending on the location within the catchment.

In 2002, beginning in the afternoon hours of August 10, it rained an average of 11mm into the night hours (around 22:00). In individual areas, significantly higher rainfall values were recorded (e.g. Stollberg 45 mm and Eibenstock 25 mm) (Schumann et al., 2016). Overall, this precipitation was followed by a precipitation-free period, which lasted until the late afternoon hours of the 11th of August (ibid.). After that, intensive precipitation continued until the early morning hours of August 13. Between August 11, 17:00 and August 13, 20:00 hours, around 120 to 300 mm of rain fell in the river basin, depending on location.

Figure 9 Rainfall intensity [mm/h] in time for the 2013 and 2002 flood events in Pegel Bad Dübren 1/Vereinigte Mulde gaging station (Schumann et al., 2016)

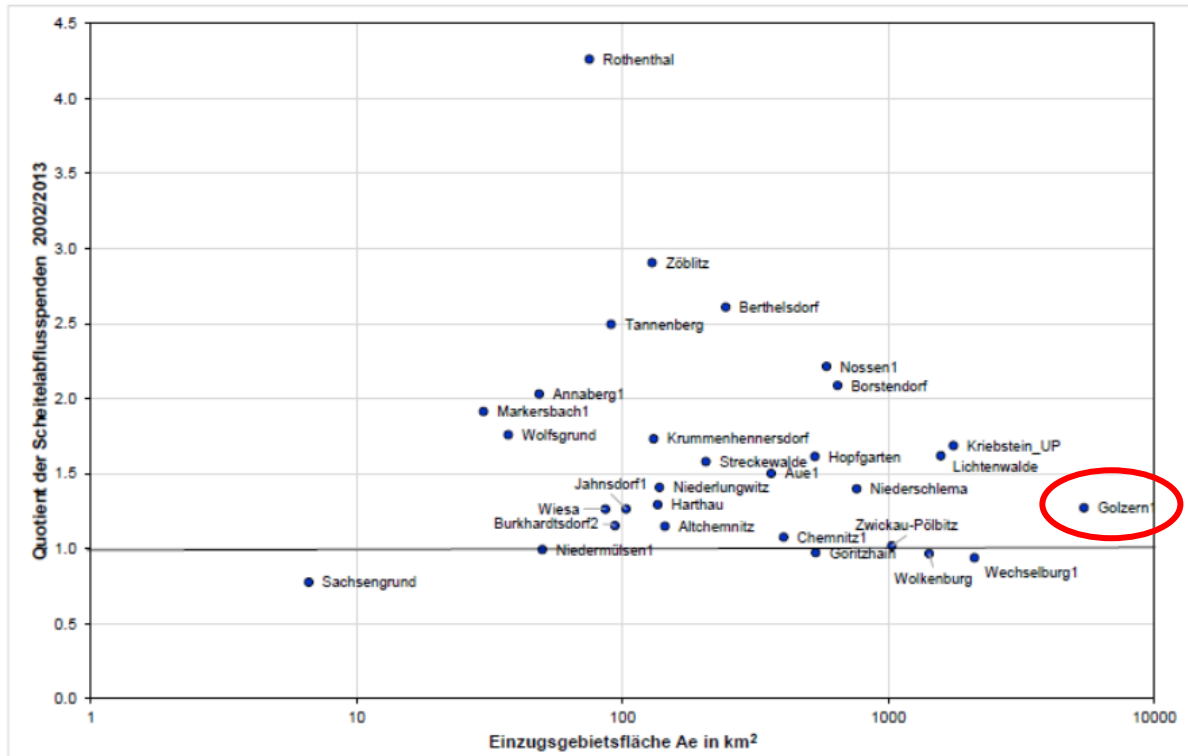
In addition, another indicator that was selected for the comparison was the peak discharge in the same gaging station, Golzern 1. In 2002, the peak discharge measured in Golzern 1 was 2600 m³/s, while in 2013, 2040 m³/s. Figure 23 shows the peak discharge ratios of 2002 and 2013 for all the gaging stations in Saxony. It is possible to see that in almost all cases the peak discharge in 2002 was bigger than the one of 2013, with a ratio that varies from 0.6 to 4.3.

Figure 10 Ratio of peak discharge in 2002 and 2013 in different gaging stations (Schumann et al., 2016)

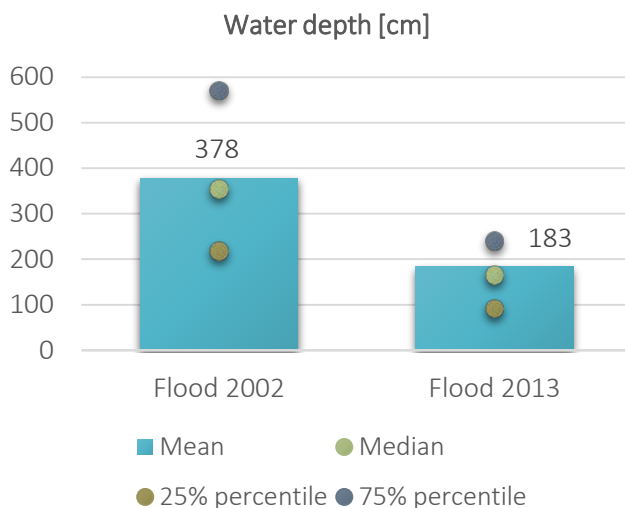
Available data regarding water depth corresponds to the data collected at a household level, through computer aided telephone interviews with residents, from the flood loss data of private households from University of Potsdam, German Research Centre for Geosciences and Deutsche Rückversicherung. Different statistics were calculated from the samples, i.e. statistical mean, median, 25th and 75th percentile, all represented in Figure 23. It is possible to note that even if there is more dispersion in the 2002 values, there is a clear upward shift of the 2002 values with respect to 2013 and, thus, the statistical mean is a good indicator for comparing both events.

Figure 11 Water depth [cm] in 2002 and 2013 floods.

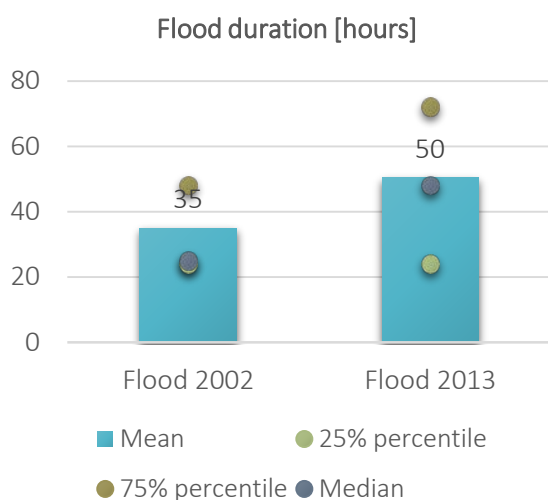
Data from the questionnaires at household level also show the difference in flood duration (Figure 24), depicted by the mean values (35 hours in 2002 and 50 hours in 2013). The higher dispersion in the flood duration values of 2013 was also expected, given that the event actually consisted of two phases, which affects reporting.

Figure 12 Flood duration [hours] at households for the 2002 and 2013 floods.

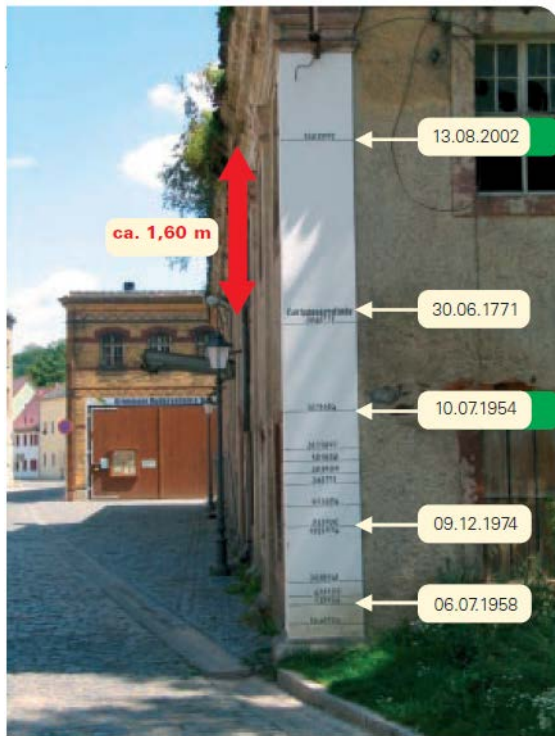
Historical records show that heavy floods occurred in Grimma in the years 1573 and 1771, while minor floods were expected every 20 years (Siedschlag, 2010). The last major flood before 2002 happened in Grimma in 1954, but the water level was not comparable either to the 2002 nor the 2013 floods (Figure 26 and Figure 27).

Figure 14 Water level of historic floods, on the Großmühle building in Grimma centre (Landestalsperrenverwaltung des Freistaates Sachsen, 2006).

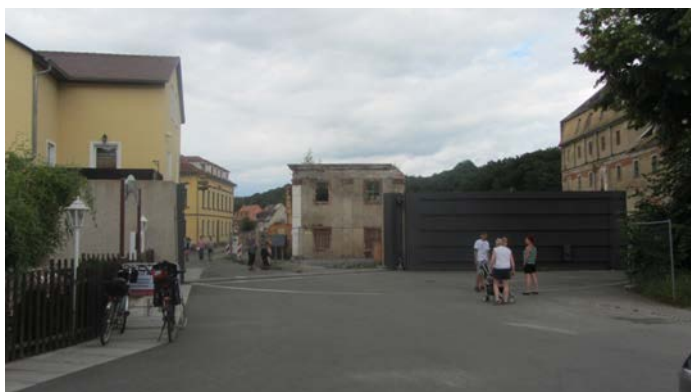
Figure 27 Floodgate, part of the floodwall Project 1.

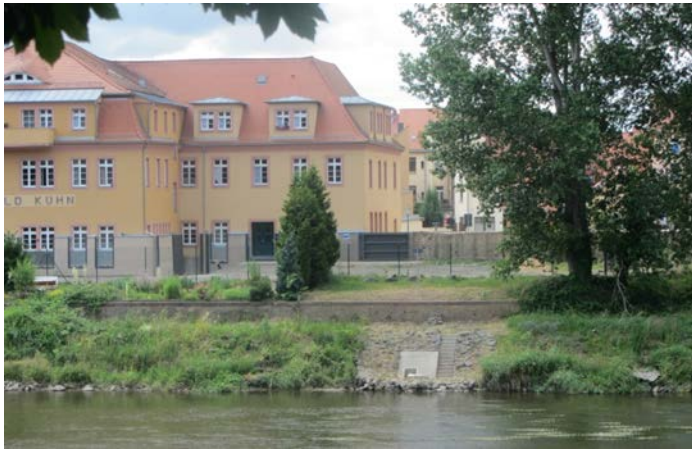
In Project 2, the old city wall from the boathouse to the monastery church, the new wall was erected directly in front of the existing city wall. The height of the floodwall varies between 3.5 m and 4.5 m. Three passageways were left on the wall to guarantee access to the river (Figure 40). All three passages are equipped with a high-water protection gate on the waterside so that the waterways can be closed at

Figure 28 New floodwall, part of Project 2, with passageways for accessing the river and allowing a view (2017, author).

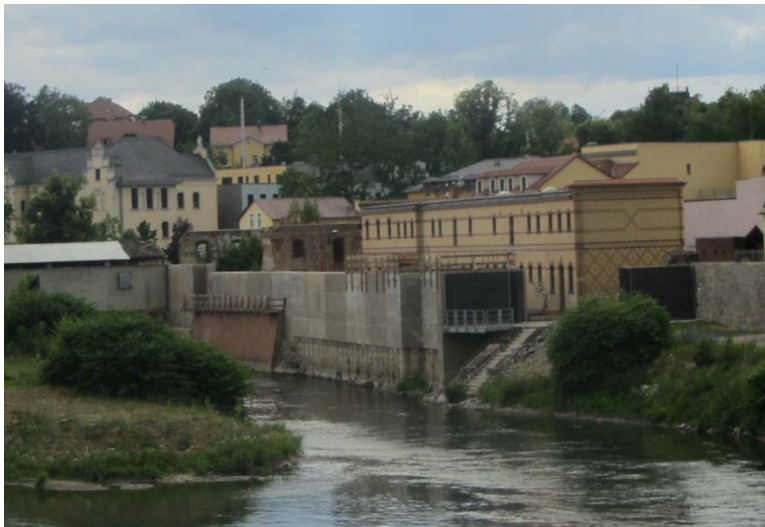
Figure 29 Floodwall, Project 2, under construction (June 2017, author).

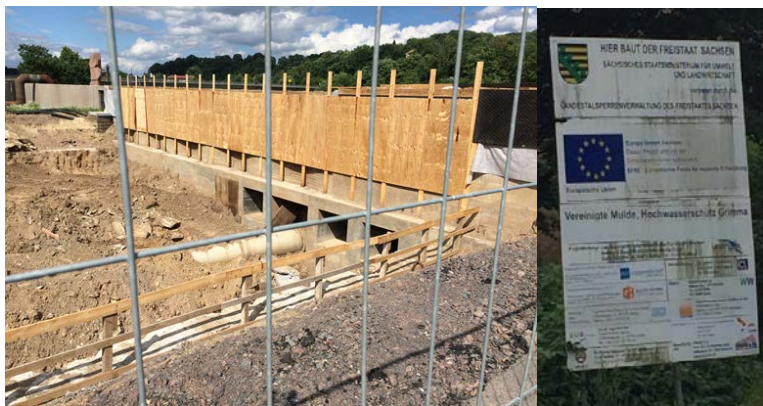
Project 4 begins at the Pöppelmann Bridge and leads to the end of the natural rock massif north of Grimma. A freestanding reinforced concrete wall is envisaged; on the north side of the Pöppelmannbrücke, the protection system runs inland to the foot of the bridge and then swings to the North to meet the new Mulde bridge in a line that is curved towards the river. The height of the flood protection system varies between 2,5 m and 3 m (hochwasserschutz-grimma.de, 2017). This project is still under construction (as to June 2017) and is expected to be finished by 2018 (LVZ, 2016) (Figure 43).

Figure 31 Floodwall, project 4, under construction (June 2017).

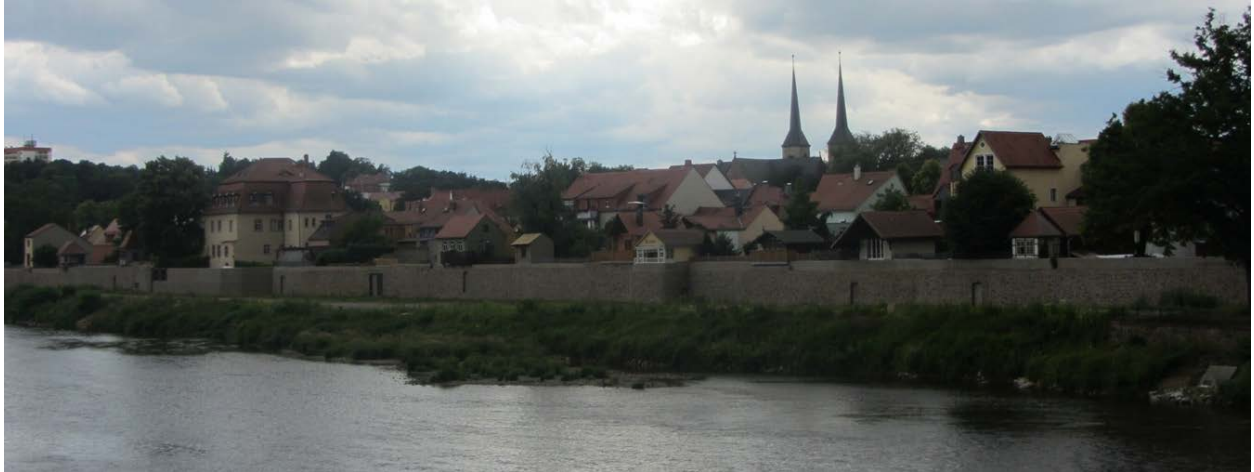
Figure 33 New floodwall, photo taken across the Mulde River by the author (June 2017).

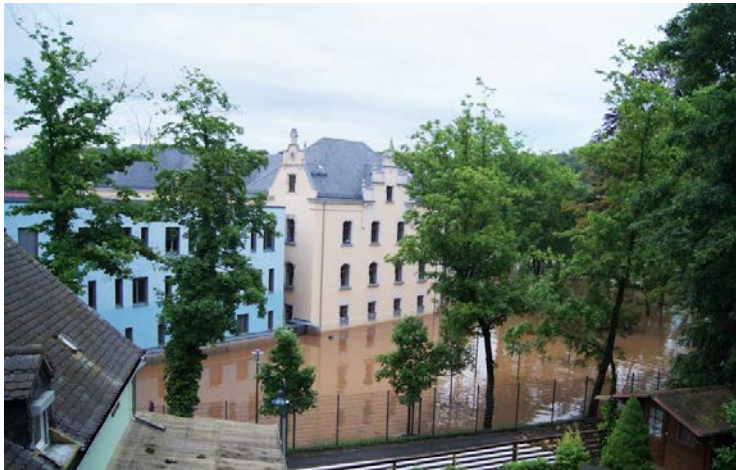
The 2013 flood caused damages of around 150 million euros in Grimma, with about 650 buildings damaged (Grimma Municipality, 2017). These included two schools, one music school, a kindergarten, the city hall, the district court and the new police station (Figure 46).

Figure 34 New police station flooded during the 2013 flood (Colditz-er-tageblatt online newspaper, 2013)

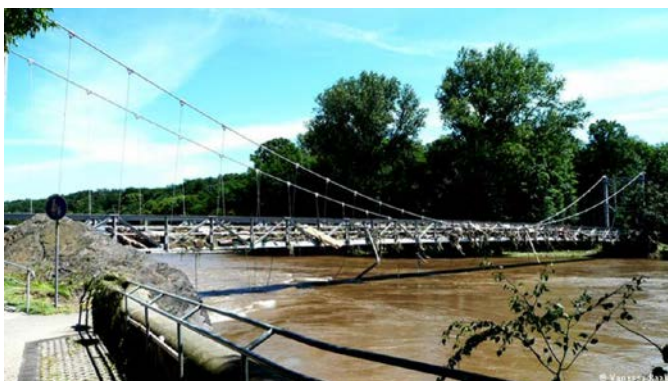
The suspension bridge over the Mulde river was covered with flotsam and unpassable, though it was not damaged (DW, 2013).

Figure 35 Suspension bridge covered in debris on June 6th 2013 (DW, 2013).

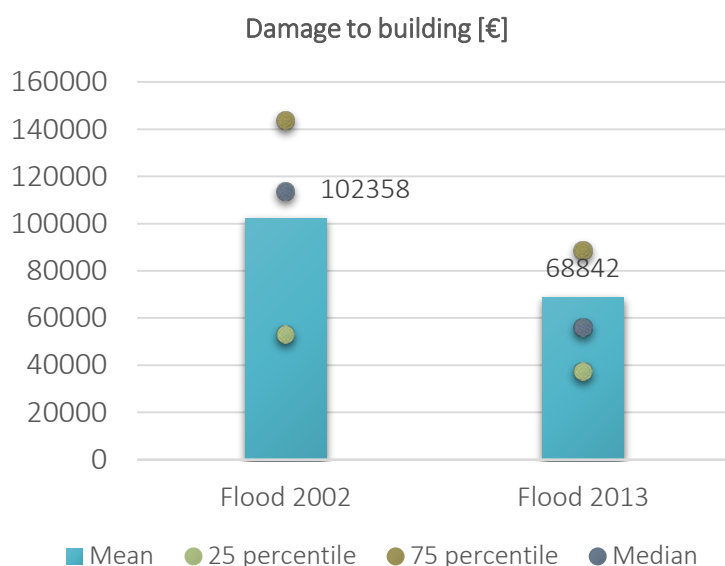
Figure 36 Damage to buildings (corrected for inflation to 2013) within the samples for the 2002 and 2013 floods.

As it would be expected, considering that the water depth was higher during the 2002 flood, as analysed in a previous section, damage to the building statistics of 2002 are higher than those of 2013. Nevertheless, damage to household contents does not follow the same trend (Figure 49). The fact that damage to contents is very similar in both events could be explained by the important difference in flood duration.

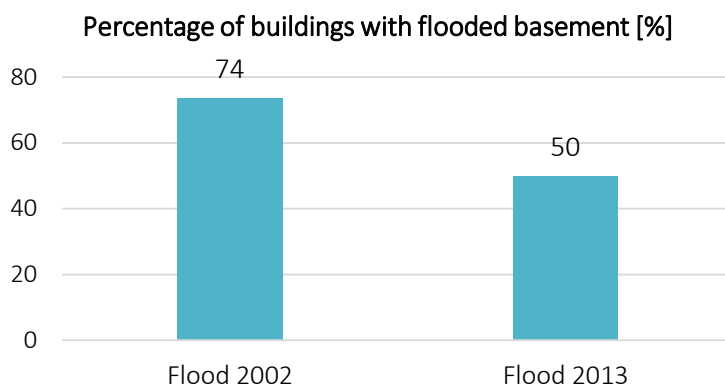
The first hypothesis or assumption to be tested is that in 2013 there were more buildings in the sample with a flooded basement. If this were the case, then basements would be flooded, and their contents damaged, which would add to the total damage to contents, even with a lower water depth.

Figure 38 Percentage of buildings within the sample with flooded basements in the 2002 and 2013 floods.
