Seismic Protection of Laboratory Contents: The UC Berkeley Science Building Case Study

**Seismic Protection of Laboratory Contents:
The UC Berkeley Science Building Case Study**

Professor Mary C. Comerio
Institute of Urban and Regional Development
University of California, Berkeley

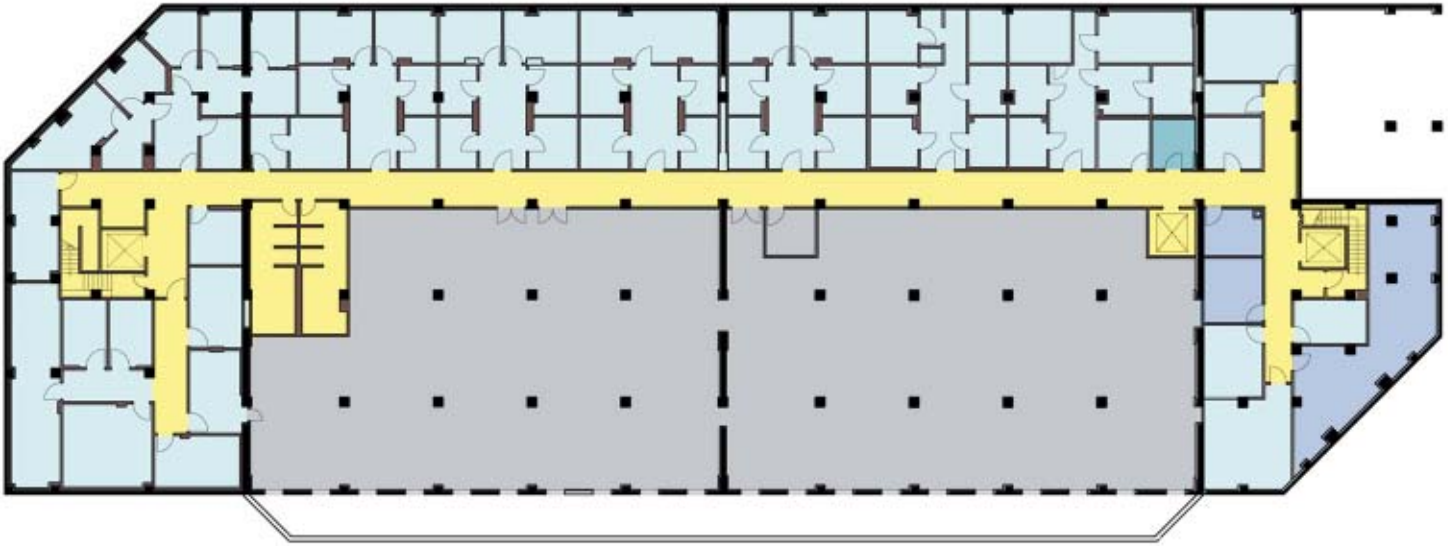
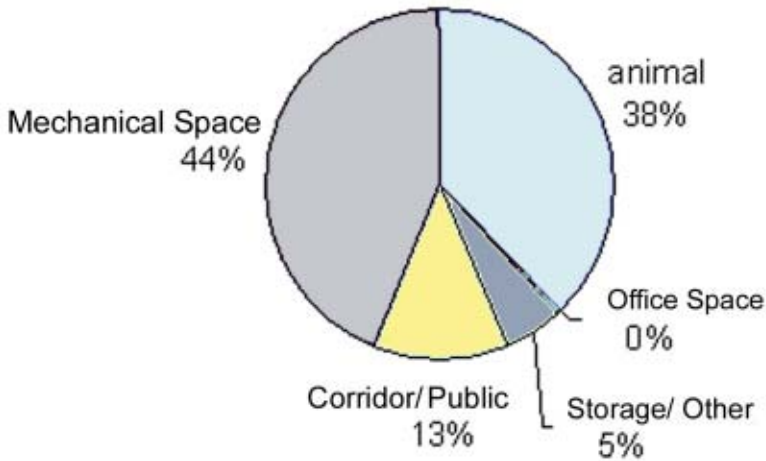
Figure 4: Basement-Floor Plan and Space Use

- Animal Space: 9,877 SF
- Office Space : 99 SF
- Storage/ Other : 1,403 SF
- Corridor/Public : 3,314 SF
- Mechanical Space : 11,442 SF

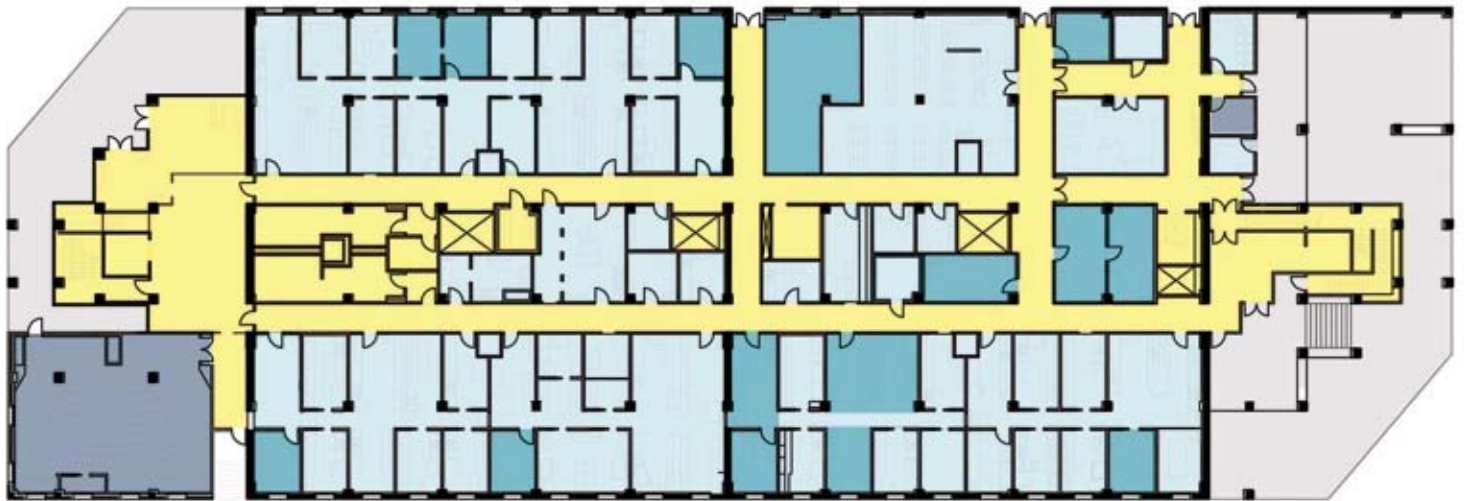
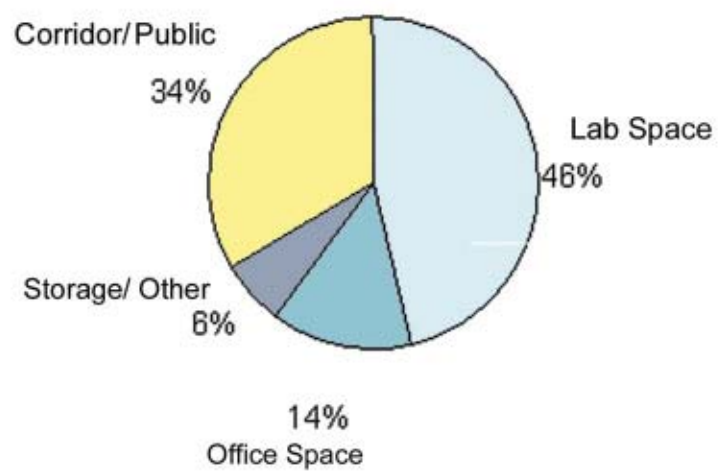
Figure 5: First-Floor Plan and Space Use

- Lab Space : 10,843 SF
- Office Space : 3,227 SF
- Storage/ Other : 1,479 SF
- Corridor/Public : 7,277SF
- Outside covered Area

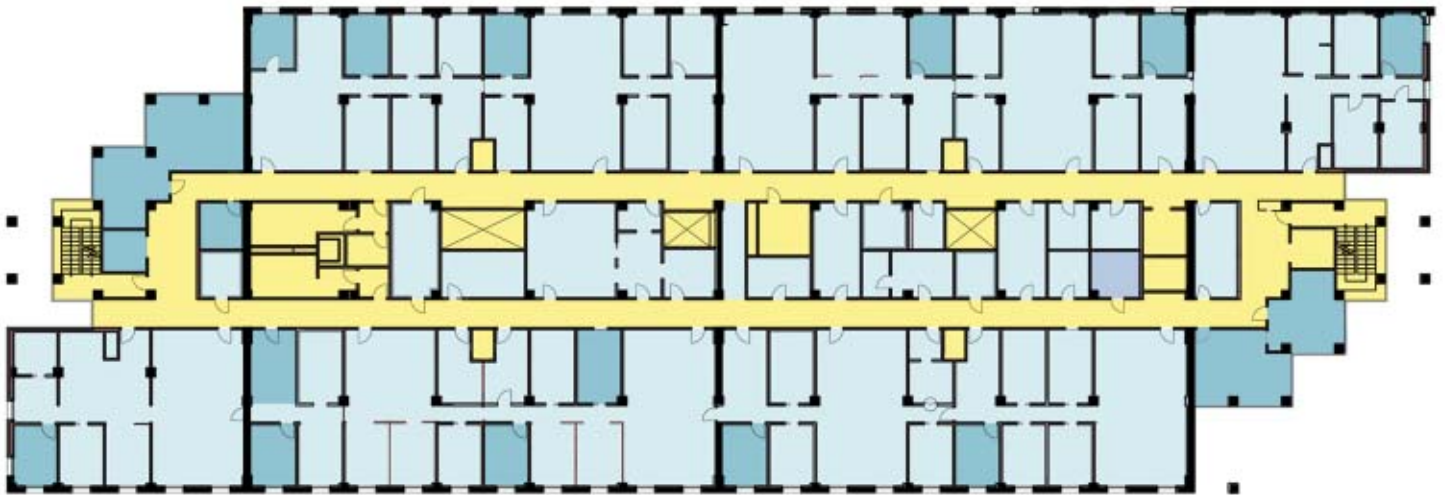
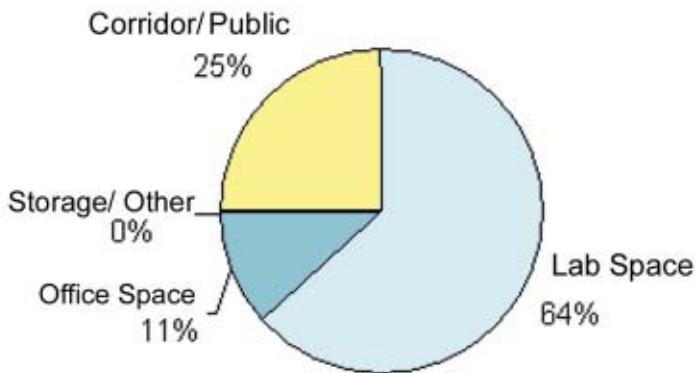
Figure 7: Third-Floor Plan and Space Use

Corridor/Public : 5,815 SF

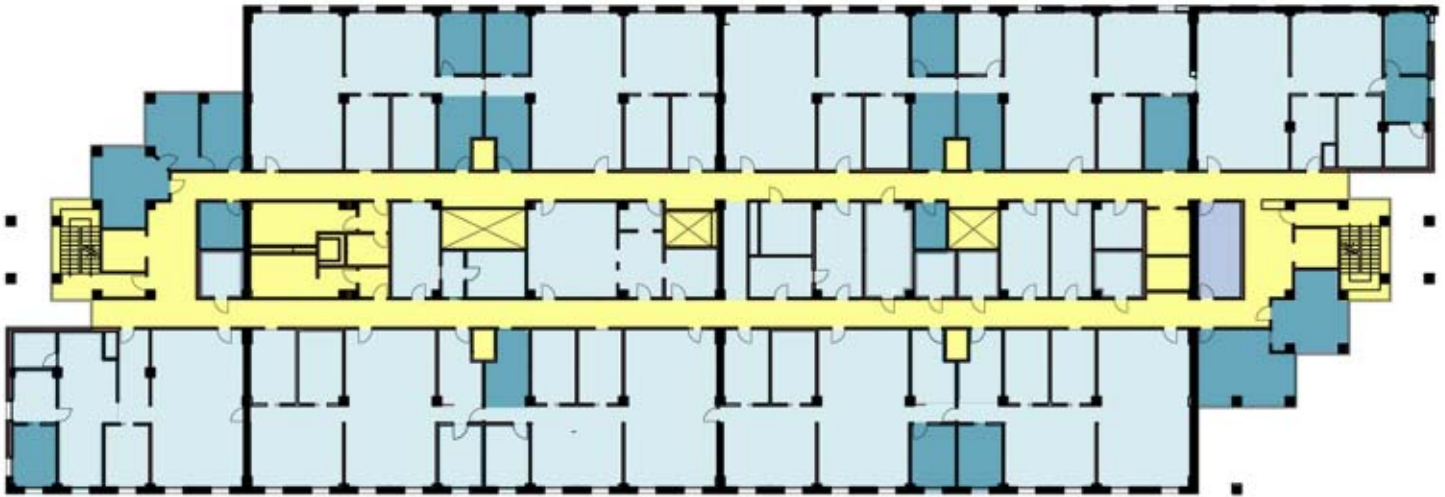
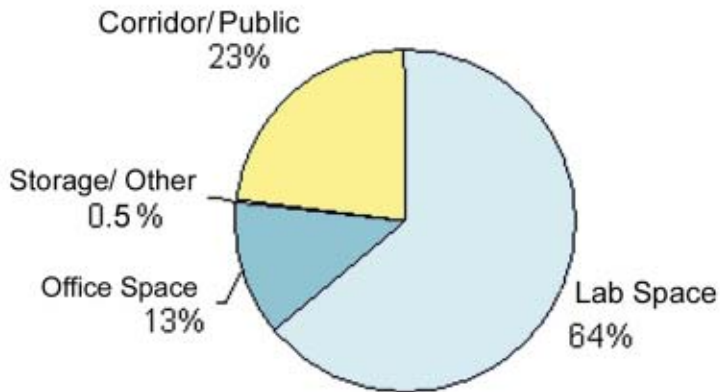
Figure 8: Fourth-Floor Plan and Space Use

- Lab Space : 16,559 SF
- Office Space : 3,301 SF
- Storage/ Other : 23 SF
- Corridor/Public : 5,374 SF

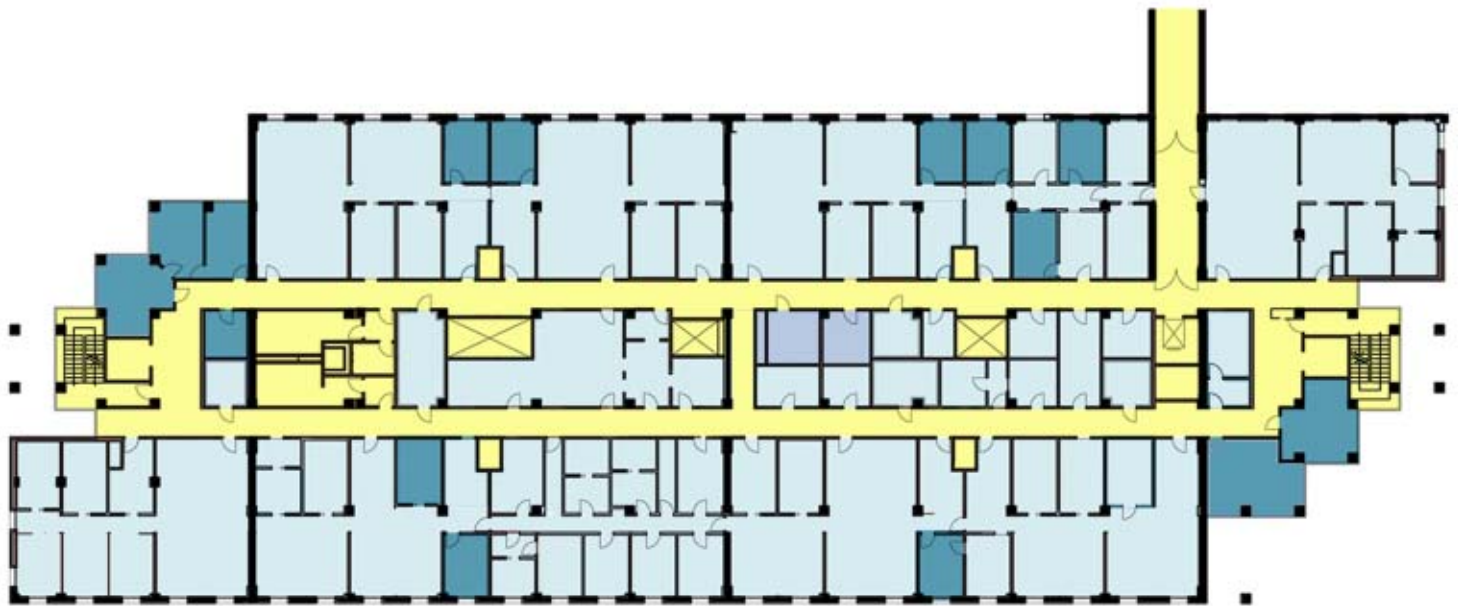
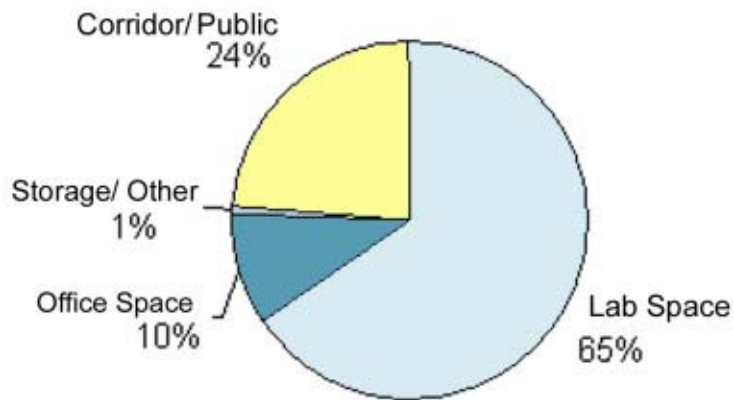
Figure 9: Fifth-Floor Plan and Space Use

- Lab Space : 16,748 SF
- Office Space : 2,649 SF
- Storage/ Other : 147 SF
- Corridor/Public : 5,531 SF

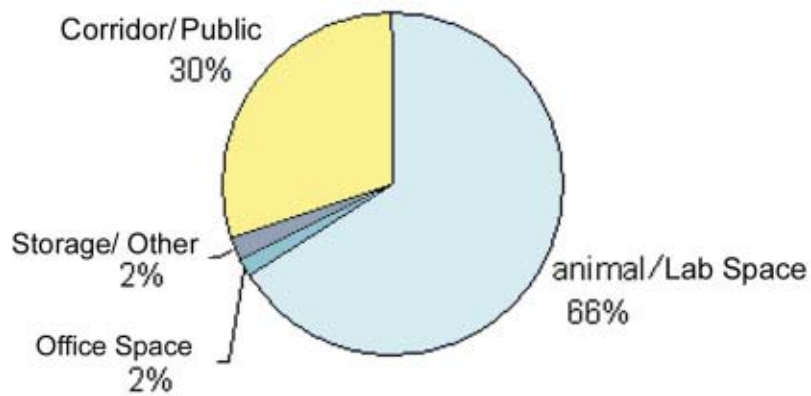
Figure 10: Sixth-Floor Plan and Space Use

- Animal/LabSpace: 16,490 SF
- Office Space : 443 SF
- Storage/ Other : 513 SF
- Corridor/Public : 6,974 SF

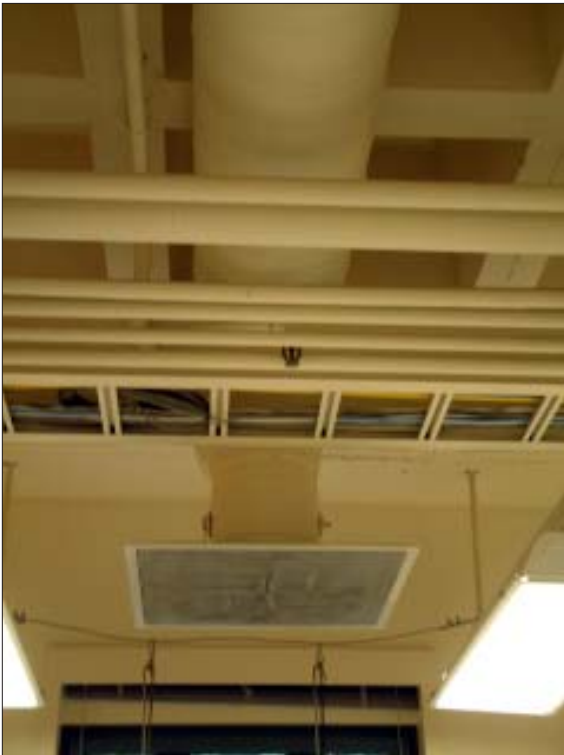
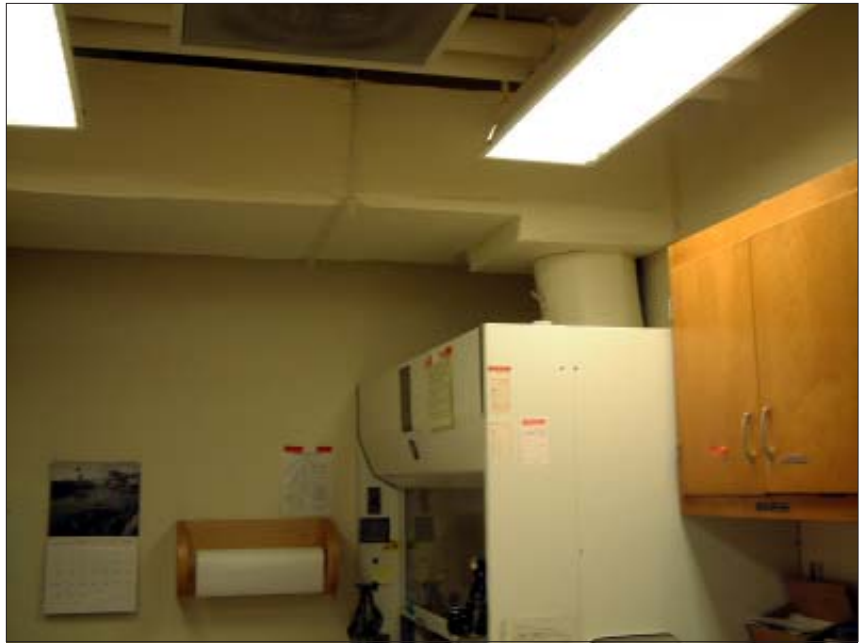
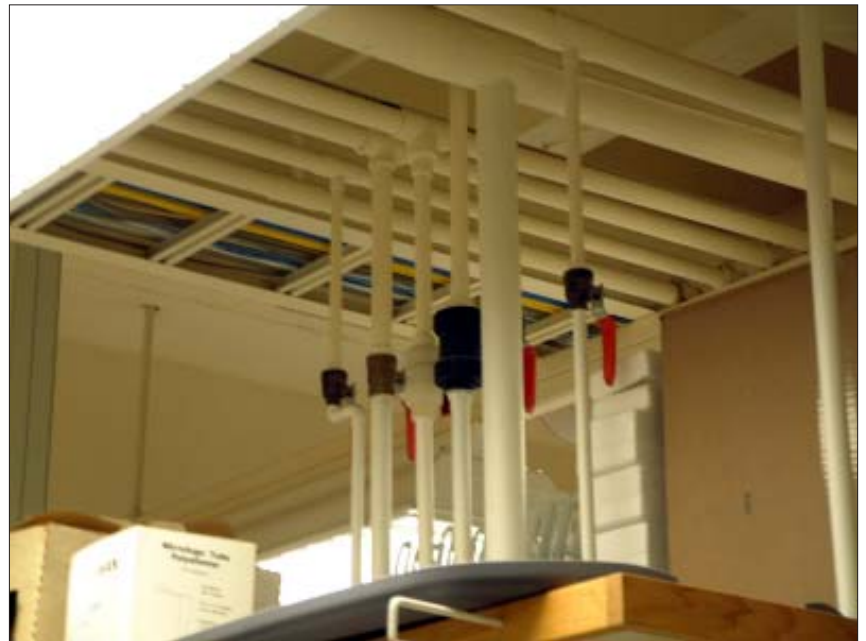
Figure 13: Mechanical System Photos

suspended air supply and cable tray

fume hood vent

lab vent and waste

laboratory support

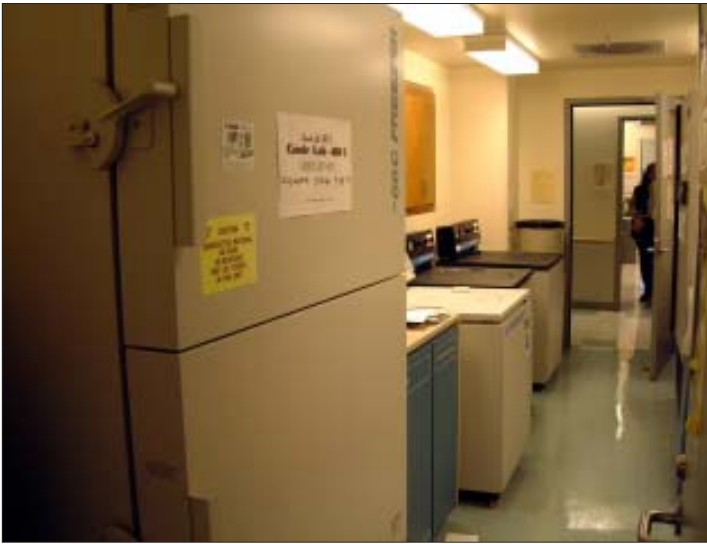
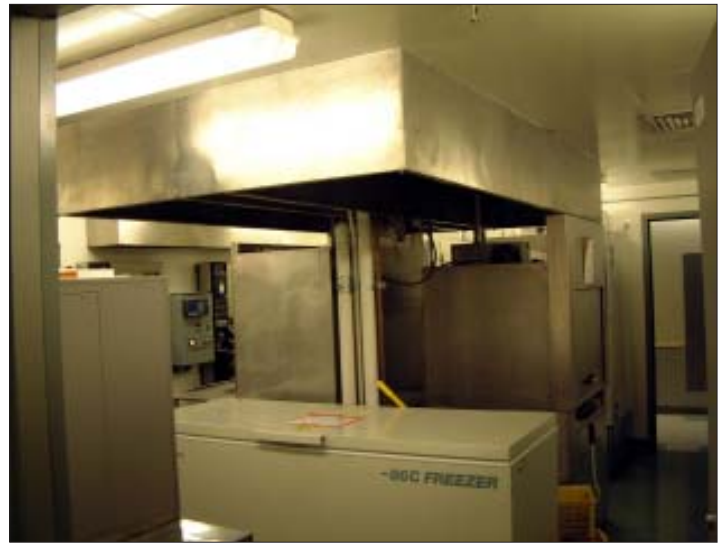
Figure 15: Interior/Exterior Conditions

equipment core

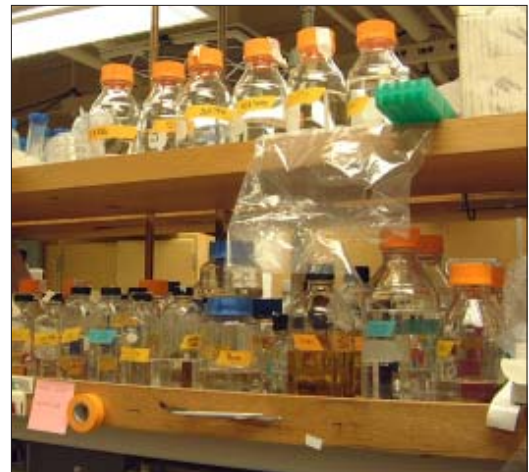
Figure 21: Sample Lab #1, Examples of Critical Items

Note: Items designated as life safety, valuable, important, and chemical hazard are **14%** of local lab contents. (Critical items may also be located in related spaces.)

*Only Life Safety Category 'D' is shown in Figure 21 & 22

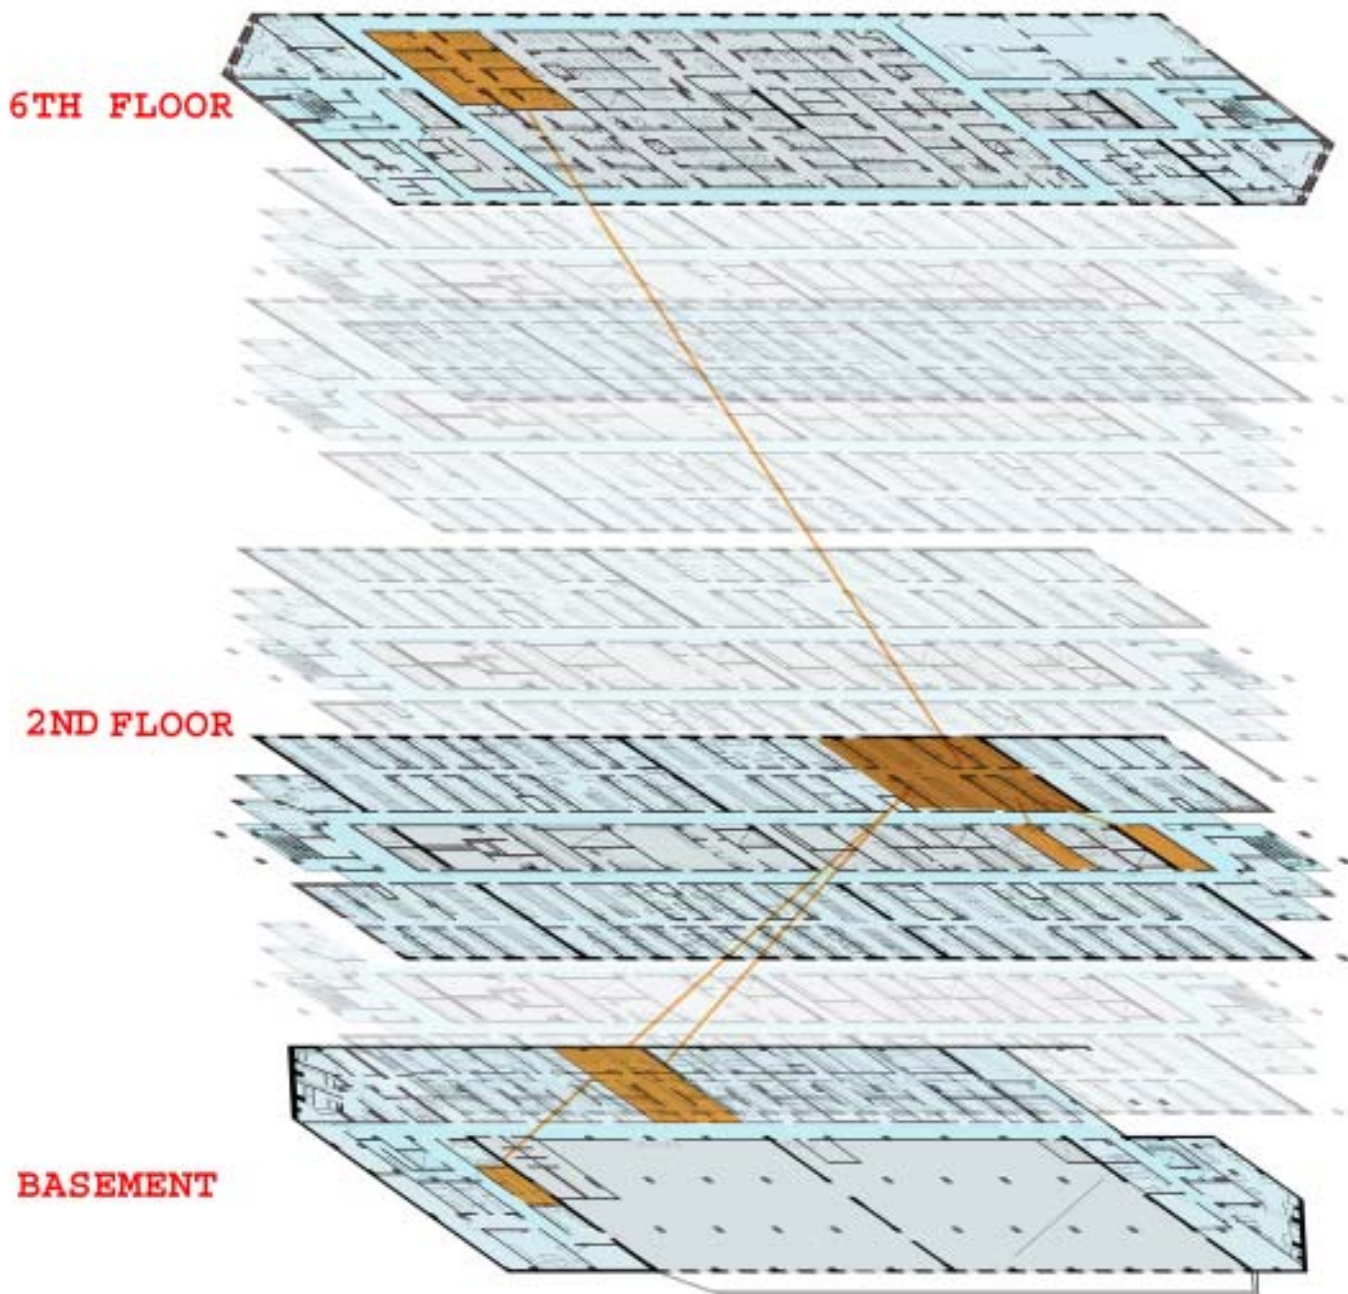
Figure 24: Sample Lab #2, Relationship Between Lab, Core, and Animal Space

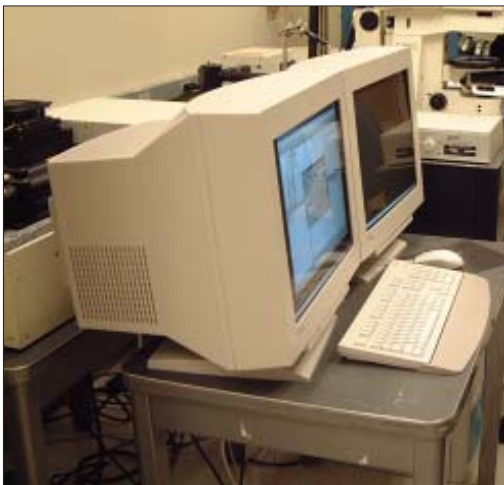
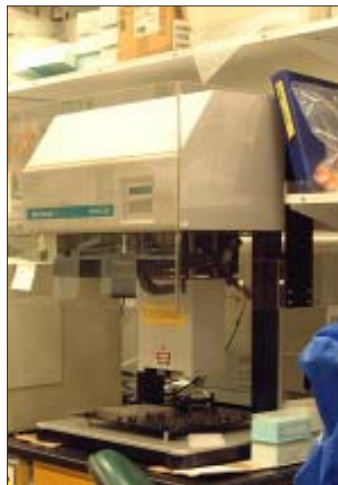
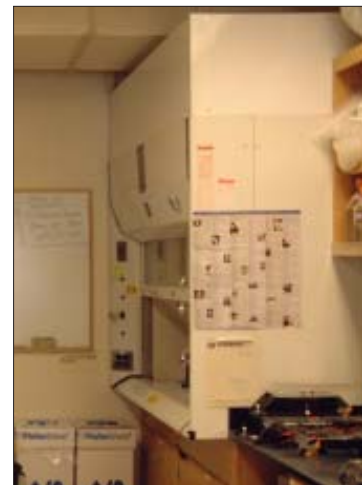
Figure 27: Sample Lab #2, Examples of Critical Items

Note: Items designated as life safety, valuable, important, and chemical hazard are **13%** of local lab contents. (Critical items in related spaces are included below the line.)

*Only Life Safety Category 'D' is shown in Figure 27 & 28

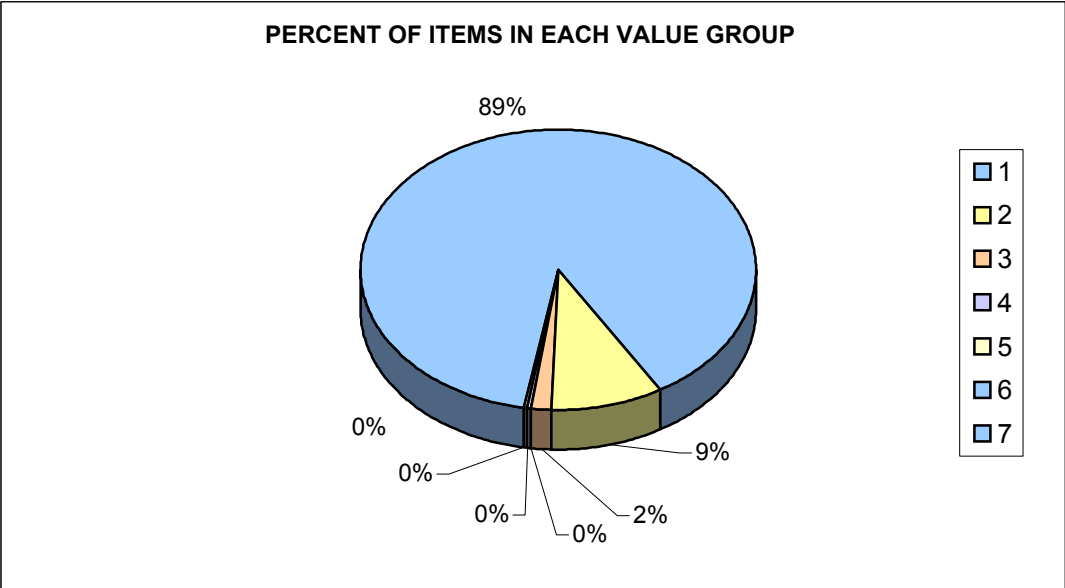
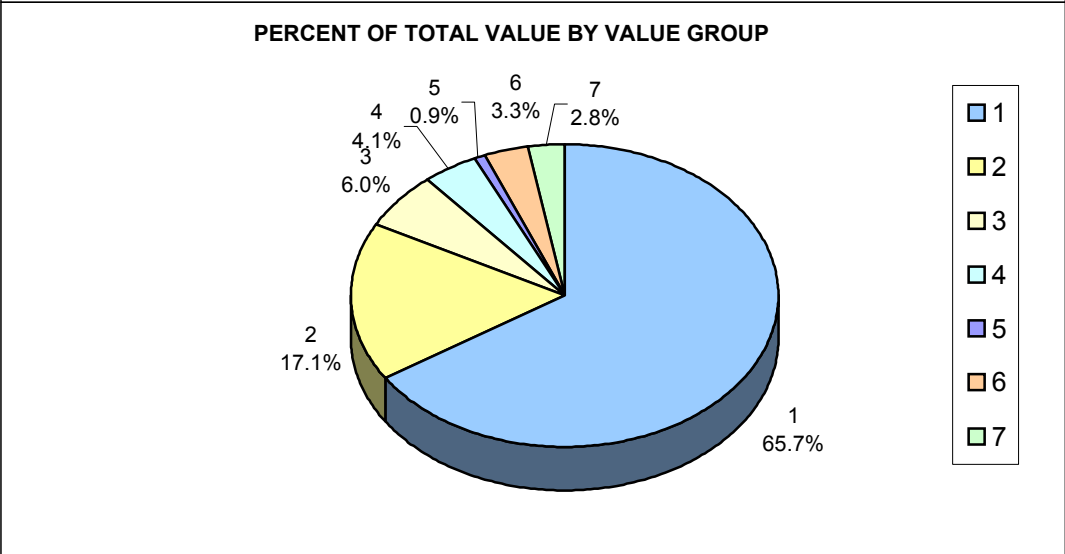
Value Group	Range of Value
1	\$0-\$5K
2	\$5-\$10K
3	\$10-\$20K
4	\$20-\$50K
5	\$50-\$100K
6	\$100-\$200K
7	\$200-\$1,000K

Figure 29: Number and Percentage in Each Value Group and Percentage of Total Value by Group

The value of the scheduled equipment (costing over \$1,500) totals \$21 million (BETS, 2001). Other equipment (valued less than \$1,500) could add another 10 percent to the total value. Eighty-nine percent of the items are valued between \$1,500 and \$5,000, nine percent are valued between \$5,000 and \$10,000 (see Figure 29). The majority of these are the bench-top microscopes, stirrers, mixers, and other small equipment. The remaining 2 percent of the equipment ranges in value from \$10,000 to \$1 million. There are only three confocal microscopes in the building—valued at \$500,000 each—serving unique research needs. Since completing the inventory, however, three laser tables with visualization computers, valued at \$1.2 million, have been purchased by researchers.

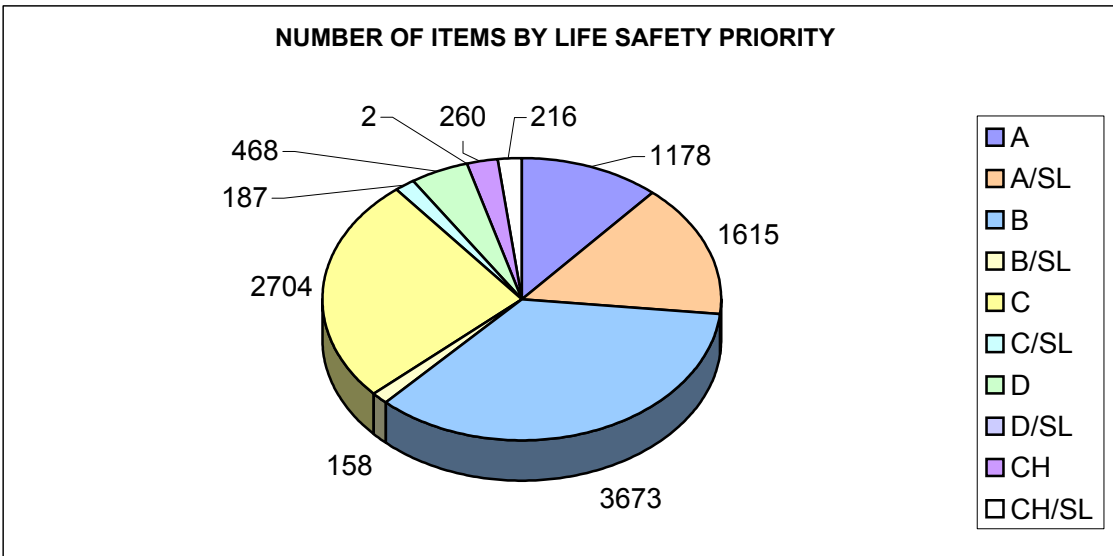
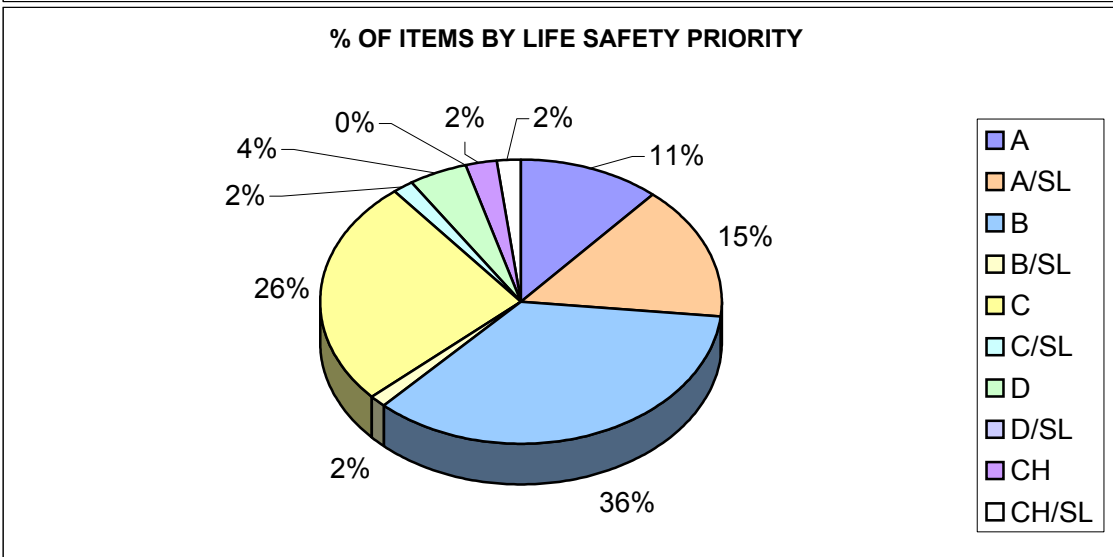
Designation	Translation
A	Low priority for anchorage
A/SL	Low priority + Shelf Lip
B	Moderate priority for anchorage
B/SL	Moderate priority + Shelf Lip
C	High Priority for Anchorage
C/SL	High Priority + Shelf Lip
D	Highest Priority for Anchorage
D/SL	Highest Priority + Shelf Lip
CH	Chemical Hazard
CH/SL	Chemical Hazard + Shelf Lip

Figure 30: Number and Percentage of Items by Life Safety Designation

Figure 30 provides the number and percentage of items in each life safety category, as well as the number and percentage of items in each category that are life safety hazards due to inadequate shelf lips. More than one-third (36 percent) of the items are categorized as life safety category C and D, or Ch, chemical hazard. Overall, almost one-quarter, (23%) of the total items have shelf lips. While only eight percent are in categories C, D, and Ch—posing life safety hazards—inadequate shelf lips create messy and difficult pose-earthquake clean-up problems.

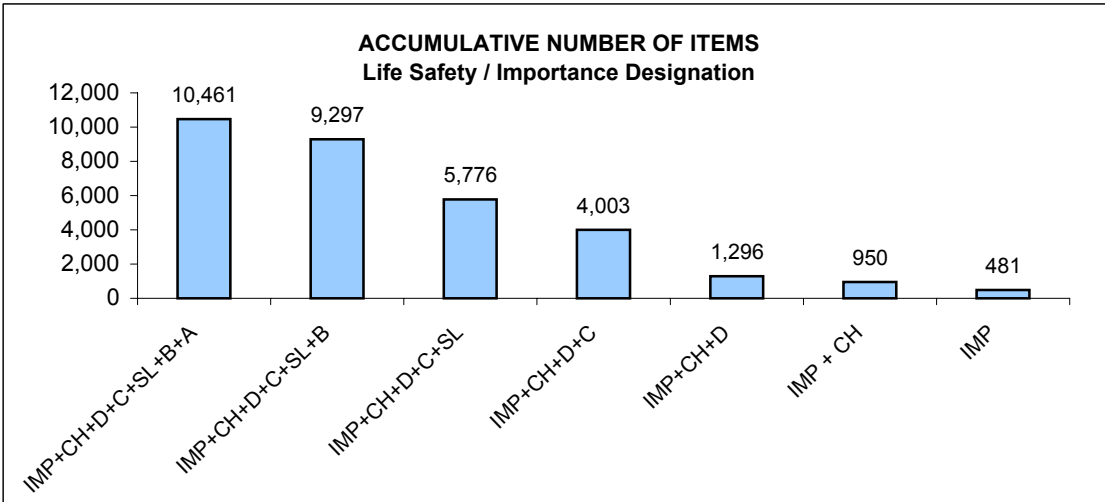
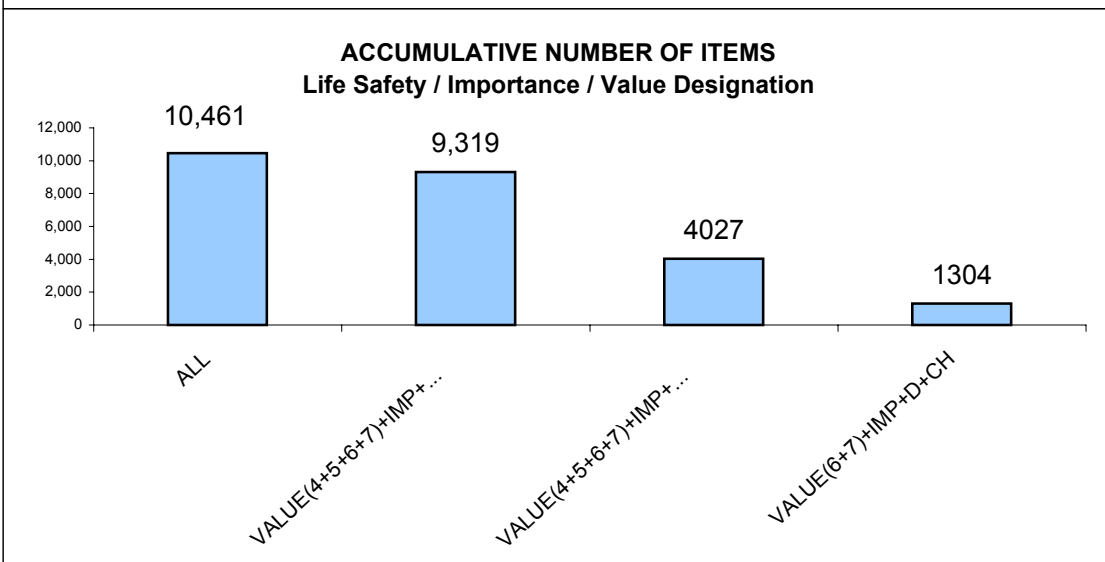
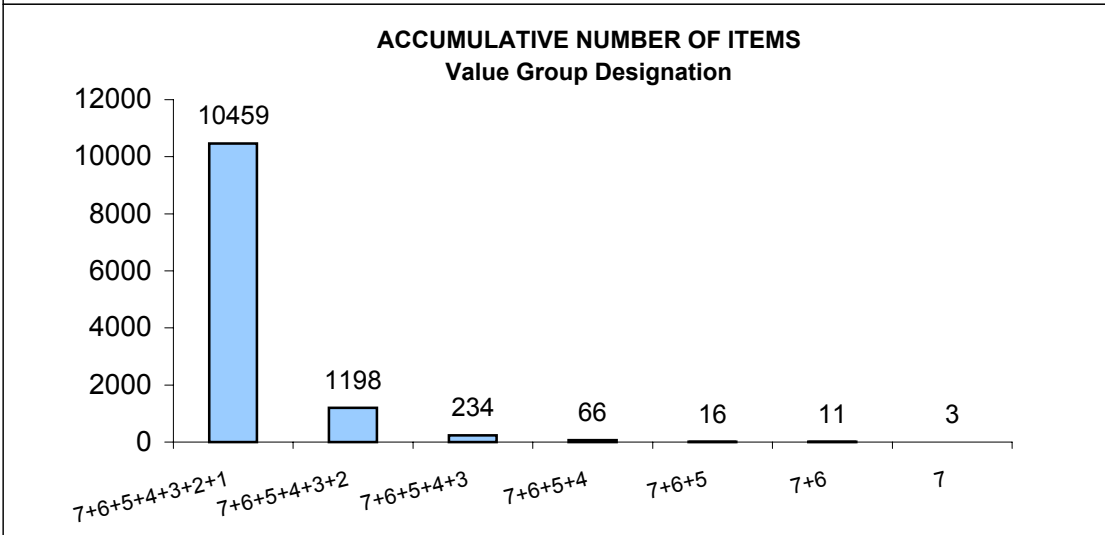
Figure 31: Accumulative Number of Items by Life Safety, Value, and Importance

Only 1,287 items (about 10 percent) are tagged as Important, Chemical Hazard, or Life Safety Priority D, or some combination of these codes. With Life Safety Category C, the total reaches 3,993 items. The High Value category was found to be a subset of those designated Important. There are only 65 items in the building valued at more than \$20,000. Thus, the combination of Important, Chemical Hazard, Life Safety Priority C and D, and Value category 4 through 7, puts the number of items that could be considered critical to operations at 40 percent of the total contents in the building (see Figure 32). Thus, 40 percent of the contents are tools and specimens that are critical to research, valuable and hard to replace, or a threat to life safety, or any combination of these categories. If this subset of items were to be seismically anchored, the overall benefit to limiting downtime would be significant. These should become a first priority in any plan to retrofit contents. Although it may be ideal to consider anchoring every item in a laboratory, it may not be practical or cost effective.

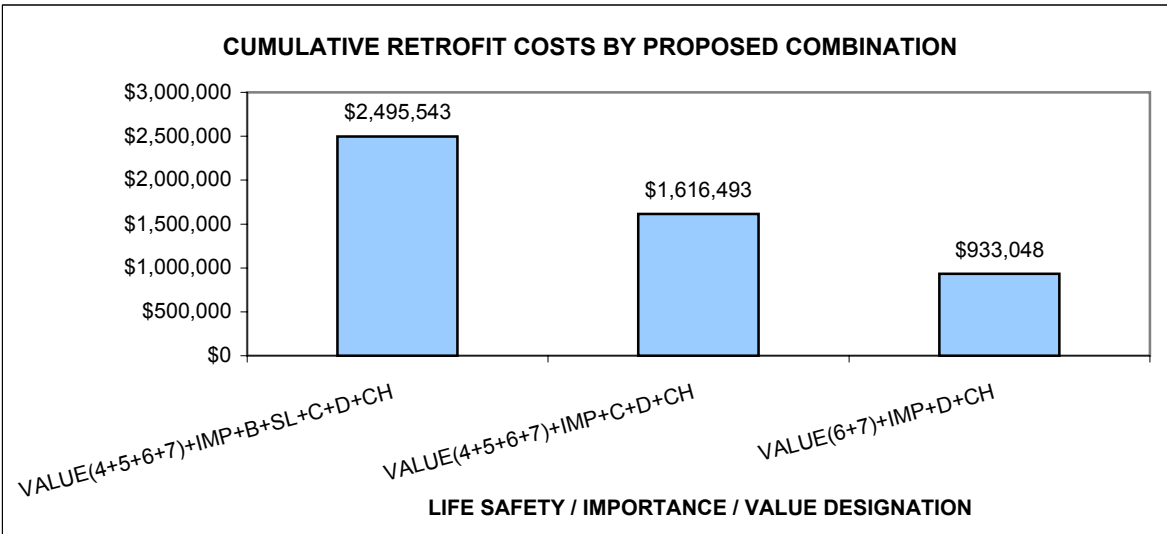
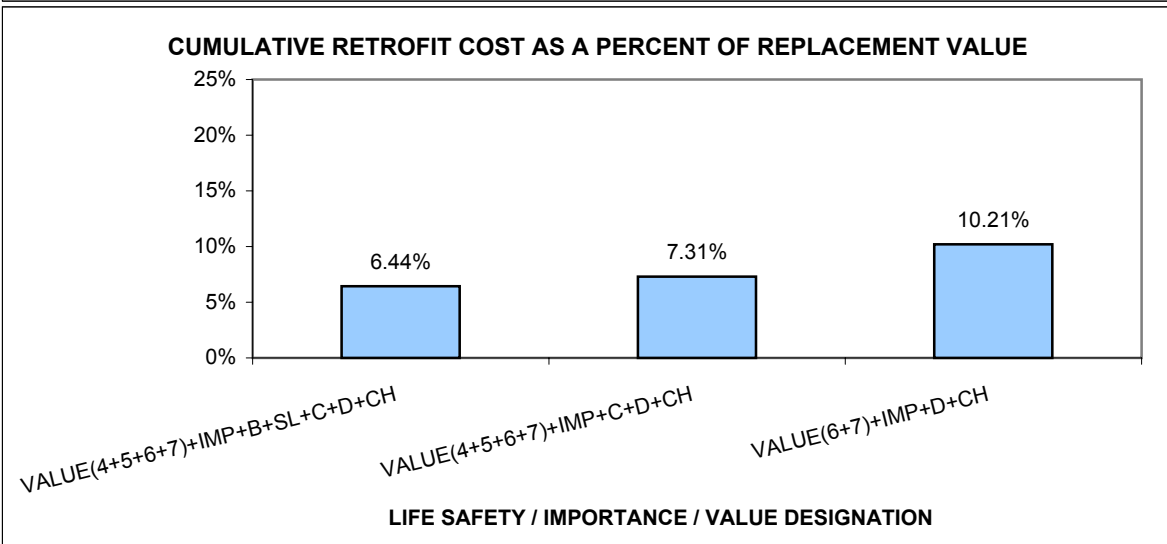
Research Laboratory	=	50,822 s.f.
Research Activities	=	22,533 s.f.
Animal Space	=	26,387 s.f.
Total Lab Space	=	99,742 s.f.
Total A.S.F.	=	122,022 s.f.
Value (4+5+6+7)+IMP+B+SL+C+D+CH		
Total Retrofit Costs	=	\$2,495,543
Cost per Lab s.f.	=	\$25
Cost per A.S.F.	=	\$21
Value (4+5+6+7)+IMP+C+D+CH		
Total Retrofit Costs	=	\$1,616,493
Cost per Lab s.f.	=	\$16
Cost per A.S.F.	=	\$13
Value (6+7)+IMP+D+CH		
Total Retrofit Costs	=	\$933,048
Cost per Lab s.f.	=	\$9
Cost per A.S.F.	=	\$8

Figure 32: Cumulative Retrofit Costs by Proposed Combination

The direct costs for contents anchorage developed in the previous study have been used in the estimate of costs for anchoring the equipment in the Case Study Building. The total cost to anchor all the equipment in the building would be \$2,495,543 (\$25 per square foot of laboratory space, or \$20 per square foot of net usable building area). By comparison, to anchor the proposed combination of items tagged as Life Safety Priority C or D, Important, Value category 4 through 7 (items worth more than \$20,000), or any combination of these codes, the cost would be \$1,616,493 (\$16 per square foot of laboratory space, or \$13 per square foot of net usable building area). If a smaller subset of these categories is anchored (Life Safety Priority D, Important, Value categories 6 and 7—items valued at over \$100,000, or any combination of these categories), then the cost of anchoring drops to \$933,048 (\$9 per square foot of laboratory space). These costs represent only 6 percent to 10 percent of the replacement value of the items (see Figure 32). It should be noted that items are not double-counted—if an item has more than one designation (e.g., as valuable and important) it is only counted once in the cost estimates.

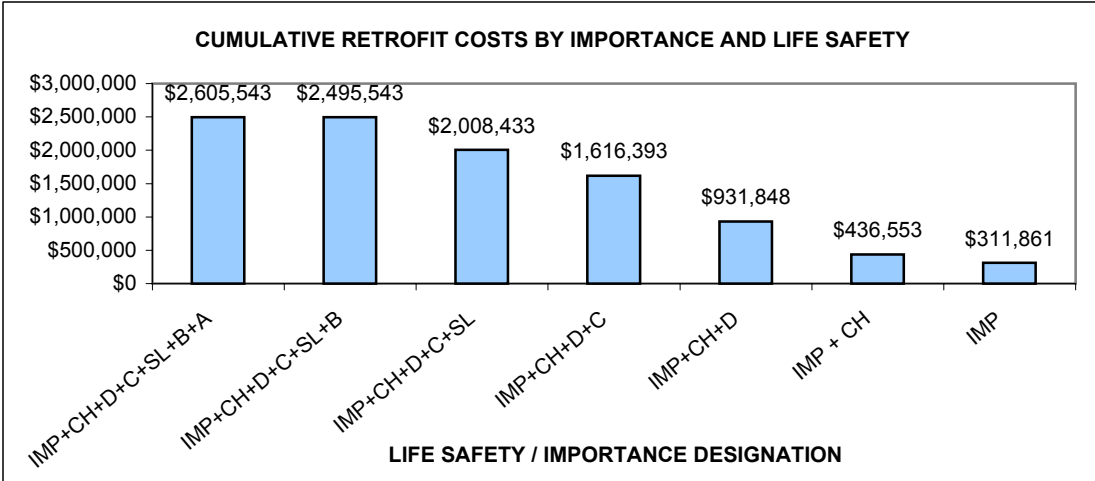
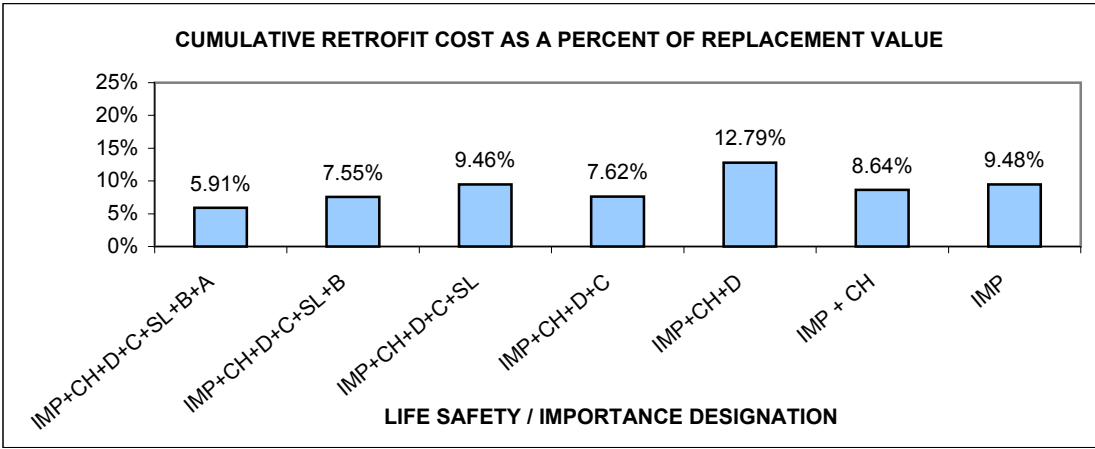
Research Laboratory	=	50,822 s.f.
Research Activities	=	22,533 s.f.
Animal Space	=	26,387 s.f.
Total Lab Space	=	99,742 s.f.
Total A.S.F.	=	122,022 s.f.

IMP+CH+D+C+SL+B+A		IMP+CH+D			
Total Retrofit Costs	=	\$2,605,543	Total Retrofit Costs	=	\$931,848
Cost per Lab s.f.	=	\$26	Cost per Lab s.f.	=	\$9
Cost per A.S.F.	=	\$21.50	Cost per A.S.F.	=	\$8
IMP+CH+D+C+SL+B		IMP+CH			
Total Retrofit Costs	=	\$2,495,543	Total Retrofit Costs	=	\$436,553
Cost per Lab s.f.	=	\$25	Cost per Lab s.f.	=	\$4
Cost per A.S.F.	=	\$21	Cost per A.S.F.	=	\$3.50
IMP+CH+D+C+SL		IMP			
Total Retrofit Costs	=	\$2,008,433	Total Retrofit Costs	=	\$311,861
Cost per Lab s.f.	=	\$20	Cost per Lab s.f.	=	\$3
Cost per A.S.F.	=	\$17	Cost per A.S.F.	=	\$2.50
IMP+CH+D+C					
Total Retrofit Costs	=	\$1,616,393			
Cost per Lab s.f.	=	\$16			
Cost per A.S.F.	=	\$13

Figure 33: Cumulative Retrofit Costs by Importance and Life Safety Designation

Another method for evaluating costs is to combine the items tagged as Important with various combinations of Life Safety priorities, broken into the categories A through D, plus those items identified as having inadequate shelf lips. Figure 33 demonstrates that replacing all the shelf lips costs \$392,040. This graph also demonstrates that valuable items are subsumed in the items included in categories Important, Life Safety C, D, and CH, as the costs for these is identical to the costs for the three groups.

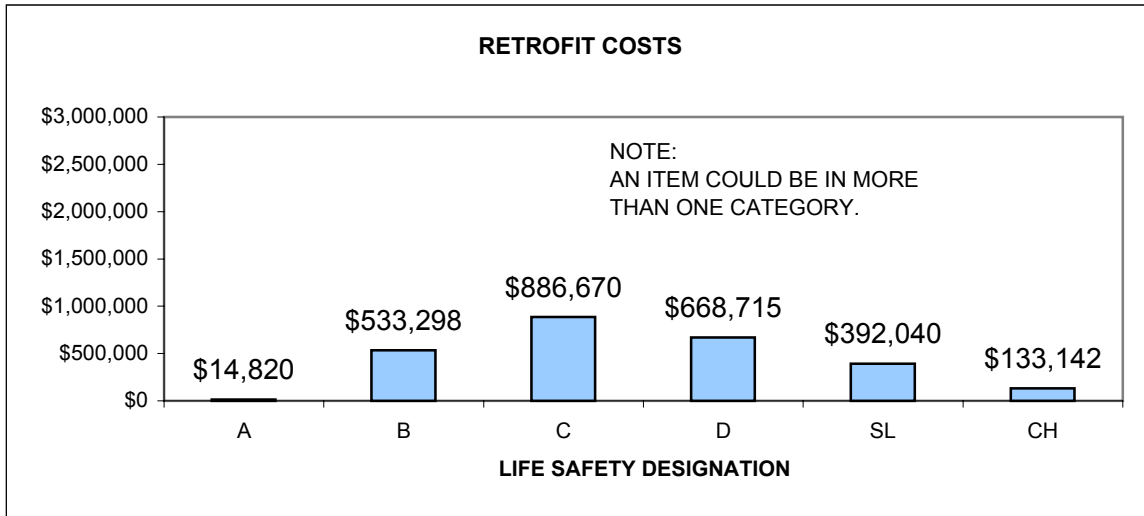
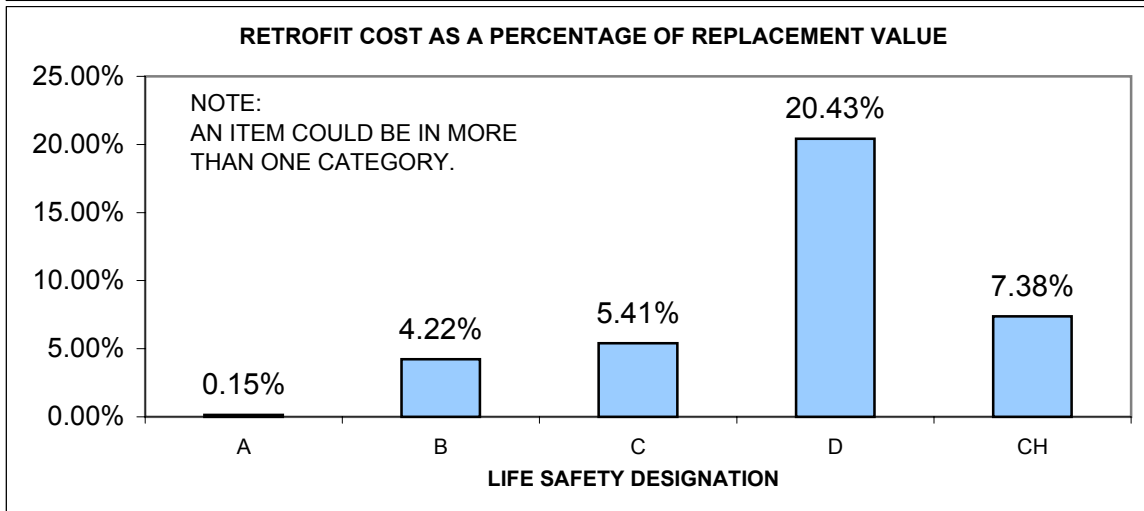
Life Safety Designation 'CH'		
Total Retrofit Costs	=	\$133,142
Cost per Lab s.f.	=	\$1
Cost per A.S.F.	=	\$1

Figure 34: Retrofit Costs for Life Safety Designations

For analytic purposes, costs can be broken down by each critical factor, as a cost and as a percentage of replacement costs. Retrofit costs for the life safety designations are shown in Figure 34, and cumulative costs by life safety designation are shown in Figure 35. Here again, these graphs illustrate that the items in Life Safety Priorities C, D, and CH overlap with the items designated important or valuable, or both. In these graphs, Life Safety Priority D stands out because the retrofit cost is 20 percent of the replacement cost, a significantly higher percentage than in other categories. The retrofit costs are high because these items are often heavy pieces of equipment requiring more complex anchoring solutions.

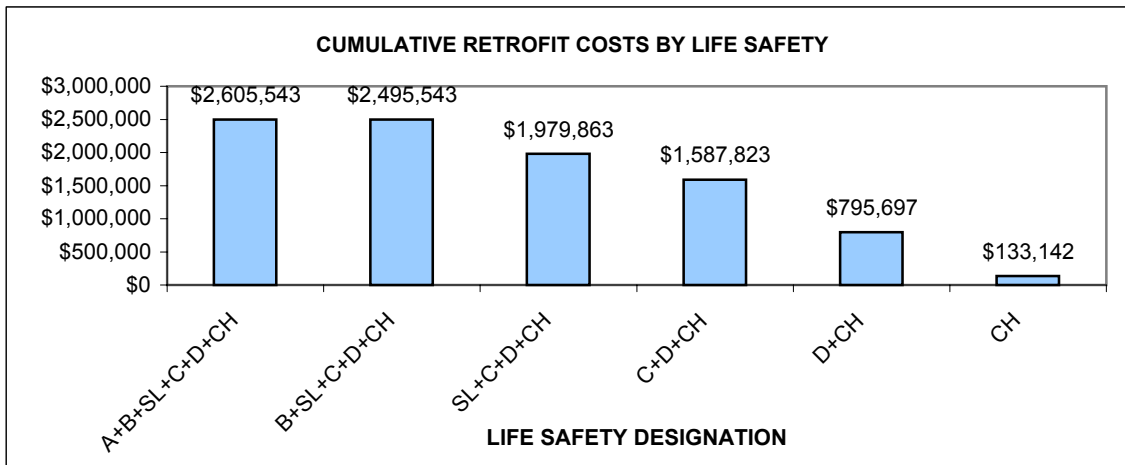
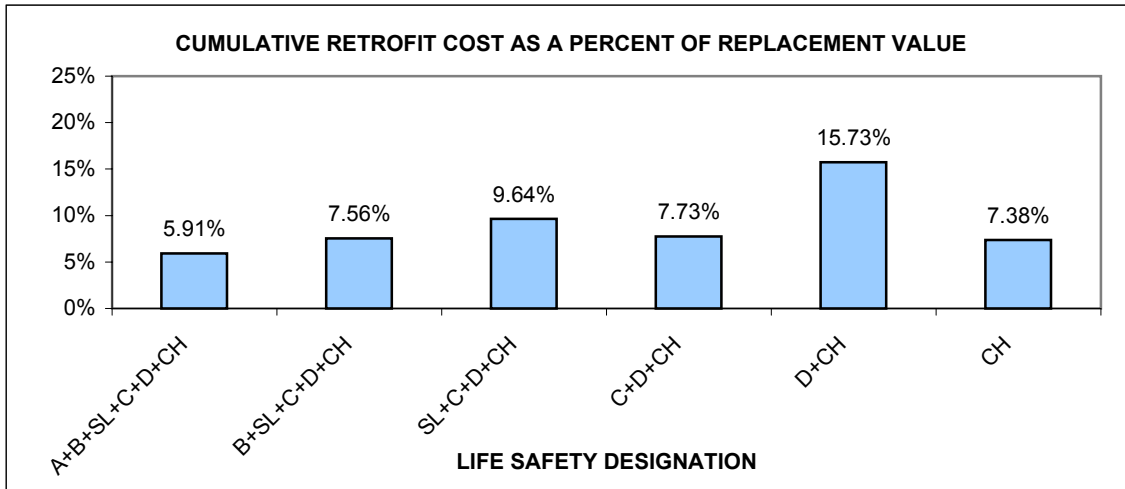
Research Laboratory	=	50,822 s.f.
Research Activities	=	22,533 s.f.
Animal Space	=	26,387 s.f.
Total Lab Space	=	99,742 s.f.
Total A.S.F.	=	122,022 s.f.

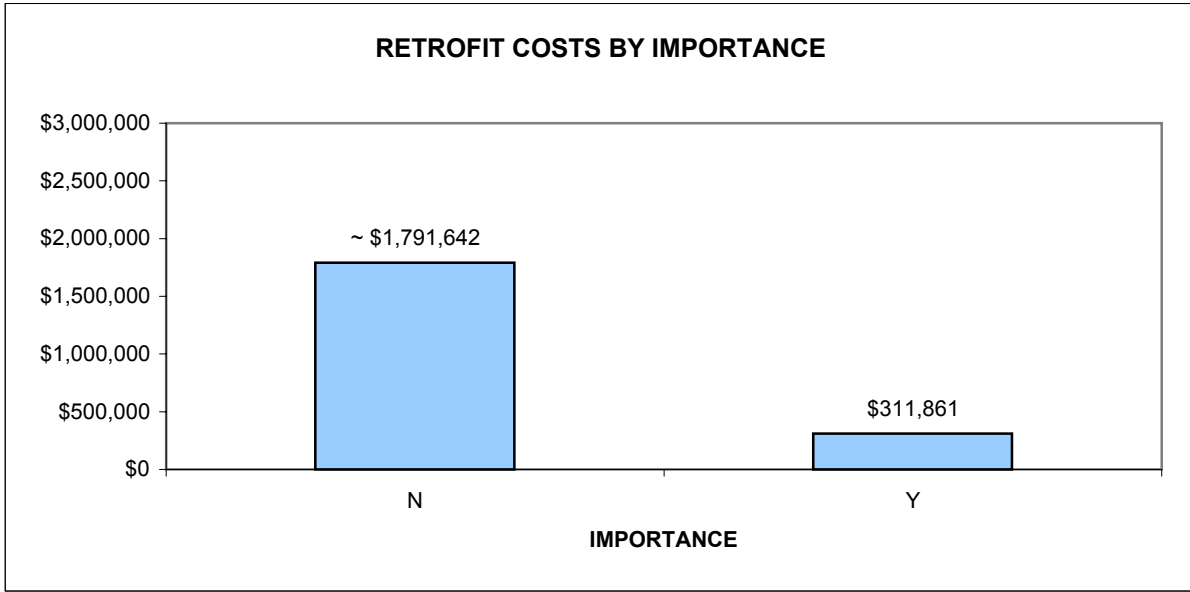
Importance 'Y'		
Total Retrofit Costs	=	\$311,861
Cost per Lab s.f.	=	\$3
Cost per A.S.F.	=	\$3

Figure 37: Retrofit Costs by Importance

Figure 37 shows the costs for retrofitting only those items designated important. Although this represents a relatively small portion of the overall retrofit costs, it should be noted that this category is the most variable. When making final choices about what equipment to anchor, researchers may designate many more items in this category than previously indicated. Still, these tend to overlap with items that are also life safety priorities—so that changes in the “importance” designation should not change the overall cost estimates dramatically.
