Seismic Protection of Laboratory Contents: The UC Berkeley Science Building Case Study

**Seismic Protection of Laboratory Contents:
The UC Berkeley Science Building Case Study**

Professor Mary C. Comerio
Institute of Urban and Regional Development
University of California, Berkeley

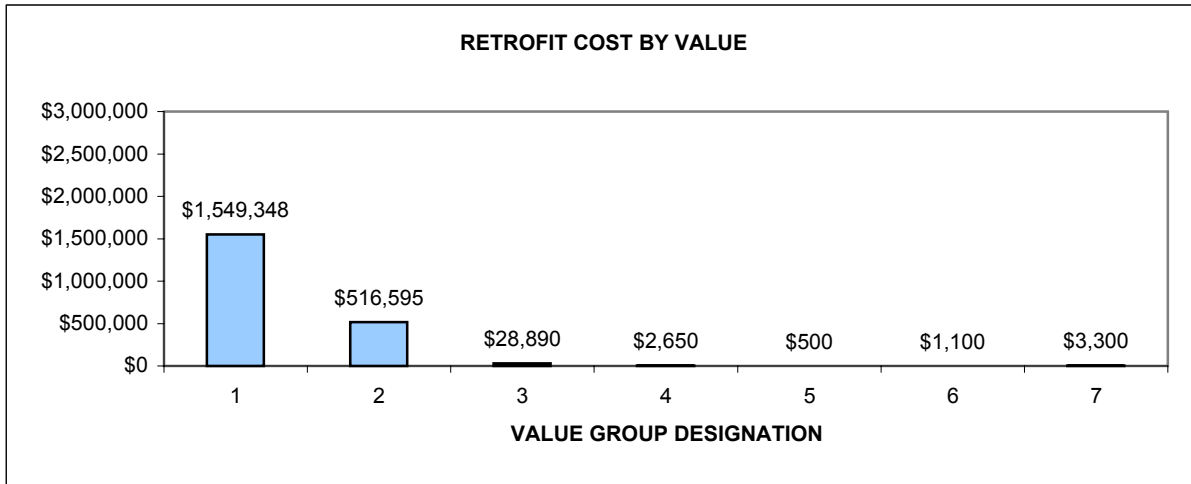
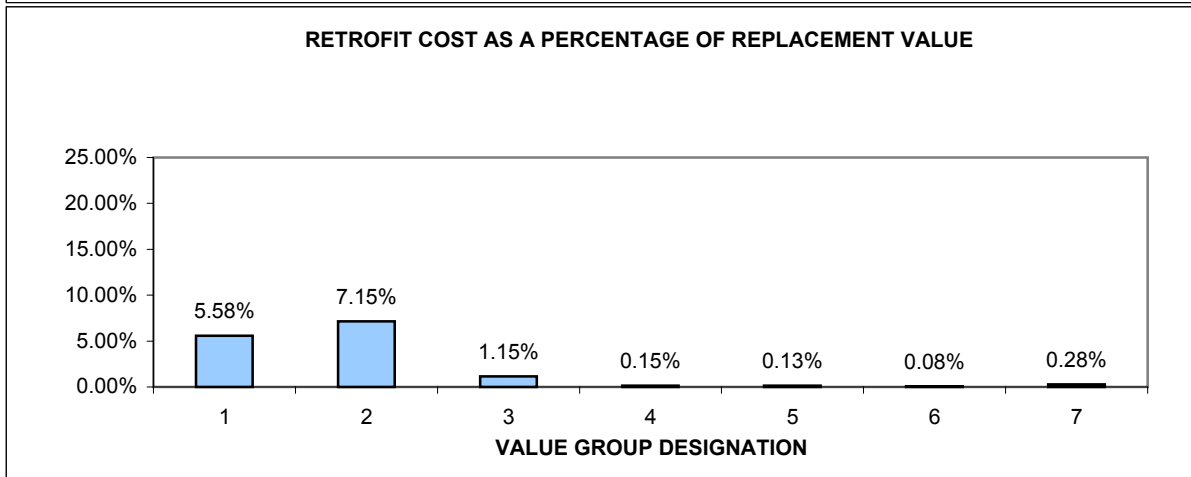
Value '4'		
Total Retrofit Costs	=	\$2,650
Cost per Lab s.f.	=	<\$1
Cost per A.S.F.	=	<\$1

Figure 38: Retrofit Costs by Value Designation

Figures 38 and 39 provide the breakdown (individually and cumulatively) of costs for items by Value categories. In this case, the predominance of items (89 percent) have values below \$5,000. Nearly 60

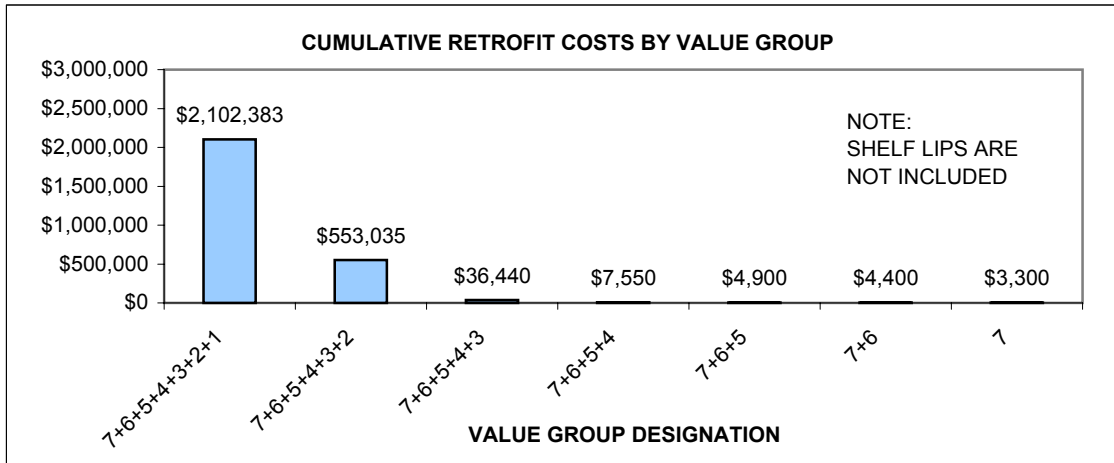
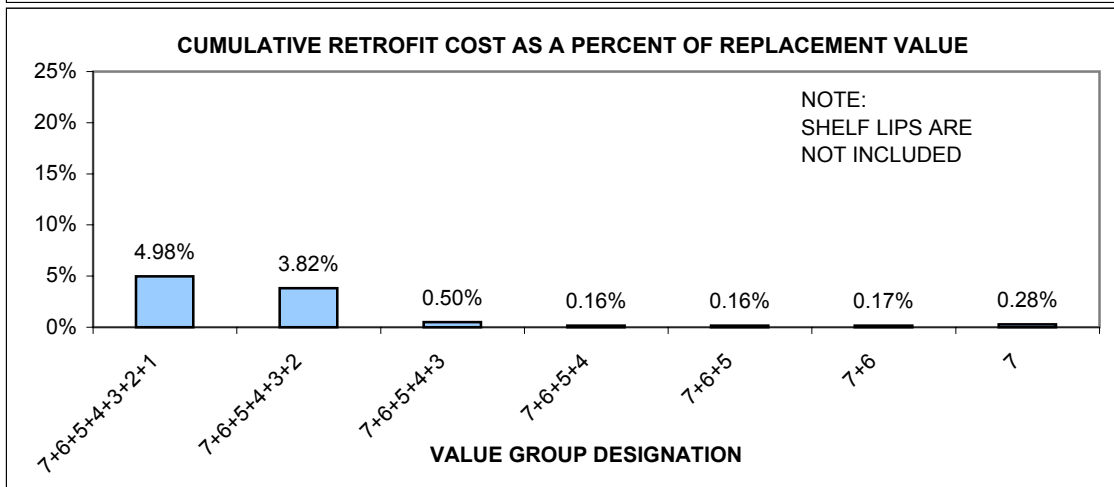
7+6+5+4+3+2+1			7+6+5		
Total Retrofit Costs	=	\$2,101,383	Total Retrofit Costs	=	\$4,900
Cost per Lab s.f.	=	\$21	Cost per Lab s.f.	=	<\$1
Cost per A.S.F.	=	\$17	Cost per A.S.F.	=	<\$1
7+6+5+4+3+2			7+6		
Total Retrofit Costs	=	\$553,035	Total Retrofit Costs	=	\$4,400
Cost per Lab s.f.	=	\$6	Cost per Lab s.f.	=	<\$1
Cost per A.S.F.	=	\$5	Cost per A.S.F.	=	<\$1
7+6+5+4+3			7		
Total Retrofit Costs	=	\$36,440	Total Retrofit Costs	=	\$3,300
Cost per Lab s.f.	=	<\$1	Cost per Lab s.f.	=	<\$1
Cost per A.S.F.	=	<\$1	Cost per A.S.F.	=	<\$1
7+6+5+4					
Total Retrofit Costs	=	\$7,550			
Cost per Lab s.f.	=	<\$1			
Cost per A.S.F.	=	<\$1

Figure 39: Cumulative Retrofit Costs by Value Groups

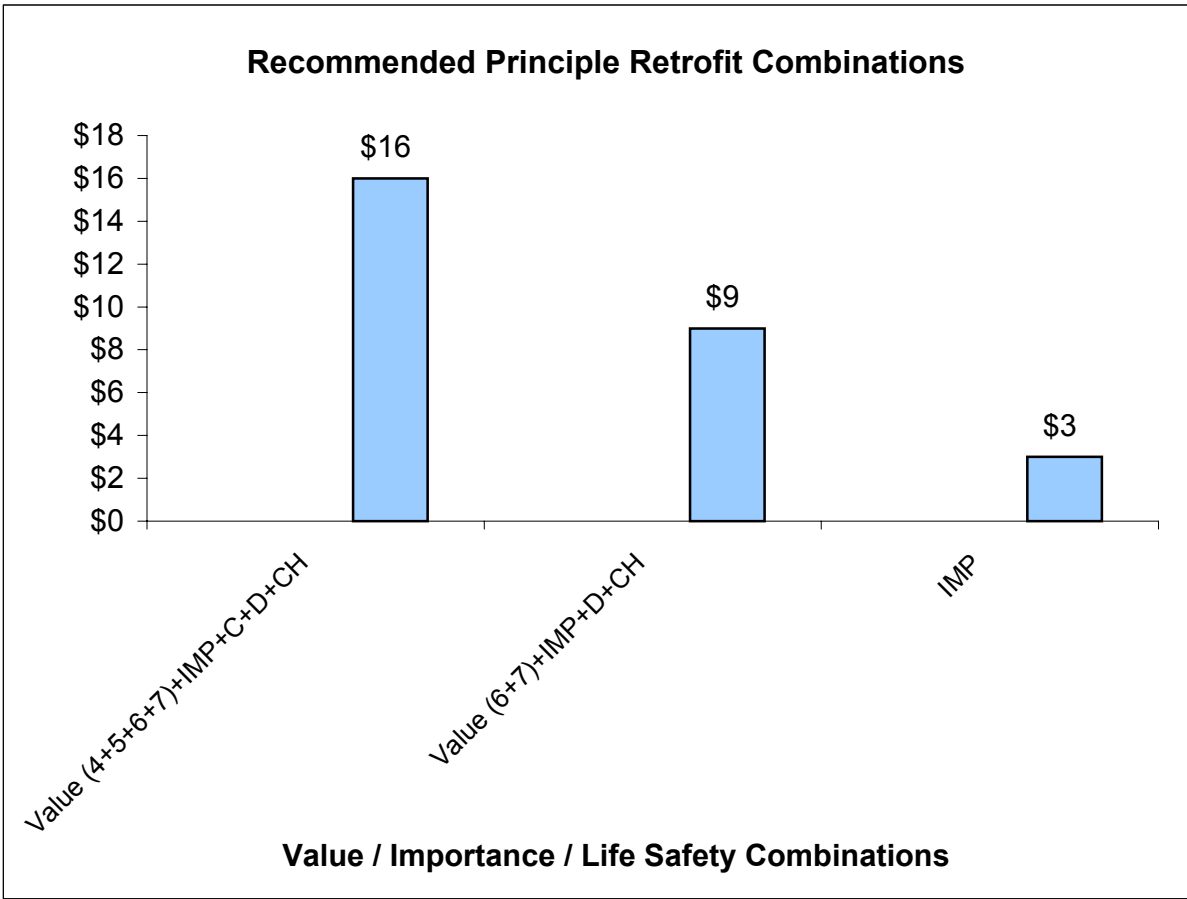
Figure 40: Retrofit Costs by Recommended Combination without Existing Measures

To summarize, the cost of anchoring all the equipment in the Case Study Building would be \$25 per square foot of laboratory space (or \$20 if measured by assignable square foot). This cost is comparable to costs estimated for individual laboratories in other buildings on the University of California, Berkeley, campus. The significant lesson from the case study of a single laboratory building is that about 40 percent of the contents are potentially hazardous, critical to research, valuable and difficult to replace, or any combination of these categories. Seismic retrofit of this subset of the contents should be a first priority. The cost will range between \$10 and \$16 per square foot of laboratory space (\$8 to \$13 per assignable square foot), depending on how some items are classified. Figure 40 shows a range of first-priority categories and their costs.

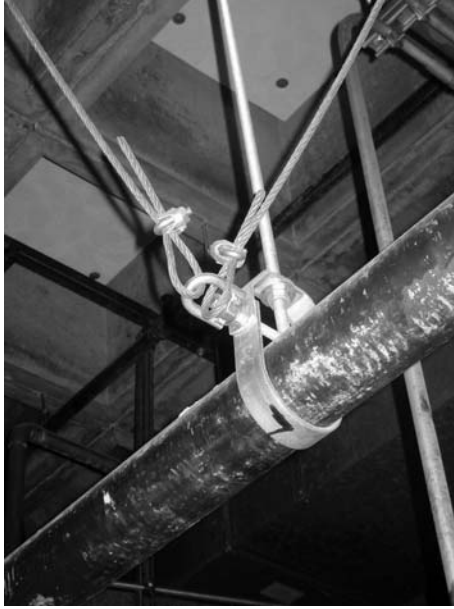
Figure A.1: Typical piping support

The usual evaluation revealed that the building systems feature an unusually high level of compliance with code seismic anchorage and bracing requirements.

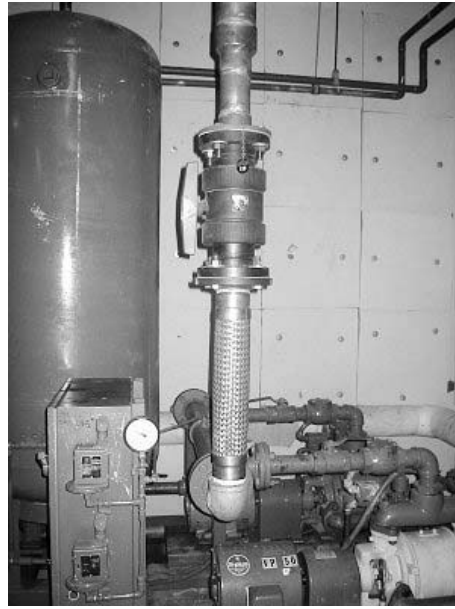
Figure A.2: Flexible piping connection

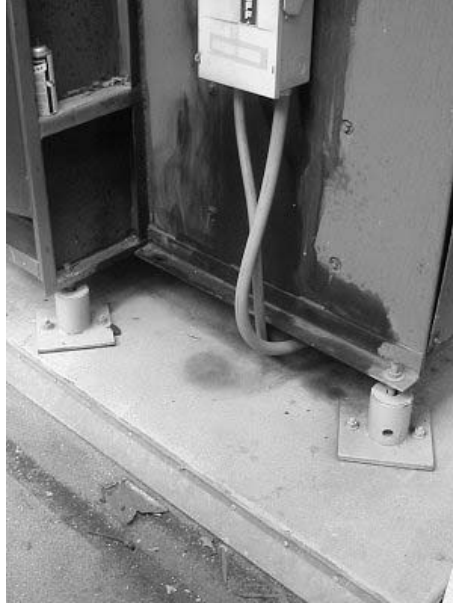
Figure A.3: Rooftop cabinet support

- Increased loading (over old code requirements) at roof (Figures A.3 and A.4).
- Installation of emergency generator (apparently as an addition).
- Effectiveness of cable bracing for piping.

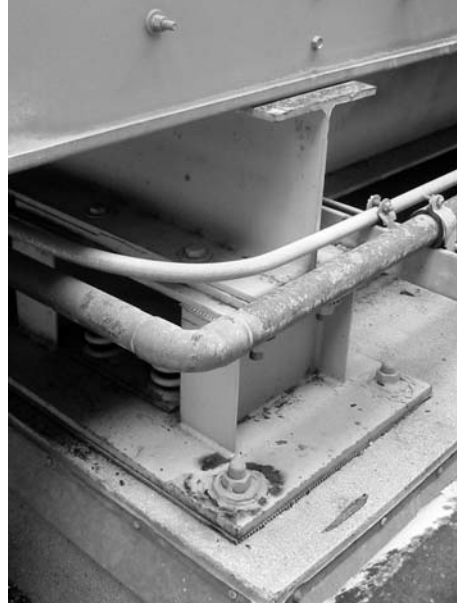
Figure A.4: Chiller support

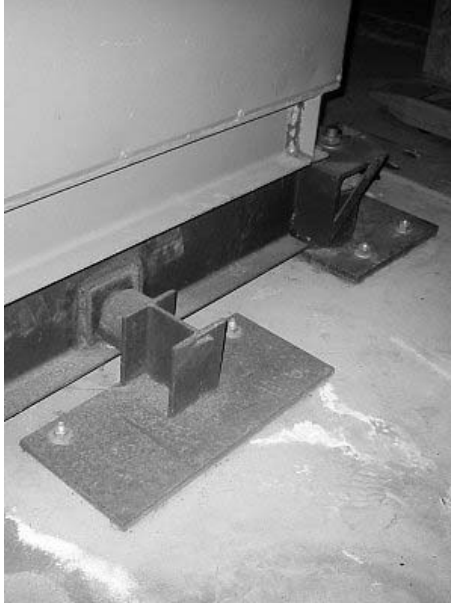
Figure A.5: Seismic bracing

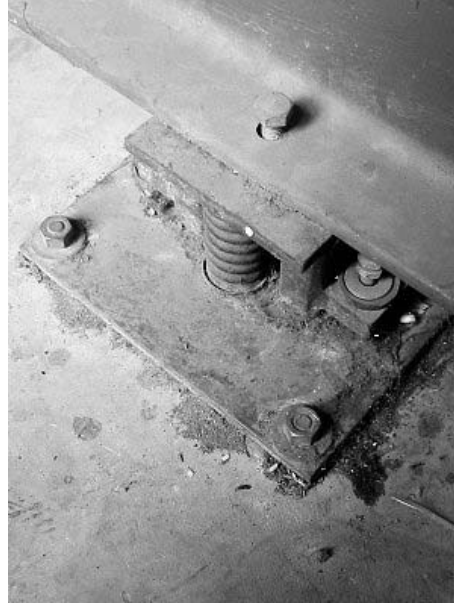
Figure A.6: Support detail

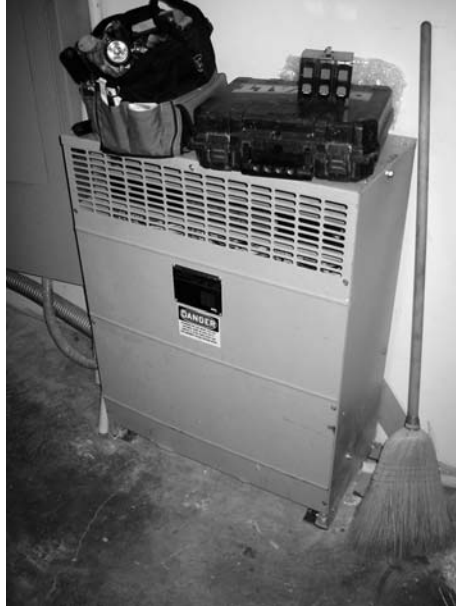
Figure A.7: Typical electrical cabinet

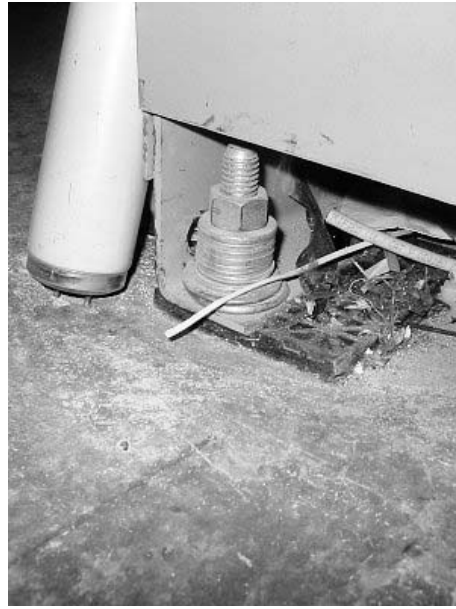
Figure A.8: Detail of bolted connection

- Adequacy of existing bolt attachments and conditions, including added washers (Figure A.8) and bolt tightness.
- Confirmation of the existence of proper restraints on cabinets where connection to the floor is not visible.

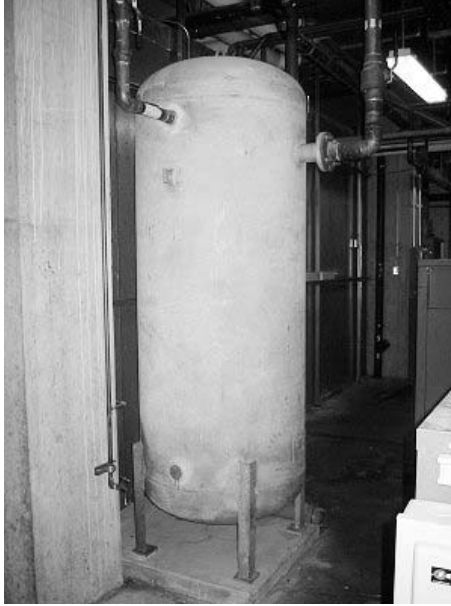
Figure A.9: Vertically oriented tank

- Adequacy of restraints for vertically oriented tanks (Figure A.9), which rely on ground level attachments to overcome the moment induced by lateral forces.
- Adequacy of multiple tank restraints (Figure A.10).

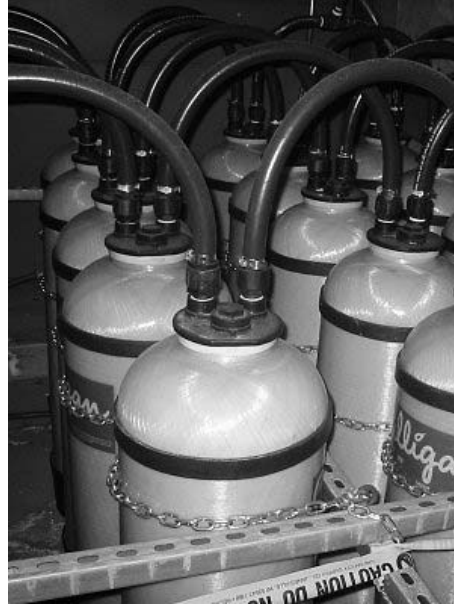
Figure A.10: Multiple tanks

Most tanks are restrained by various methods, depending on size and portability requirements. Larger tanks are permanently restrained to concrete pads at the basement level. Issues regarding the effectiveness of these existing conditions include:

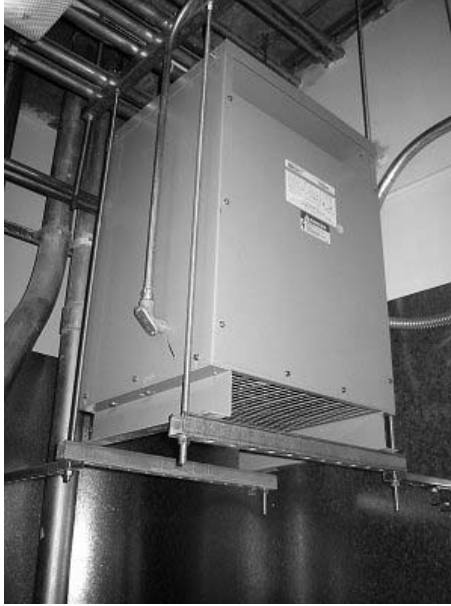
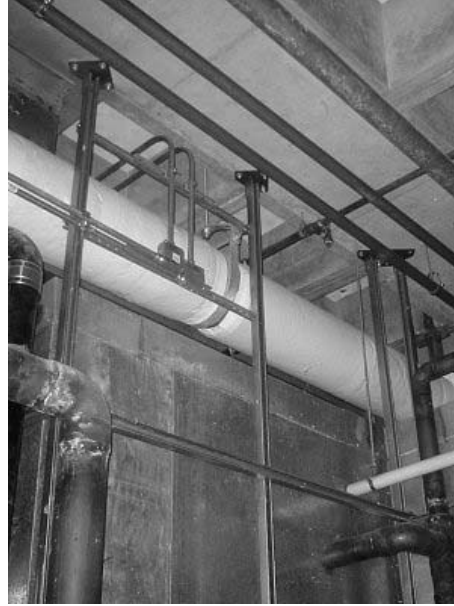
Figure A.11: Typical suspended cabinet *Figure A.12: Typical strongbacks*

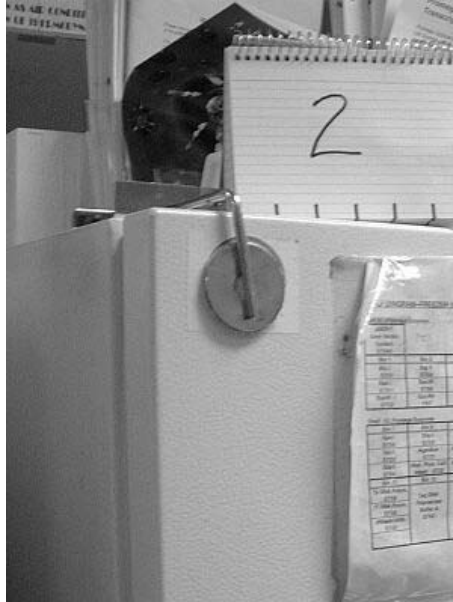
Figure B.1: Refrigerator latch

Mechanical latches have also been added to prevent doors from opening during an earthquake (Figure B.1) on approximately 50% of refrigerators. Although these haven't been tested, they are most likely adequate for restraining the doors. Further consideration should be given, however, to the condition of the contents after strong shaking.

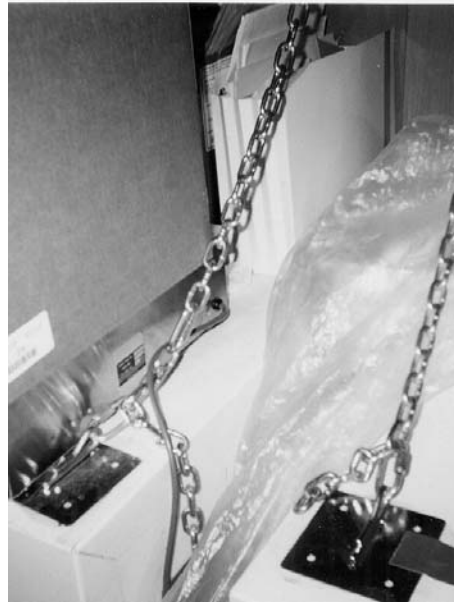
Figure B.2: Adhesive connections

- Some refrigerators, incubators, racks, and other large and heavy equipment have been attached to walls, strongbacks, or each other with chains. Manual latches have also been added to some refrigerators or cabinets to prevent doors from opening during earthquake motions.
- Lips, elastic cords, or metal plates have been added to some cabinet or open shelves in order to prevent chemicals, lab samples, or books from falling. Also, some floor mounted bookcases and cabinets have been attached directly to shear walls or partitions with screws, nails, or bolts.
- Commercial fabric tethers have been attached with adhesive to some computers, microscopes, microwave ovens, and other small items to secure them to desks or shelves.

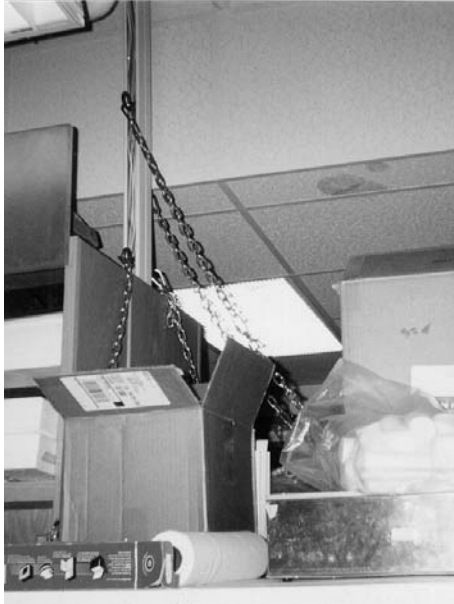
Figure B.3: Connection to strongbacks *Figure B.4: Chain connection to wall*

- The effectiveness of statically unstable restraint cables is unknown.
- The effectiveness of the partitions to restrain the heavy loads is uncertain, since the partitions appear to be discontinuous at the core of the building. This is a particular concern at the core of the building, where many refrigerators are restrained by the partitions.
- Where four screws are used to connect metal plates to partition walls, the effectiveness in resisting loads is unknown. If the attachment is to drywall only and not to braced metal framing, very limited restraint is provided.

- Where expansion anchors are used to connect metal plates to concrete, the effectiveness in resisting the required loads is unknown and may vary due to discrepancies in installation and materials.
- Withdrawal forces from existing ceiling connections are unknown. Some chained restraints for heavy objects are attached only to the ceiling overhead, providing limited lateral support.
- There is significant variation in the application of epoxy and plates. In some cases, the metal plates are attached to 1-inch wide areas of the equipment. In other cases, the epoxy is peeling. Other areas appear to have too little epoxy applied. More importantly, the strength and type of epoxy is unknown.
- In cases where heavy equipment is attached to each other (stacked or adjacent) for seismic restraint, the effectiveness of the connections needs to be determined.

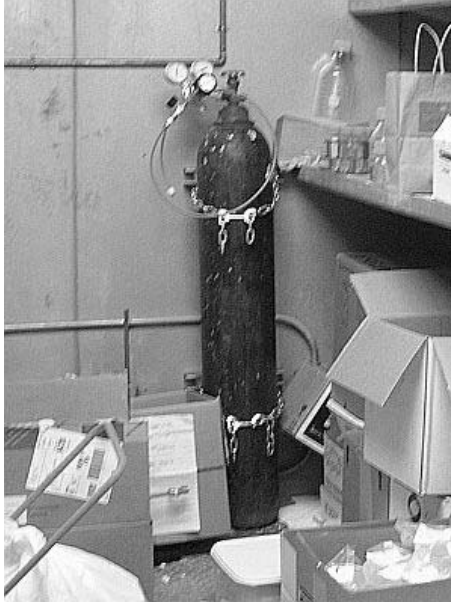
Figure B.5: Smaller tank restraint

- Adequacy of chain to restrain tank, including clasp connection and tautness of chain.
- Adequacy of connection between chain restraint and building structure, including additional Unistruts or connection to tables or strongbacks instead of walls.
- Risk of damage from movement, even when restrained, to pressurized valves, pipe connections, or any area of tank where chemicals could escape.

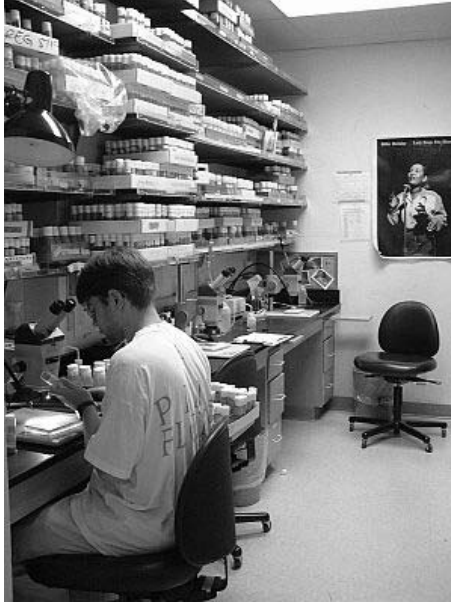
Figure B.7: Lips on lab sample shelves

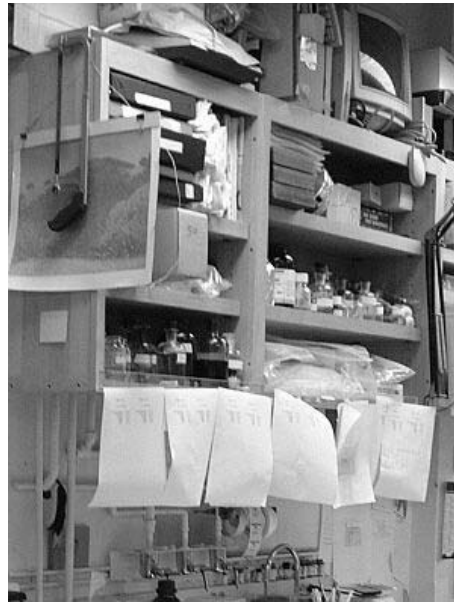
Figure B.8: Lips on chemical shelves

One concern with both the lips and elastic cords is the weight and center of gravity of the chemical bottles. The restraints may not be high enough to prevent the bottles from falling over the lips or pushing the elastic cords out far enough to allow the bottles to fall. In some cases, bottles can slip under the elastic cords as well. Also, reactions between chemicals in the event of simultaneous bottle breakage are an issue of concern.

- Effectiveness of shelf lips against center of gravity of shelf contents, especially chemical bottles and glassware.
- Effectiveness of metal face plate connections under torsional stress due to the limited area of resistance (screw heads). Life safety risk of falling metal plates.
- Effectiveness of bookcase restraints to walls or other heavy equipment.

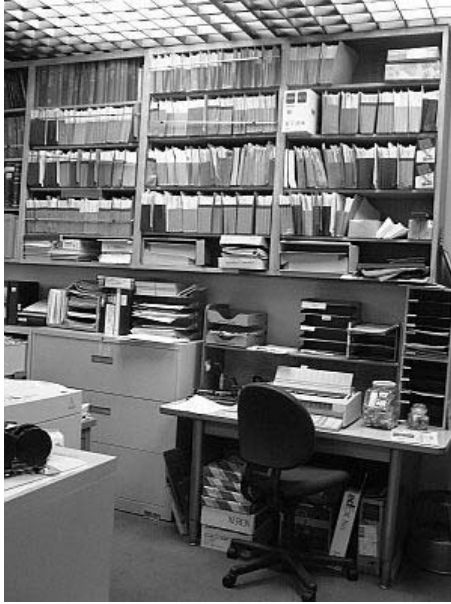
Figure B.9: Shelves with bungee restraints

Bookcases or open shelves may be secured to walls or strongbacks with bolts or screws, but that provides little or no seismic restraint to contents without additional protection at the front of the shelves. In some cases, elastic cords or shelf lips have been added to these shelves (Figure B.9), but lip additions can be more effective than elastic cords. Lip additions have a greater ability than cords to restrain heavy loads.

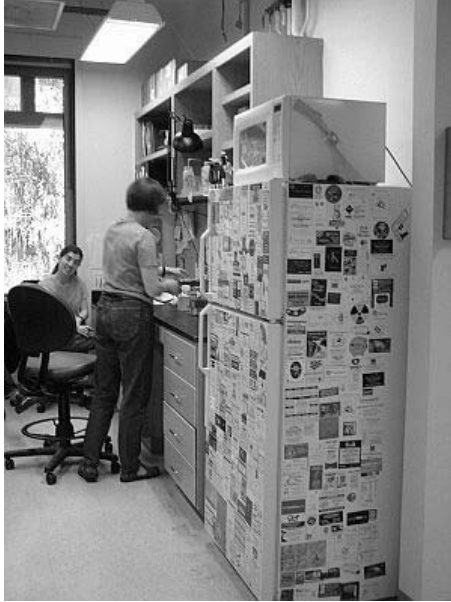
Figure B.11: Microwave with fabric tethers

Off-the-shelf fabric tethers from one or two manufacturers have been added to several small pieces of equipment, including computers, monitors, microscopes, and microwave ovens (Figure B.11). These tethers consist of adhesive pads attached to hard surfaces, with a fabric strap (and buckle) connecting them. Usually, a pair of tethers is placed on either side of the object at a 45-degree angle to provide resistance against both vertical and lateral loads (Figure B.12). In some cases, the tethers are attached incorrectly (adhesive poorly connected or loose, poor location of anchor, etc.) to the tables or equipment or are unbuckled.
