Are coastal protective hard structures still applicable with respect to shoreline changes in Sri Lanka?

ADB Working Paper Series, No. 1240

ARE COASTAL PROTECTIVE HARD STRUCTURES STILL APPLICABLE WITH RESPECT TO SHORELINE CHANGES IN SRI LANKA?

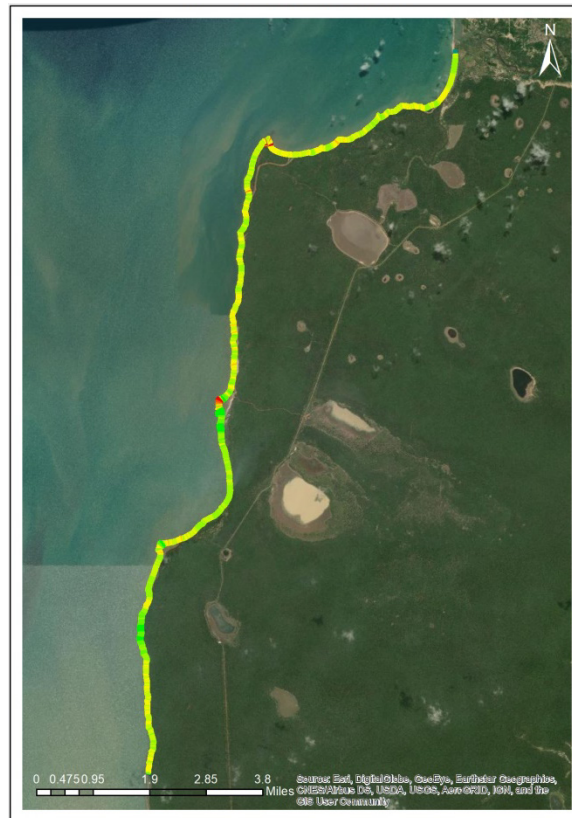
Figure 4: EPR of the Kalutara (A), Colombo (B), Gampaha (C), and Puttalam (D) Districts and the Wilpattu Region

The place with the highest recorded EPR in Gampaha district is Daluwakotuwa beach, with a 15.47 m yr^{-1} rate, and the place with the lowest recorded EPR in Gampaha district is near Dikowita harbor, with a -6.03 m yr^{-1} rate. The place with the highest recorded EPR in Puttalam district is in Kudawa upper division, with 32.3 m yr^{-1} . The place with the lowest recorded EPR in Puttalam district is Kandakuliya, with -39.91 m yr^{-1} .

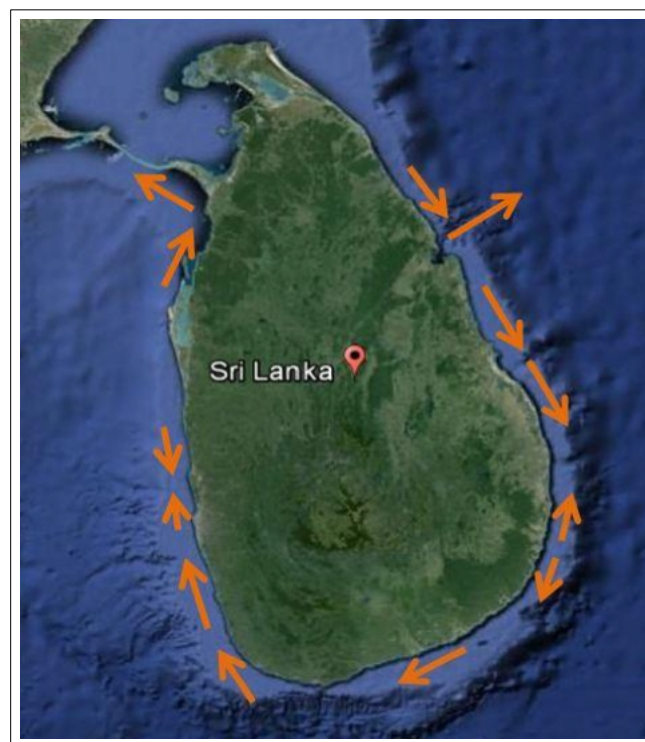
Figure 9: Near-Shore Sediment Transportation Directions

In addition, the sediment deposition pattern associated with breakwaters and groynes in the entire area shows sand transportation predominantly toward the north (Figure 9). According to Lakmali et al. (2017), sediment deposition in the northern section characterizes the south-western coastal area, whereas erosion characterizes the southern section, implying predominant sediment transportation toward the north. Therefore, the south-western monsoon winds, which power the northerly-directed longshore transport, predominantly governs the south-western coastal belt.
