# Are coastal protective hard structures still applicable with respect to shoreline changes in Sri Lanka?

ADB Working Paper Series, No. 1240

No. 1240  
March 2021

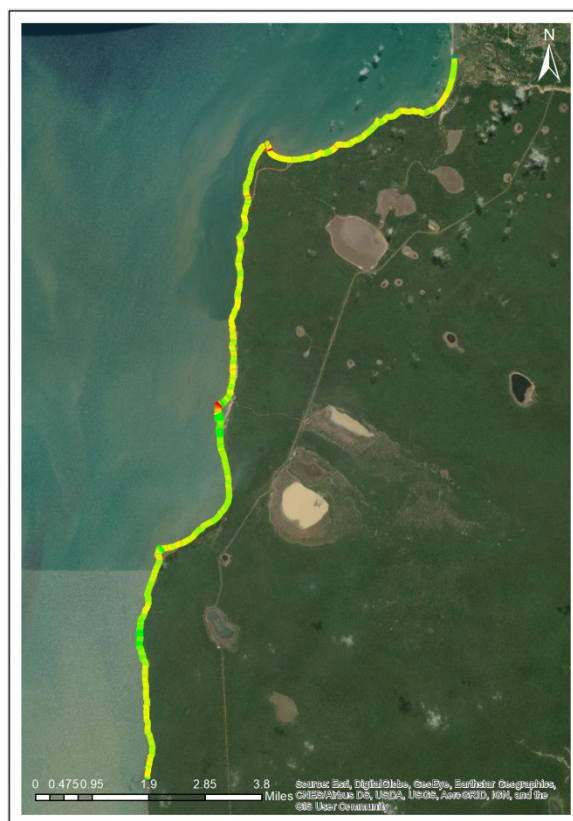
**Figure 4: EPR of the Kalutara (A), Colombo (B), Gampaha (C), and Puttalam (D) Districts and the Wilpattu Region**

The EPR levels exhibit nine color variations according to the differences in erosion and accretion. The bright red (■) represents the area that has experienced a very high erosion rate with  $X < \text{EPR} \leq -3.0$ , and the different shades of red represent high erosion (■) with a  $-3.0 < \text{EPR} \leq -2.0$  rate range, moderate erosion (■) with a  $-1.0 < \text{EPR} \leq -2.0$  rate range, and low erosion (■) with a  $-1.0 < \text{EPR} \leq -0.5$  rate range. The yellow (■) represents the stable condition in the shorelines with a rate of  $-0.5 < \text{EPR} \leq 0.5$ . The shades of green represent low accretion (■) with  $0.5 < \text{EPR} \leq 1.0$ , moderate accretion (■) with  $1.0 < \text{EPR} \leq 2.0$ , high accretion (■) with  $2.0 < \text{EPR} \leq 3.0$ , and very high accretion (■) from  $3.0 < \text{EPR} \leq X$ , which the bright green represents.

The place with the highest recorded EPR in Gampaha district is Daluwakotuwa beach, with a  $15.47 \text{ m yr}^{-1}$  rate, and the place with the lowest recorded EPR in Gampaha district is near Dikowita harbor, with a  $-6.03 \text{ m yr}^{-1}$  rate. The place with the highest recorded EPR in Puttalam district is in Kudawa upper division, with  $32.3 \text{ m yr}^{-1}$ . The place with the lowest recorded EPR in Puttalam district is Kandakuliya, with  $-39.91 \text{ m yr}^{-1}$ .

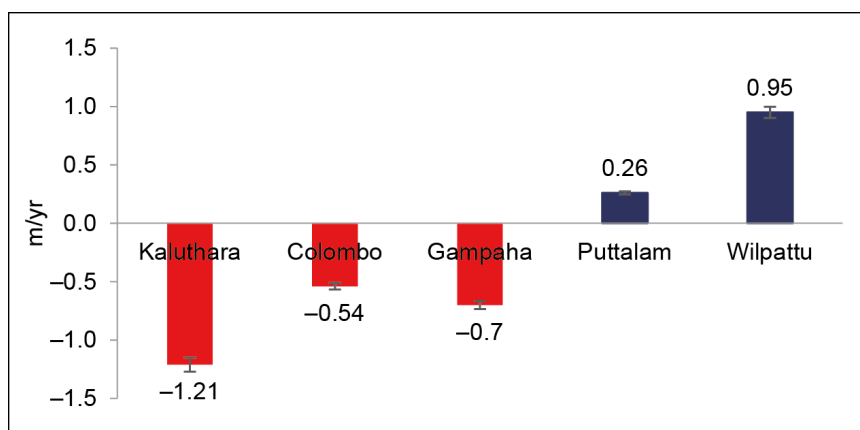
**Figure 6: Average Rate of the Shoreline Changes in each Selected Area**

When considering the total average EPR in each district, as Figure 6 shows, the Kalutara district recorded the highest rate of shoreline erosion ( $-1.21 \pm 0.04$  m/yr) and the Wilpattu region recorded the highest rate of accretion ( $0.95 \pm 0.58$  m/yr). Unlike the Kalutara district, the Colombo and Gampaha districts also recorded changing erosion rates. However, Puttalam district had a changing accretion rate.

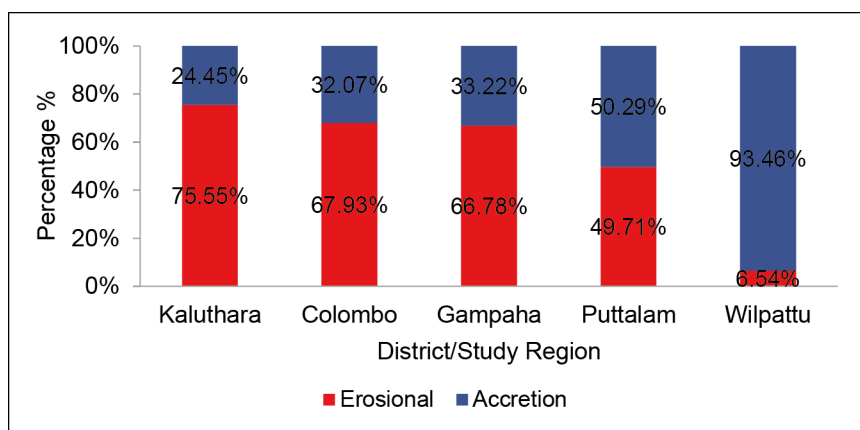
**Figure 7: Percentage of Erosion and Accretion in Each Selected Area**

As Figure 7 represented, erosion has strongly influenced the highest percentage (75.55%) of shorelines in the Kalutara district (approximately three-fourths of the Kalutara coast suffered erosion) and the Wilpattu region recorded the smallest area of erosion, with a high accretion percentage (93.46%) of the shoreline. Relative to the above rates of erosion and accretion (Figure 6), these results represent the same eroded and accreted percentages.

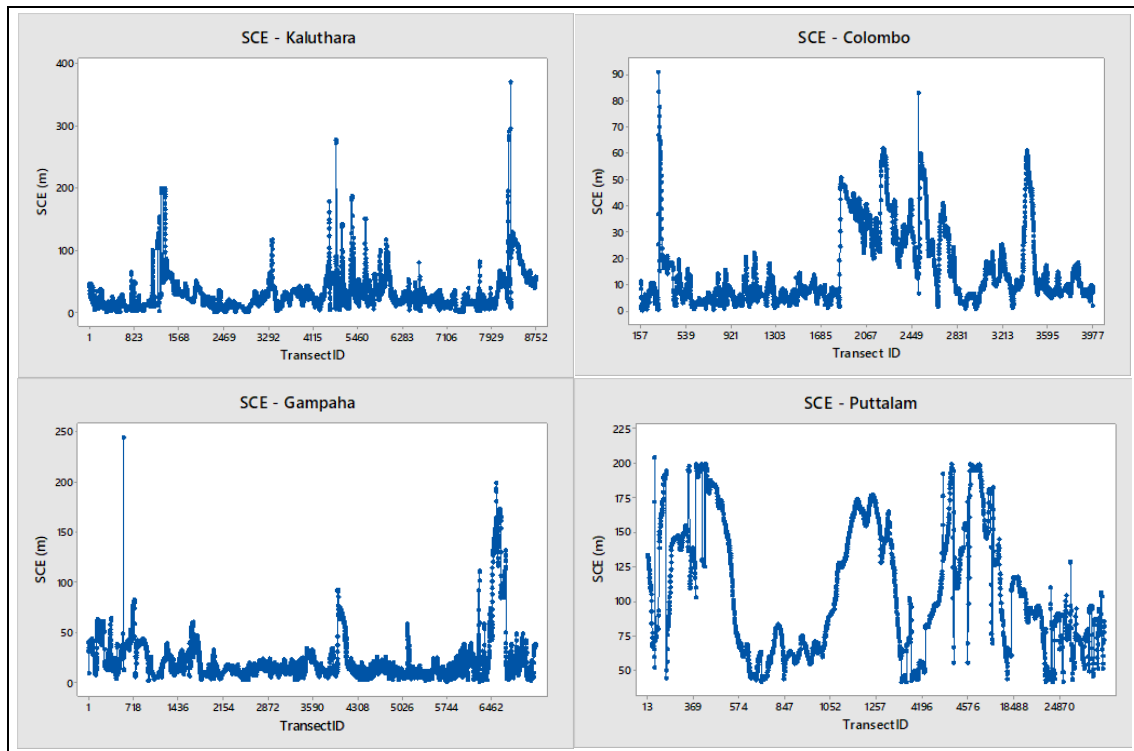
**Figure 8: Graphical Representation of the SCE of Kalutara, Colombo, Gampaha, and Puttalam Districts**

The comparison of the two districts with the greatest erosional changes (Kalutara) and the greatest accretion changes (Puttalam), using the SCE statistical data of Kalutara, showed that the maximum of 368 m accretion during the period 2010 to 2019 occurred in Kaluwamodara-West region (6°33'50.09"N, 79°59'14.93 E–6°26'7.31"N, 79°59'27.92"E) and the least dynamic shoreline, with a minimum of 0.76 m accretion from 2005 to 2015, was in Pothupitiya-West region (6°38'7.52"N, 79°56'13.17"E–6°37'55.45"N, 79°56'17.75"E). Kaluwamodara-West region's considerably higher accretion level may be due to freshwater discharging from the Benthota River. The visual observations indicated that sand and mud particles that washed away from the inner land formed deposits around this estuary, so the seaward movement of land is apparent.

The SCE of Puttalam district indicated that the coastal zone of Puttalam has a stable and accretional beach with a low level of erosion. The upper part of the Kalpitiya peninsula showed a comparatively high erosion rate and high shoreline movement, including accretion and erosion. Further, the study identified this area as a critical region based on the large shoreline movement. According to Samanmali, Piyadasa, and Wickramasinghe (2014), a 32 m/yr shoreline change occurred from 1973 to 2014 in the Kandakuliya and Kudawa regions. Further, the shoreline change varied between  $32.3 \pm 7.50$  m/yr and  $-39.91 \pm 7.50$  m/yr along the Kalpitiya region (Kandakuliya–Kudawa). These two results coincide and could be due mainly to natural phenomena, the sea-level rise, and the adverse effects of climatic change. All the aquatic ecosystems will be susceptible to variation of inundation, and coastal erosion and alterations in coastal ecosystems may lead to the sea level rising (Nianthi and Shaw 2015). The sea level rise in Sri Lanka was 0.3 m by 2010, and forecasts indicate that the sea level will rise by 1.0 m by 2070 (NATCOM 2000). It will also lead to increased coastal erosion in the coastal zone of Sri Lanka (Nianthi and Shaw 2015).

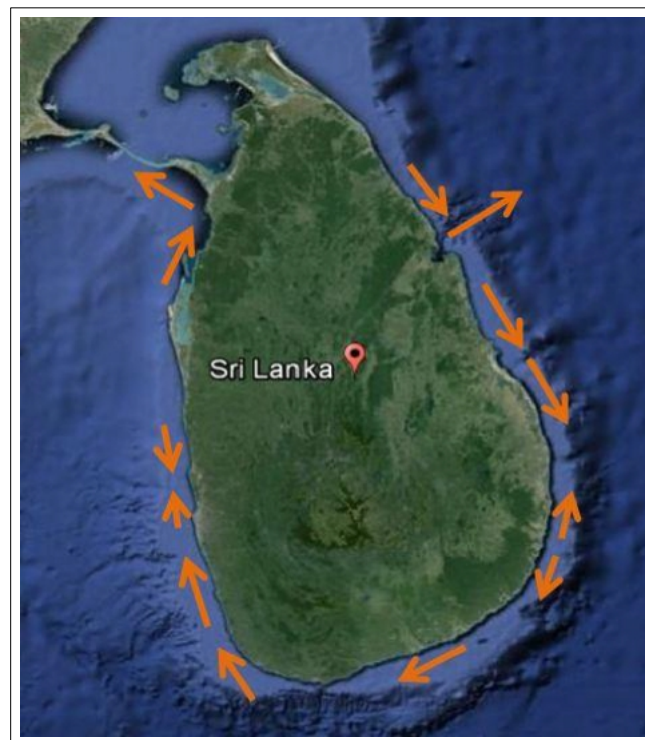
**Figure 9: Near-Shore Sediment Transportation Directions**

In addition, the sediment deposition pattern associated with breakwaters and groynes in the entire area shows sand transportation predominantly toward the north (Figure 9). According to Lakmali et al. (2017), sediment deposition in the northern section characterizes the south-western coastal area, whereas erosion characterizes the southern section, implying predominant sediment transportation toward the north. Therefore, the south-western monsoon winds, which power the northerly-directed longshore transport, predominantly governs the south-western coastal belt.

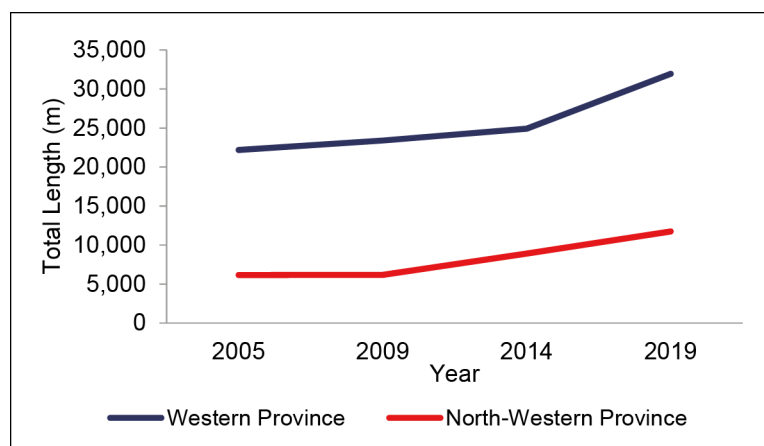
**Figure 11: Total Hard Structures in the North-Western and Western Provinces**

Figure 11 proves that the Western province has implemented a larger amount of coastal protection techniques to conserve the coastal zone than the North-Western province. This conservation method is based entirely on utilization, humans’ alterations of the shoreline, and the adverse effects of natural phenomena. The Western province (Colombo, Kalutara, and Gampaha) has utilized its coastal zone more to for development projects, the tourism industry, residences, infrastructure, and so on than the North-Western province. To some extent, there has been minimal human influence along the North-Western province’s shoreline, so there is a naturally behaving sandy beach up to Kalpitiya peninsula.
