Nitrile cup seal robustness in the India Mark II/III hand pump system

Development Engineering

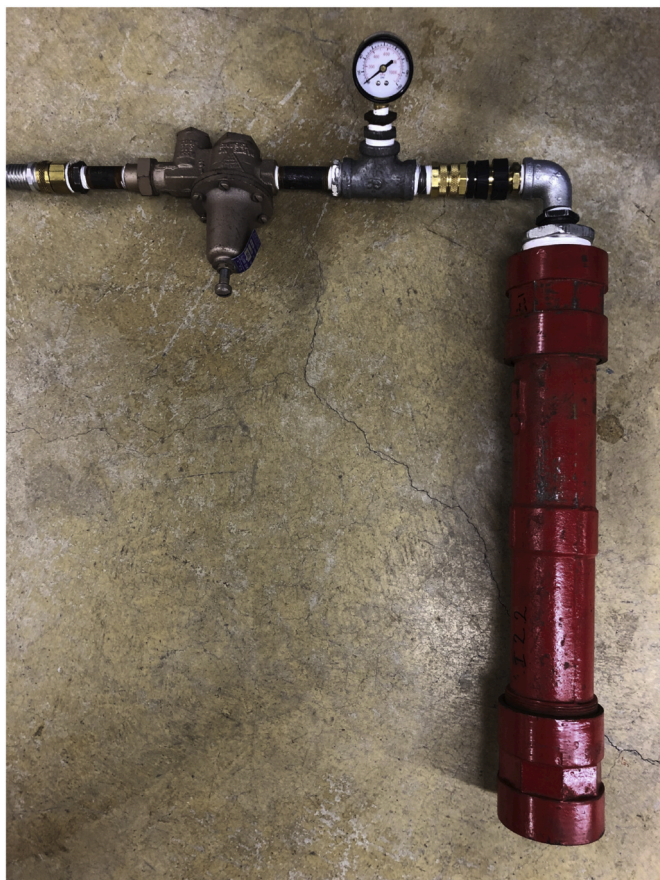
Fig. 10. Test setup for determining cup seal leak rate.

To find the leak rate of each purchased seal, a static seal leak-rate test rig was built at Brigham Young University (see Fig. 10). It consisted of a pump cylinder from an India Mark III hand pump system complete with a plunger. Attached to the pump cylinder was a high pressure water source, an adjustable regulator, and a gauge. Different well depths could be simulated by adjusting the pressure of the water entering the pump cylinder. Each seal was tested individually and the data collected and evaluated. The seal being tested was placed in the lower seal position of the plunger (see Fig. 5(c)).
