Seismic Protection of Laboratory Contents: The UC Berkeley Science Building Case Study

**Seismic Protection of Laboratory Contents:
The UC Berkeley Science Building Case Study**

Professor Mary C. Comerio
Institute of Urban and Regional Development
University of California, Berkeley

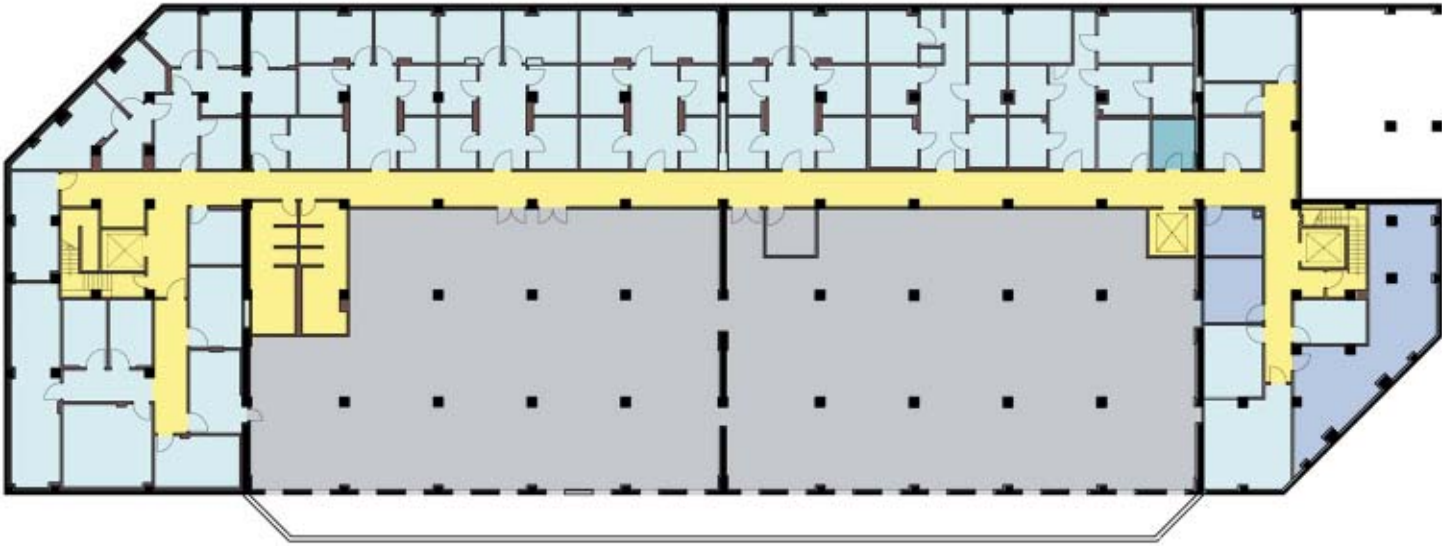
Figure 4: Basement-Floor Plan and Space Use

- Animal Space: 9,877 SF
- Office Space : 99 SF
- Storage/ Other : 1,403 SF
- Corridor/Public : 3,314 SF
- Mechanical Space : 11,442 SF

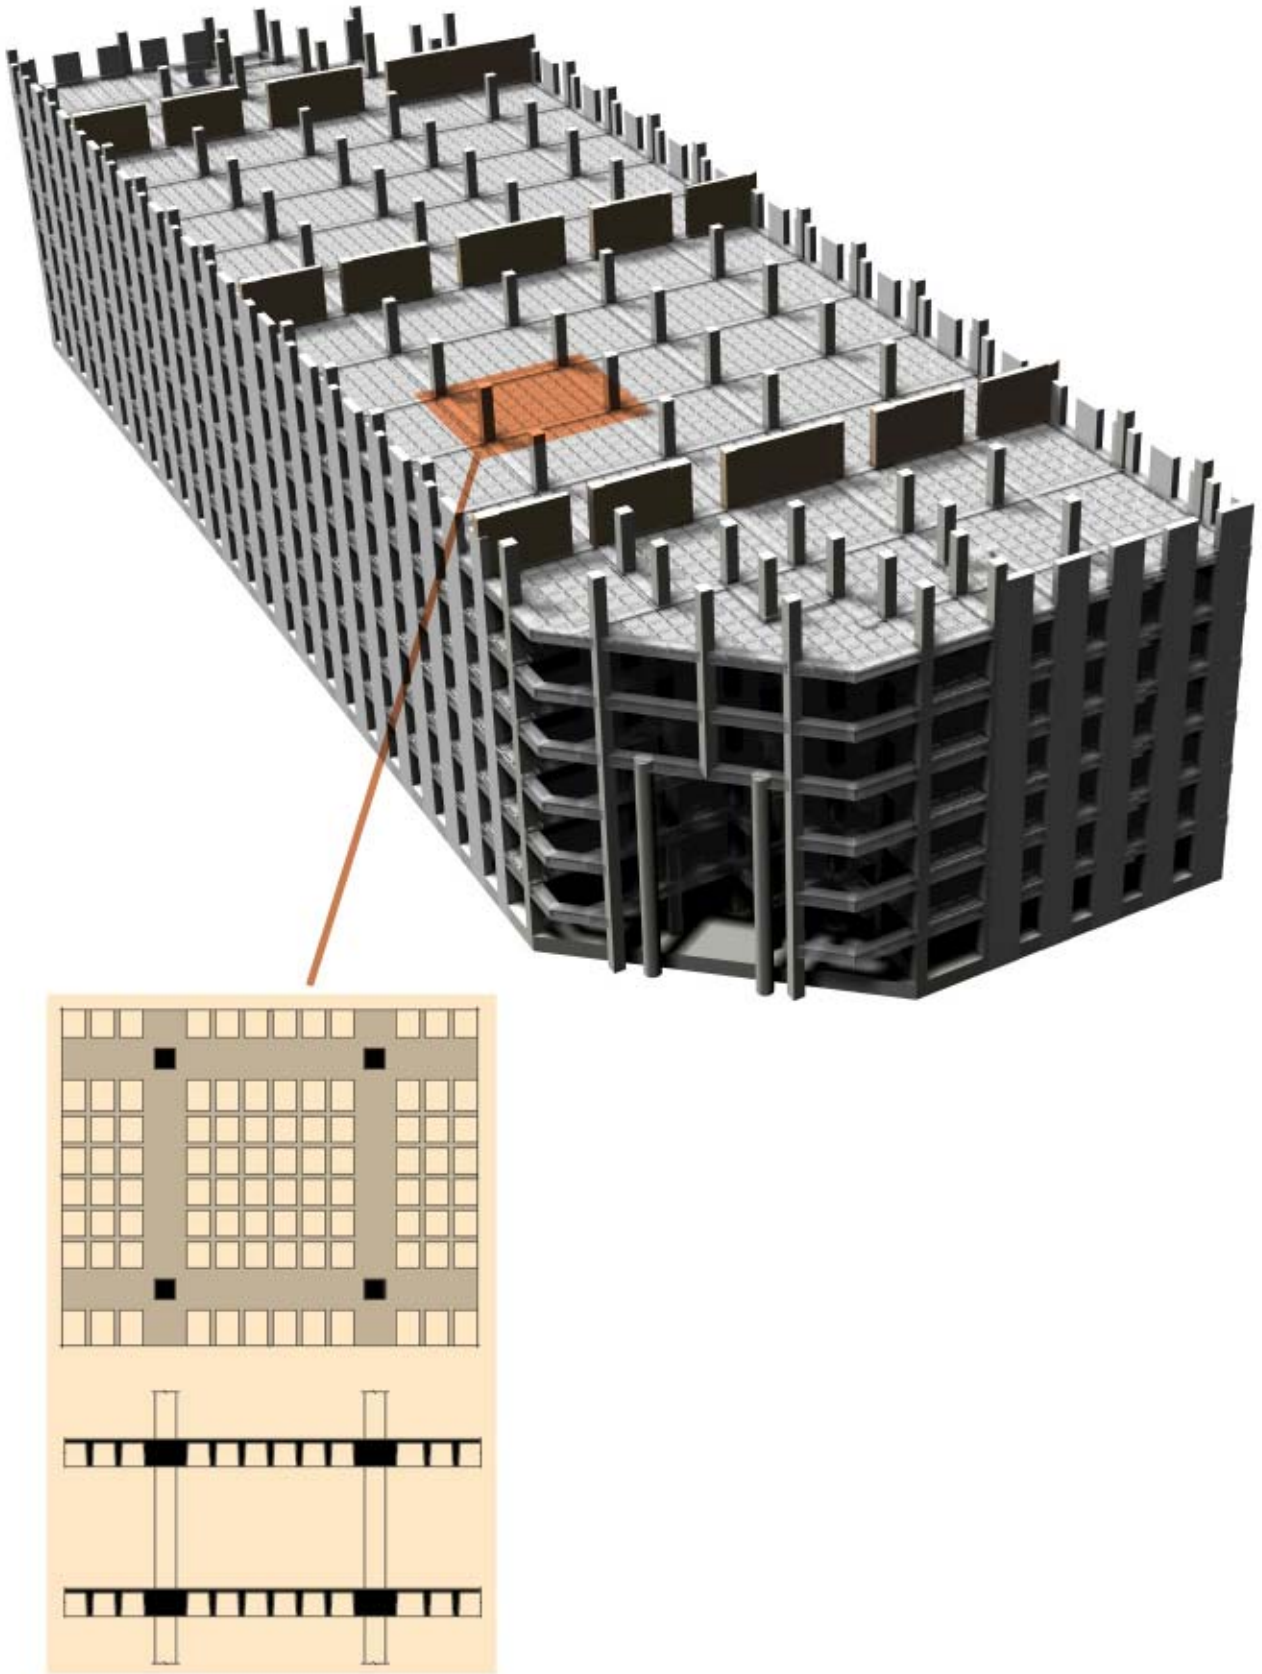
Figure 12: Diagram of Structural System

Structural Features. The vertical-load carrying system consists of a reinforced concrete frame. The floor structure is a waffle slab on every level and is composed of a 4½-inch-thick concrete slab supported on 20-inch-deep joists in each direction. The waffle slab is supported by concrete girders, which in turn are supported by concrete columns. The typical bay spacing is 20'-0" in the longitudinal direction and 22'-10" in the transverse direction. The foundations consist of a 38-inch-deep continuous mat foundation.

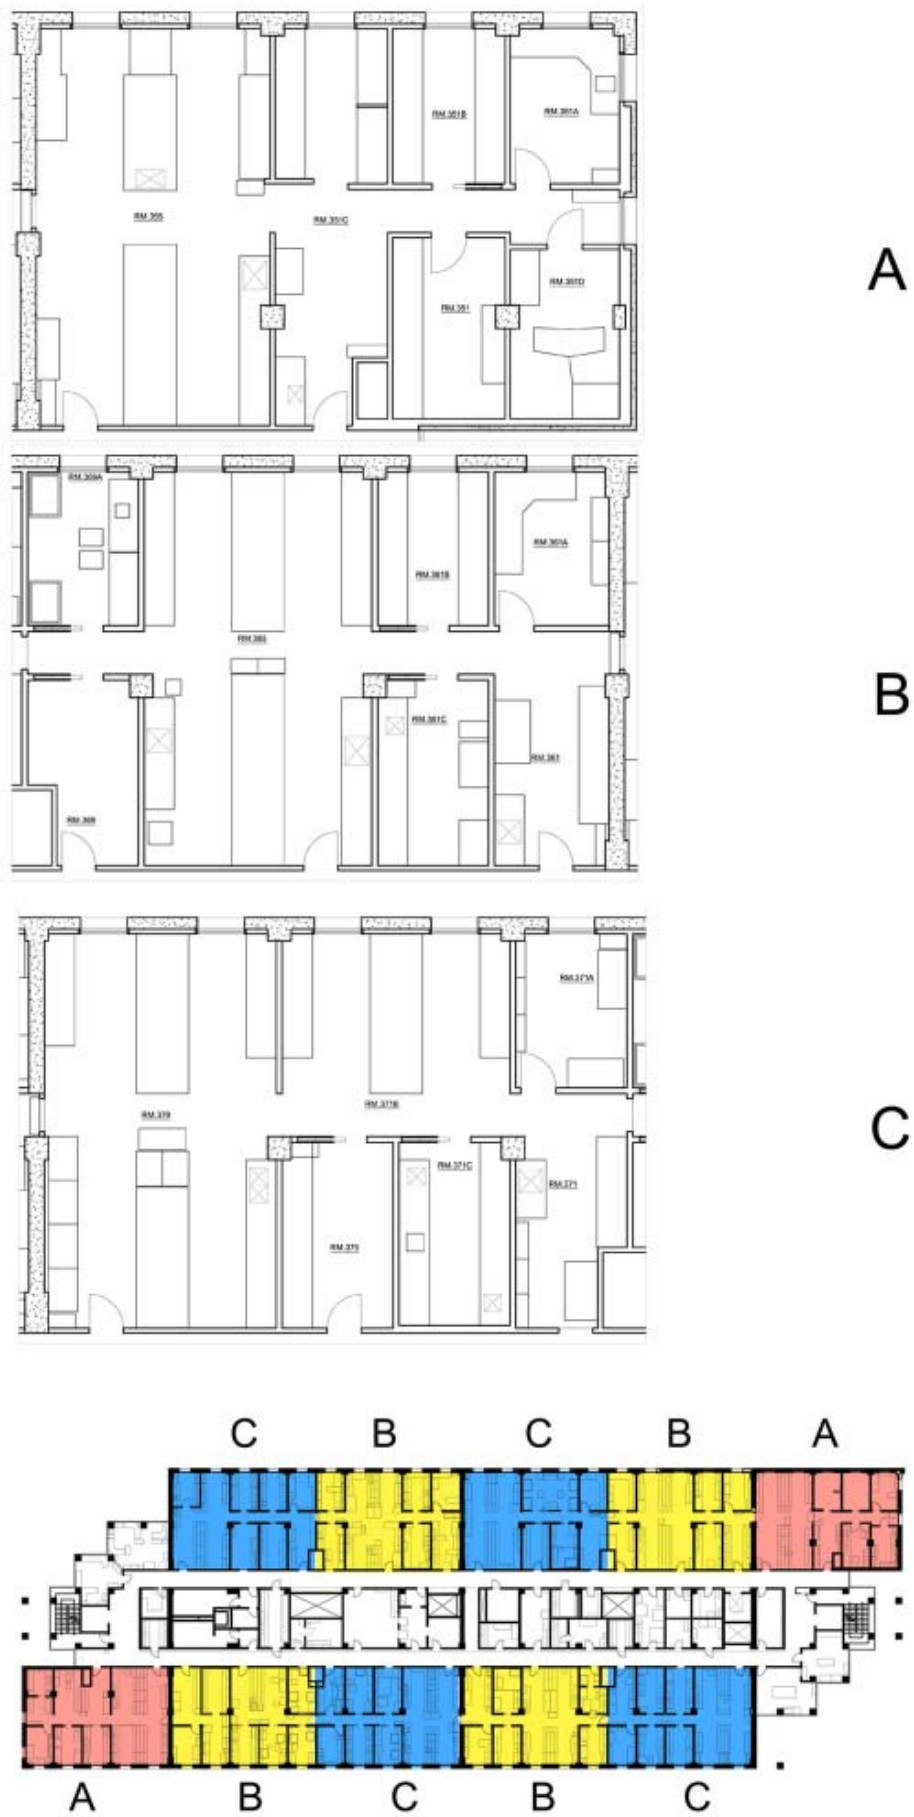
Figure 16: Diagram of Typical Laboratory Layouts
