Seismic Protection of Laboratory Contents: The UC Berkeley Science Building Case Study

Working Paper 2003-02

Professor Mary C. Comerio
Institute of Urban and Regional Development
University of California, Berkeley

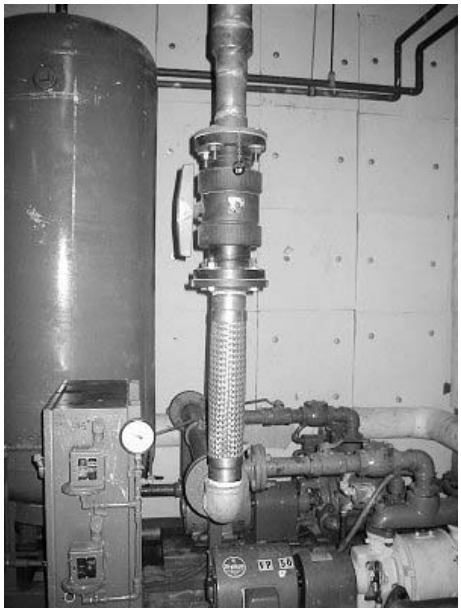
Figure A.1: Typical piping support

- Adequacy and condition of lateral seismic bracing (Figure A.1). Lateral bracing often consists of cables attached diagonally to sleeves used for vertical support. The attachment of the sleeves to the piping appears inadequate for lateral forces.
- Adequacy of flexible seismic connections (Figure A.2) between stationary floor-mounted equipment and ceiling-supported piping.
- Adequacy of strength of piping joints and connections to resist lateral forces where unrestrained.
- Adequacy of trapezes carrying laboratory utilities.

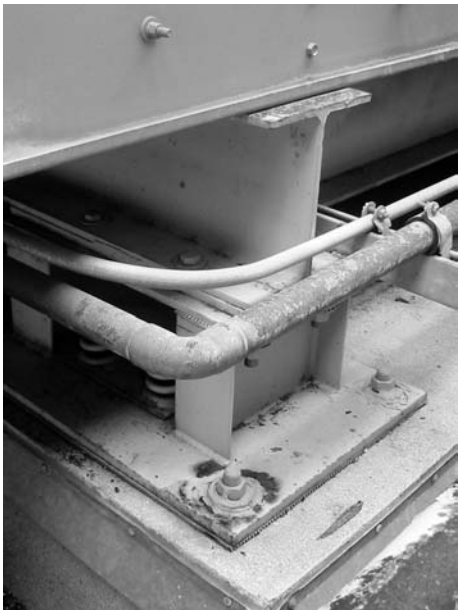
Figure A.3: Rooftop cabinet support

- Increased loading (over old code requirements) at roof (Figures A.3 and A.4).
- Installation of emergency generator (apparently as an addition).
- Effectiveness of cable bracing for piping.

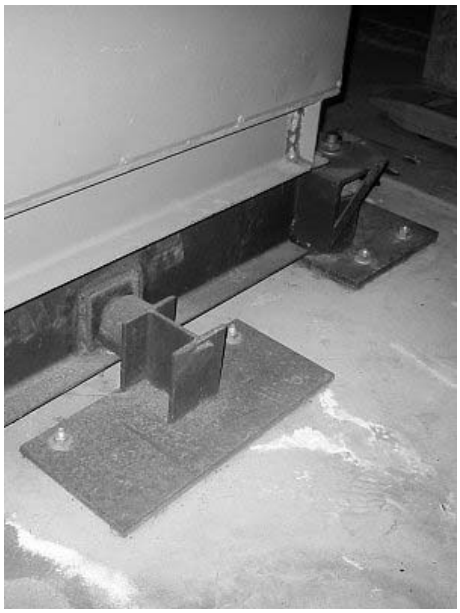
Figure A.5: Seismic bracing

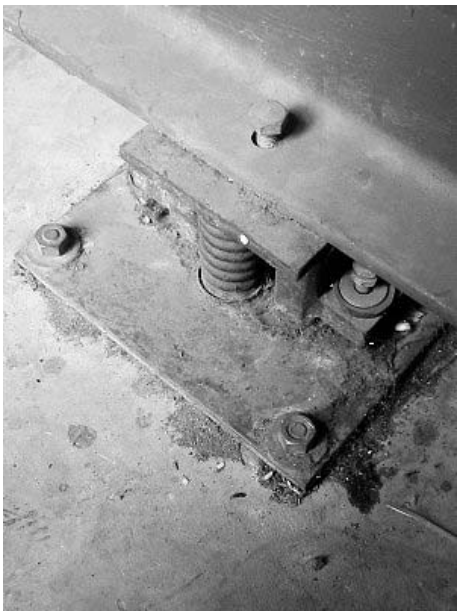
Figure A.6: Support detail

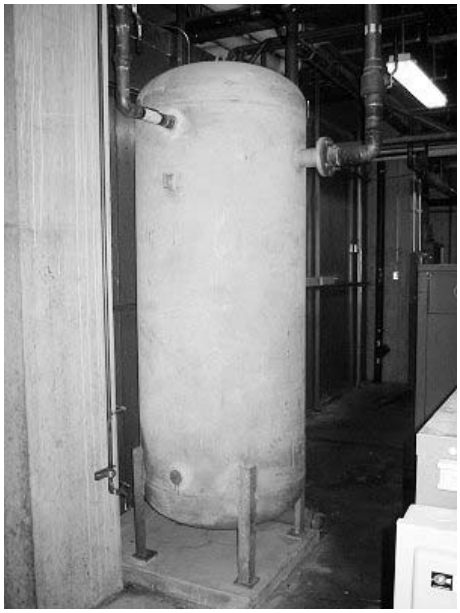
Figure A.9: Vertically oriented tank

- Adequacy of chain to restrain tank, including clasp connection and tautness of chain.
- Adequacy of connection between chain restraint and building structure, including additional Unistruts or connection to tables or strongbacks instead of walls.
- Risk of damage from movement, even when restrained, to pressurized valves, pipe connections, or any area of tank where chemicals could escape.

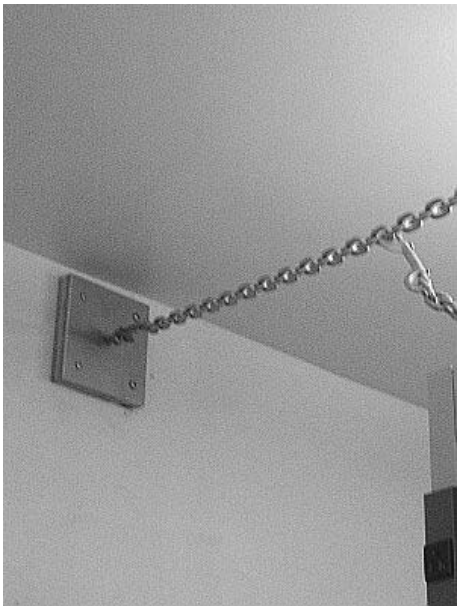
Figure B.4: Chain connection to wall

- Where expansion anchors are used to connect metal plates to concrete, the effectiveness in resisting the required loads is unknown and may vary due to discrepancies in installation and materials.
- Withdrawal forces from existing ceiling connections are unknown. Some chained restraints for heavy objects are attached only to the ceiling overhead, providing limited lateral support.
- There is significant variation in the application of epoxy and plates. In some cases, the metal plates are attached to 1-inch wide areas of the equipment. In other cases, the epoxy is peeling. Other areas appear to have too little epoxy applied. More importantly, the strength and type of epoxy is unknown.
- In cases where heavy equipment is attached to each other (stacked or adjacent) for seismic restraint, the effectiveness of the connections needs to be determined.

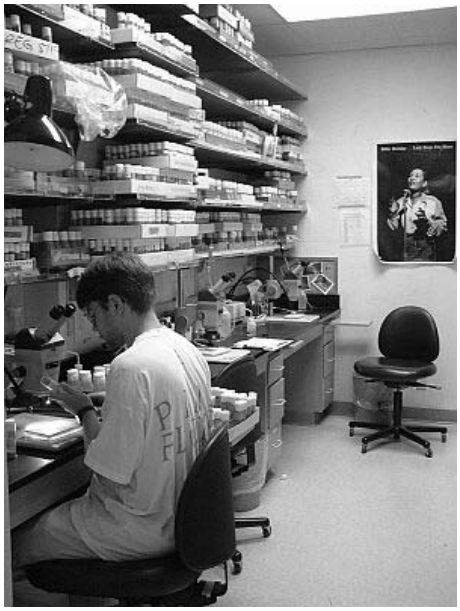
Figure B.7: Lips on lab sample shelves
