Assessing the resurgent irrigation development program of the Philippines: Communal irrigation systems component

PIDS Discussion Paper Series, No. 2020-02

Assessing the Resurgent Irrigation Development Program of the Philippines – Communal Irrigation Systems Component

Roger A. Luyun Jr. and Dulce D. Elazegui

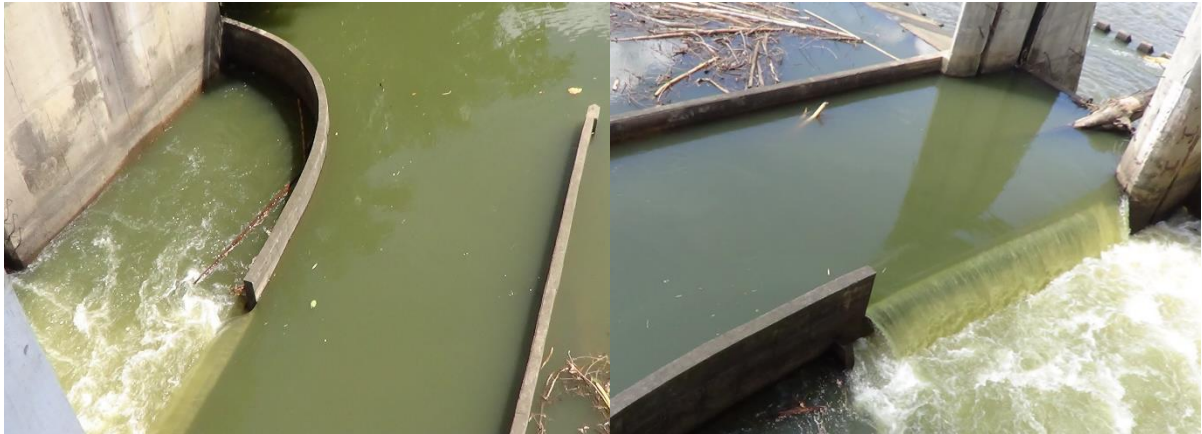
Figure 23. Construction of silt excluder at the MalRIS

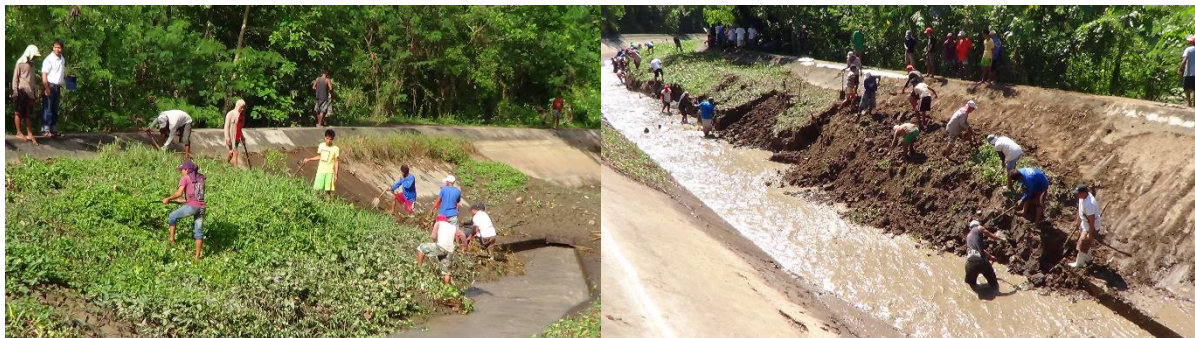
Figure 26. Clearing of the settling basin by combined manual and hydraulic flushing using the silt ejector during the fallow period.

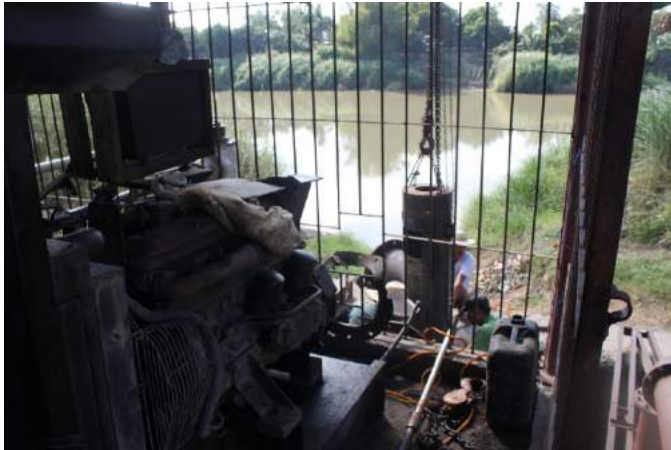
Figure 1A-2. One of 2 Iveco diesel engines for the mixed flow pumps; at the background is the Pampanga River where the PIS derive its waters

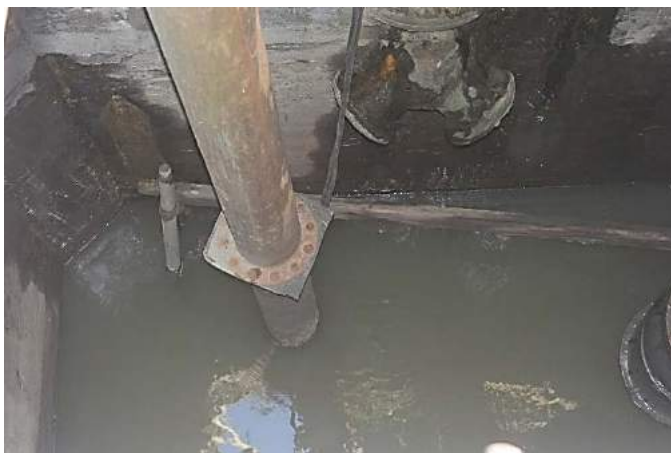
Figure 1A-3. The concrete intake pit for the suction pipes of the Gulap Pump Irrigation System; also shown is the 10-in pipe of the submersible pump

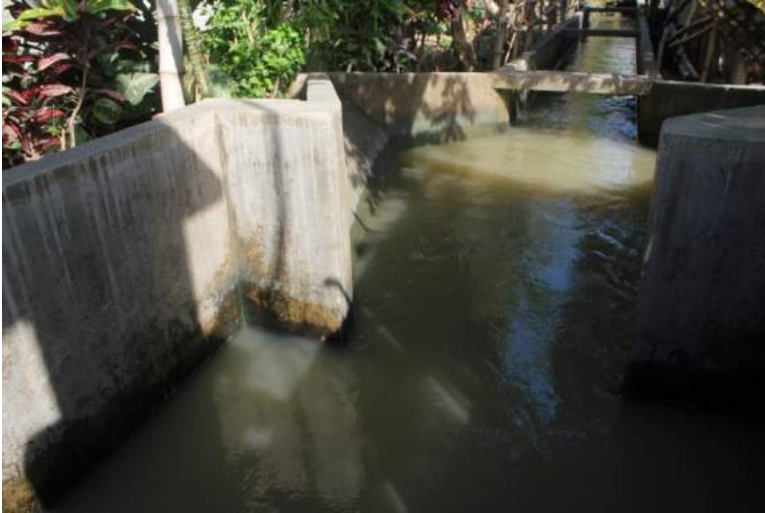
Figure 1A-5. The outlet of the inverted siphon under the road across the concrete sump and pump house; this channels the water into the main canal

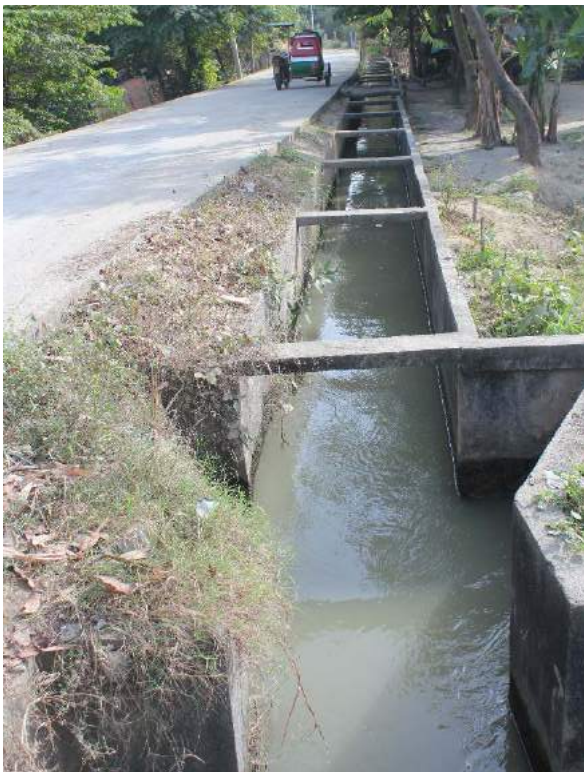
Figure 1A-6. The 1-m wide, 1-m deep concrete lined main canal of the Gulap PIS. The main canal and structures are well built since the IA said that they monitored the actual construction

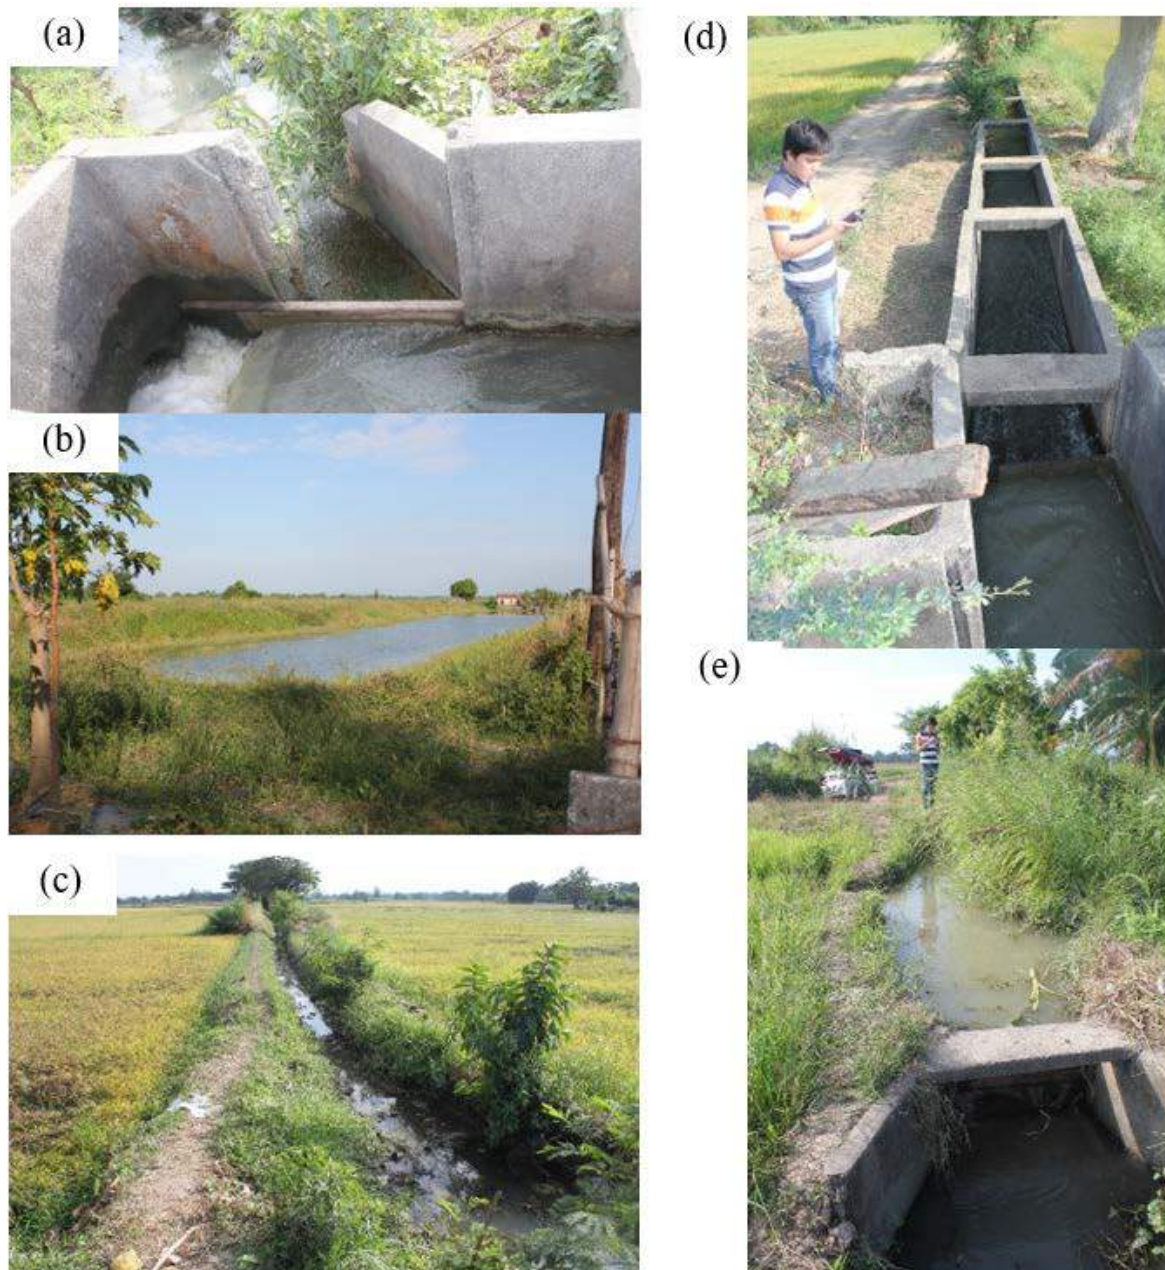
Figure 1A-7. (a) A typical control structure combining a turnout (using wooden slabs), a drop and a road crossing; (b) one of several fishponds being served by the PIS; (c) a typical unlined lateral; (d) continuation of the concrete-lined main canal with control structure combining turnout (wooden slabs) and drop structure; (e) the end check of the main canal, from here on the canals are unlined.

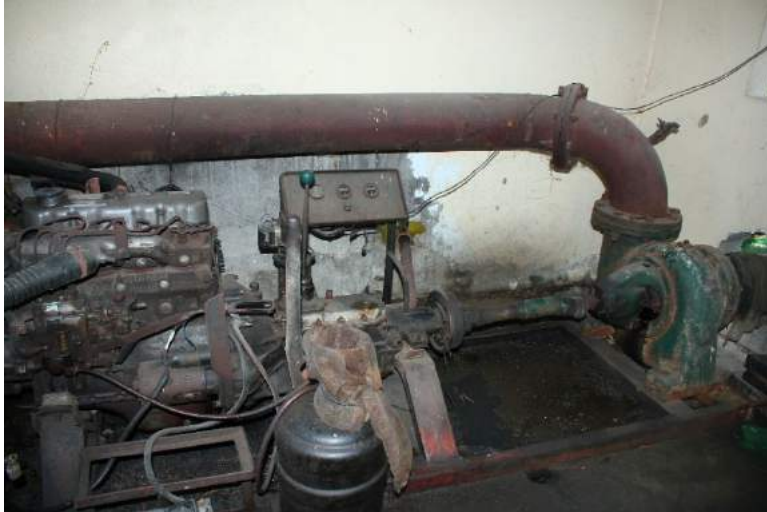
Figure 1A-8. The 8-in dia. centrifugal pump powered by a 4DR5 diesel engine of the Sapa-San Vicente PIS

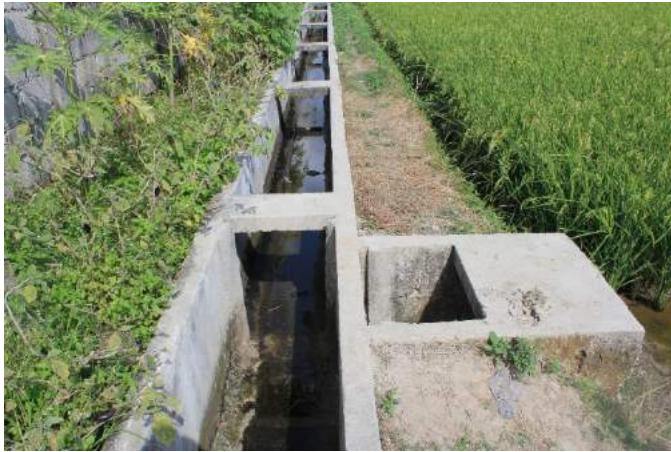
Figure 1A-10. The concrete-lined main canal with a simple turnout gate using slots and wooden slabs as gate

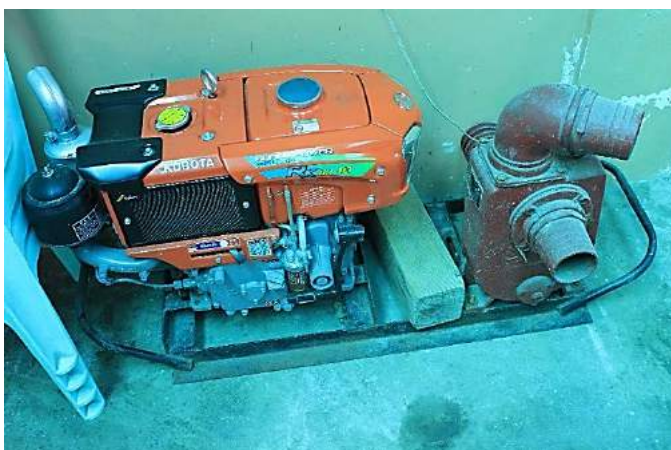
Figure 1A-12. A typical pumpset with a 4x4 self-priming centrifugal pump driven by an 8-Hp Kubota diesel engine (RK80-1S)

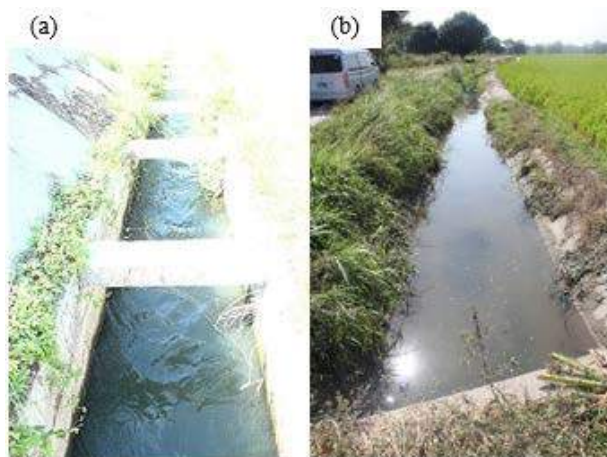
Figure 1A-18. (a) Rectangular portion of the main canal parallel the mega-dike immediately downstream of the dam; (b) trapezoidal portion of the main canal

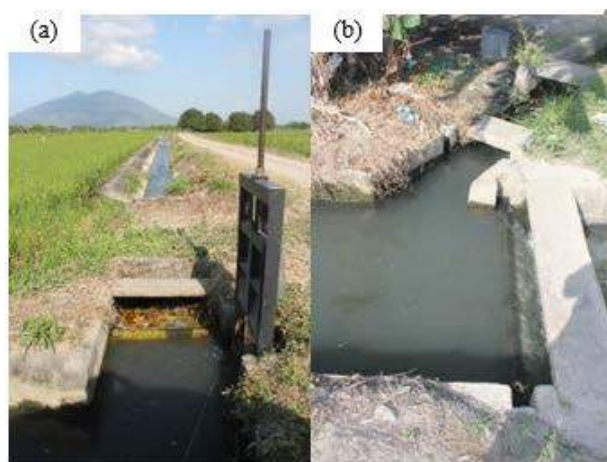
Figure 1A-19. (a) A check gate that serves as a turnout for distributing water to a secondary lateral; (b) a flow dividing structure to a lined lateral; the control has slots for wooden slabs and combined with a shallow drop

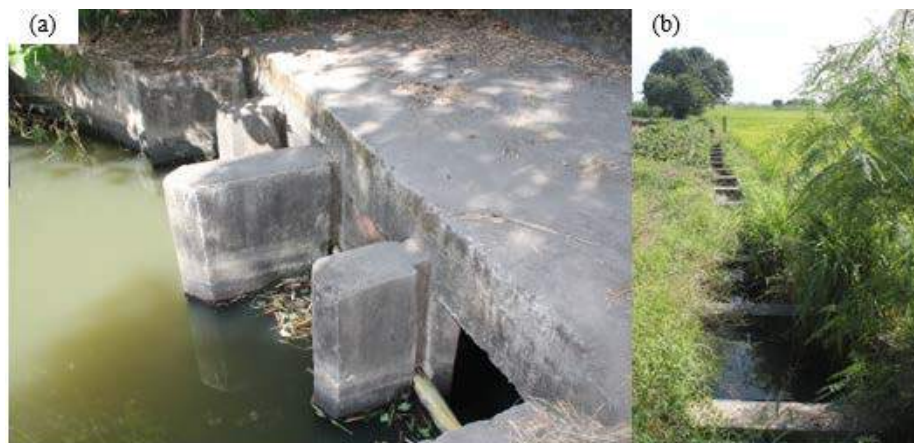
Figure 1A-20. (a) The check gate which the IA refers to as "Dam 2" is used to increase the head at the main canal for distribution to secondary laterals; (b) one of the laterals (concrete-lined) served by the check gate

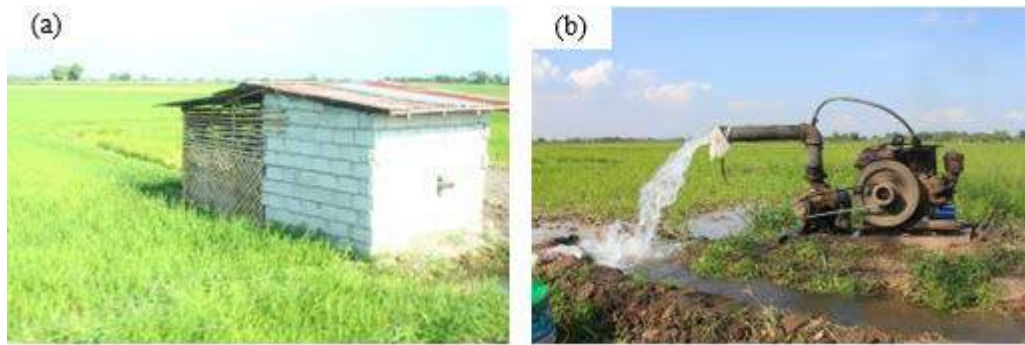
The walkthrough team observed several shallow tubewells (STW) downstream of the CIS area (Figures 1A-21) and were able to interview two farmers who used STWs for supplemental irrigation. An estimated 100 STWs are scattered along the CIS. The groundwater level was about 10 ft during dry season and the commonly installed pipe lengths range from 30-40 ft. Most pipes are made of G.I. steel but a few uses PVC pipes. Most use second-hand diesel engines as prime movers with normal operation of around 12 hours per day consuming about 15 liters per day. The farmers used their STWs more often during the dry season when irrigation is limited.

Figure 1A-21. (a) A shallow tubewell (STW) pump house in Anao CIS; (b) an operating STW pump set with a 4-in non-self-priming centrifugal pump driven by a second-hand 9-Hp Kubota water-cooled diesel engine; the discharge was estimated at ~16 lps

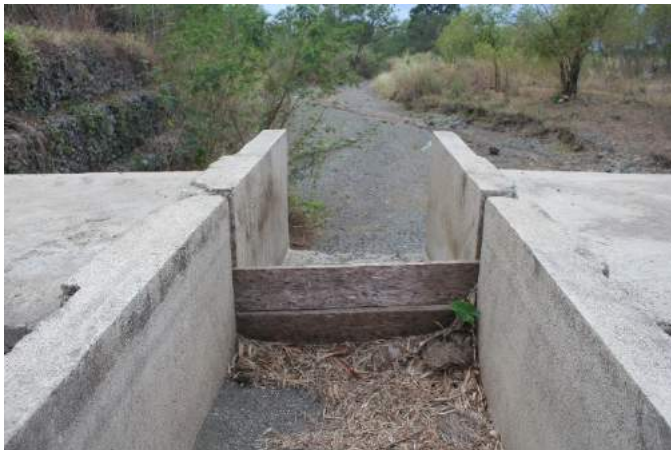
Figure 1A-25. The sluice gate is made of concrete with slots for wooden slabs serving as gates; the background is the downstream portion of the dam

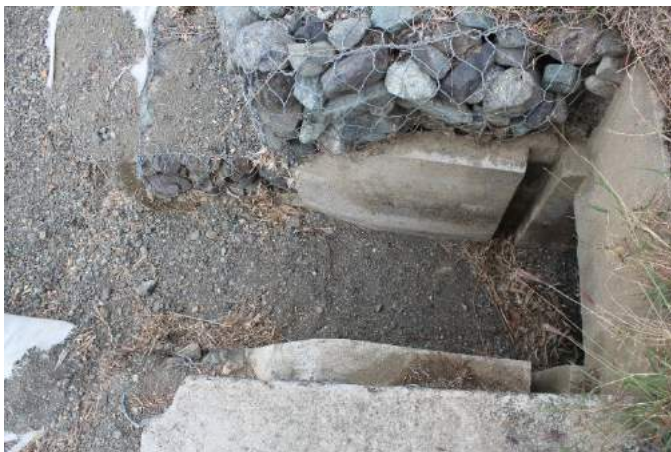
Figure 1A-26. The intake structure with the slots for the wooden gates

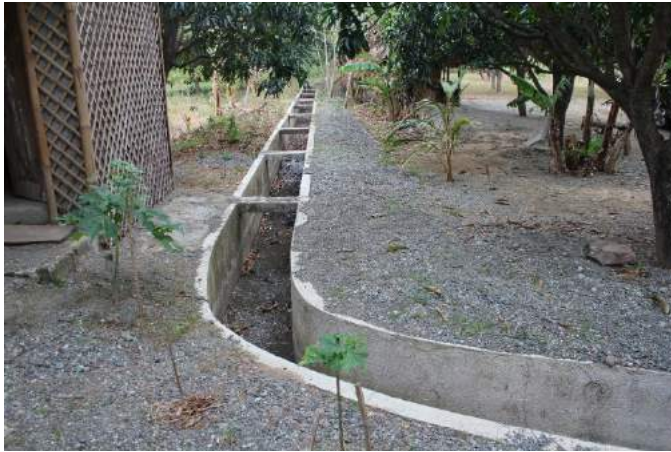
Figure 1A-27. The concrete-lined rectangular main canal

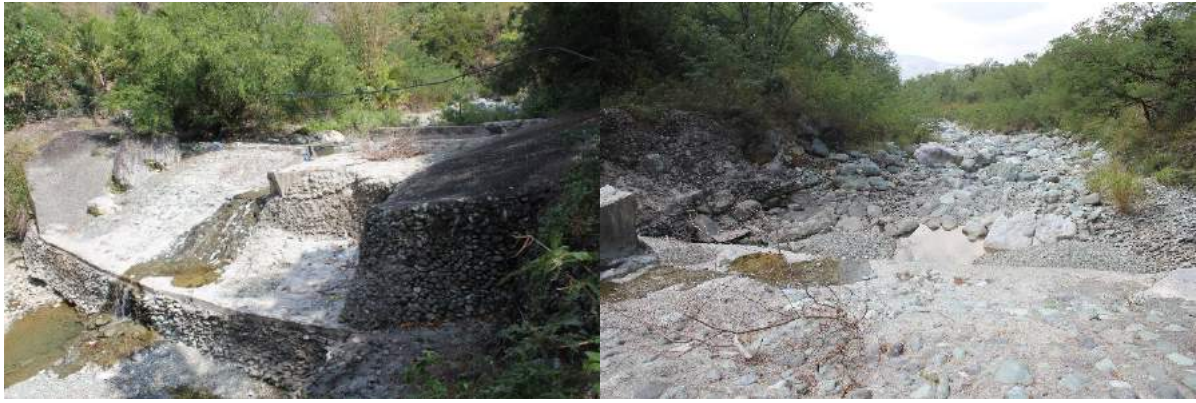
The dam was anchored between two large rocks in the river, but during one flashflood in 2012, one of the rocks was dislodged and a large hole underneath the dam was created. The dam was repaired with rocks and concrete configuration that stands to this day (Figure 1A-28). The river portion where the dam is located is filled with rocks and boulders. The sluice gate is made of wooden slabs stack together on slots (Figure 1A-29). There are two intake gates, with dimensions 1-m depth and 2-m width, leading into the main canal where the initial section is tunneled underground (Figure 1A-30). The water permit granted is 299 Ips. Steel grills can be inserted at the intake gate entrance to prevent debris and rocks from entering the underground main canal.

Figure 1A-28. Left: The Inasan CIS dam along the upstream of the Inasan River made of rock and concrete; Right: boulders and rocks downstream of the dam

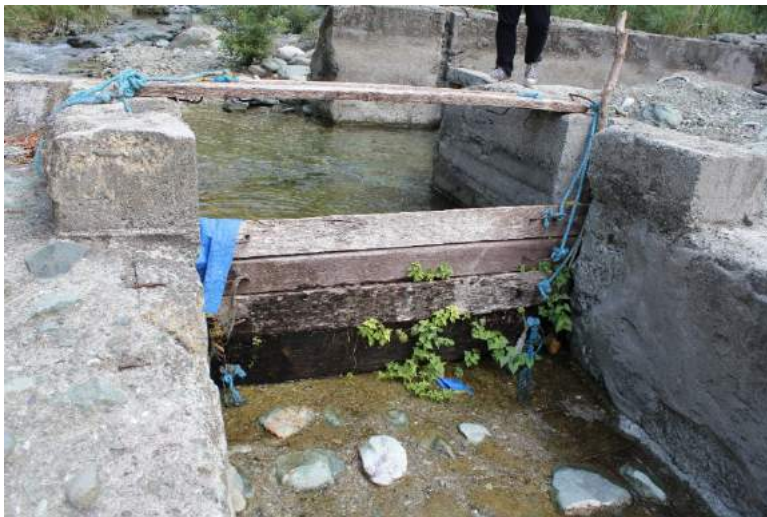
Figure 1A-29. The sluice gate is made of wooden slabs stacked together in a slot serving as water level control gate

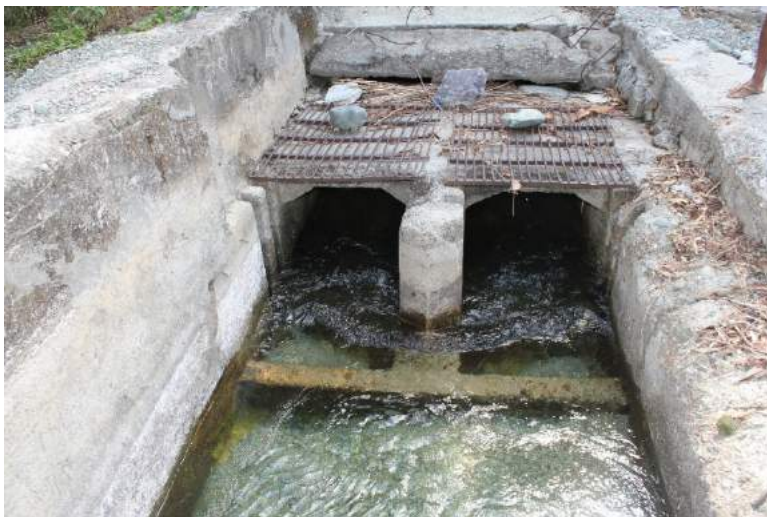
Figure 1A-30. The intake structure leading to the underground tunnel into the main canal

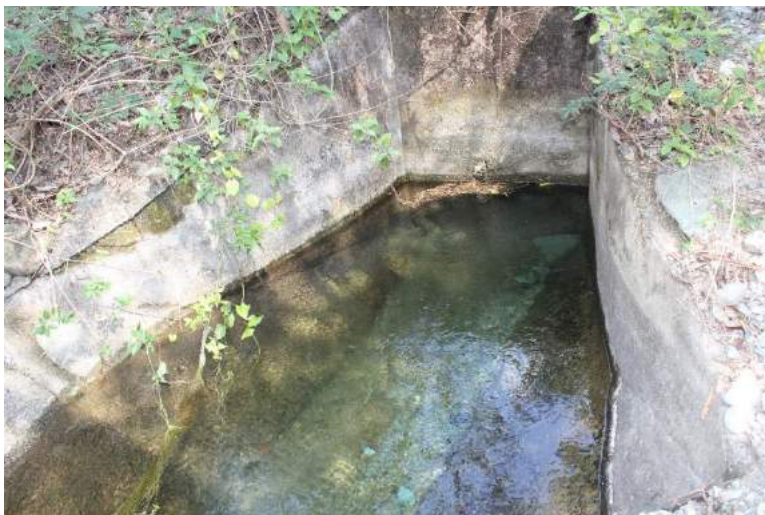
Figure 1A-32. The main canal coming from the underground tunnel from the dam

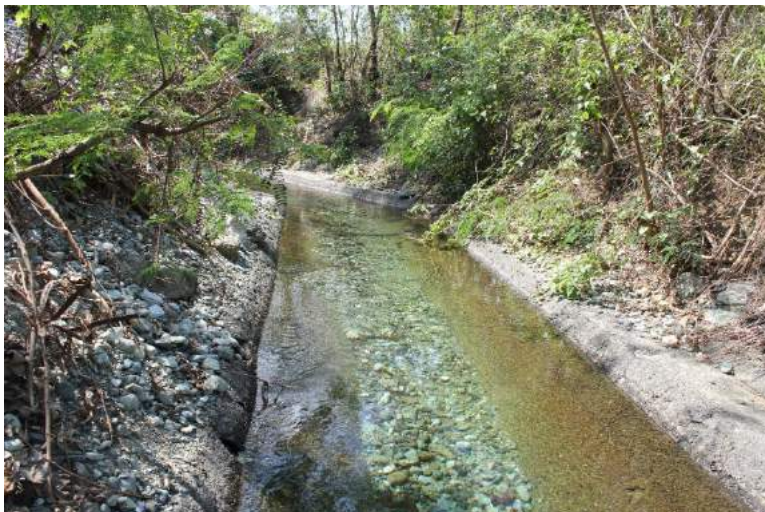
Figure 1A-33. The trapezoidal main canal; the canal bottom is filled with small rocks

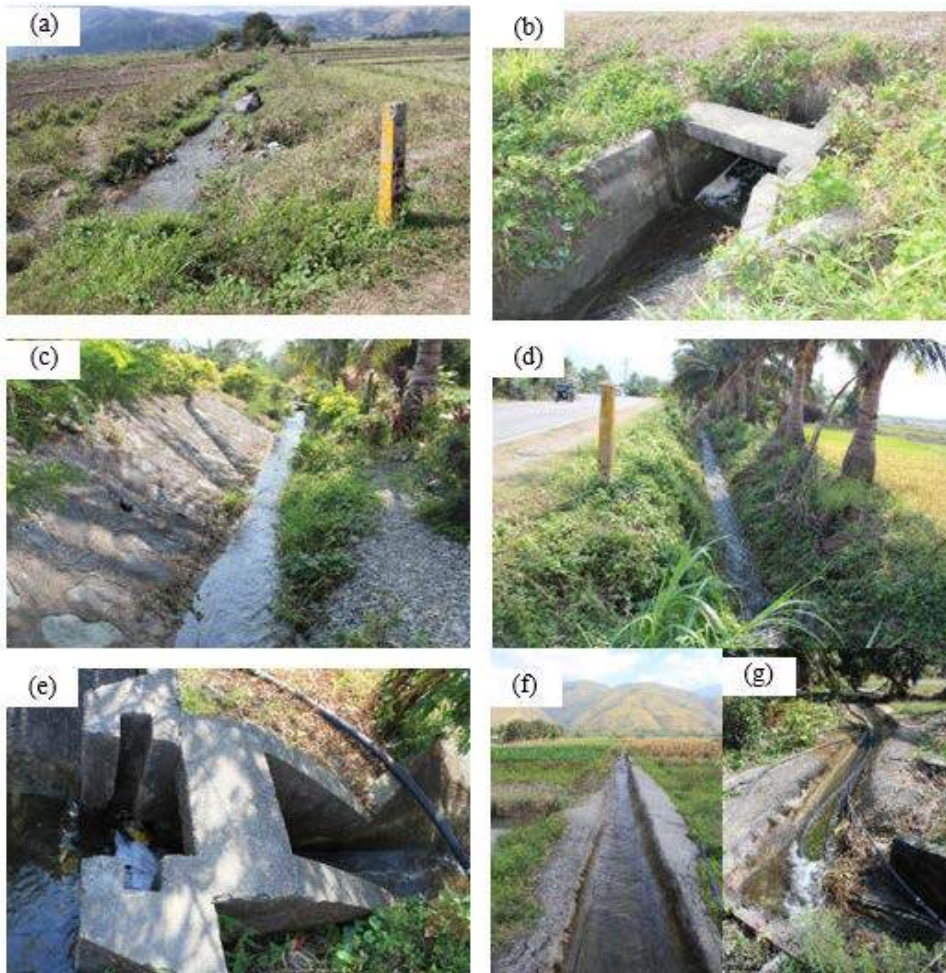
Figure 1A-35. (a) An unlined secondary canal; (b) a concrete check gate and inlet to a road crossing; (c) a lateral at the side of the highway which has a riprap side wall; (d) an unlined lateral at the side of the highway; (e) a concrete check gate in a lateral; (f) a concrete-lined lateral; (g) domestic water supply flexible pipes along a lined lateral

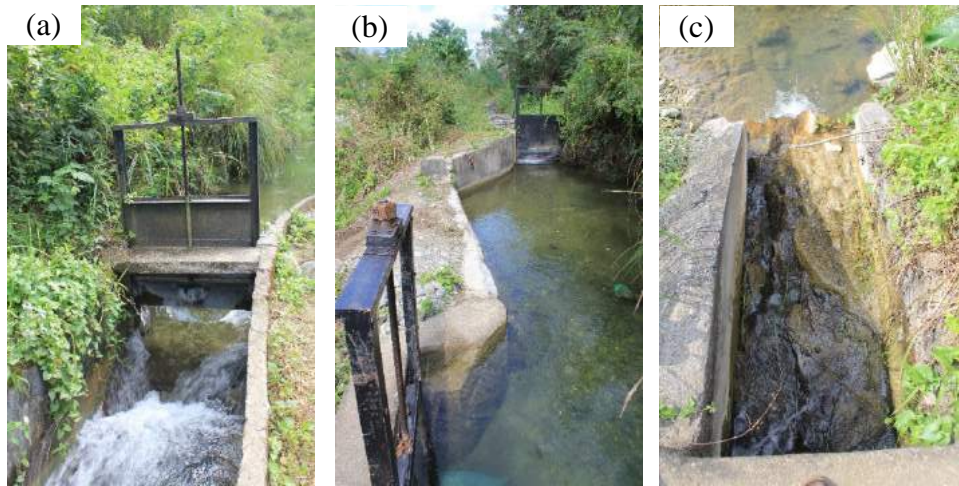
Figure 1A-40. (a) Check gate to control the flow to the main canal; (b) the gate at the top controls the flow to the main canal while the left gate controls return flow to the river; (c) guide chute for excess water reverted back to the river

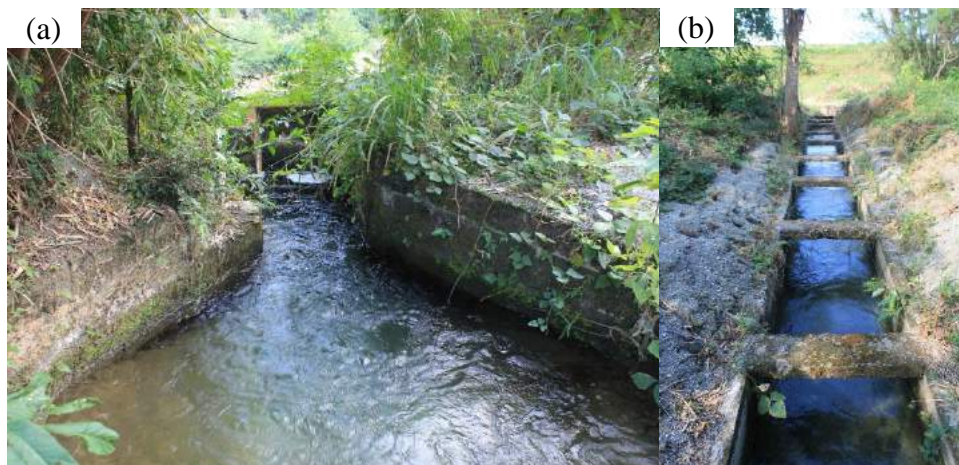
Figure 1A-42. (a) Outlet of the inverted siphon under the river; (b) the concrete-lined lateral canal after the outlet of the inverted siphon used to distribute the water to Parang-Bugnan CIS area across the river

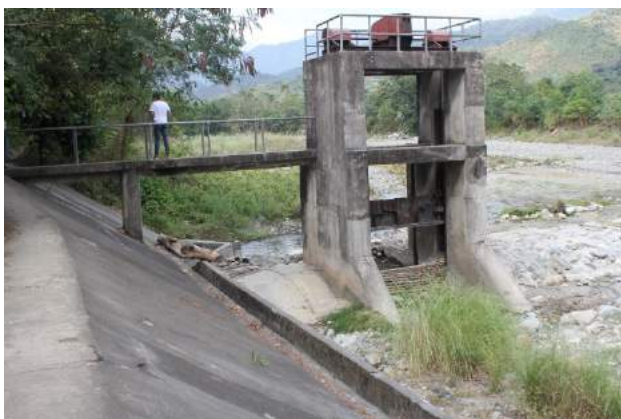
Figure 1A-51. The sluice gate structure and side embankments are still in good condition but the sluice gate itself is now replaced with bamboo and sand bags

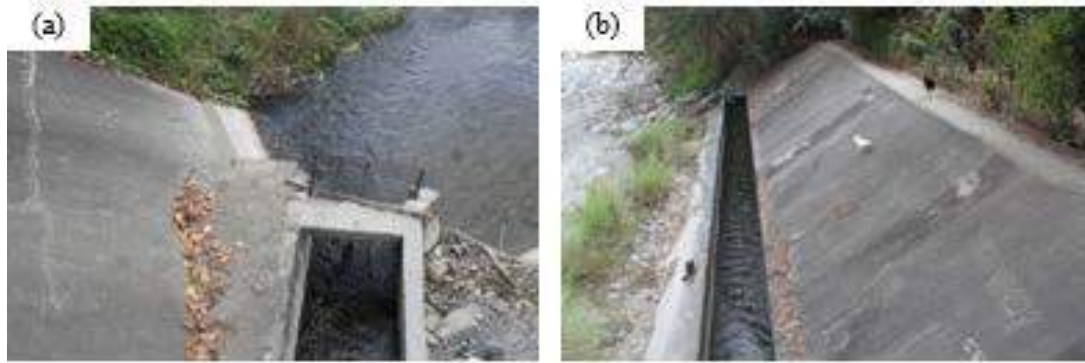
Figure 1A-52. (a) The intake structure with a steel grill to prevent entry of large debris and stones into the main canal; (b) the intake channel at the bottom of the embankment

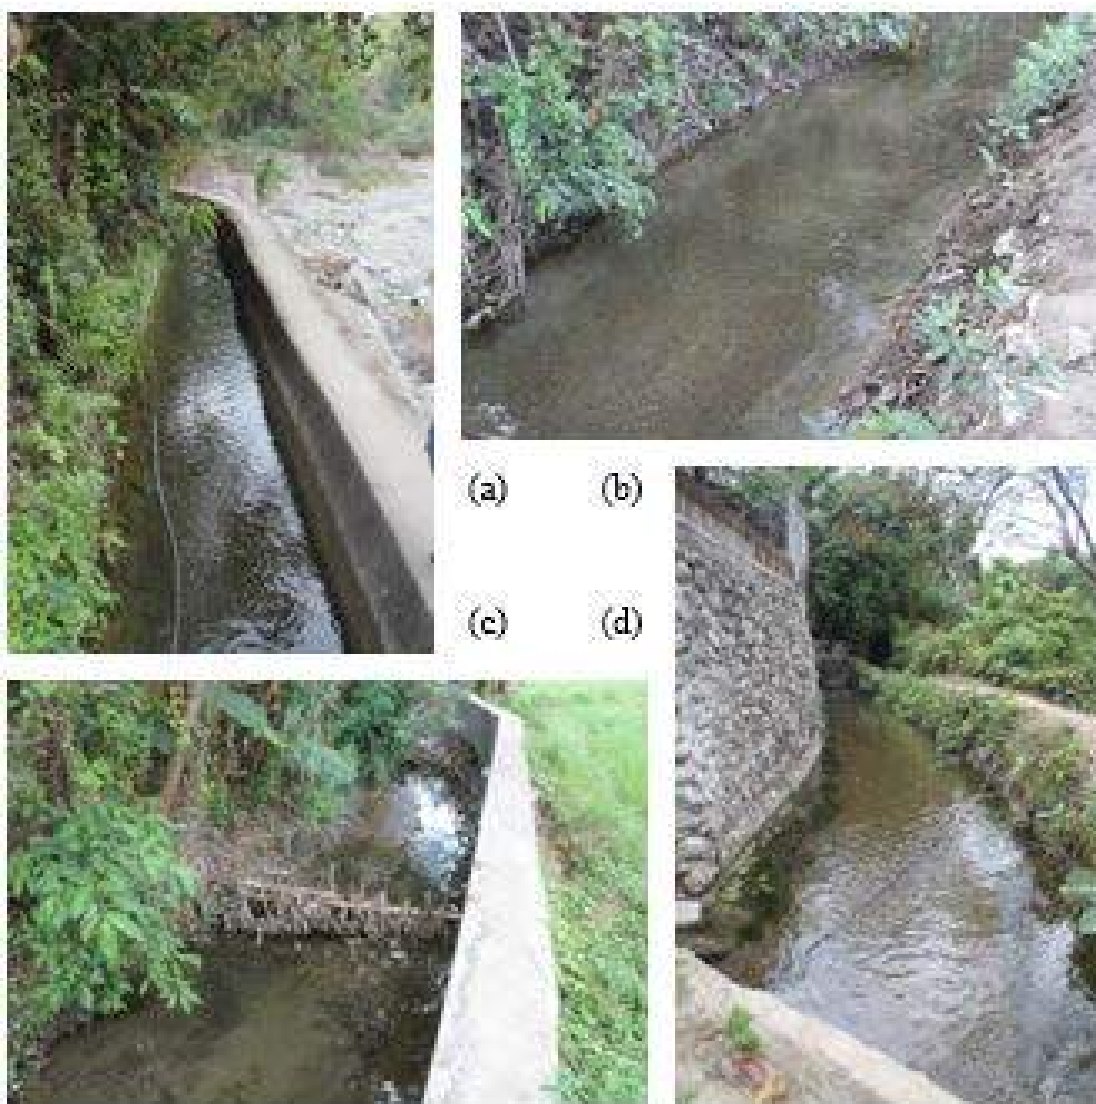
Figure 1A-53. (a-d) Pictures of the canal system with some having concrete lining, some have ripraps and most are unlined; most canals exhibit heavy siltation

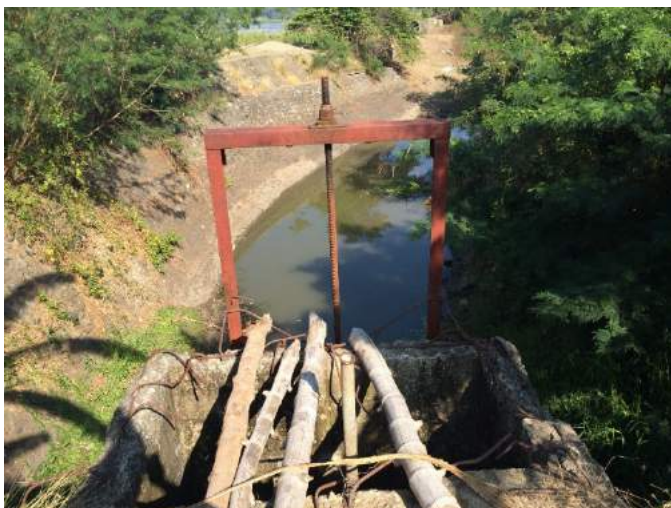
Figure 1A-55. The Baay CIS intake structure
Source: Author's capture

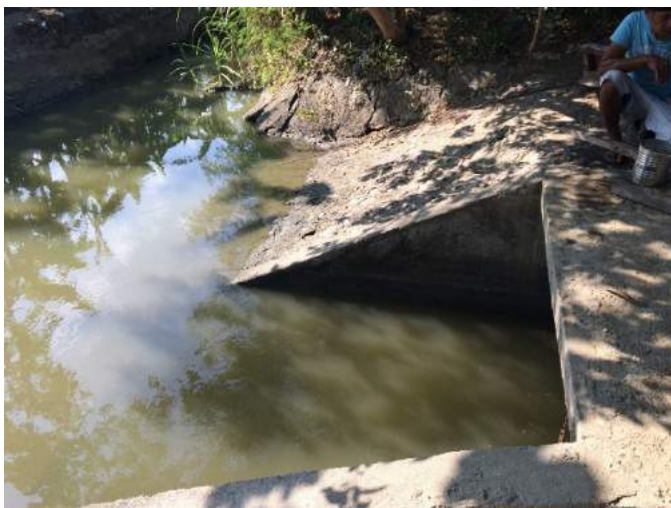
Figure 1A-56. The end of the tunnel connecting the from intake and main canal
Source: Author's capture

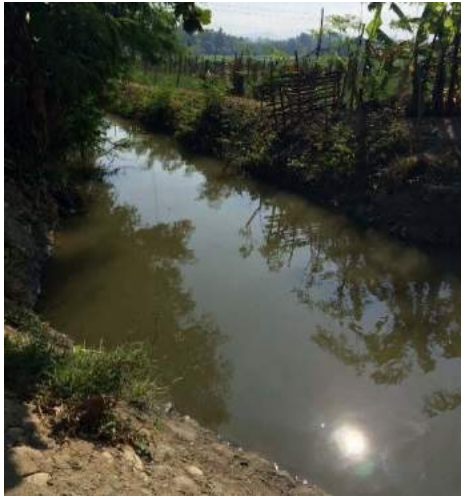
Figure 57. The main canal is unlined and heavy with siltation

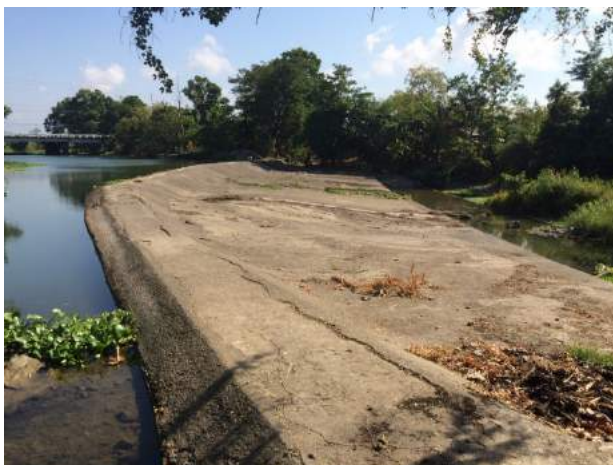
Figure 1A-58. The Zanjanera Bangsirit CIS dam

The Zanjanera Bangsirit CIS is located at Bacarra, Ilocos Norte with its run-of-the-river dam located at the Co-ca River. The dam (Figure 1A-58) was rehabilitated by NIA and US AID. Heavy siltation can be observed near the dam and intake. The IA do not desilt the structures.

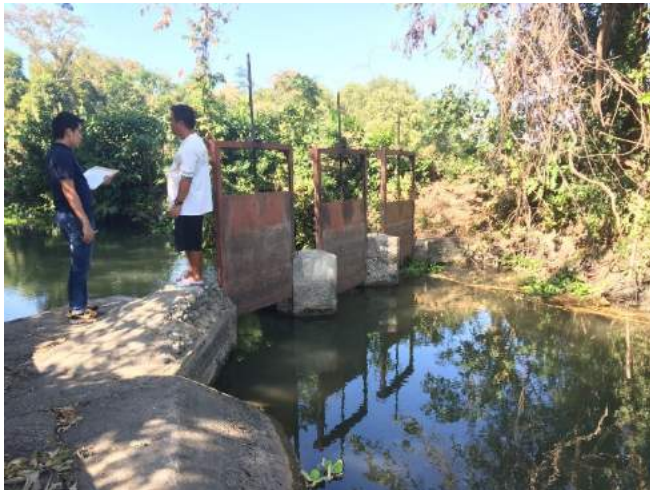
The IA was able to generate PhP 250,000 from LGUs last 2010 for riprapping. They also raised PhP 280,000 in 2013 to install/repair three sets of gates. Heavy siltation occurs on the first set of gates near the intake structure (Figure 1A-59). In the second set of gates (upstream), one of two check gates is broken and a wooden plank is used as replacement (Figure 1A-60). In the third set of gates (midstream), the three gates are damaged and non-operational because a tree fell on it last 2014 during typhoon Mario (Figure 1A-61). It has not been fixed yet though the IA has been requesting for repair since. Since the third set of gates were broken, the IA have experienced water shortage in the downstream portion of the system. There is no water master/tender so the officers just take turns in operating the gates. The IA uses both STW and LLP for other crops (tobacco, garlic, onion). But illegal pumping from the main and lateral canals occurs. Some farmers pumping water are not even members of the IA. Some lateral canals have unwanted grasses growing at the bottom and banks.

Figure 1A-59. The intake structure of the dam

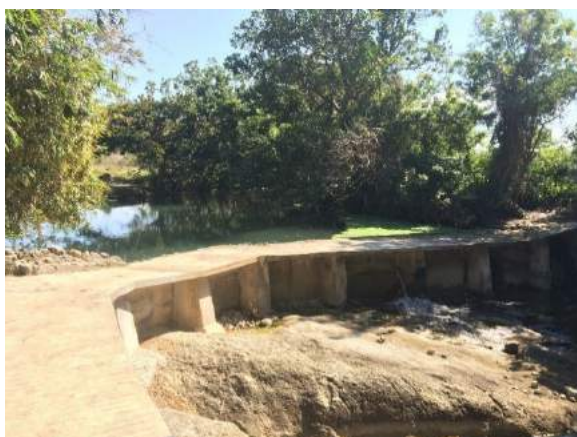
Figure 1A-63. The simple concrete dam of the Der-Ap Saoit CIS

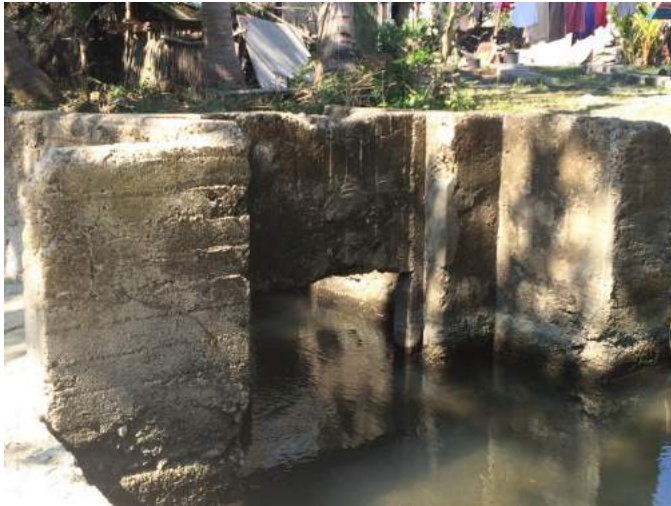
The dam is a simple concrete dike (Figure 1A-63). The intake gate is broken and only wooden planks are used (Figure 1A-64). The main canal have patches of concrete lining (Figure 1A-65). Holes were made in the main canal to serve as turnouts to lateral canals where rocks are used to control the flow of water. A part of the main canal is along the national highway where some rocks from the highway contribute to the canal's sediments. Heavy siltation also occurs in a road crossing especially during the wet season clogging it. The IA spends at least a day to clean the clogged culvert.

Figure 1A-64. The intake structure with no gate; wooden planks are placed to regulate the flow of water

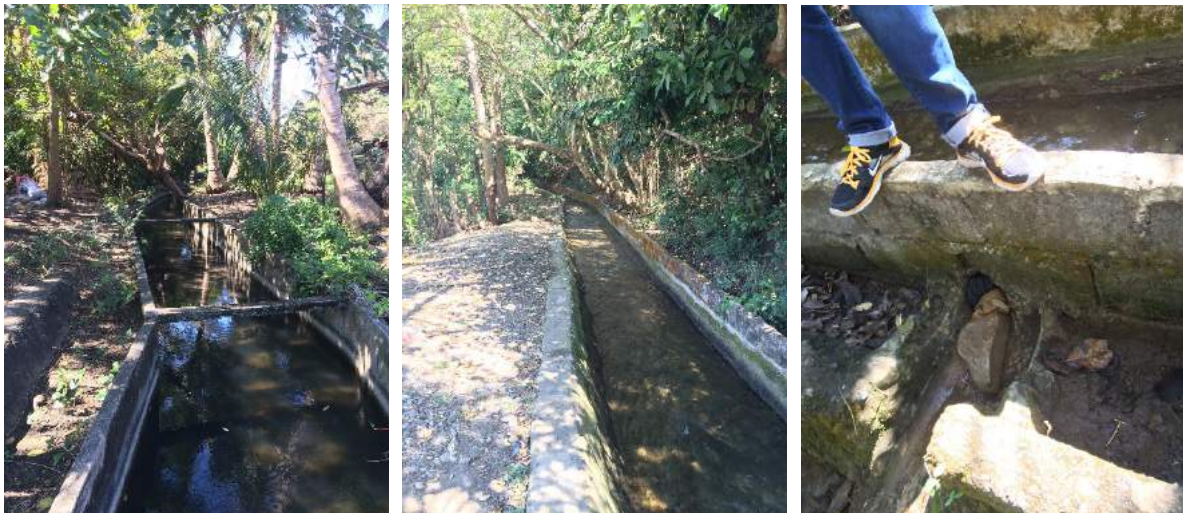
Figure 1A-65. Concrete sections of the main canal upstream (left) and midstream (middle); holes in the concrete canal serving as turnouts for distributing water to laterals; rocks are used to control the flow from the canal (right).

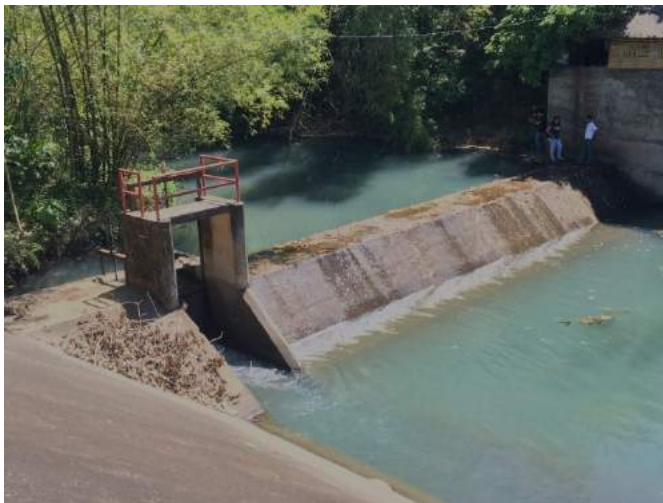
Figure 1A-66. Maybatang Dam

The Maybatang dam (Figure 1A-66) is a run-of-the-river dam originally constructed in 1980. The system was rehabilitated in 2009. Heavy siltation were observed in both the upstream and downstream portion of the dam, with the sediment nearly reaching the level of the crest upstream. The sluice gates of the intakes and spillway are properly maintained and well lubricated for ease of operation, as the Cooperative allots PhP 50,000 per year for the maintenance of irrigation structures. The intake structure and the main canal is connected by a culvert approximately 50 m long. The stretch of the main canal after the culvert has a rectangular cross-section with dimensions of 1m by 1m (Figure 1A-67). However, reductions in dimensions of the main canal were observed as it approaches the downstream portion. The cooperative has a budget of PhP. 110,100 per year for the clearing and desilting of canals.

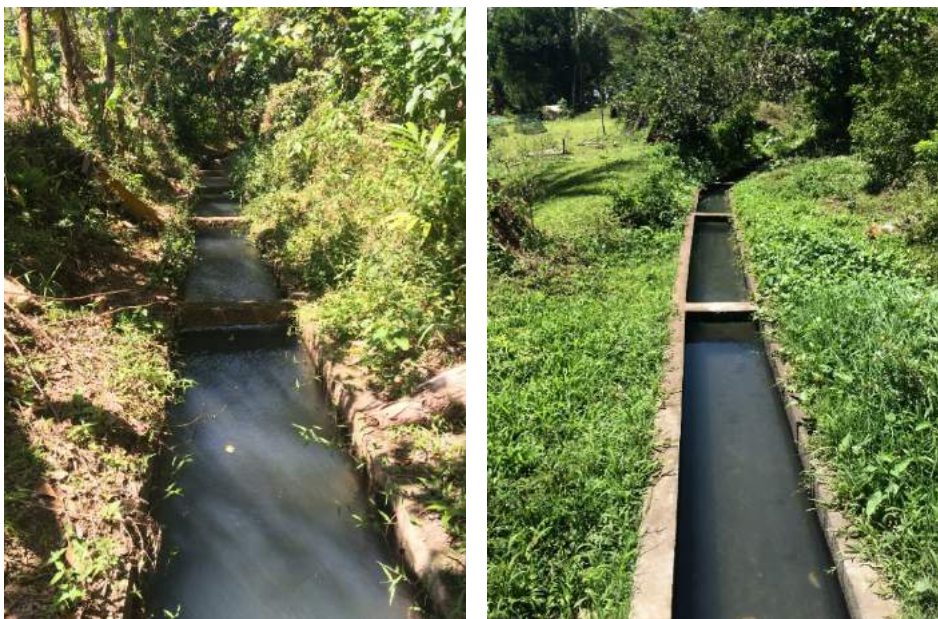
Figure 1A-67. Left: Upstream portion; Right: downstream portion of the rectangular main canal

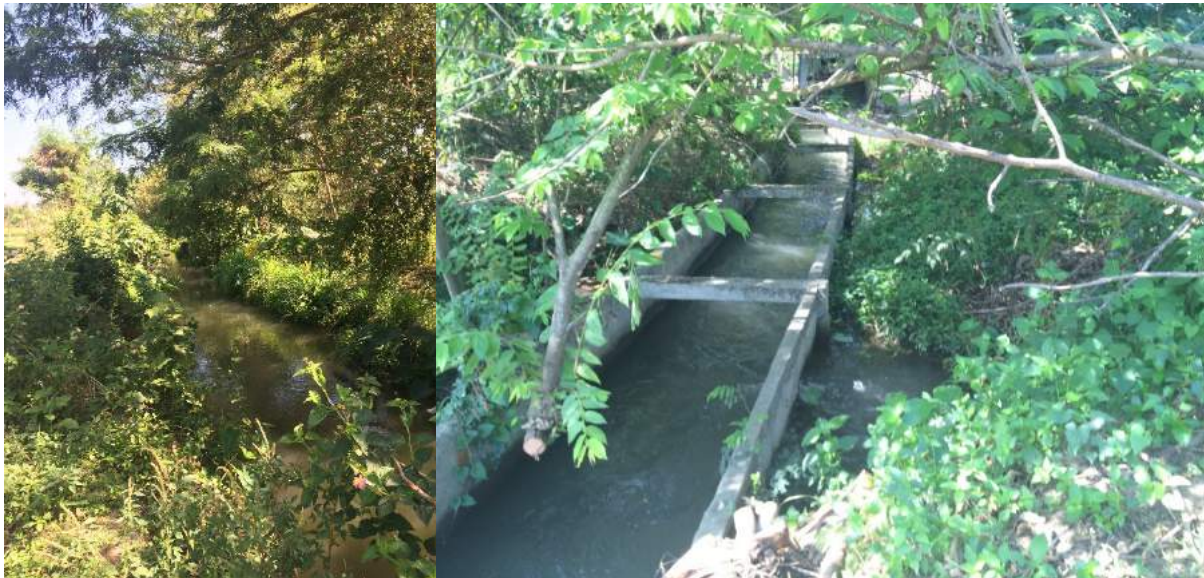
Figure 1A-73. Left: unlined portion of the main canal; Right: lined portion of the main canal with illegal turnout

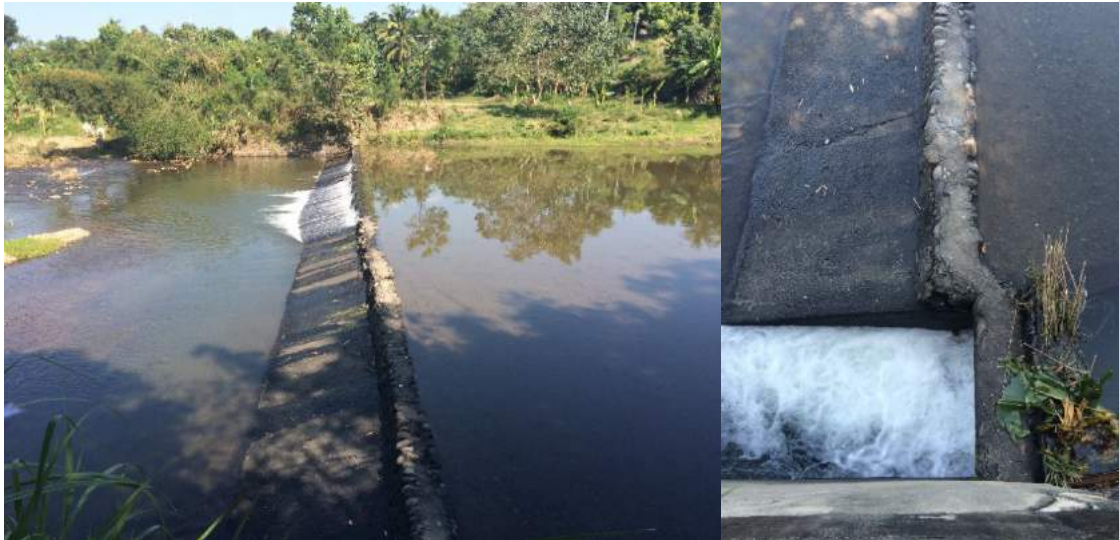
The Boliwao CIS is located at Brgy. Boliwao, Bayombong, Nueva Vizcaya. It diverts water from the Boliwao River and serves 73 hectares with 66 farmer beneficiaries. Siltation at the dam (Figure 1A-74) is nearly level with the dam crest. The downstream portion is also heavily silted, with islands already formed in the center of the river. The sluiceway (Figure 1A-74) currently has no gate hence water is constantly flowing through it, except for garbage which restricts the flow. According to an IA official, dredging operations have not yet been done on

the system since the construction of the dam. Heavy siltation comes from the deforested mountain covers upstream.

Figure 1A-74. Left: Boliwao dam with high level of siltation; Right: sluiceway

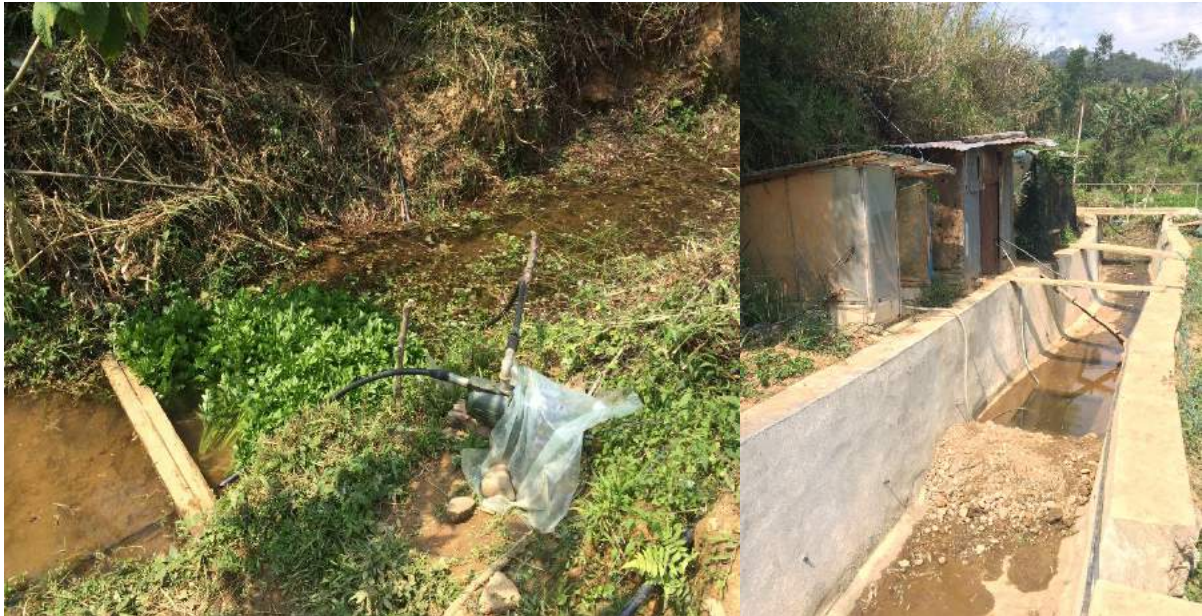
Figure 1A-77. Left: electric motor along the unlined portion of the creek; Right: diesel engines sheltered in pump houses and cavity made by the farmers at the bottom of the main canal

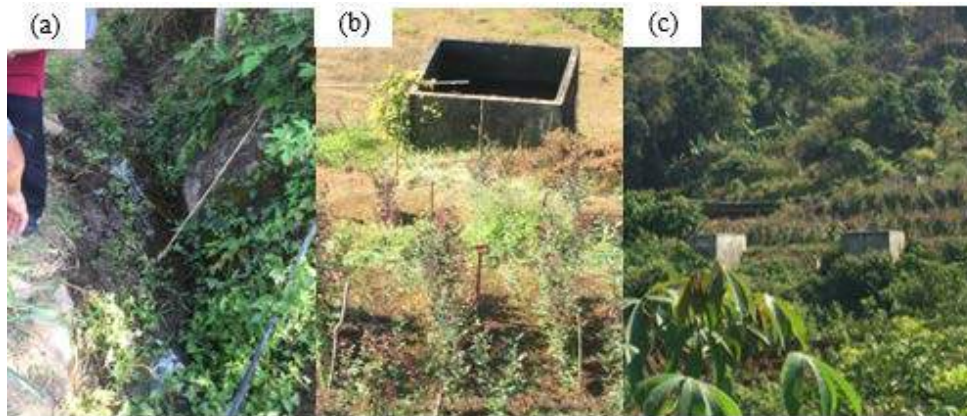
Figure 1A-80. (a) Unlined main canal used to irrigate rice (b); (c) some of the concrete tanks

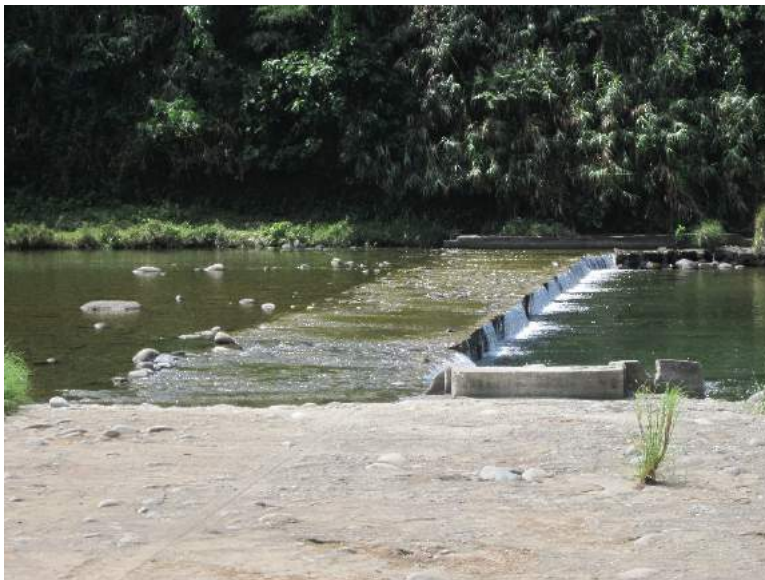
The Casiligan Balacong CIS derives its water from the Bintakan River and has a service area of 175 ha. The old dam (Figure 1A-87) was constructed in 1982 but it was damaged by two typhoons Goring and Iliang. The dam was repaired by NIA in 1996 but this include only the concreting of one side of the dam, construction of a new intake to replace the old one which was a siphon but was fully filled with rocks and sediments during the typhoons, and the dredging and lining of some canals. The dam is filled with sediments and the intake has no screen so the intake canal at the side of the river leading to the main canal is also filled with sediments (Figure 1A-88). The IA guide during the walkthrough said that the original depth of this intake canal may be about 2 man standing on top of another but is now about 3-ft deep. This intake canal was originally covered with concrete slabs but it was removed during one dredging operation and never put back again (Figure 1A-89). The intake canal leads to an intake gate then to a long underground culvert then to the main canal. The gates controlling water flowing to the main canal are still operational but the entry is filled with sediments (Figure 1A-90). The main canal is unlined and the only lateral which runs along the foothills is not only unlined (Figure 1A-91) but is constantly filled with silts from the hills. So the IA are requesting that their canals be lined and the lateral be covered to prevent siltation. There are 6 drops along the main canal.

Figure 1A-87. The old dam (top) and the repaired part (bottom); the old intake can be seen in between the two
