Assessing the resurgent irrigation development program of the Philippines: Communal irrigation systems component

PIDS Discussion Paper Series, No. 2020-02

Assessing the Resurgent Irrigation Development Program of the Philippines – Communal Irrigation Systems Component

Roger A. Luyun Jr. and Dulce D. Elazegui

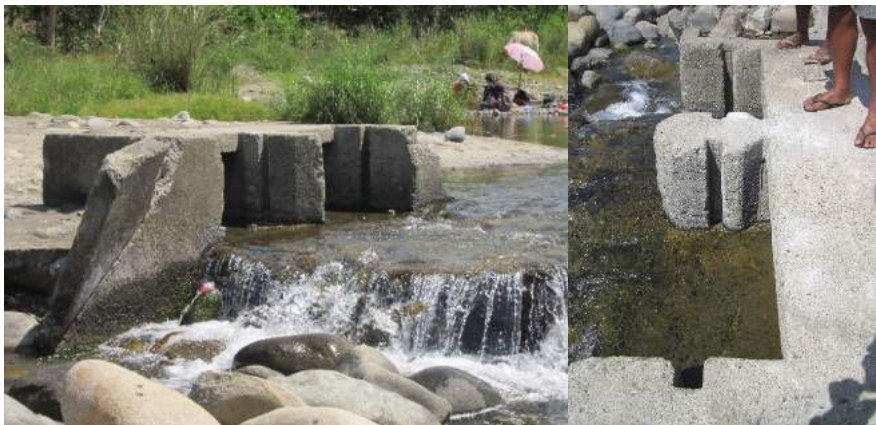
Figure 1A-89. The old intake siphon but was filled with sediments during the typhoons Goring and Iliang

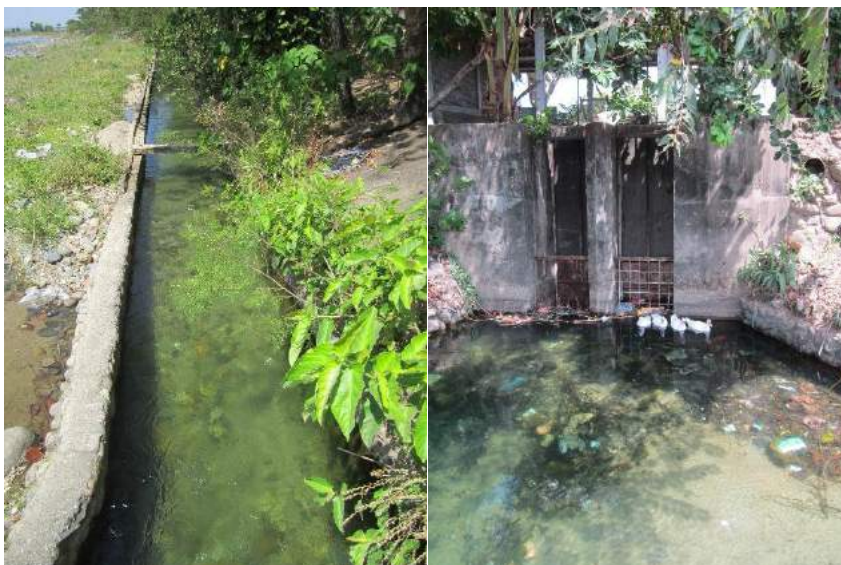
Figure 1A-90. The intake canal filled with sediments and the intake gate where the entry way is also filled with sediments

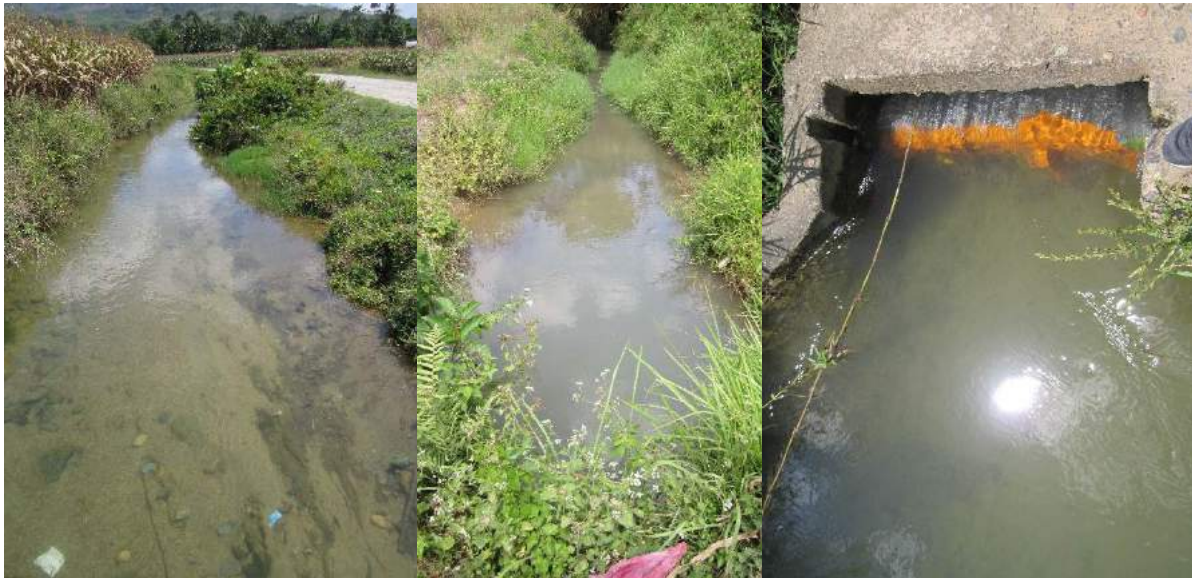
Figure 1A-91. The unlined main and lateral canal and one of the drop structure combined with siphon

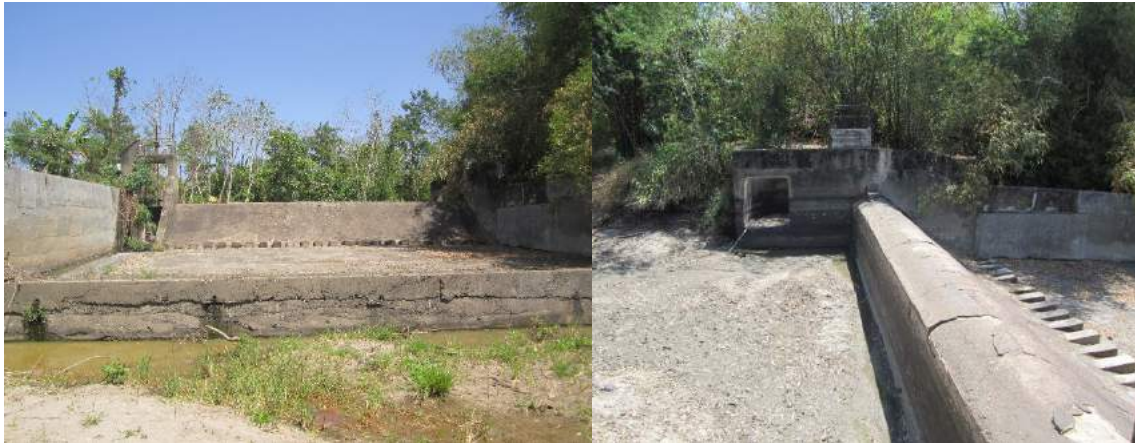
Figure 1A-94. The ogee dam exposed because there are no water on Pangul Creek during the visit; also shown is the bypass inlet used to divert water downstream during high flows

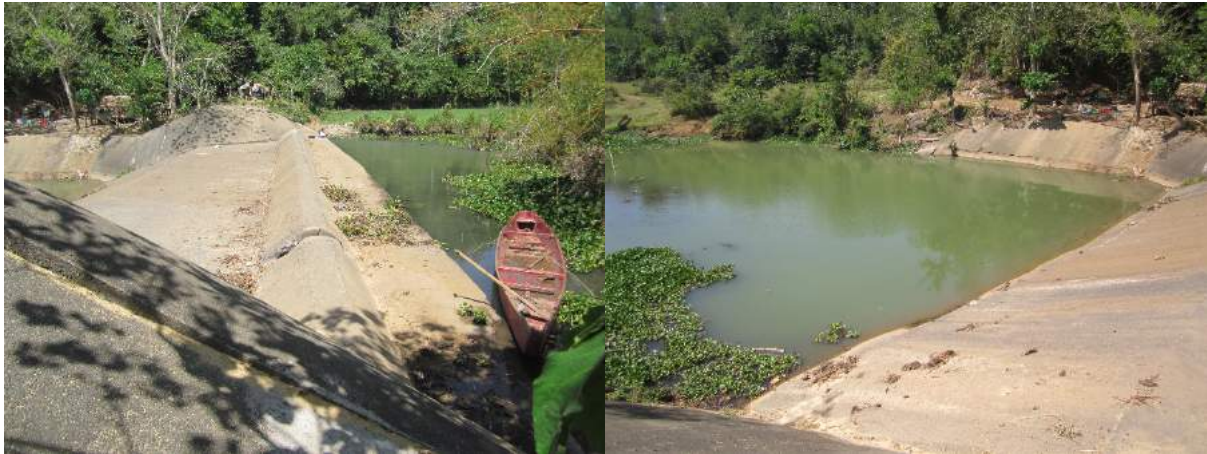
Figure 1A-98. The impounding dam upstream (left) showing crest height increased by a few feet where the overflow water goes downstream (right) to the brush dam

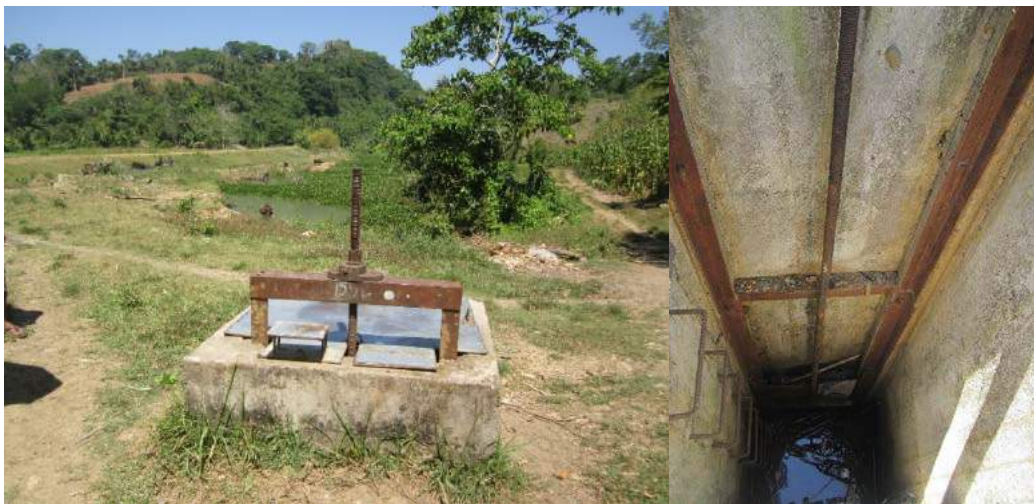
Figure 1A-99. The intake structure with cover (left); the intake gate inside

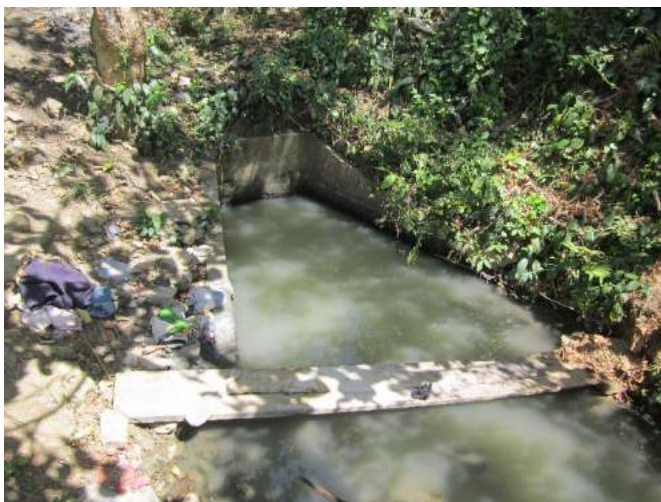
Figure 1A-100. The outlet from the intake gate leading to the trapezoidal main canal

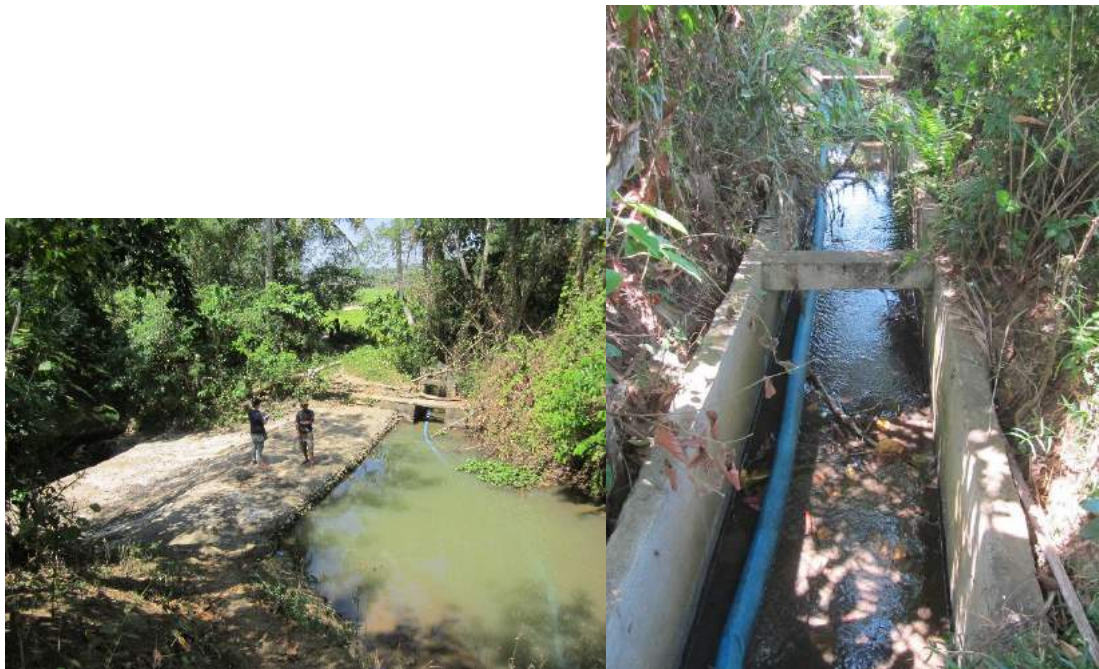
Figure 1A-101. The brush dam now made of concrete and the rectangular lined canal constructed by the IA; water is pumped to the canal due to low flow

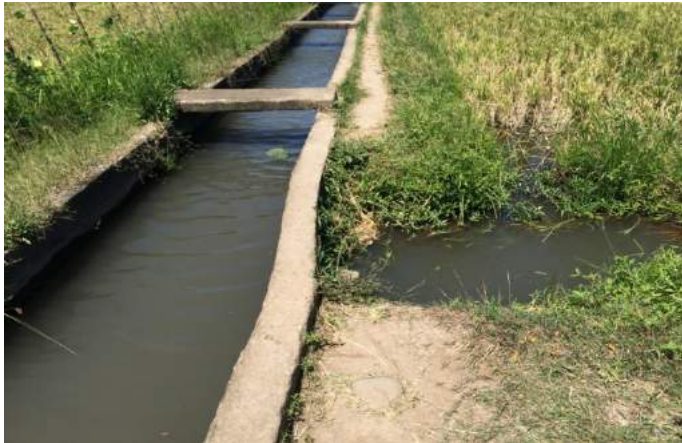
Figure 1A-103. The 1-m wide, 1-m deep concrete-lined main canal of Maria Pelaez CIS
Source: Author's capture

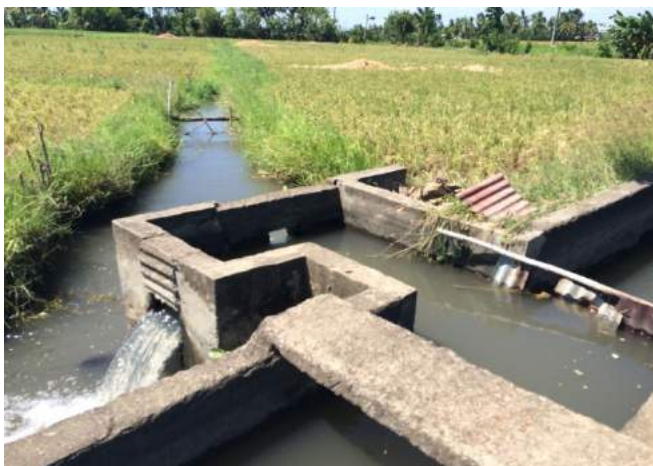
Figure 1A-104. One of the division boxes of the irrigation system with corrugated GI as control gate
Source: Author's capture

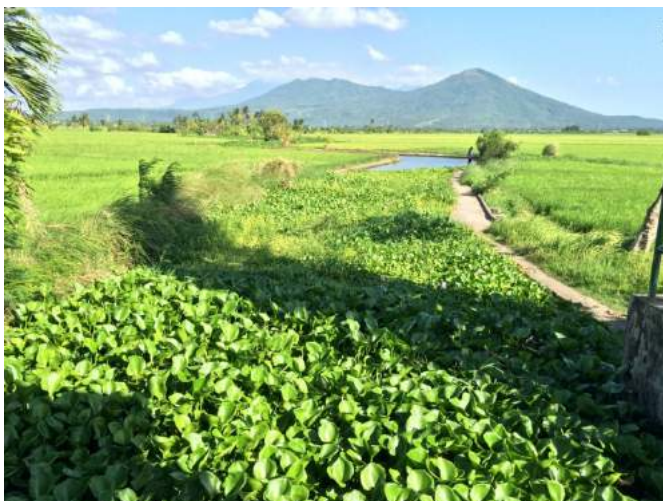
Figure 1A-107. Downstream portion of the dam that is full of water lilies

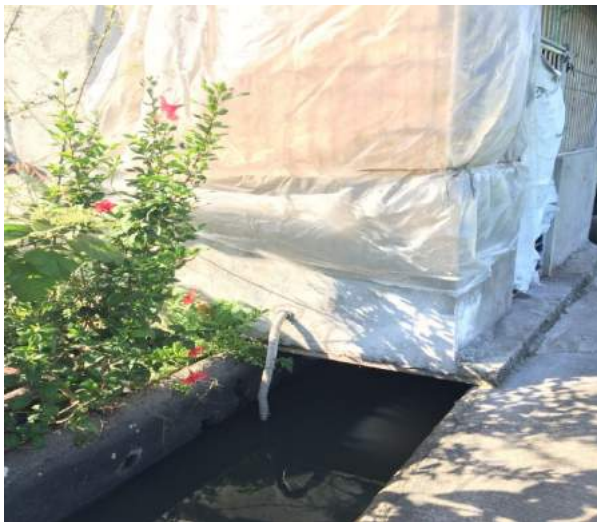
Figure A1-109. A drainage outlet of a house alongside of the main canal

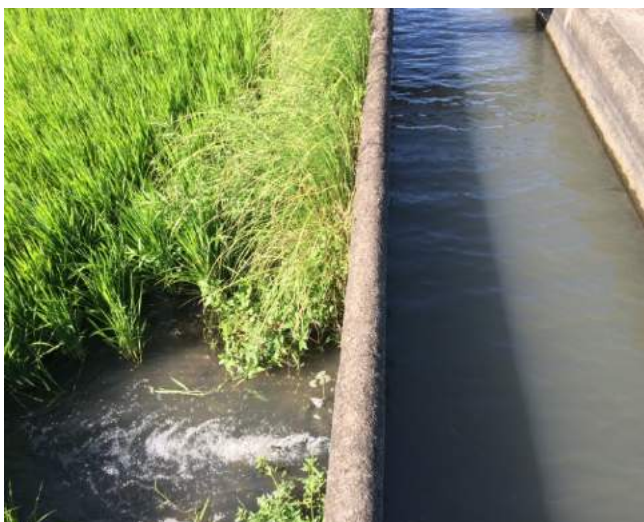
Figure 1A-110. Illegal turnouts directly tapped on main canal

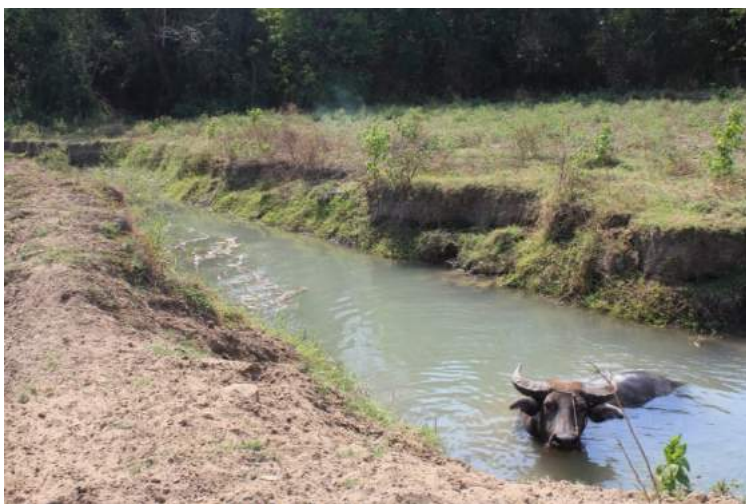
Figure 1A-114. Unlined main canal
Source: Author's capture

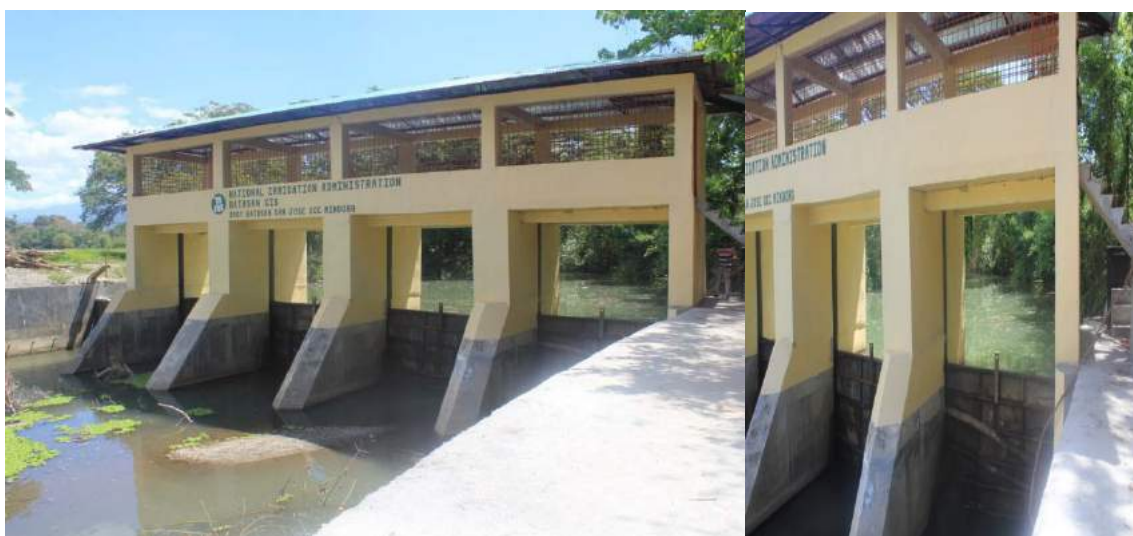
Figure 1A-116. The Batasan CIS dam that was only built last October 2014
Source: Author's capture

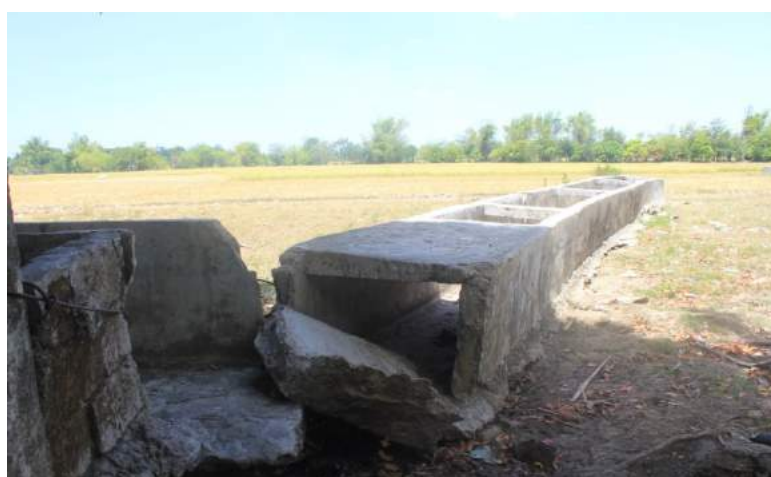
Figure 1A-118. Detached Main canal due to typhoon Glenda

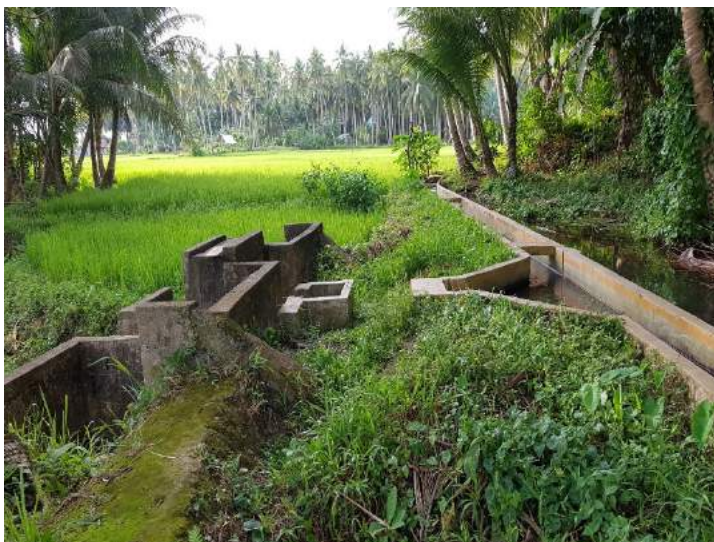
Figure 1B- 10. The original dam constructed in 1960 downstream of the new site. The main canal of the new dam is seen on the right side

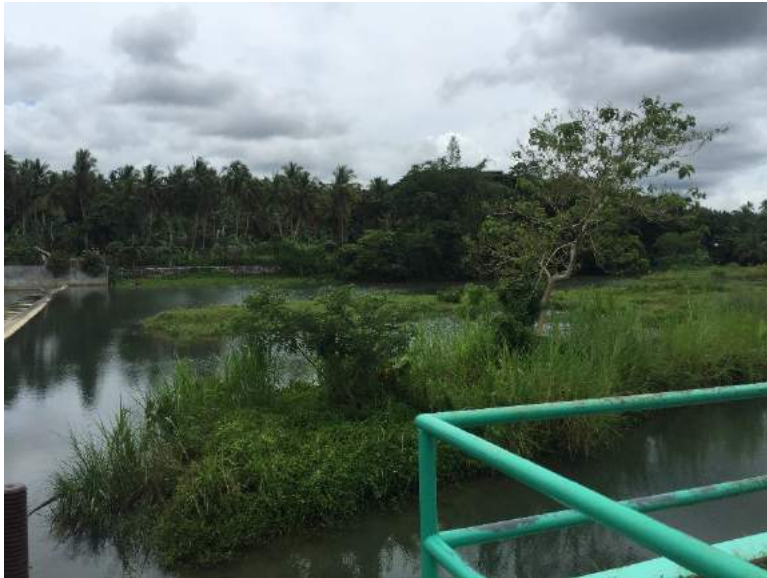
The CIS has two dams, one of which is already operational (Figures 1B-13 and 1B-14) while the other is under-construction. The diversion dam spillway, aprons, sidewalls and sluice gates are all properly maintained and in good conditions. There is visible sedimentation in the storage area of the dam but since the water is still enough to service the required water of the CIS, no dredging is being done by the IA (Figure 1B- 15).

Figure 1B- 15. Dam site showing that dredging is not practiced

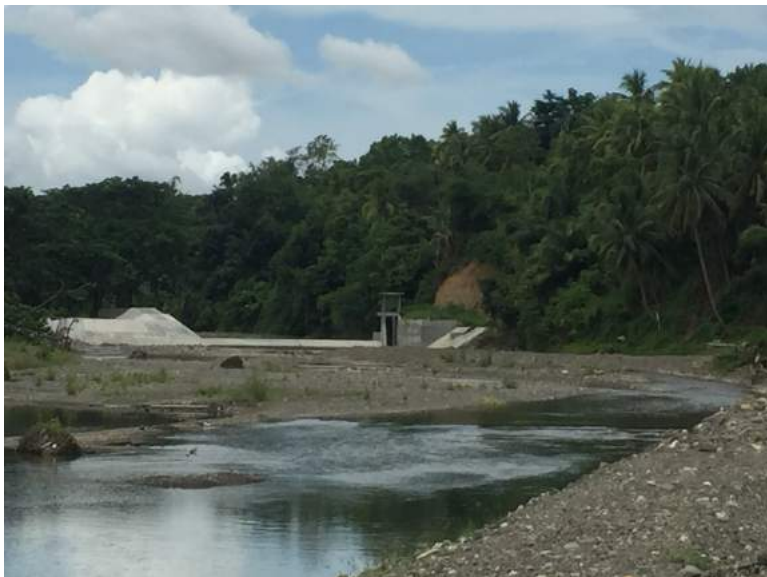
Another dam is being constructed downstream to service an additional 100 ha. The construction of the dam started September 2017 and the expected date of completion was May 2018 (Figure 1B- 16). However, the construction was stopped since there is no more budget allotted. The association also have to negotiate for the right of way during the construction of canal. The start of dry cropping season was already delayed due to the dam construction.

Figure 1B- 16. Construction of the new dam

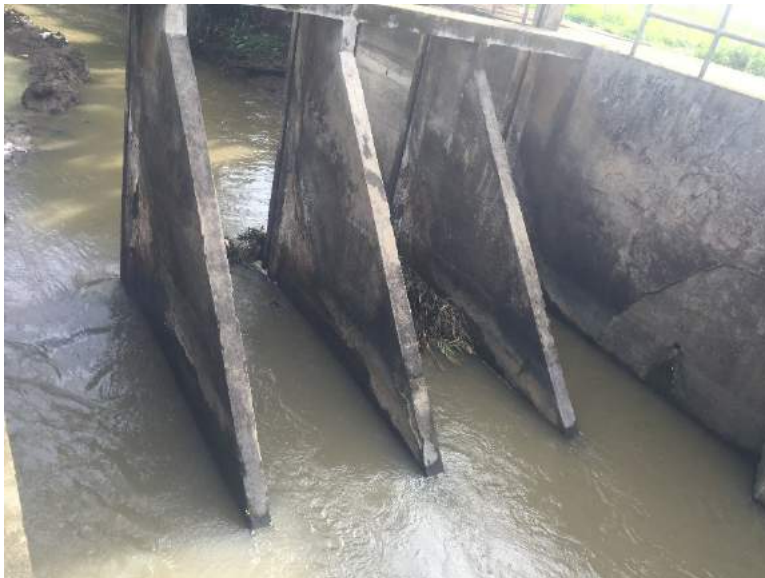
Figure 1B- 17. The buttress dam of Sta. Elena CIS. The IAs use wooden planks since no steel gates were installed

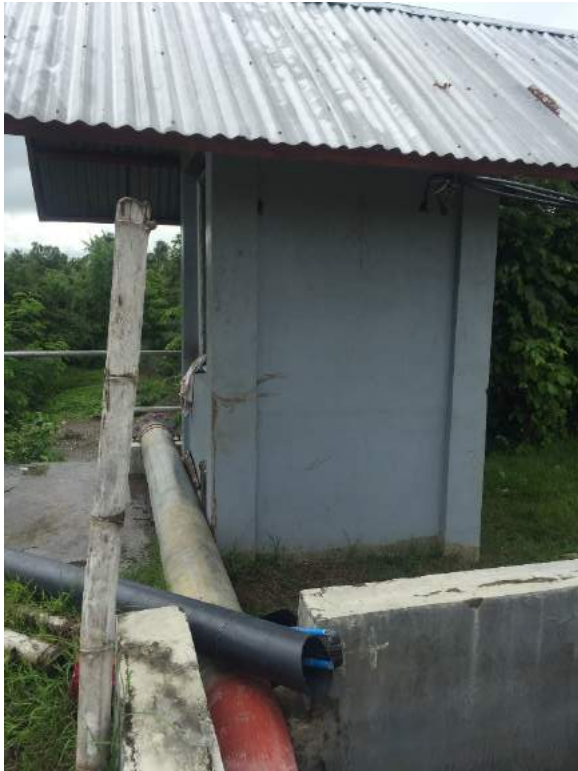
Figure 1B- 21. The 10" pipe connected to the original pump that delivers water to the main canal

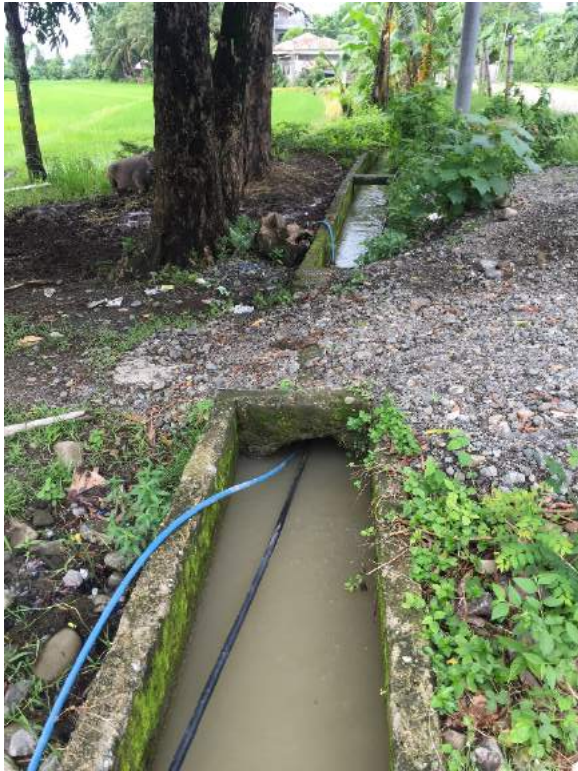
Figure 1B- 25. Main canal of Tumagboc CIS with width of 60 cm and depth of 60 cm

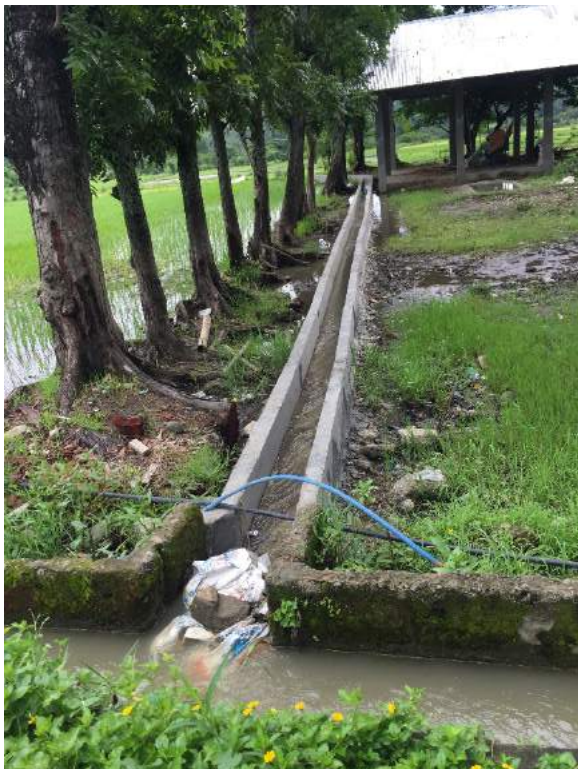
Tumagboc CIS in Miag-ao, Iloilo is managed by the Banbanan, Aguianan, Cubay, Tan-agan Irrigators Service Association (BACTISA). The association was organized in 1970's and currently have 115 members. The source of water of the system is the Tumagboc River. The new run-of-the-river ogee dam (Figure 1B- 24) was actually the third dam built upstream of the first two. The original dam was built in the 1970s which was rehabilitated to create the second dam in 1980. However, it was damaged by typhoon Undang. The current dam was constructed in year 2000. The inlet and main canal of the current dam is partially covered by a road widening currently being done by the DPWH, decreasing the conveyed water into the system. Main canals of the system were all lined (Figure 1B- 25) but they have problems of small diameter culverts underneath roads leading to clogging and hence low and interrupted flows downstream. Last May 2018, a new lined lateral canal was built servicing an additional 5-ha field (Figure 1B- 26).

Figure 1B- 26. The newly built lateral canal of the system

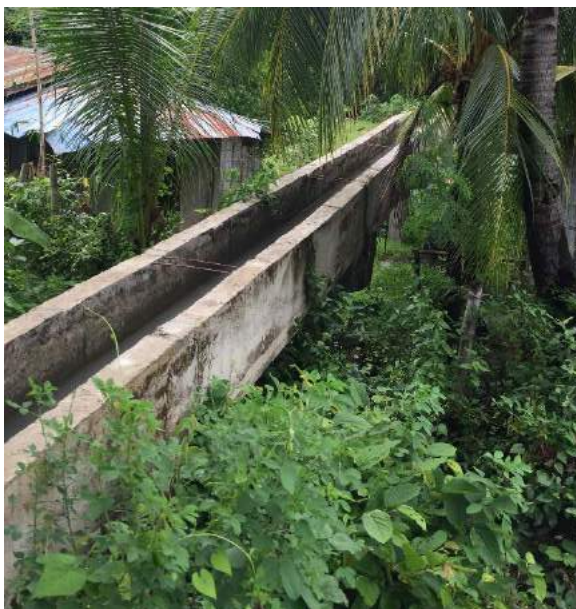
Figure 1B- 27. Elevated flume of Siwaragan CIS

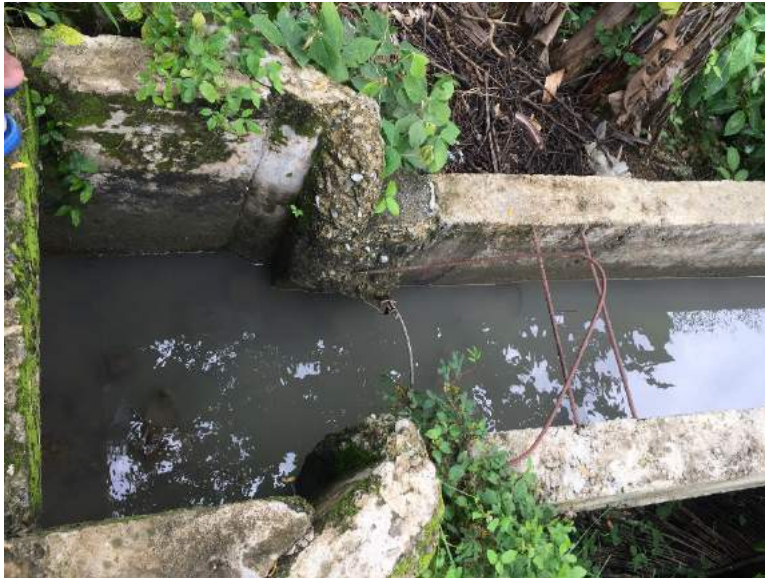
Figure 1B- 28. Connection of the main canal and the elevated flume showing the difference in width and height

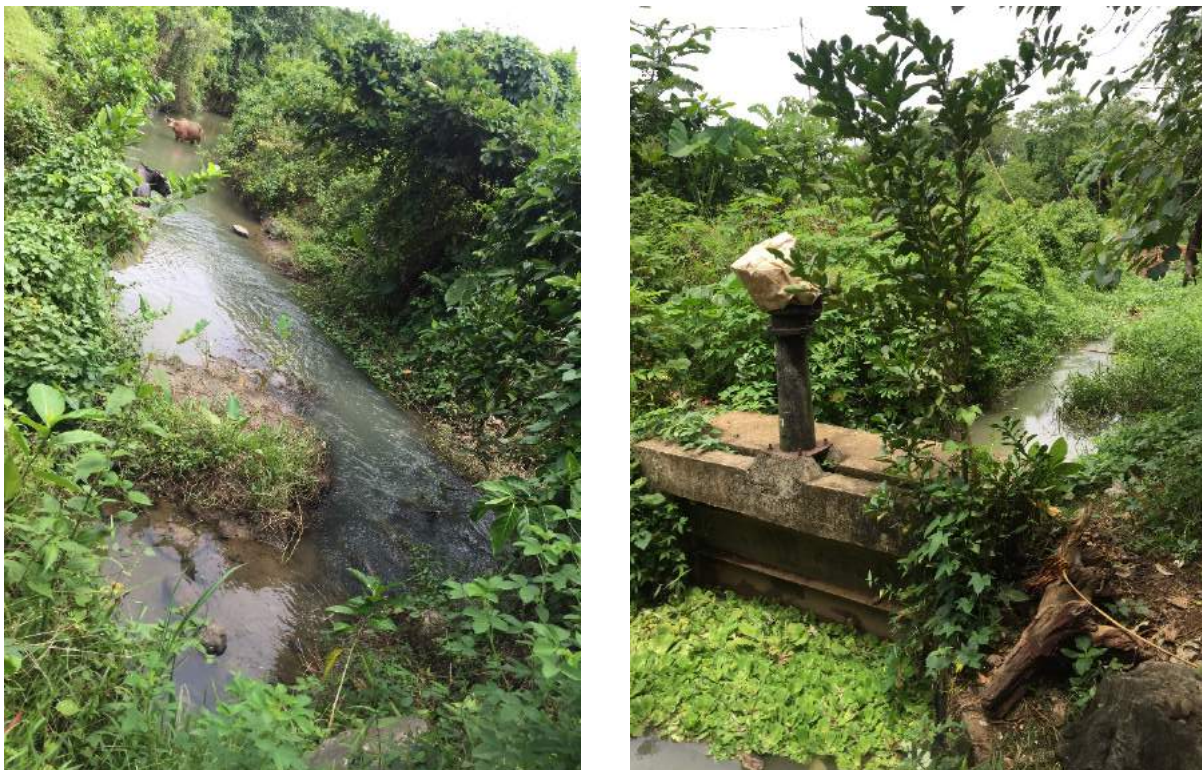
The CIP has a 12-km main canal and all but a few stretches are not lined yet, although there are several concrete control gates within the system (Figure 1B- 30). The design service area was 780 ha and the IA is working out for the right of way on Poblacion Ilaya to allow the construction of line canal to traverse it to Poblacion Ilawod and Fernandez. There are also some parts where the main and lateral canals are not connected yet. The system still has sufficient water even during summer. Since the main and lateral canals are unlined, they are easily damaged by strong flows. There are also two sluice gates on the dam but only one machine is fully functioning to operate them. The dam is not silted, and dredging is not needed.

Figure 1B- 30. The unlined main (left) and lateral (right) canal with some control structure

The association will request to NIA the concreting of the main and lateral canals. Officials of the association admitted lack of support from the local government unit.

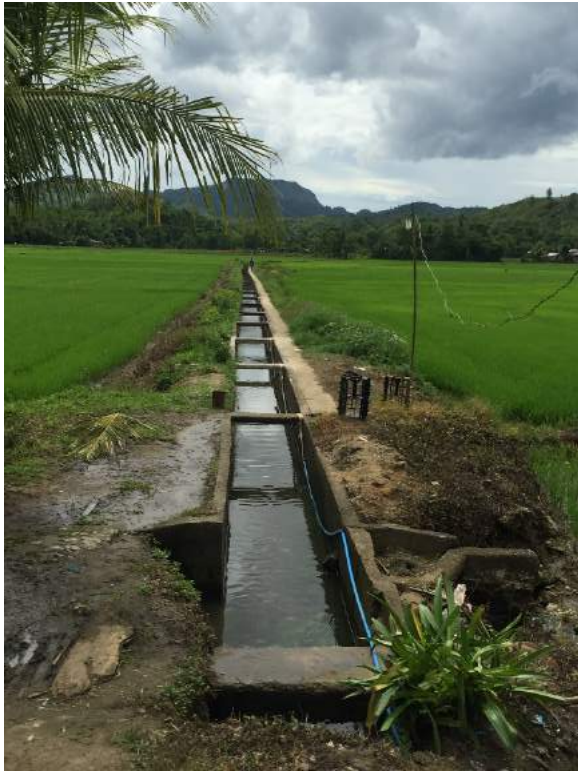
Figure 1B- 32. Main canal of Salcedo CIS

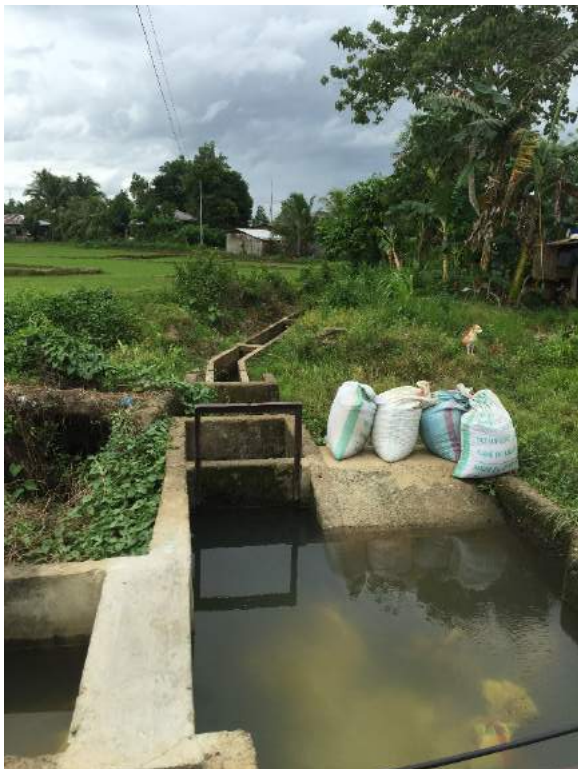
Figure 1B- 33. Lateral canal A and division box of the system

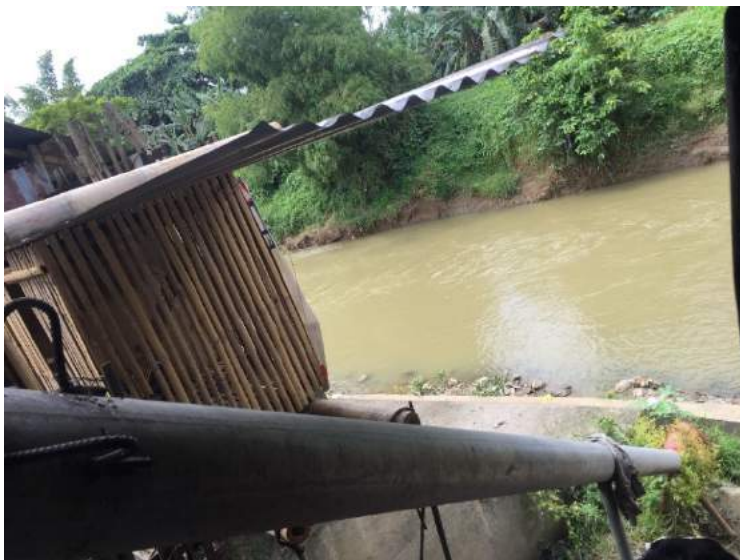
Figure 1B- 34. The 6" suction pipe used in drawing water from the Mambusao River

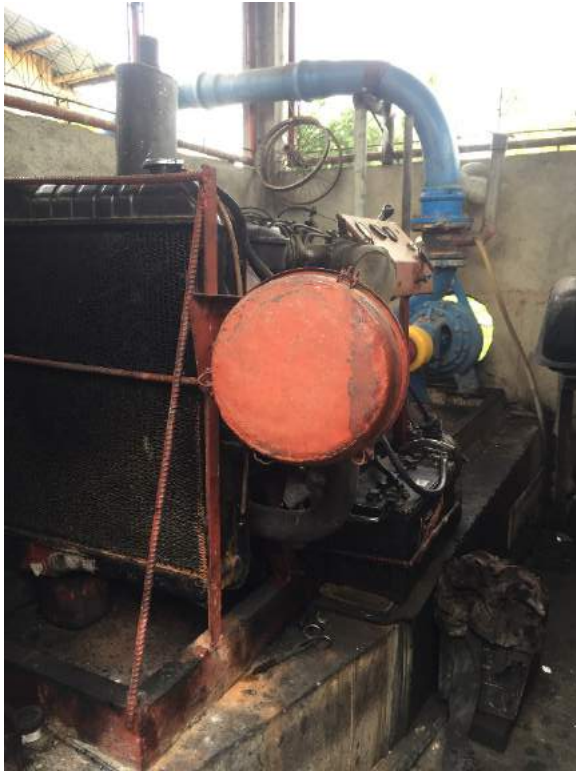
Figure 1B- 35. The centrifugal pump and the diesel engine of the Sigma Sur PCIS

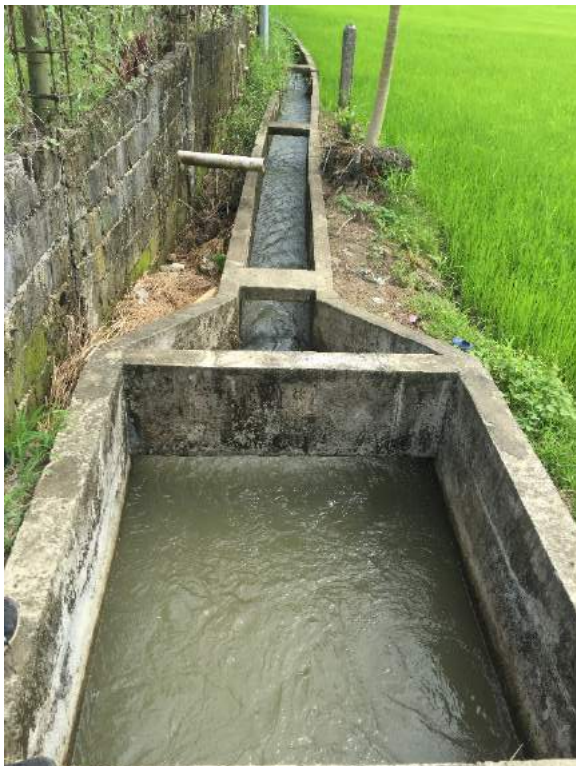
Figure 1B- 36. The main canal of the system as the canal emerged from an inverted siphon across a road

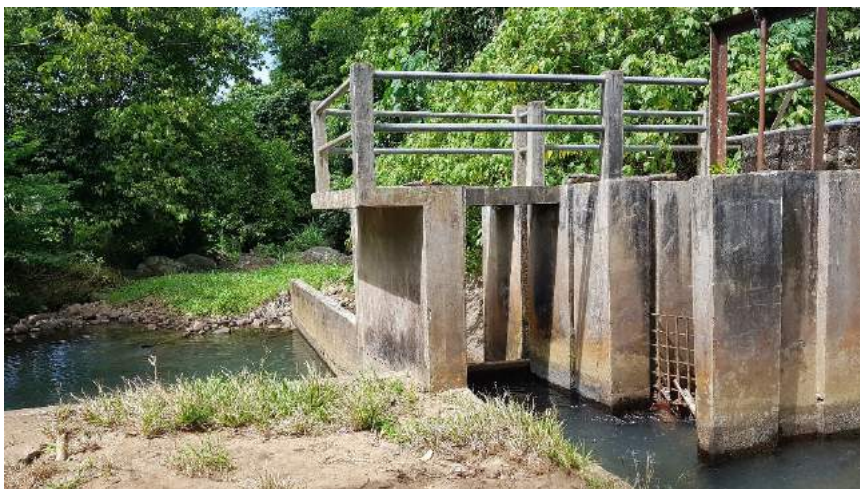
Figure 1C-2. Matanao Dam of Unifarm CIS

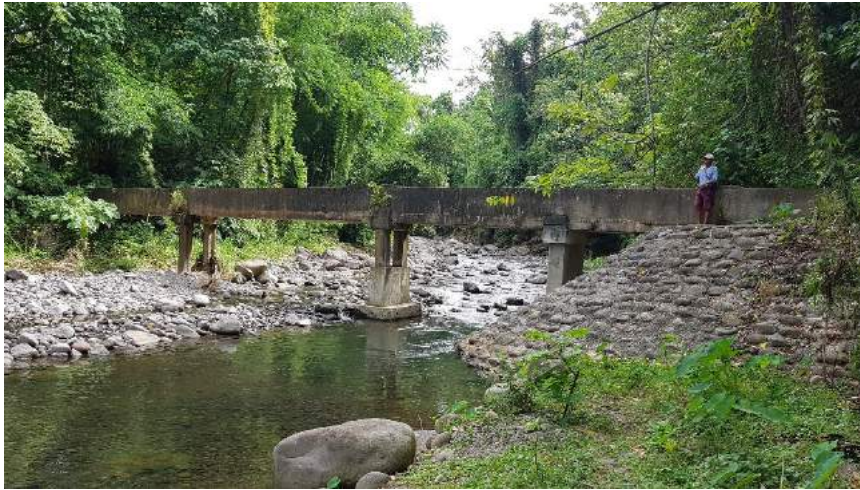
Figure 1C-3. Elevated flume from Matanao dam

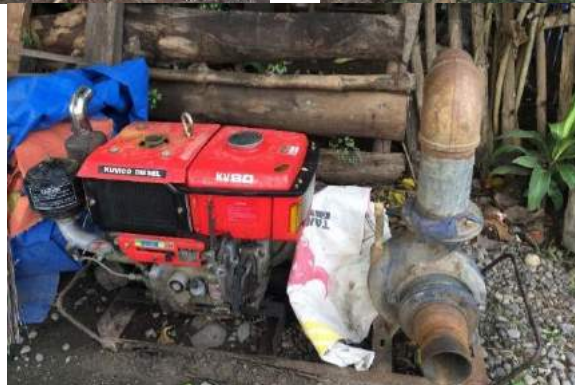
Figure 1C-7. The pumps of the New Katipunan Irrigator's Association

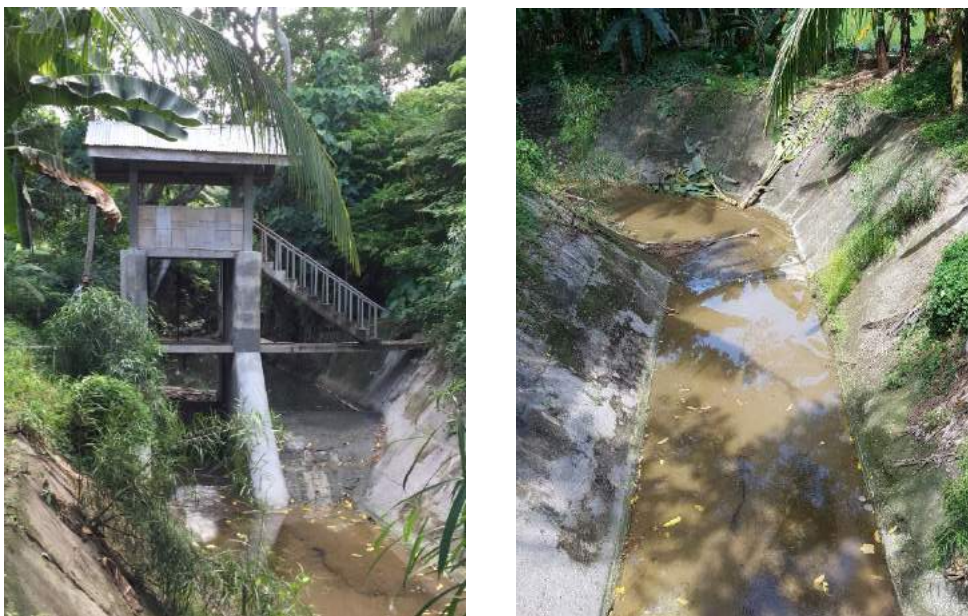
The old dam, built through FSDC in the 1980's, was an ogee-type dam with a wooden plank serving as the gate. After the rehabilitation in 2013, the buttress dam with a sluice gate was constructed (Figure 1C-8), the upstream and downstream apron and side walls were extended, the spillway and intake were repaired, additional concrete lining of 4 km of canal, and a rest area for the water master above the dam was added. The rehabilitation cost a little less than ₱8 M, and complete turn-over to the IA was done in 2015. The previous screw-type sluice gate was then replaced by the IA with a chain block for faster lifting costing them ₱4500. The main canal (Figure 1C-9) is lined but the lateral canals of the system are still earthen.

Figure 1C-8. The dam of Butilon CIS with the extended apron and side wall

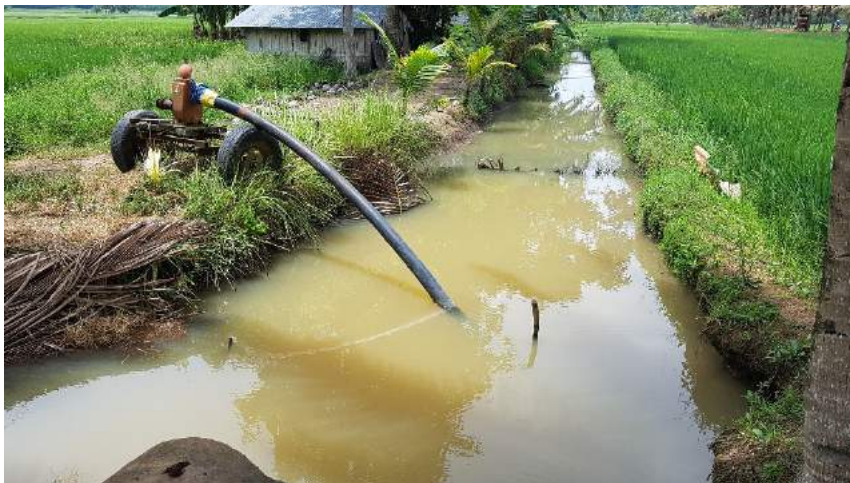
Figure 1C-16. Where the IA pumps water to reach the other side of the field

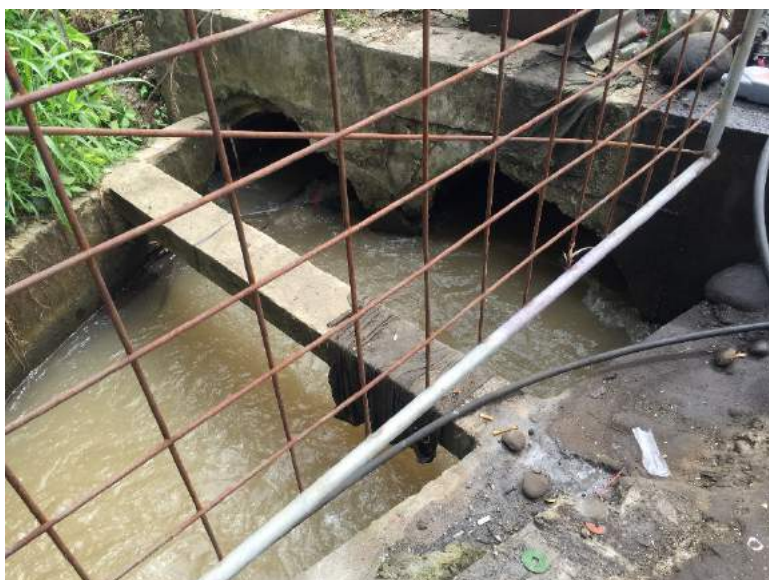
Figure 1C-20. The main canal and division box to divide flow from to different zones

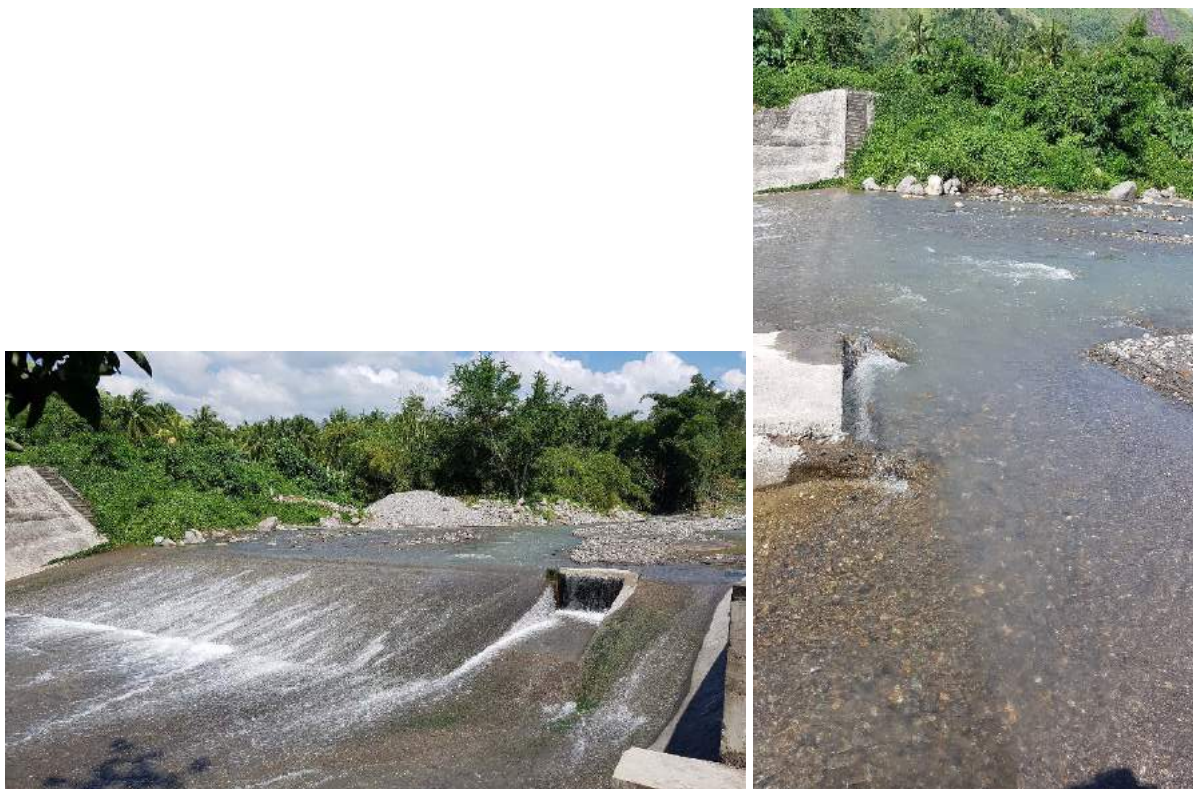
Figure 1C-22. The dam of LMT CIS filled with sediments

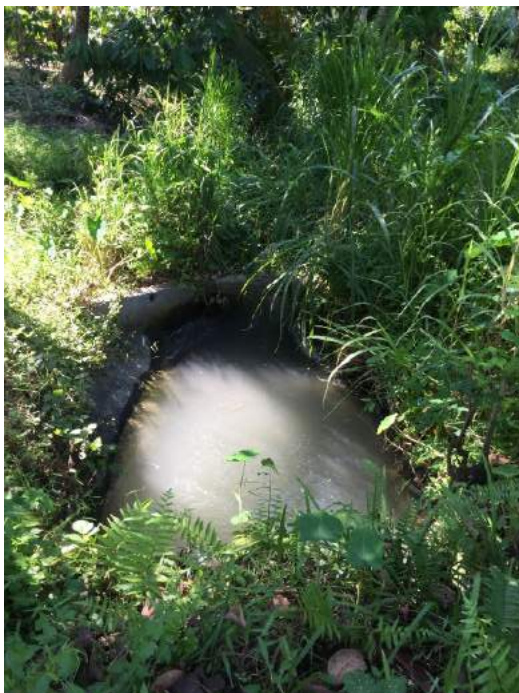
Figure 1C-24. Main canal of the system

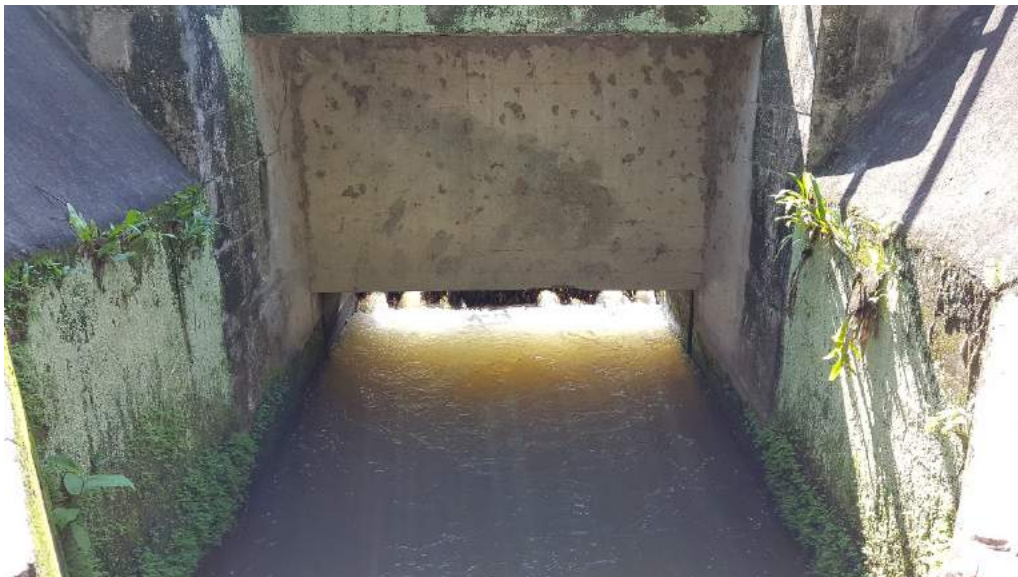
Figure 1C-26. The intake gate that is permanently open
Source: Author's capture

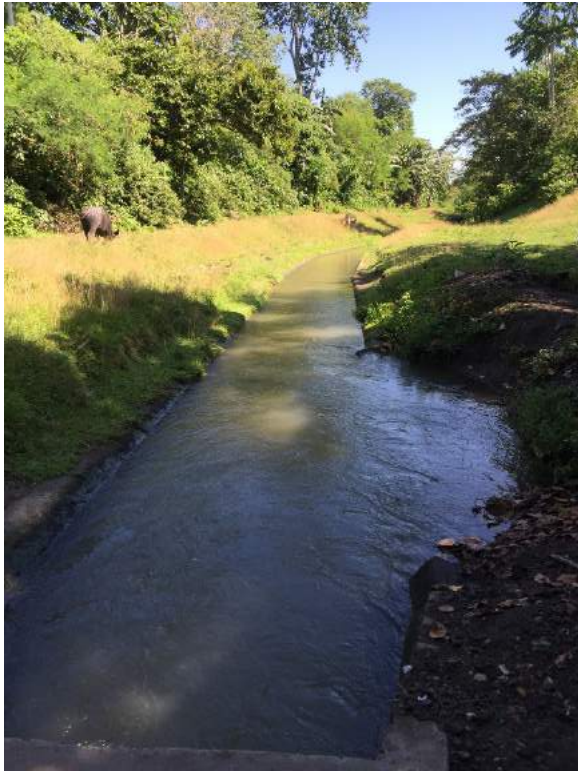
Around 3.5 km of the main canals are lined but the laterals of the system are still unlined. There was one main problem where the main canal narrowed causing the water to overflow. There are also some damaged portions of the main canal causing water leakage. There are no illegal turnouts for the system but some farmers do not follow the imposed schedule when there is not enough water.

Figure 1C-27. The main canal of Mani CIS from the dam

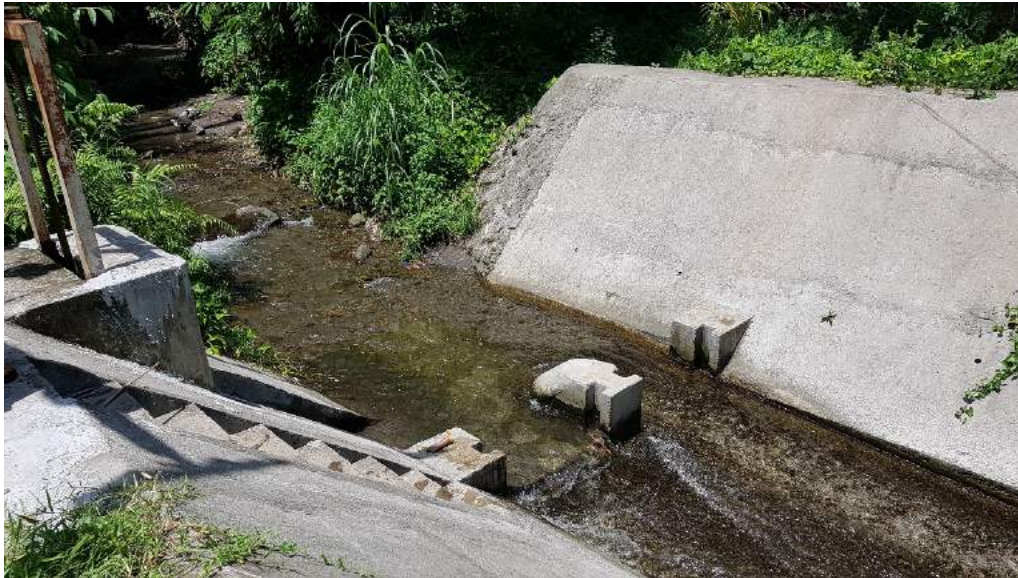
Figure 1C-29. The simple gated dam of Bunao CIS

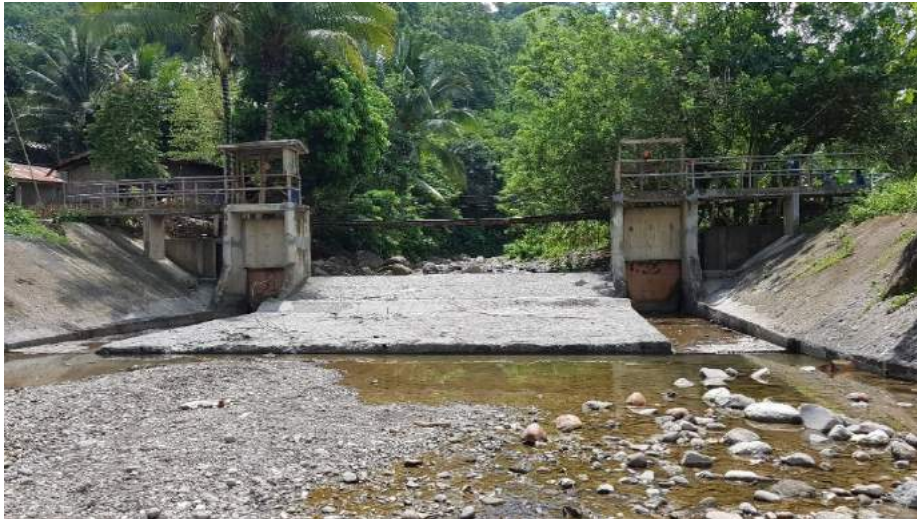
The original dam was built in 1975 through the FSDC and the previous gates were made of wood. The dam was 4-ft deep before but was filled with rocks and boulders starting 2003. It was replaced by NIA in 2013 with a new dam (Figure 1C-32), including steel sluice gates and intake gates on both sides, and lined canals. Last 2017, the dam was damaged due to typhoon Vinta and the dam storage is again filled with rocks and boulders. The downstream apron of the dam is also damaged with scoured concrete lining and exposed steel frames (Figure 1C-33). The lifting mechanisms of the gates were replaced with secondhand chain blocks bought by the IA at ₱6,000 for the 5-ton capacity and ₱5,000 for the 3 tonners.

Figure 1C-32. The dam of Delapa CIS

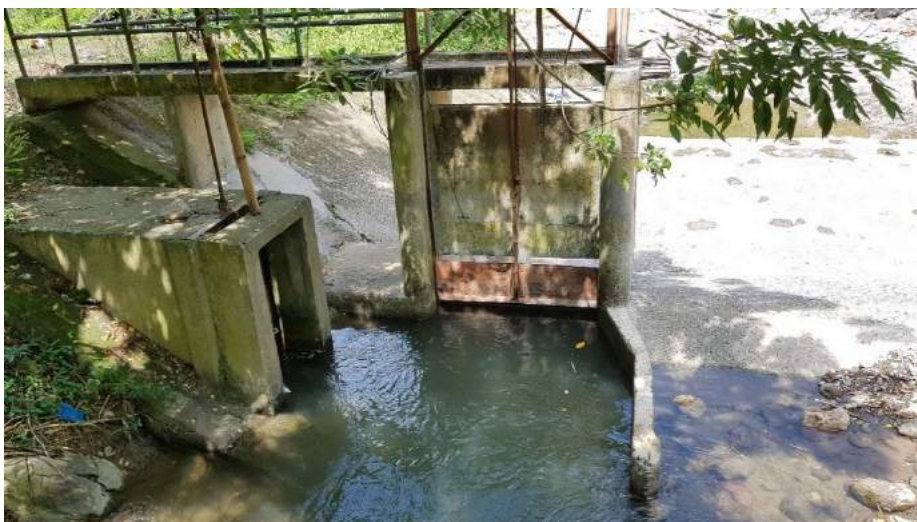
Figure 1C-34. The left sluice gate and intake gate of the dam
