Assessing the resurgent irrigation development program of the Philippines: Communal irrigation systems component

PIDS Discussion Paper Series, No. 2020-02

Assessing the Resurgent Irrigation Development Program of the Philippines – Communal Irrigation Systems Component

Roger A. Luyun Jr. and Dulce D. Elazegui

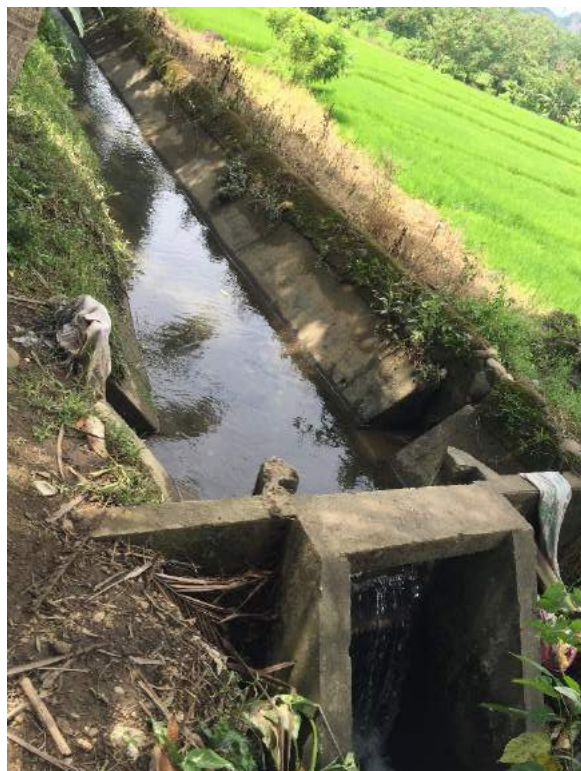
Figure 1C-35. Trapezoidal main canal of the system

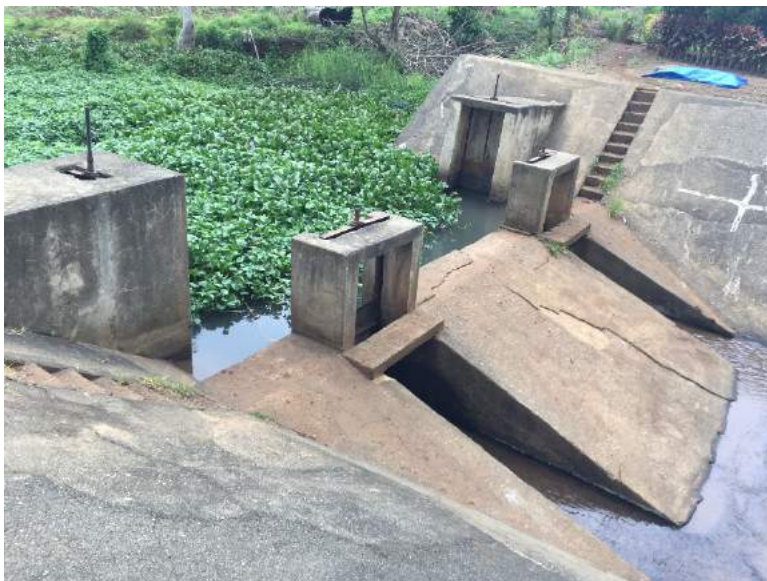
Figure 1C-37. The dam of the system

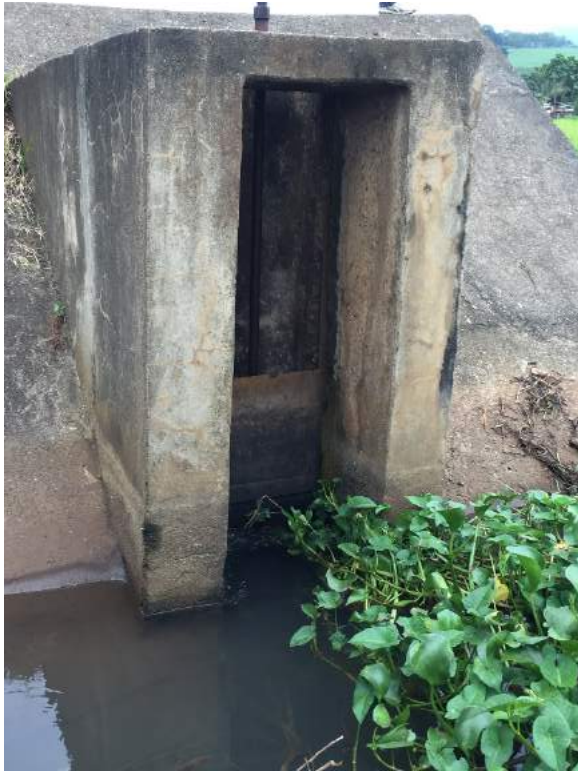
Figure 1C-38. Right main canal intake with 0.5 m width

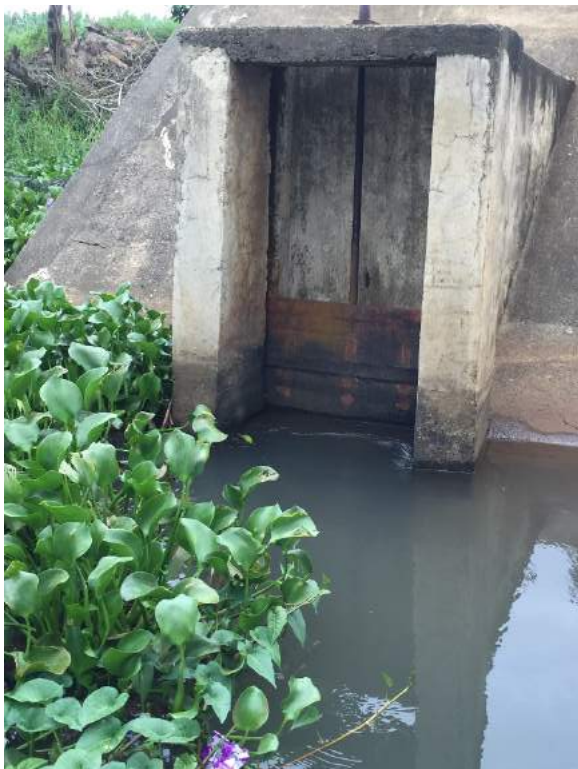
Figure 1C-39. Left main canal intake with 1 m width

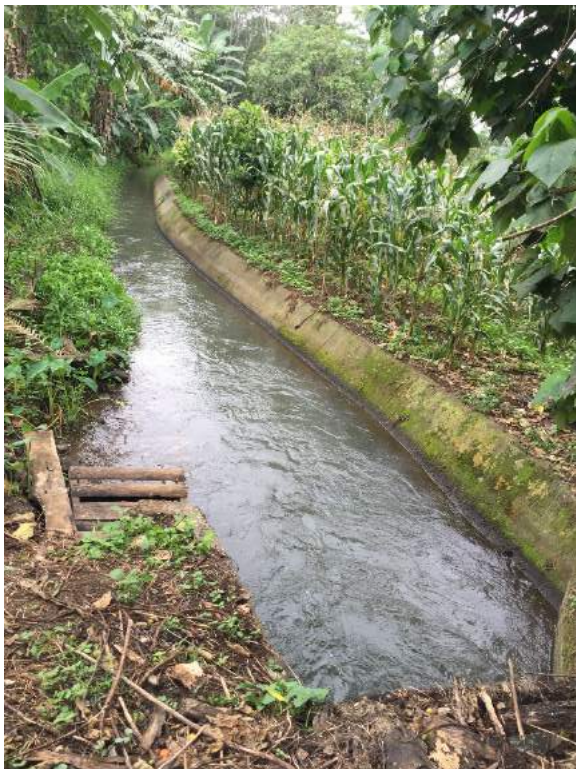
Figure 1C-41. Left main canal of the CIS
Source: Author's capture

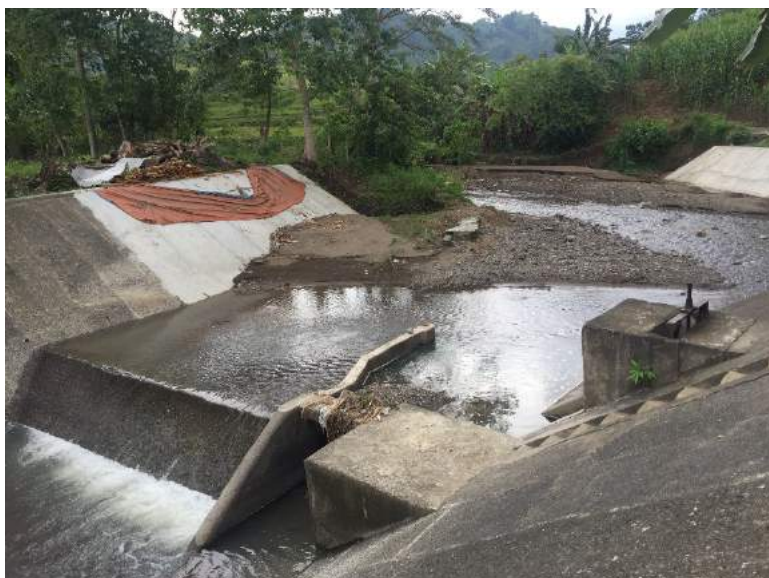
Figure 1C-45. Dam 2 of the system wherein the sand also enters the intake gate

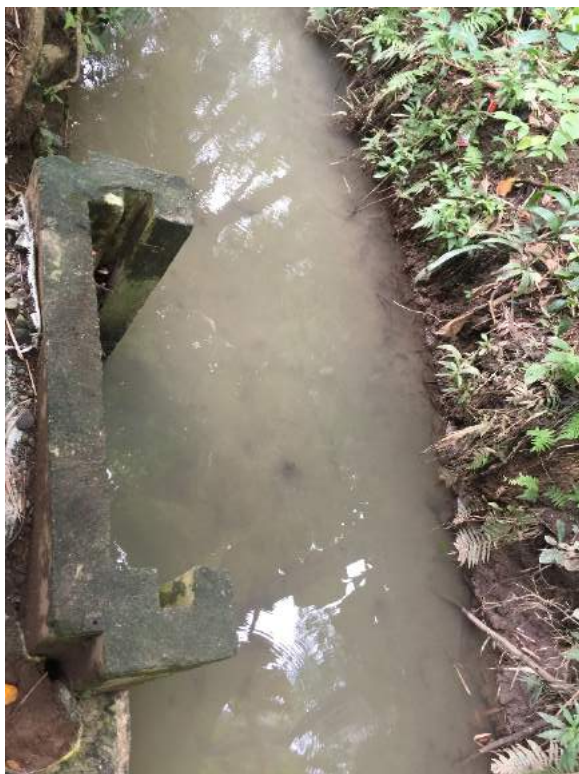
Figure 1C-46. Silt ejector in main canal connected to Dam 1

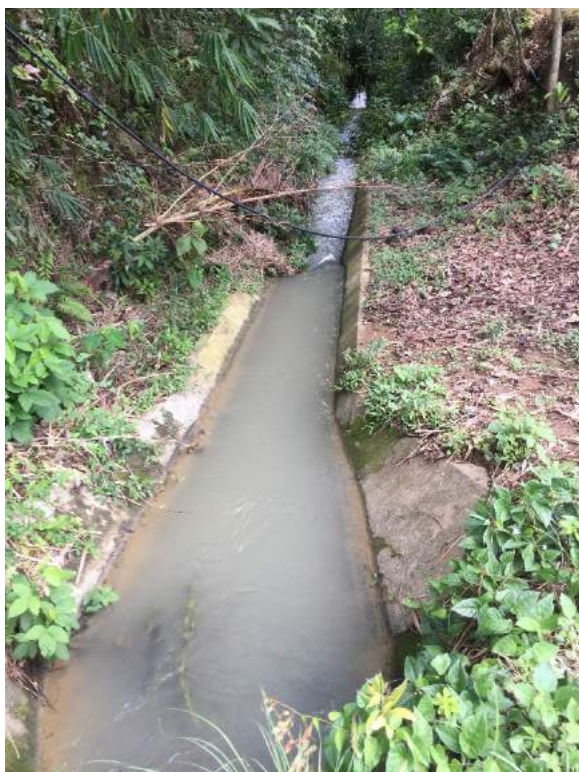
Figure 1C-47. Main canal connected to Dam 1

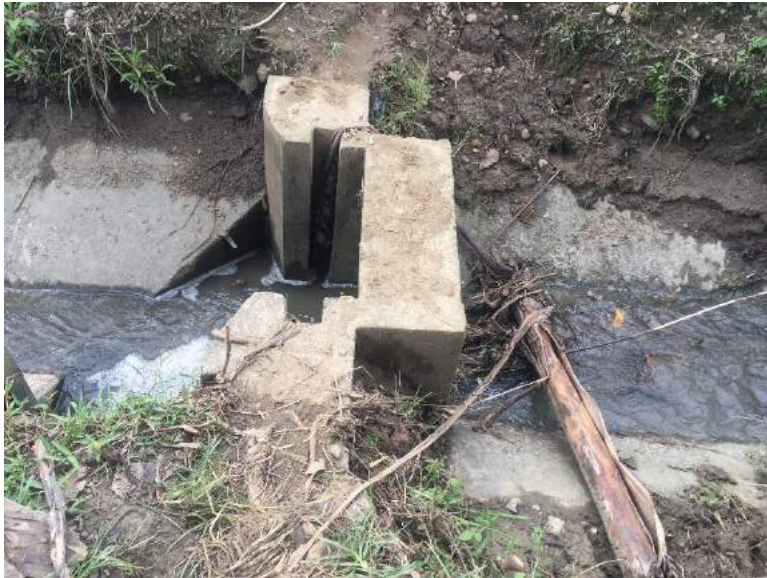
Figure 1C-48. Ejector for silts in main canal connected in Dam 2
Source: Author's capture

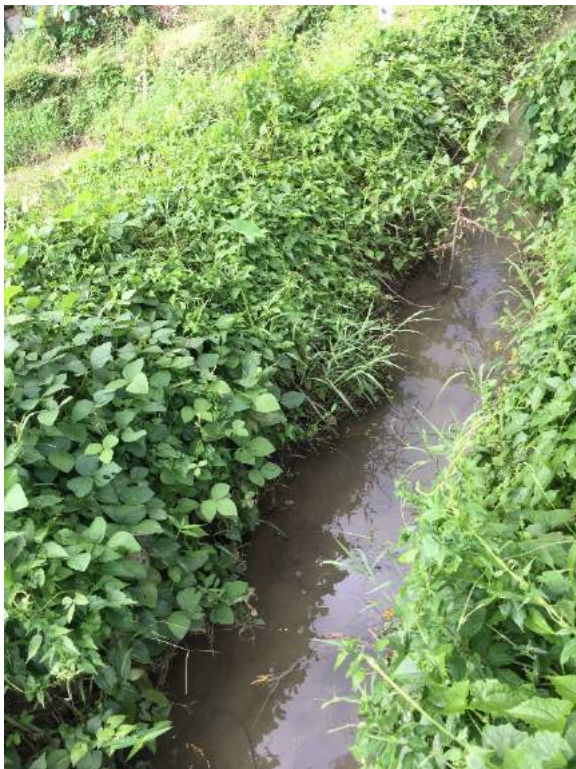
Figure 1C-49. Silted main canal connected to Dam 2
Source: Author's capture
