## Planning and Protecting Historical Buildings in Kaleiçi Region of Edirne/Turkey

46th Congress of the European Regional Science Association: "Enlargement, Southern Europe and the Mediterranean", August 30th - September 3rd, 2006, Volos, Greece

# **PLANNING AND PROTECTING HISTORICAL BUILDINGS IN KALEİÇİ REGION OF EDİRNE/TURKEY**

**Key words: Planning and Protecting, Cultural Inheritance, Traditional Houses, Edirne, Kaleiçi**

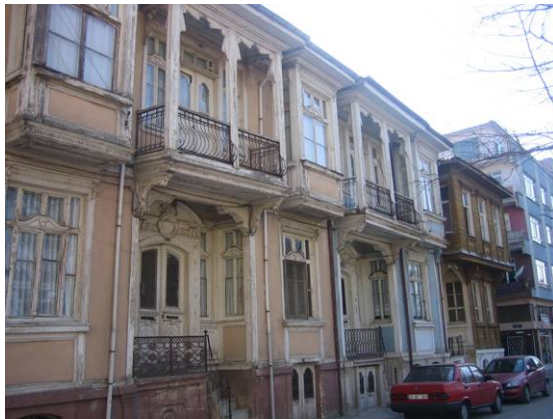
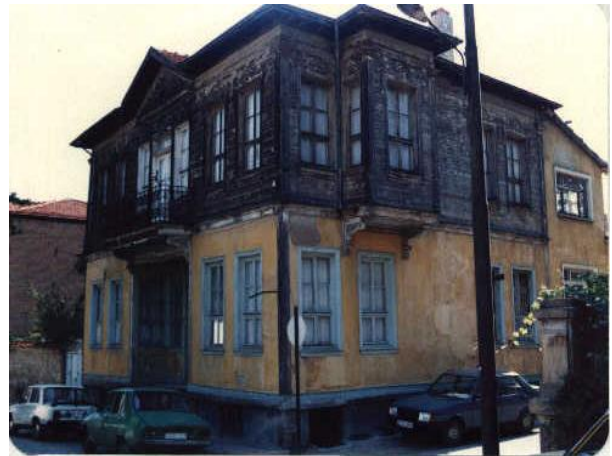
All of the houses were in a row and were built in the way that they faced the street. Houses in a row, unusual in the Ottoman city pattern, appeared as the architecture of the minority and reflected the socioeconomic characteristics of the era. (Batur ve diğ., 1979, s.185-203), (Figure 5, 6). 4 pairs of houses, designed as twin houses, took place in the area of settlement (Akansel, 1990, s.34).

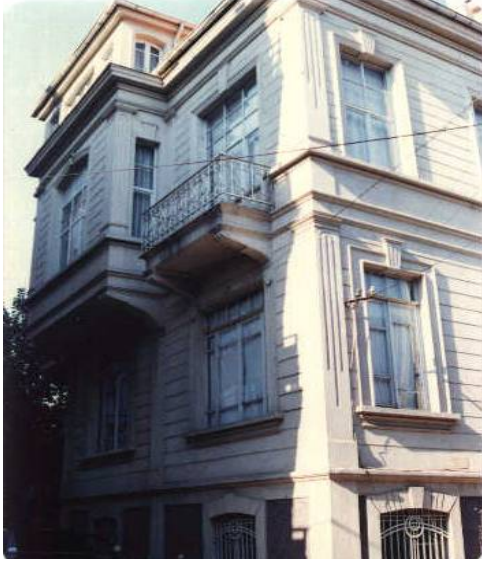
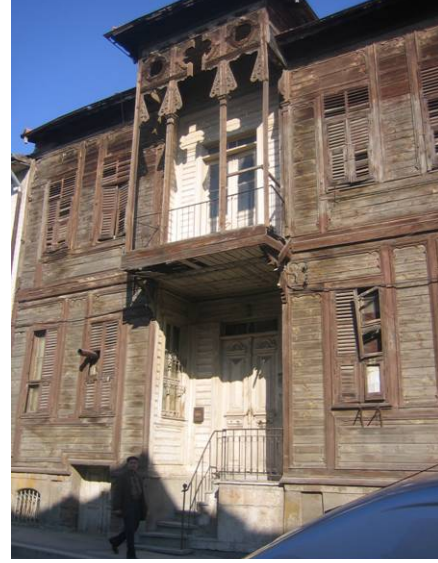
Historical houses in Kaleiçi the entrances of which open directly to the street have generally two floors and a basement but no main floor that traditional Turkish houses have (Figure 8, 9)

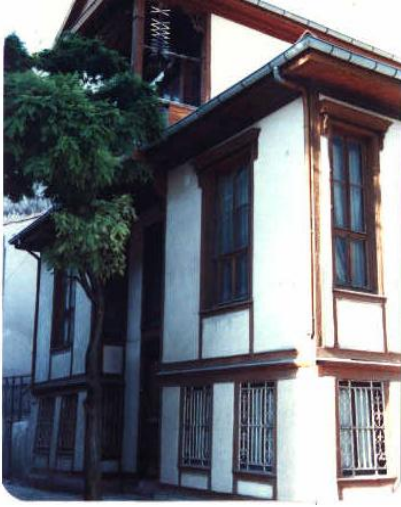
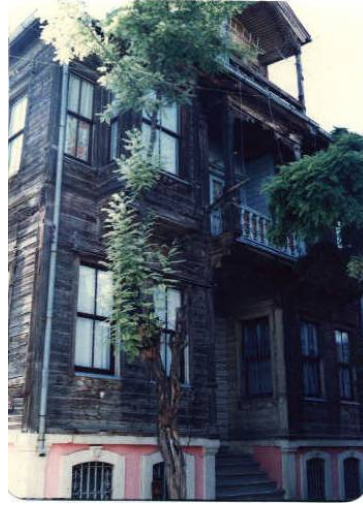
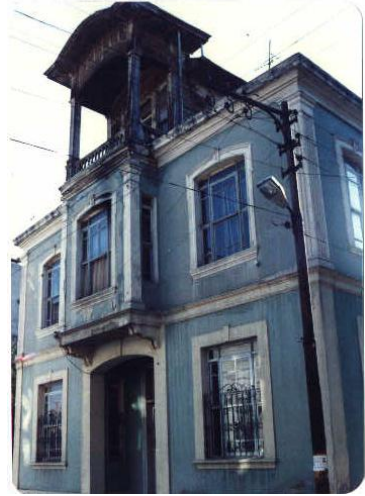
A roof terrace was also available both in the one-floor and two-floor houses although it was not used very frequently. There are also times when these were located in the attic storey in one-floor houses (Figure 13, 14, 15).

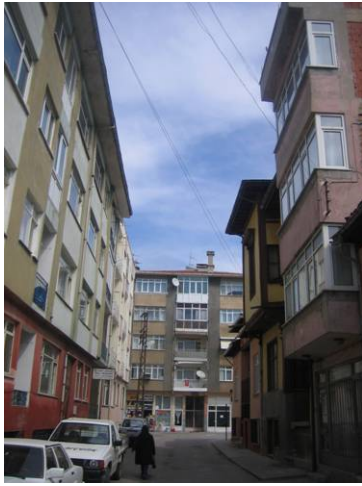
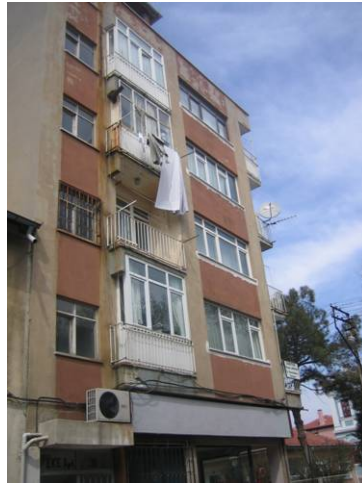
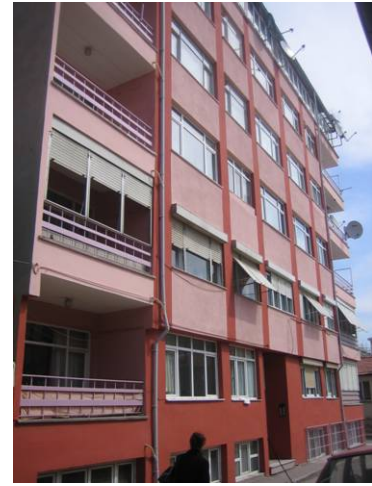
After the fires and earthquakes, 5 or 6-floor buildings destroying the traditional patterns and appearance have been built as a result of the regulations allowing construction and illegal applications (Figure 18, 19, 20).

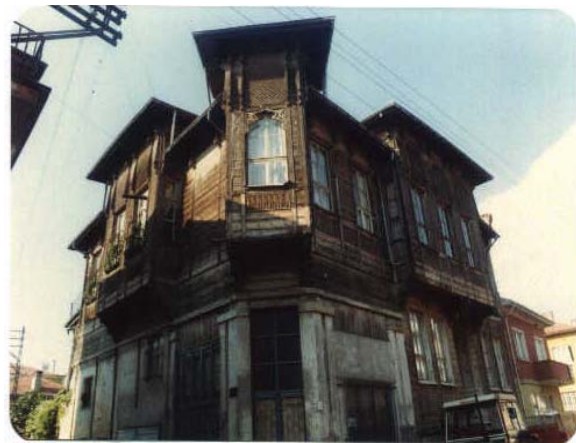
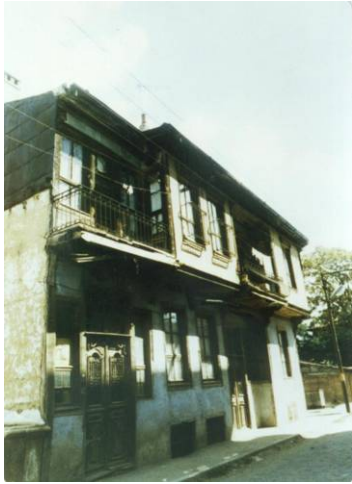
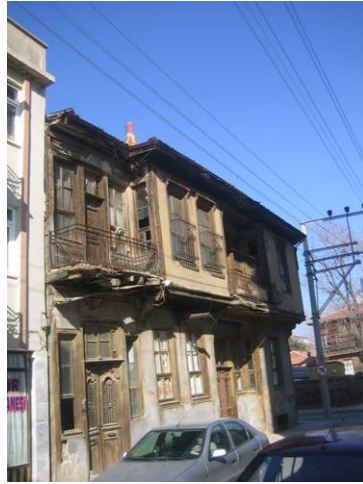
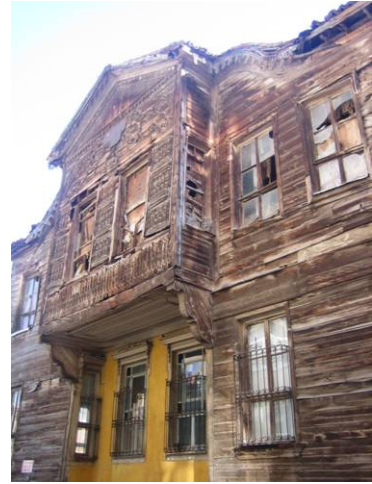
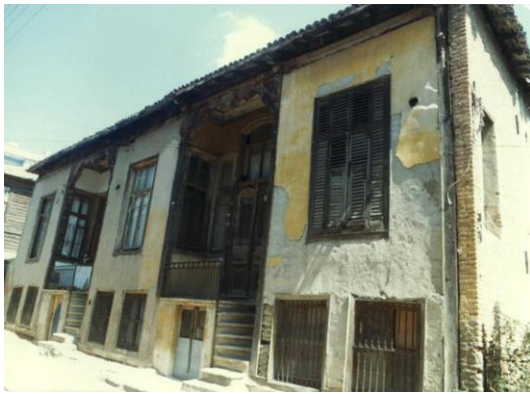
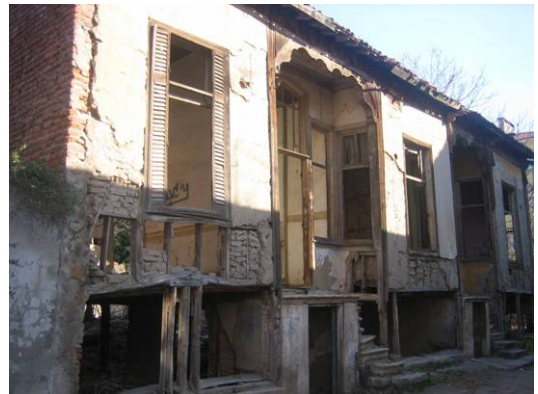
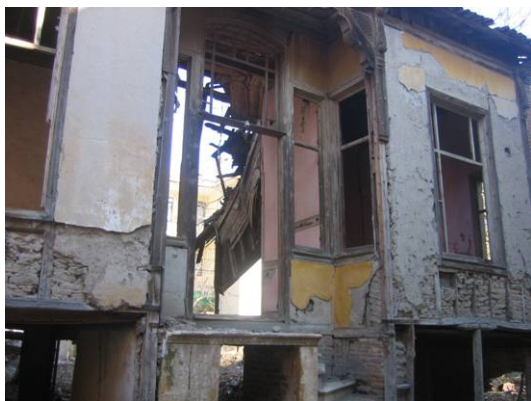
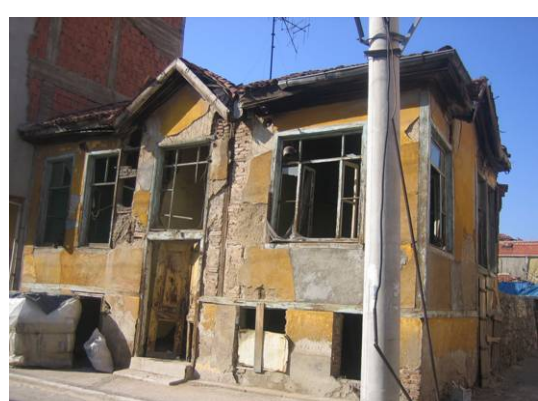
The changes mentioned have mainly affected the historical pattern. These houses, considered to be the sample of civilian architecture, either destroyed and more dense buildings were built instead: or left in a bad condition within the framework of the power of protection rules because modern life conditions could not be provided. Because of the reasons such as the insufficiency in the economic and social structure of the users of these ruined houses, we have some problems waiting to be solved such as that these houses left their liveliness and some of the houses near to the trade region were put into the function of trade; and need

for the car park and vehicular traffic (Figure 21, 22, 23, 24, 25, 26, 27, 28)
