## Assessing the resurgent irrigation development program of the Philippines: National irrigation systems component

PIDS Discussion Paper Series, No. 2020-01

# Assessing the Resurgent Irrigation Development Program of the Philippines – National Irrigation Systems Component

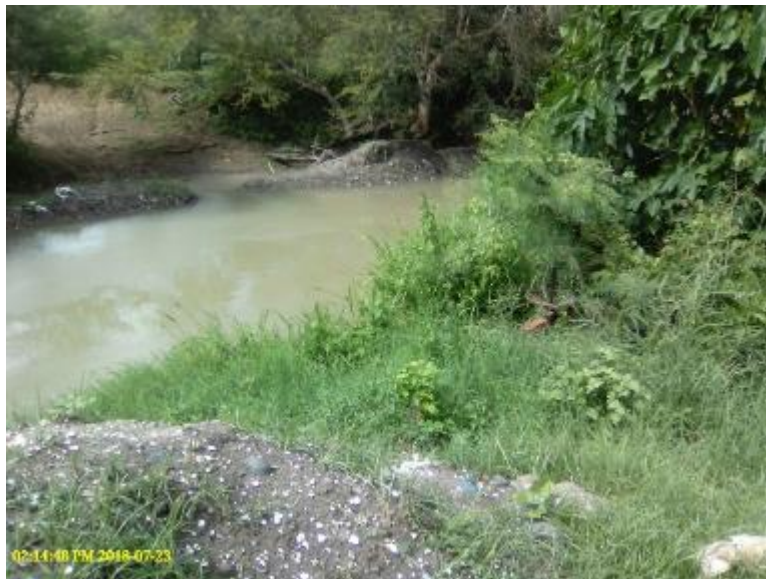
Photo 1. Silted diversion dam of Dipalo RIS

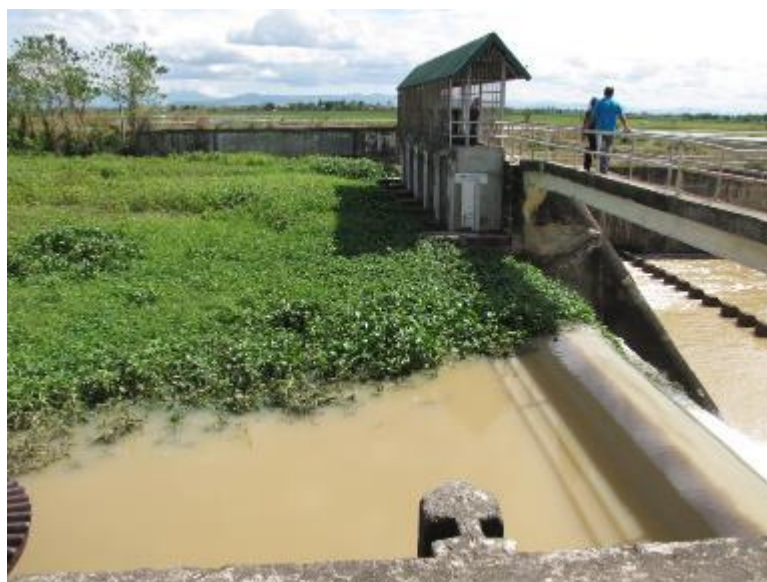
Photo 7. Vaca Dam of Division 2, UPRIS

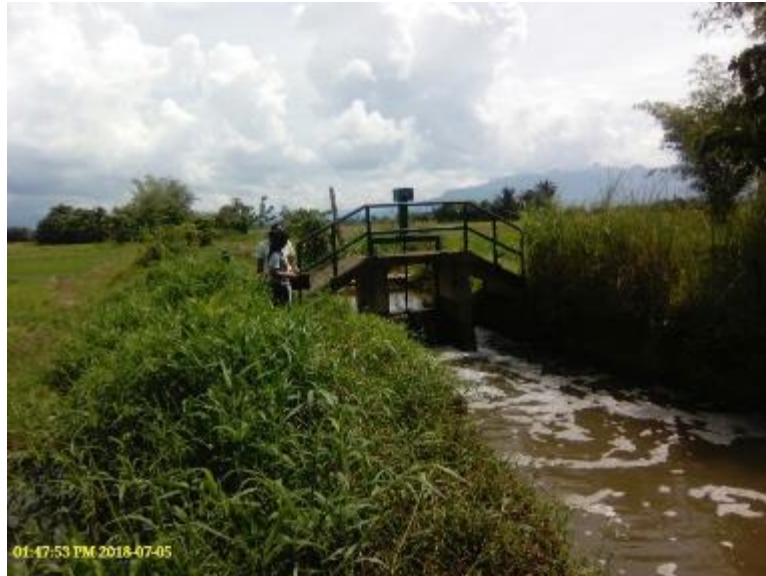
Photo 8. Belisong #1 dam (re-use dam) of Lower Binahaan RIS.

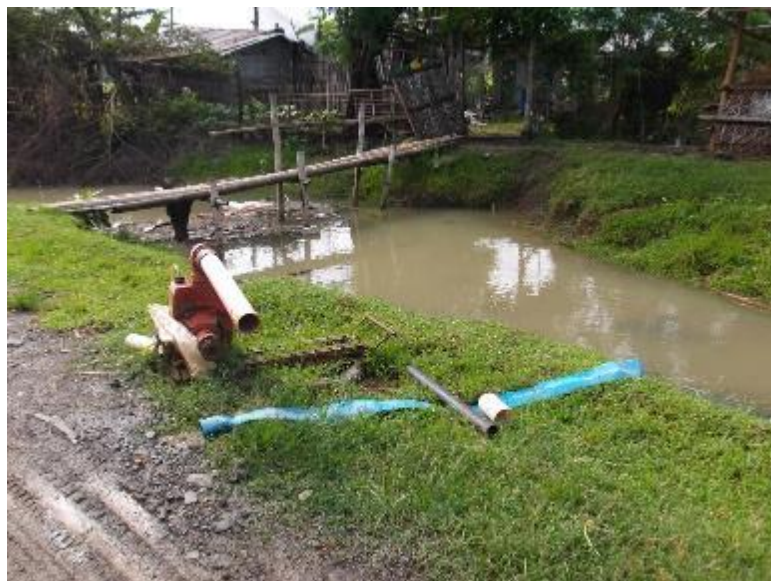
On the other hand, in the point of view of IAs and farmers, the irrigation system should supply the required irrigation for the duration of the cropping. The lack of water supply would mean using supplemental modes of irrigation. The most common supplemental mode of irrigation is pumping. Sources of water for pumping are irrigation and drainage canals, tubewells, lakes, and nearby creeks and streams. Pumping from irrigation and drainage canals could be observed in BPIS, Solana and Magapit PIS (see Photo 9), UPRIIS, MARIIS, Libmanan-Cabusao PIS, Malinao IS, Binahaan-Tibak RIS, Sibalom-Tigbauan RIS (see Photo 10), Padada RIS, MalMar 2, and M'lang RIS (see Annex C for other systems). Although only a few STW were observed during the walk-throughs (see Photos 11 and 12), FGDs showed that STWs were being used in some NIS cases. Based from groundwater potential maps in Annex C, service areas of PDRIS, BPIS, Bonga Pump #2 PIS, TASMORIS, some areas of UPRIIS and MARIIS, and Solana and Magapit PIS, Binahaan-Tibak RIS, Jalaur-Suague RIS, Barotac Viejo RIS, Padada RIS, M'lang RIS, and Pulangui RIS are within shallow well potential areas. During dry season or periods of prolonged water shortage, alternate wetting and drying (AWD) approach is being practiced in most of the irrigation systems covered. This is an example of deficit irrigation (DI) where water delivery is reduced to a level lower than discharge capacity or design discharge. However, to be effective, DI should be practiced in such a way that the reduction in water delivery should not be lower than what is required by the crops to obtain optimum production. To achieve this, the concept of DI should be applied at different growth stages of crop growth which correspond to different levels of water requirement. If this is adopted properly then optimum production and profit can be achieved.

Photo 10. A pumpset installed along Main Canal, Sibalom-Tigbauan RIS (downstream section).

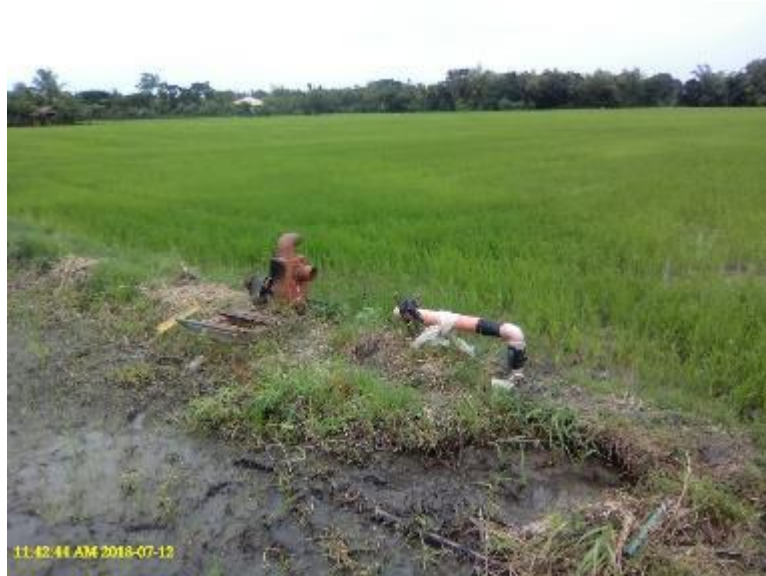
Photo 11. A pumpset installed in the service area of Jalaur RIS (downstream section).

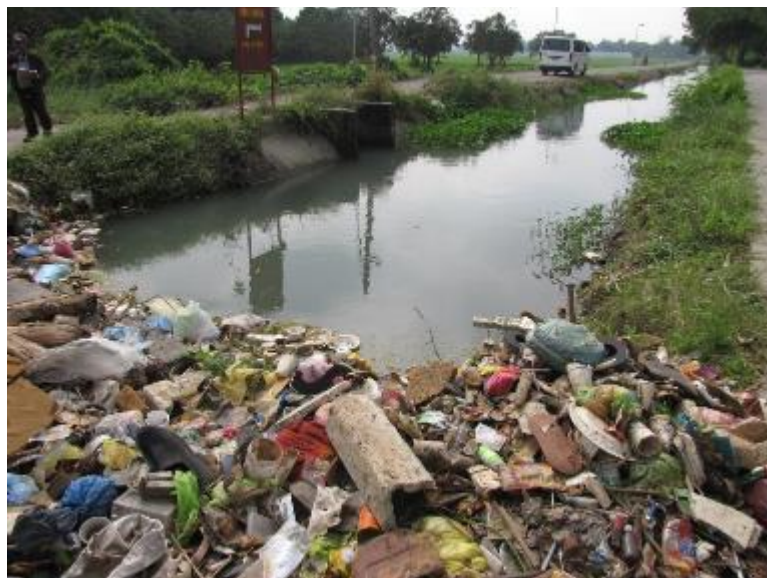
Lack of policy or its weak implementation on illegal settlers (e.g. Camalap IA in Magapit PIS), dumping of garbage, and illegal pumping have caused both delivery and environmental issues. In Div. 3 of UPRIIS, informal settlers along the canals pose solid waste problems. Garbage was observed in a section of lateral in AMRIS (Photo 13) and Pulangui RIS (Photo 14). According to different IMO, different Resolutions were issued by LGUs concerned regarding waste disposal in the canals but to no avail. Other issues include poor water delivery scheduling and distribution (e.g. TGIS, Kadaklan Baldias IA in Nueva Era RIS, Cabusligan IA in BPIS, New Life IA in Division 2 of MARIIS, and Kaps Ambayoan IA in Ambayoan RIS) and conflicts among users especially when upstream members block the path of water which reduces the water supply for the downstream part. Illegal pumps also exist in some laterals (see

Photo 13. Garbage in gates of one section of Lateral B NMC, AMRIS

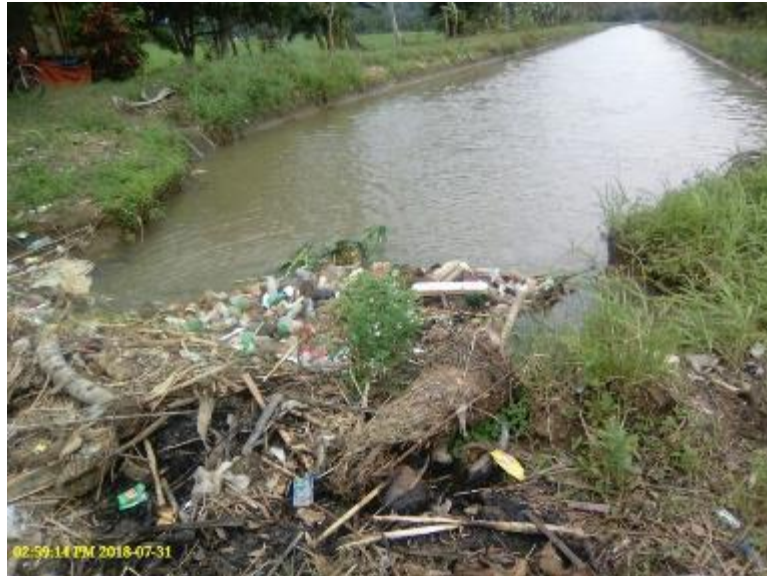
Photo 14. Section of South Main Canal of Pulangui RIS with floating debris trapped in a headgate.

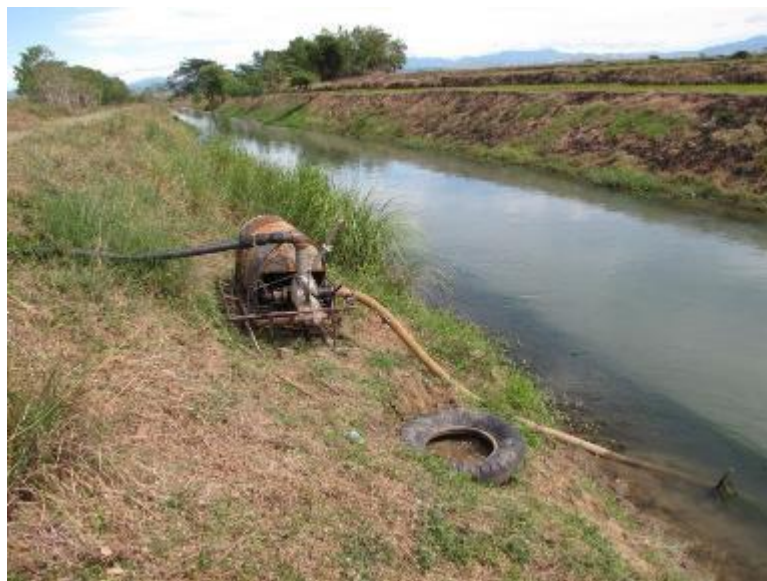
Photo 15) plus illegal diversion of water through KKB (“kanya kanyang butas”) along the canals (see Photo 16). It is however difficult to track down the violators since the improvised holes are not visible when water is flowing deep.

Photo 15. Illegal pumping unit along MC of LTRIS, Division 2, UPRIIS

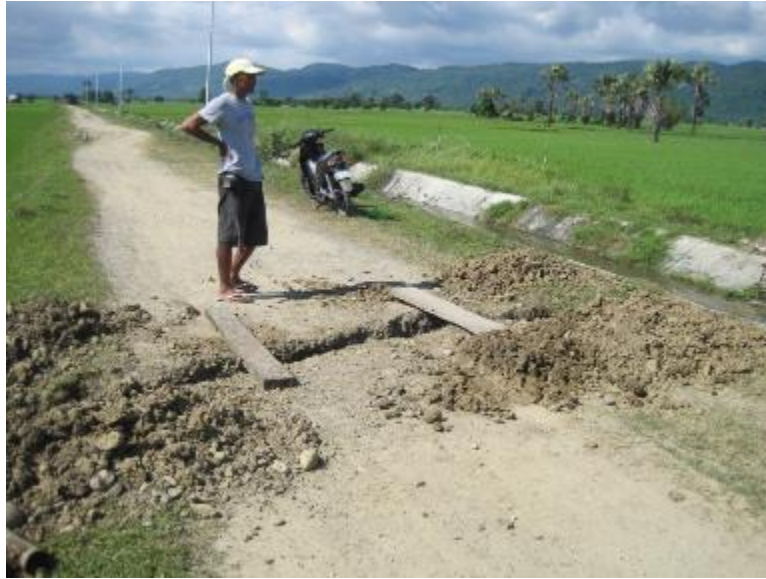
Photo 16. Illegal turn out along lateral of Caguray RIS  
(Photo courtesy of Engr. Wilson Lopez)

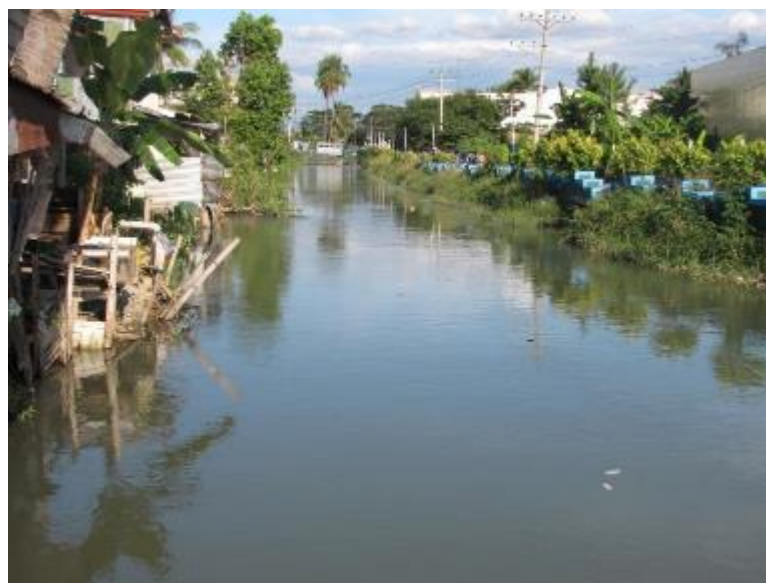
Three divisions of UPRIIS (2, 3 and 4) were visited. Siltation problems (see Photo 22) exist across all sections of the canal network which again points to the technical deficiency in the maintenance of the canal network. This is even worst in unlined canals which are eroded and damaged by uncontrolled animals frequenting the sides of the canals. As observed in other NIS, similar concerns exist such as lack of staff gauges to measure flow, siltation of canal up to lateral level, illegal pumping, garbage dumping in canals due to illegal settlers (Photo 23) and lack of maintenance were also observed in UPRIIS. Water shortage is expected to occur during El Nino this year. Another major issue is the collapse of LTRIS dam (see Photo 24) due to typhoon Mario in 2014.

Photo 23. Direct household refuse into MC of Division 4, UPRIIS

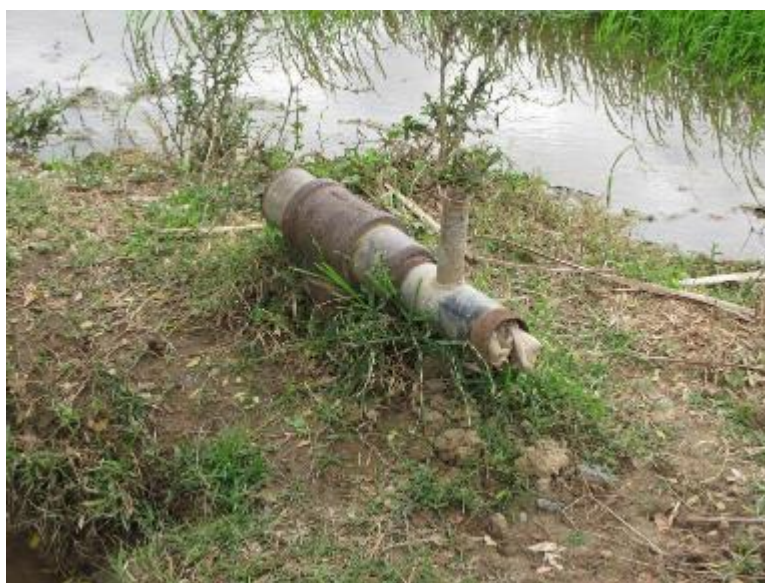
UPRIIS was able to irrigate at most 114,000 hectares, however due to the declining water this is now reduced to around 86,000 hectares (Table 12). Some notable issues of UPRIIS were the declining water supply due to El Nino and prolonged drought. Reduction of irrigated area was due to declining inflow in Pantabangan dam and other intakes. As shown in the cropping intensity in the last ten years, there were years that it reaches to near 200%. To maximize water, re-use dams were constructed like the one visited Vaca dam (Division II) and Campana dam (Division IV). Moreover, some farmers are using LLPs and STWs (Photo 25) to supplement irrigation during low water supply.

Photo 25. STW in Division II, UPRIIS

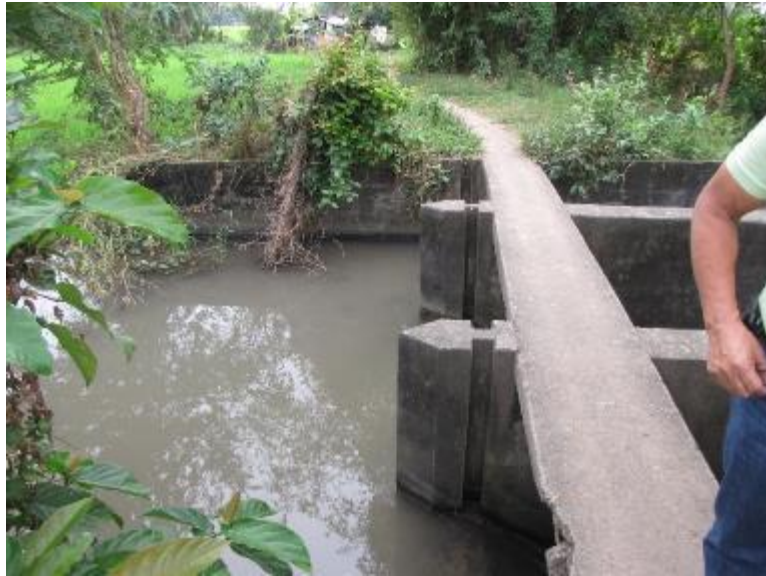
Photo 31. Check gate of Palomares Diversion Dam.  
One of the re-use dam in Div. 2, MARIIS.

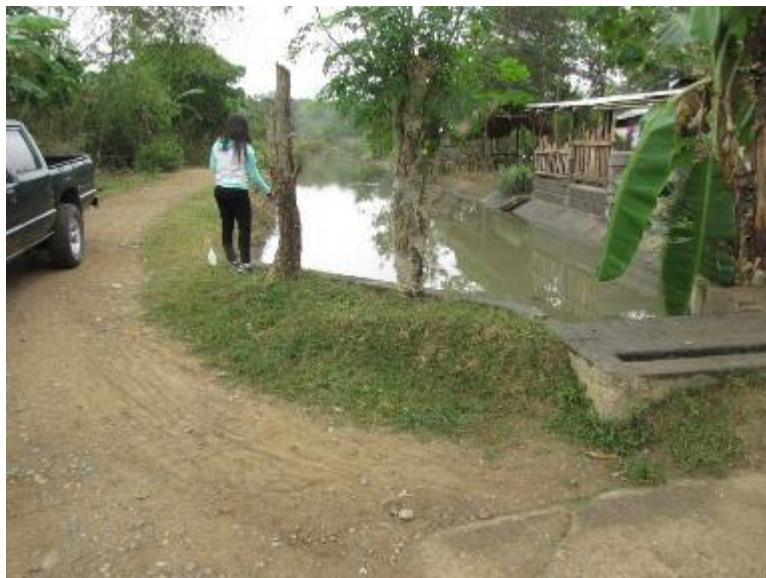
Photo 32. Main canal of Nungnung Dam (re-use dam), Div.4, MARIIS.

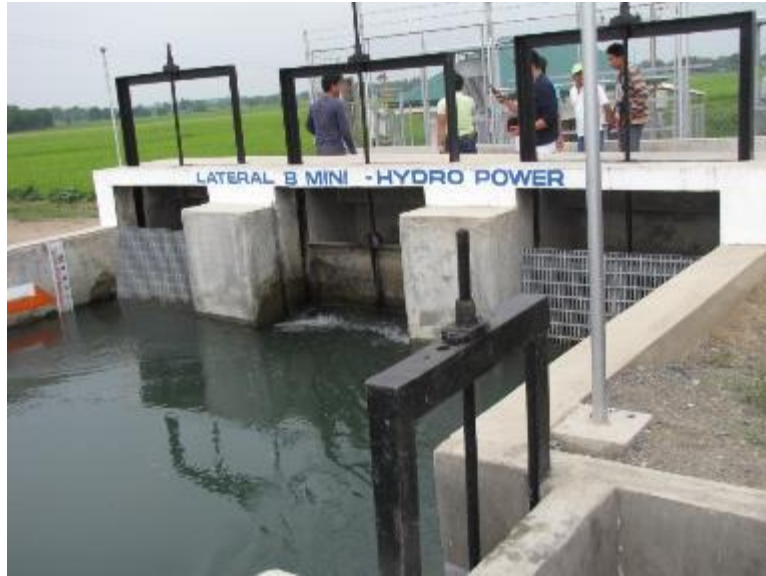
Photo 33. Mini-hydro power plant (45kW) along Lateral B, Div. 2, MARIIS.

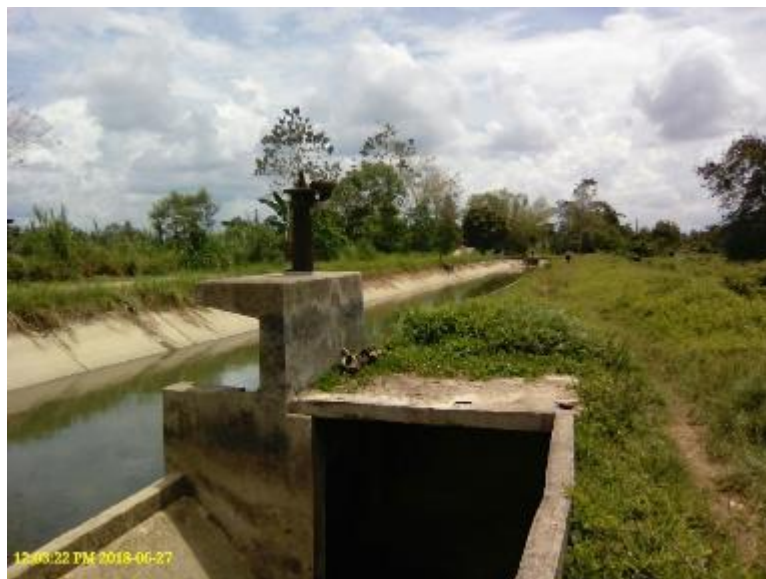
**Photo 34. Gate of the spillway that supply water to Malinao IS to Bayongan reservoir**

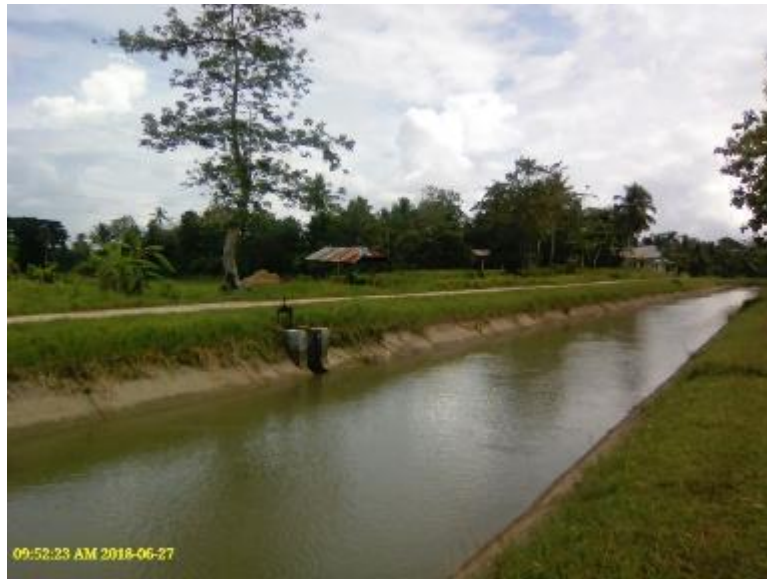
There were about 50 direct turnouts from the Main canal (Photo 35). The system allowed pumping (Photo 36) from the main canal, on the right side. Schedule of pumping depends on their location. It was mentioned that siltation could be observed in some downstream sections but minimal. It could be flushed out during high flow but was not documented during the visit.

Photo 35. A direct turnout along MC of Malinao IS near Sta 0+00

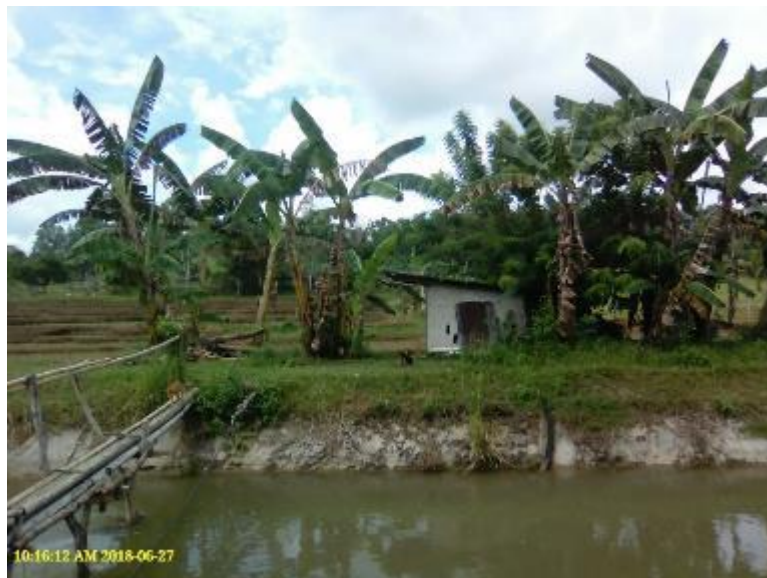
Photo 36. A pumphouse along MC in the upstream section of Malinao IS.

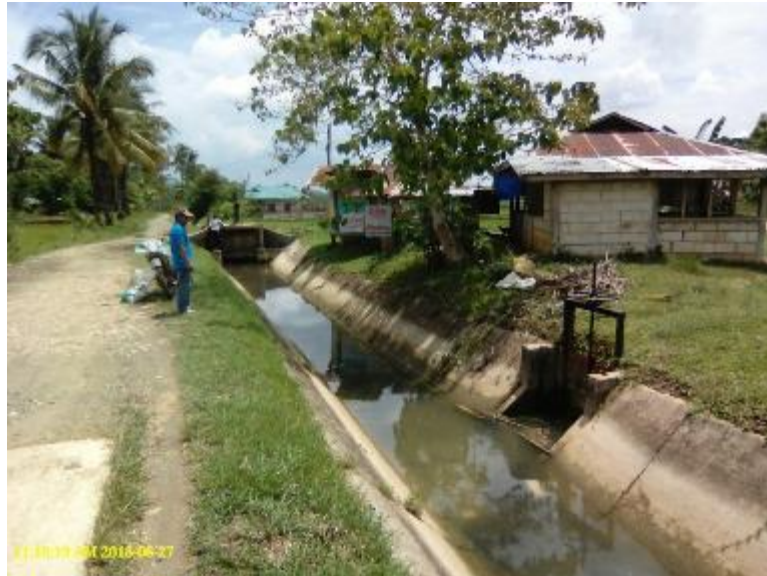
Most of the Main and Lateral canals of the three systems are lined (Photo 37-41). Canal layout map of Malinao IS is presented in Figure 26.

Photo 37. Section of Lateral D, Malinao IS in the downstream that are lined.

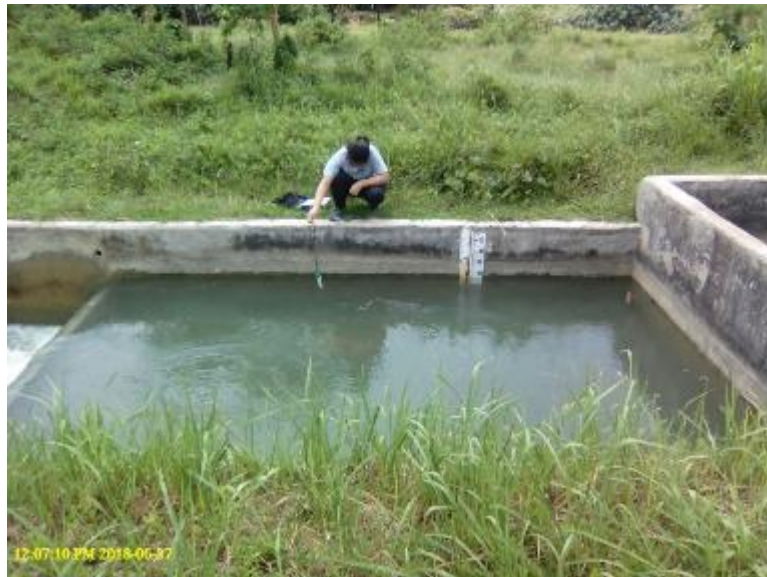
Most of the Main and Lateral canals of the three systems were installed with staff gages for monitoring flow intakes (Photo 38). Same with NIS in Luzon some of the gates of systems in Bohol has padlock (Photo 39). Siltation in the canals came from roads along the canal. Debris from plants and trees in the area usually clogged the gates at the lateral

Photo 38. Staff gage installed in the downstream section of Malinao IS MC.

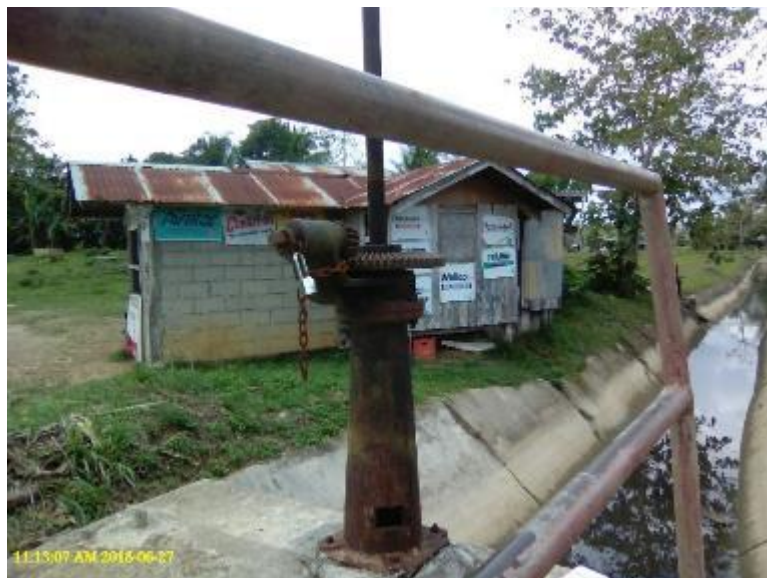
Photo 39. A gate with padlock in the downstream section of Malinao IS Lateral F.

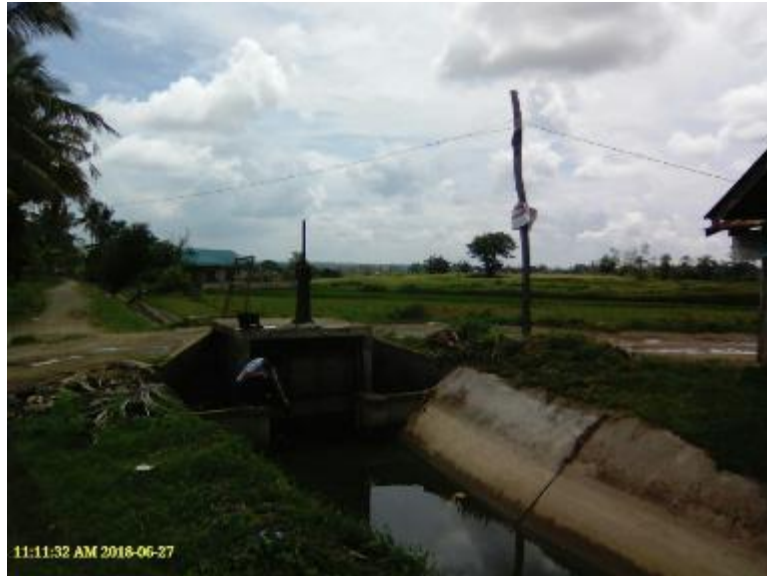
Photo 40. Check gate at the downstream section of Lateral D, Malinao IS. Take note of the debris on both sides of the canal.

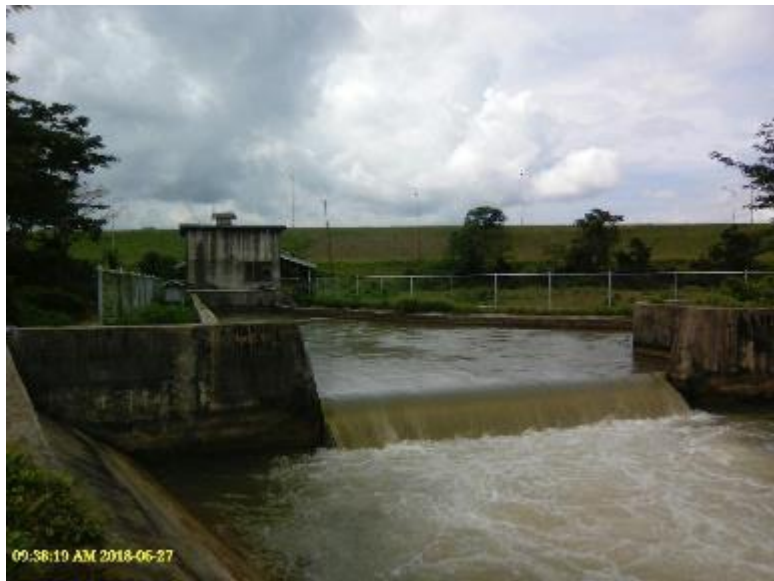
Photo 42. Headwater of the Main Canal, Malinao IS.

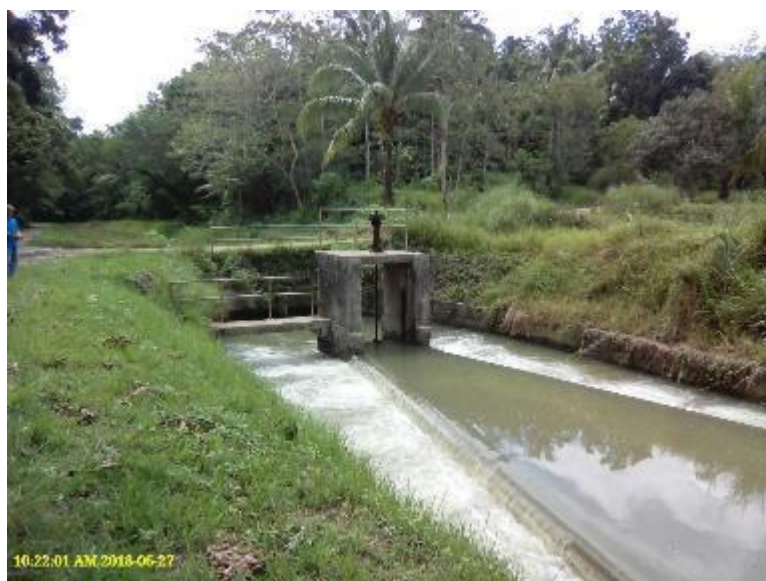
Photo 43. Duckbill weir near Lateral A, Malinao IS.

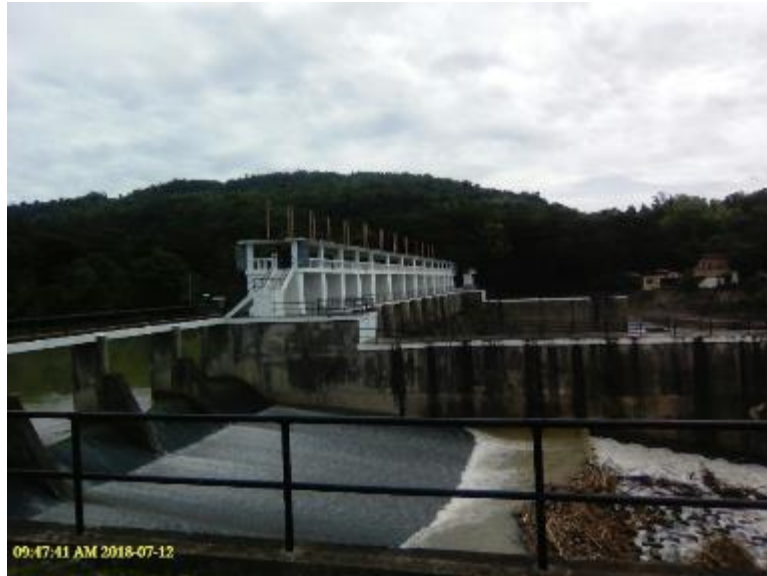
In the Jalaur-Suague RIS, separate Main Canal supplies Jalaur Proper and Jalaur Extension (Photo 44) but only one source. Suague RIS has separate diversion dam and canal layout (Photo 46). Moreover, the main canal and Lateral B of Suague RIS is connected to the main canal of Jalaur Proper to augment water supply (Figure 45). One of the problems in the operation of Jalaur-Suague RIS is siltation in the canal as mentioned by the farmers and observed in the field (Photos 47 and 48).

Photo 44. Diversion dam of Jalaur Proper and Jalaur Extension RIS.

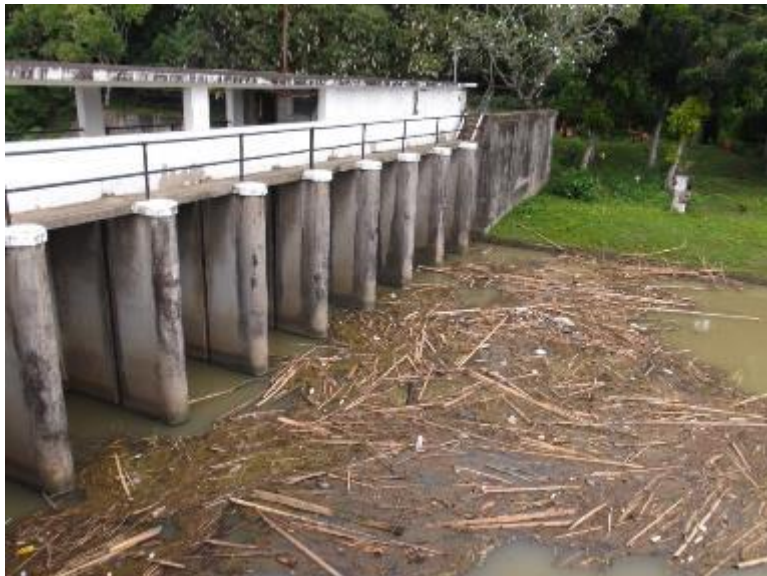
Photo 45. Dry log debris on the side of Jalaur-Suage RIS

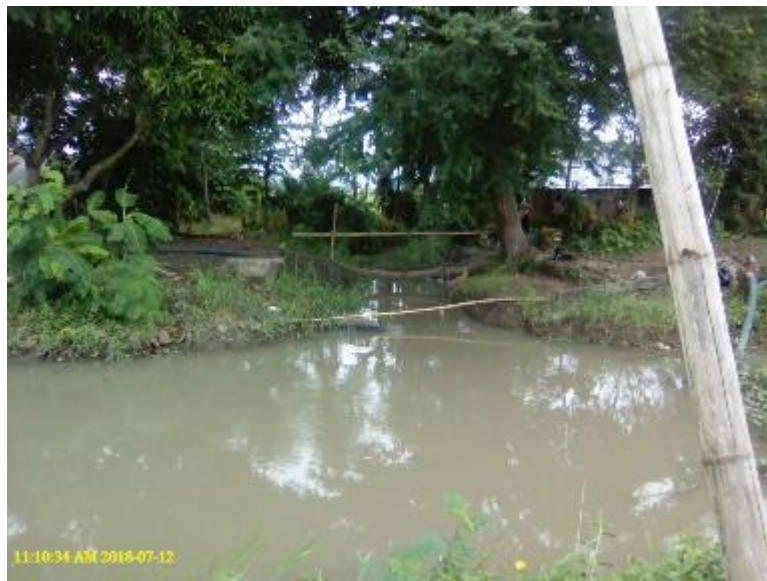
**Photo 46. End section of the Main canal of Suague RIS that flows into the Main Canal of Jalaur Proper RIS. Take note of the pumpset on the right side.**

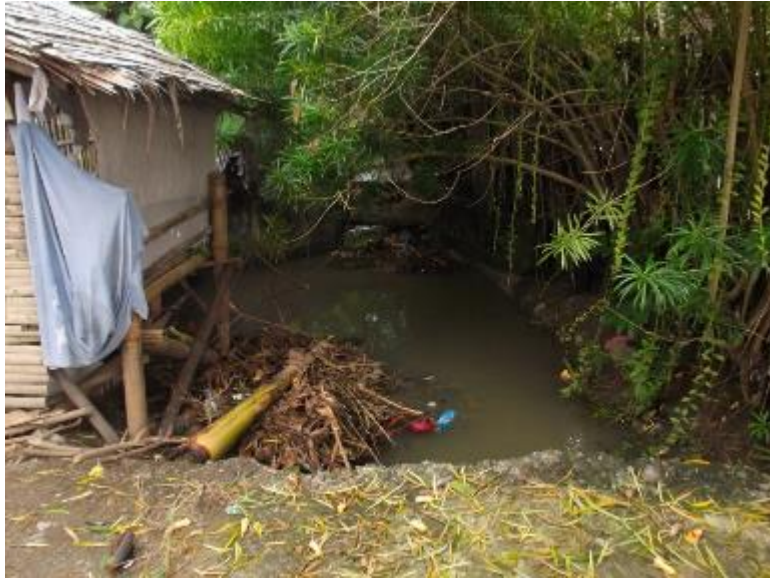
Photo 47. Section of Jalaur Suage near the residential areas.

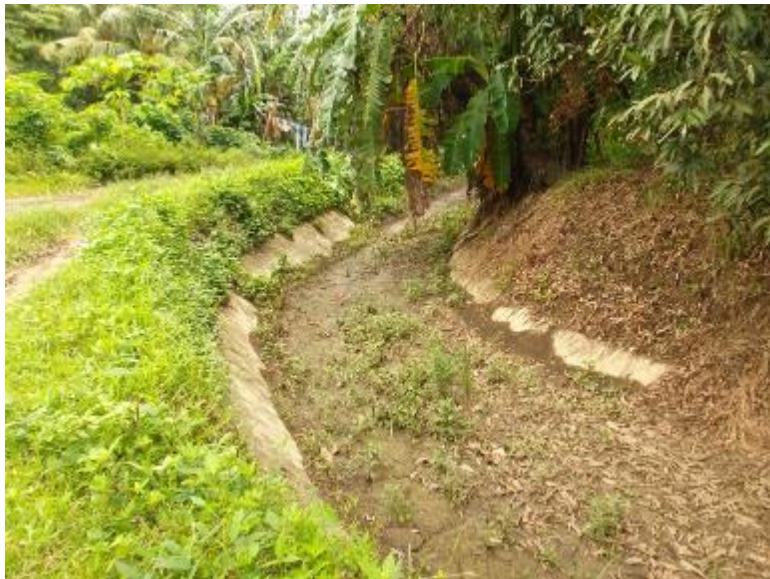
Photo 48. Silted section of Lateral C, Jalaur Proper RIS near the headgate.

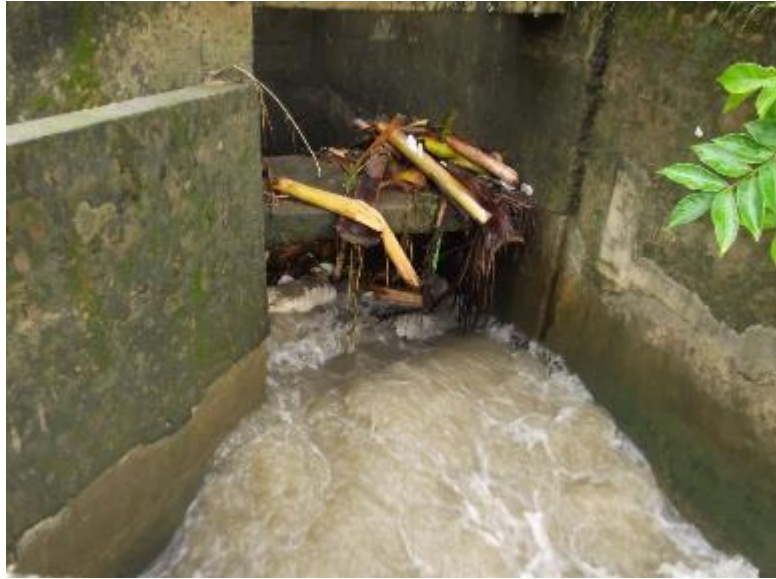
Photo 49. Clogged canal in Sibalom Tigbauan.  
(Take note of the dead swine together with the debris)

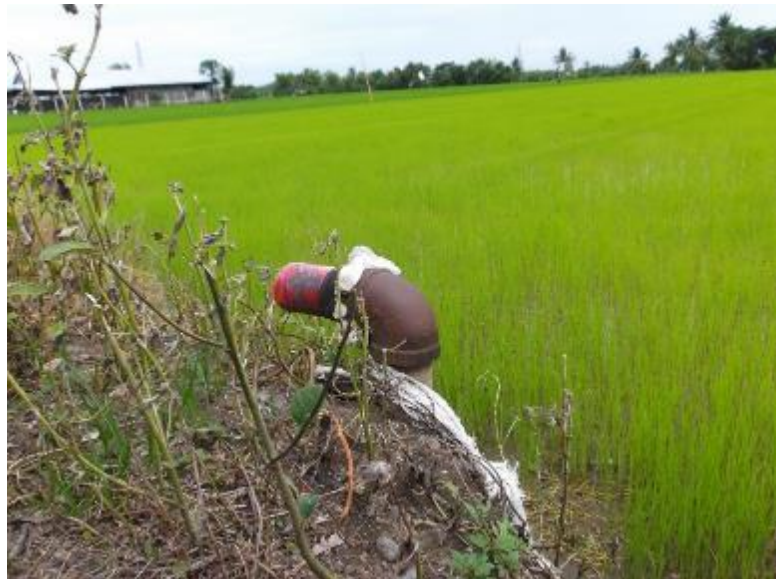
Photo 50. Shallow tubewell in Jalaur-Suage.

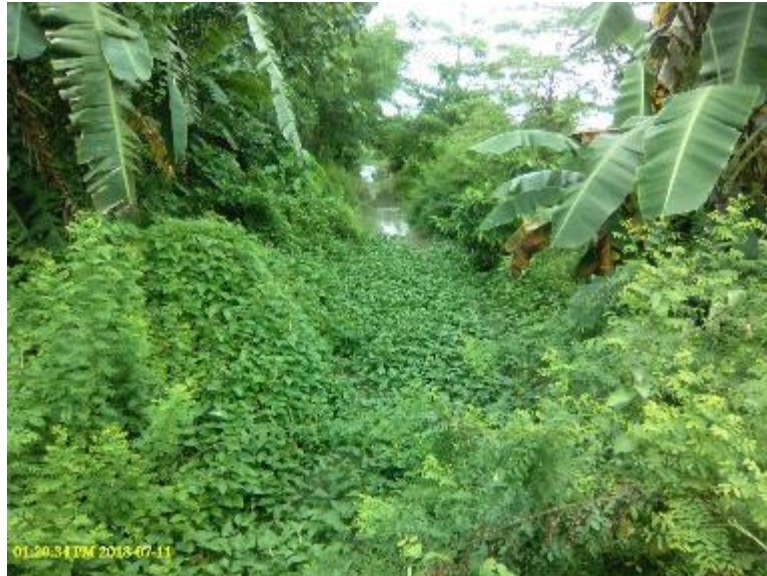
Photo 51. Vegetations that clogged the end check and drainage outlet of Jalaar Extension RIS.

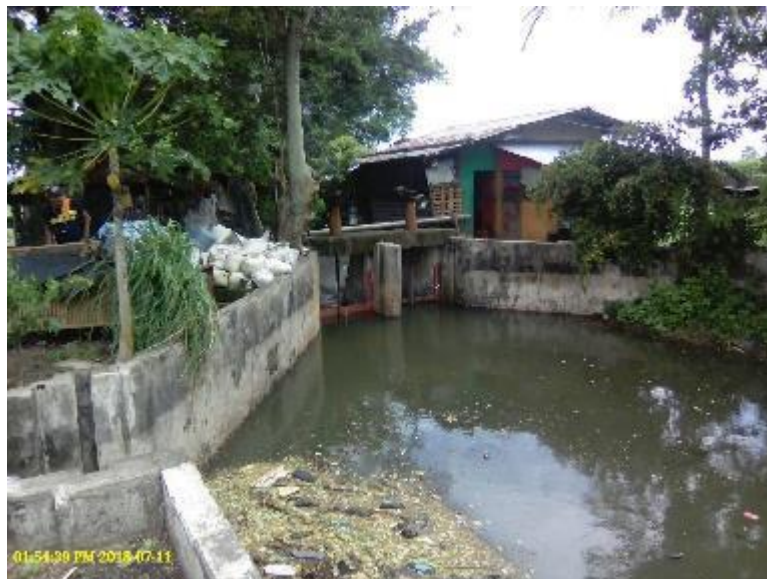
Photo 52. Checkgates at Lateral F, Jalaar Extension RIS.  
Take note of the floating debris on the left side.

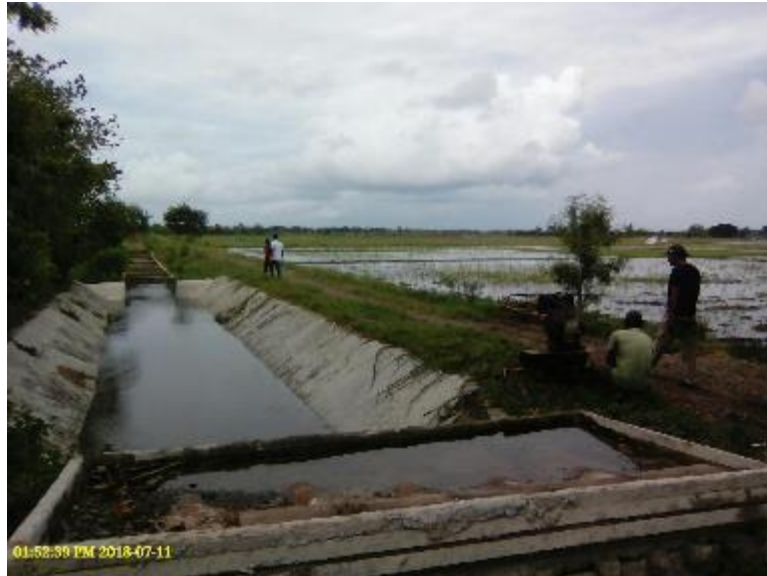
Photo 53. Lined section of Lateral F, Jalaur Extension RIS.

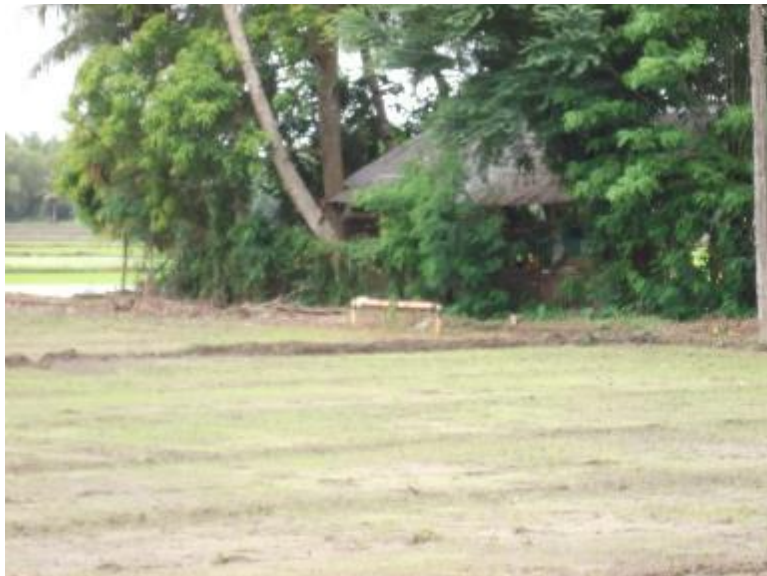
Photo 54. A shallow tubewell (well point system) in the midstream section of Jalaur Proper RIS.

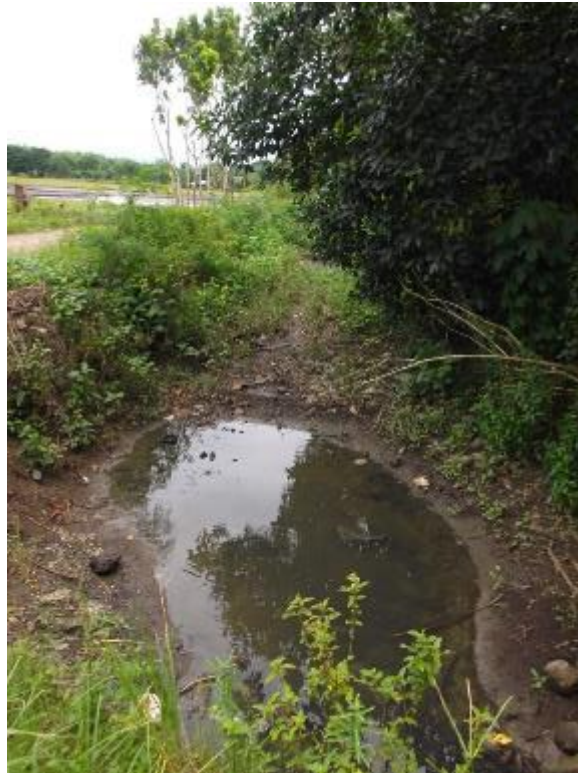
Photo 55. Downstream section of Lateral C, Jalaar Proper RIS.

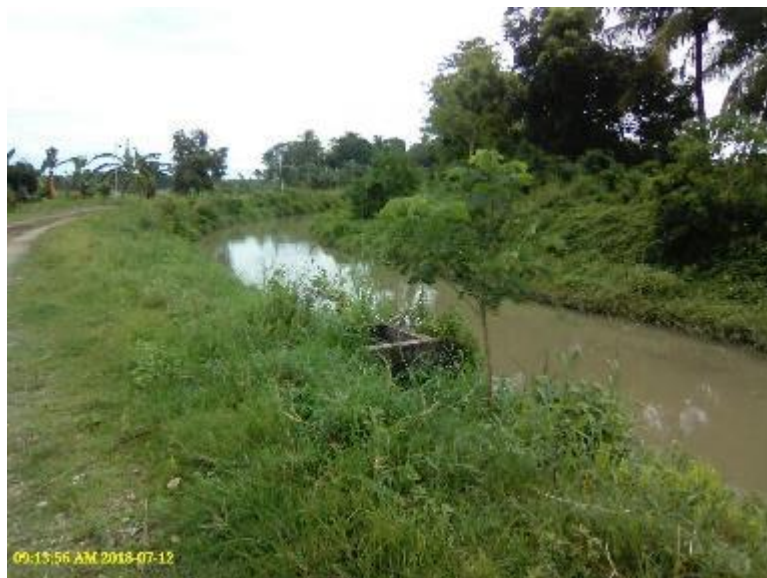
Photo 56. Direct turnout along Main Canal, Jalaar Proper RIS.

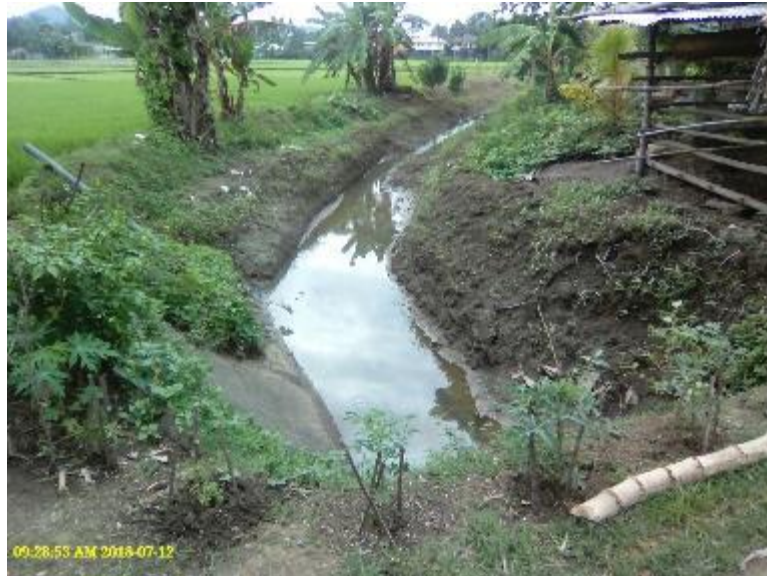
Photo 57. Section of Lateral B, Jalaar Proper RIS.

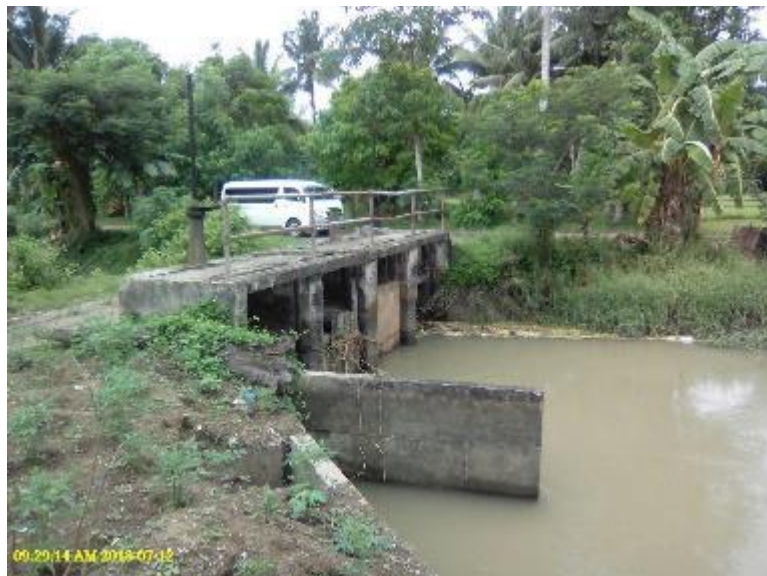
Photo 58. Check gate structure of Lateral B, Jalaar Proper RIS.

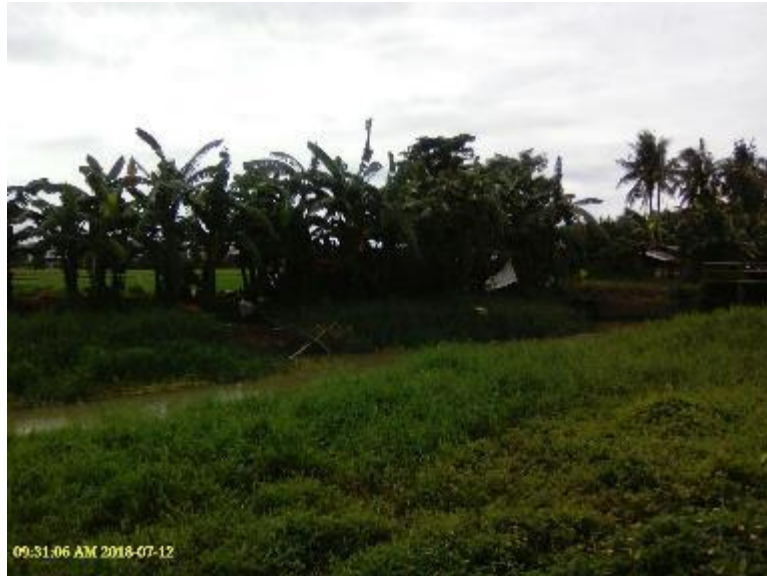
Photo 59. A pumpset along Main Canal, Jalaur Proper RIS.  
Take note of the width of the canal and vegetations along.

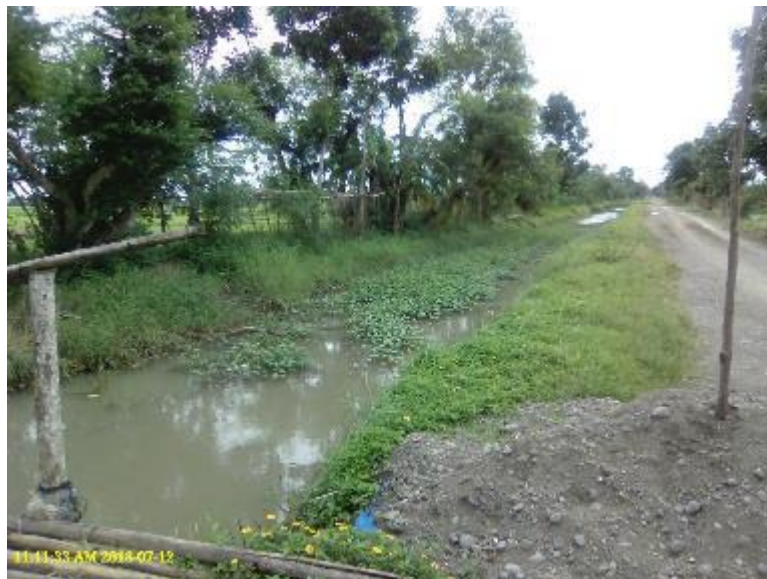
Photo 60. Section of the Main Canal of Jalaur Proper RIS with vegetations.

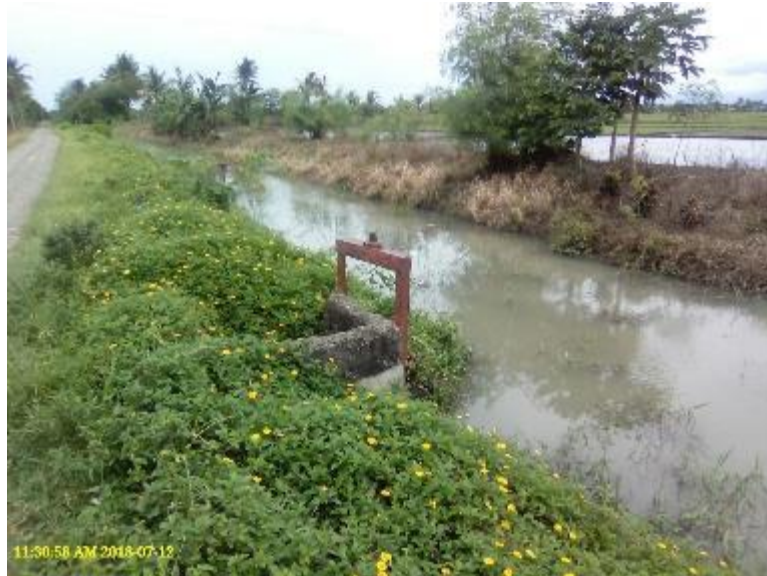
Photo 61. A direct turnout in the midstream of Main Canal of Jalaur Proper RIS.

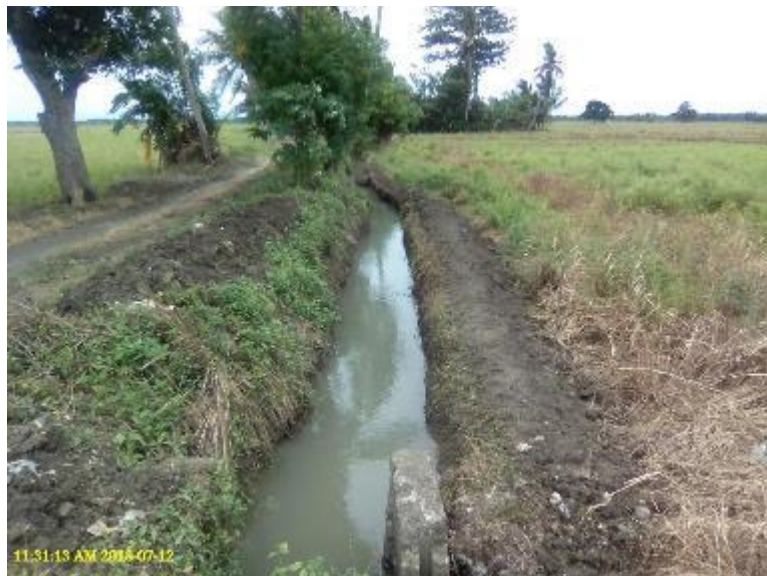
Photo 62. Newly-cleaned main farm ditch in Jalaur Proper RIS.

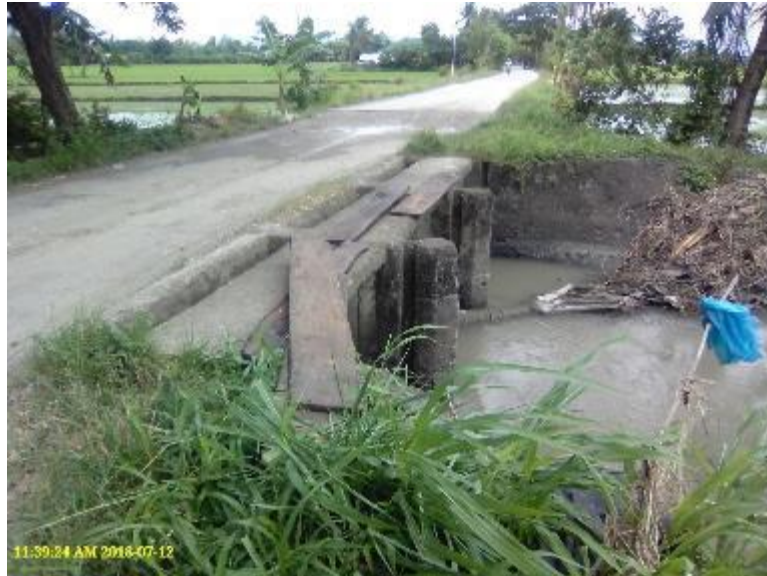
Photo 63. A checkgate using wood planks near the downstream of Main Canal of Jalaur Proper RIS. Take note of the debris on the right side of the canal.

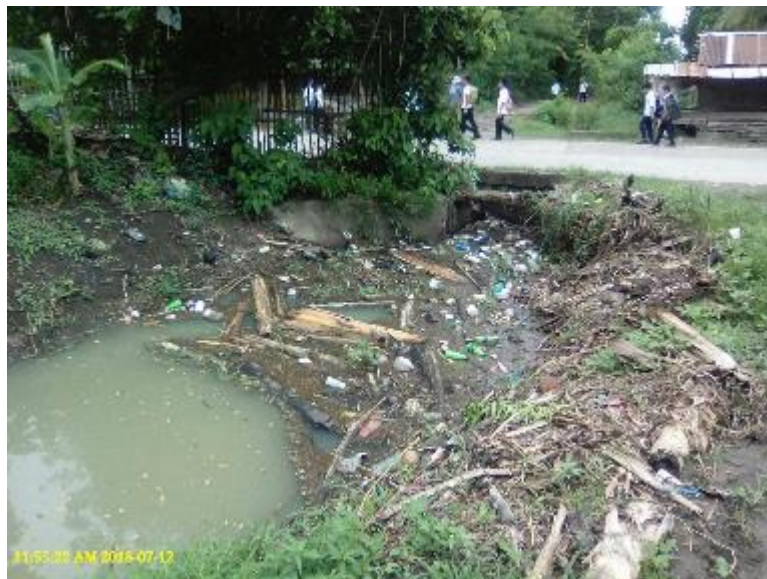
Photo 64. Downstream section of Lateral G, Jalaur Proper RIS.

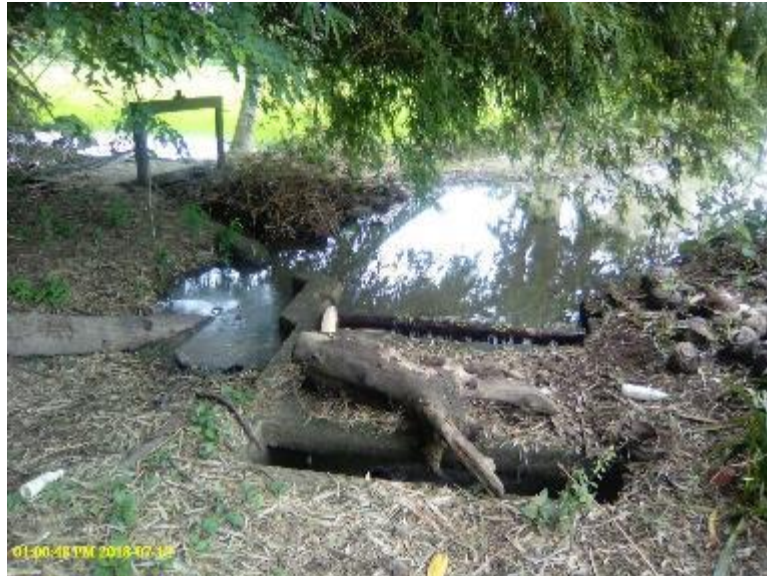
Photo 65. A re-use dam in Suague RIS.  
The intake gate is on the left side covered with debris.
