## Assessing the resurgent irrigation development program of the Philippines: National irrigation systems component

PIDS Discussion Paper Series, No. 2020-01

# Assessing the Resurgent Irrigation Development Program of the Philippines – National Irrigation Systems Component

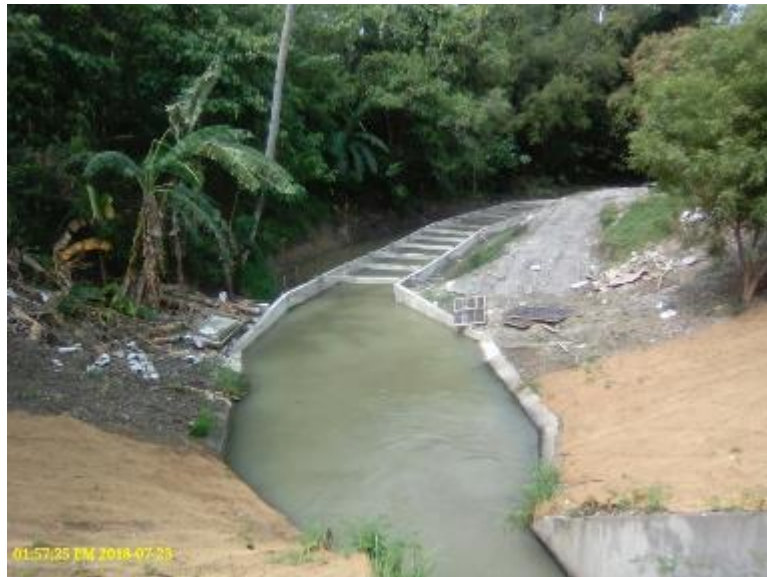
During the time of visit at Padada RIS, the unlined sections of Main Canal were being lined (Photo 67). The Laterals and Main Canals of other supply dams (Photo 68) were turned over to IAs (part of Modified IMT) as presented in Table 24. Of the total length (42.565 kms) of canal sections managed by the IAs, about 69.5% were unlined (Table 23). System layout and parcellary map of Padada RIS is shown in Figures 39 and 40.

Photo 67. Newly lined headwater section of Padada RIS Main Canal.

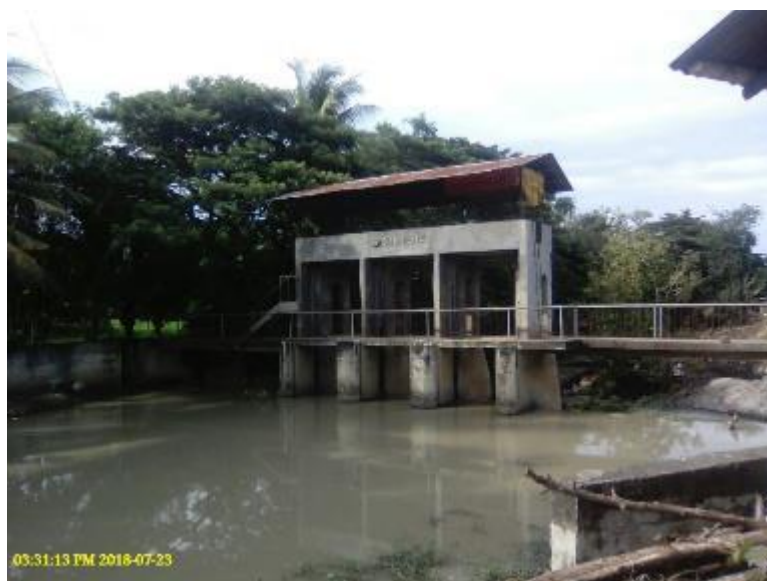
Photo 68. Parat dam along Sacub river (Intake dam for Padada RIS area).

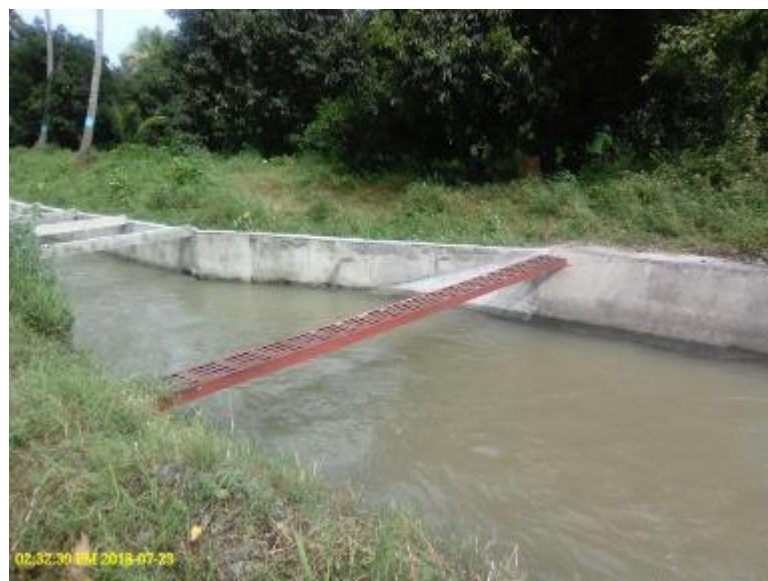
Photo 69. Bridge crossing over the Main canal of Padada RIS.

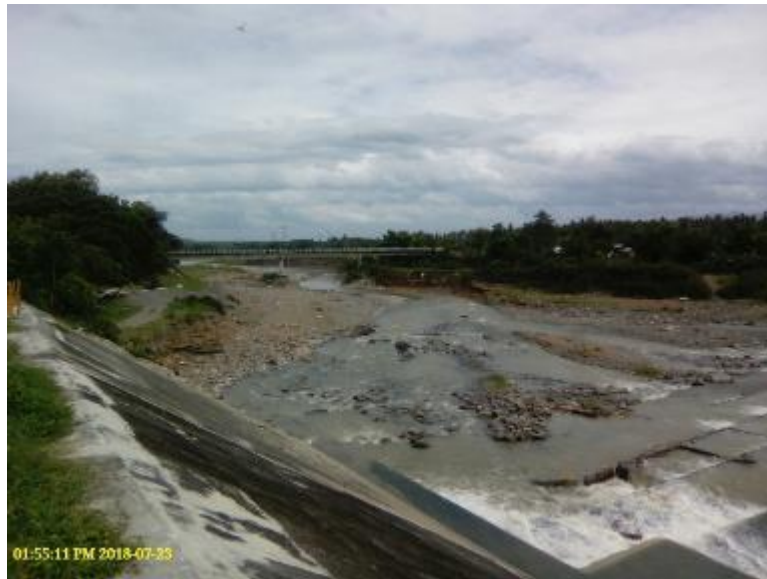
Photo 70. Problem at the dam site due to over quarrying near the downstream section of Padada RIS dam.

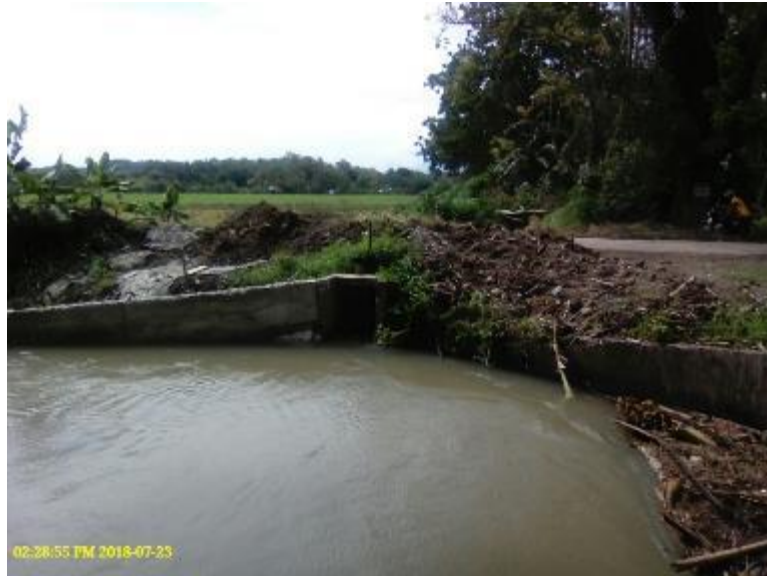
During the field visit in Padada RIS, we observed some odd structures. The headwater of Lateral A has two checkgates (Photos 73 and 74). Additional gate was installed to increase water intake into the Lateral. On the other hand, the silt ejector opposite the headgate of Lateral B was converted into farm turn out (Photo 75).

Photo 74. Second intake gate of Lateral A.

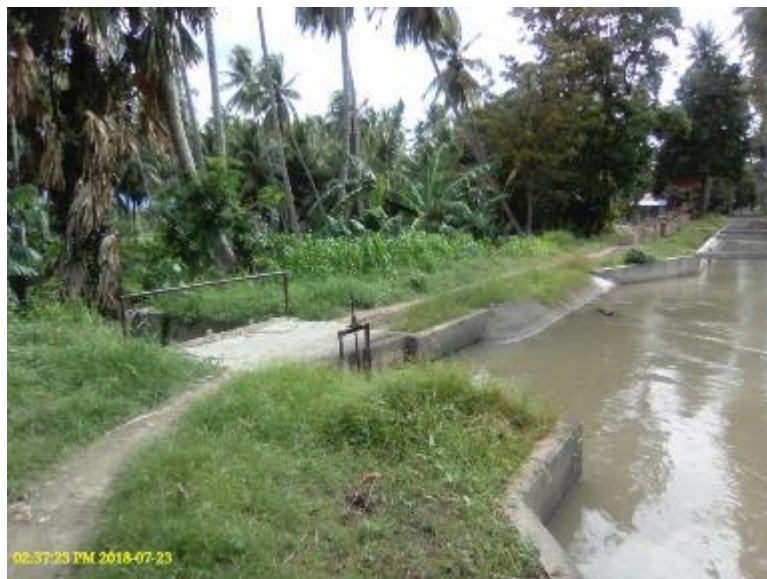
Photo 75. Silt ejector converted into supply gate opposite Lateral B headgate.

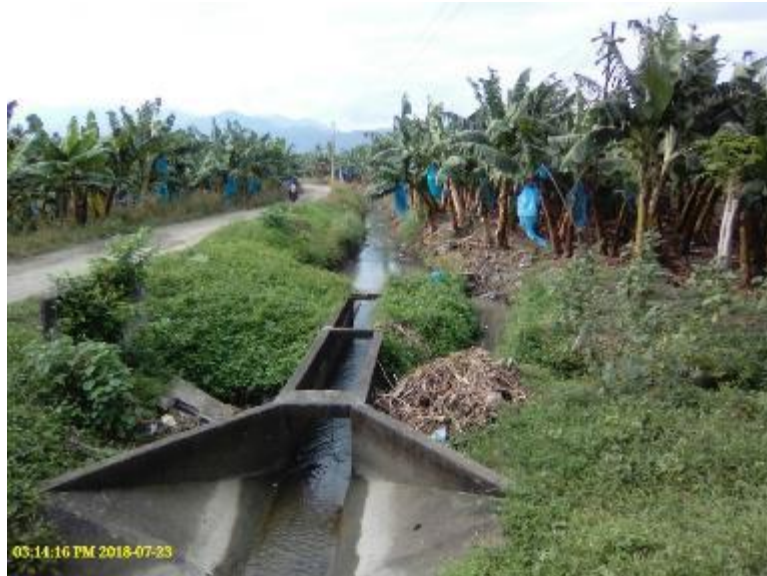
Photo 76. Portion of lined section followed by unlined section in the downstream of Padada RIS.

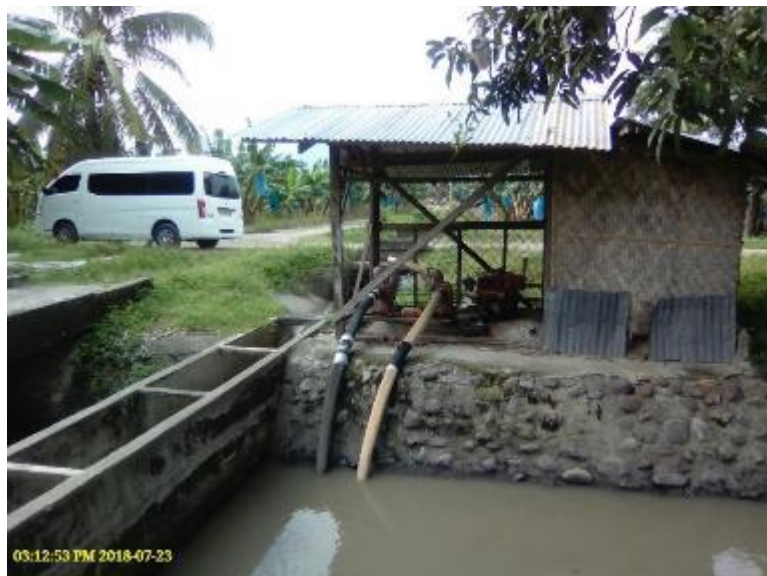
Photo 77. Pump house beside a reuse point in Padada RIS.

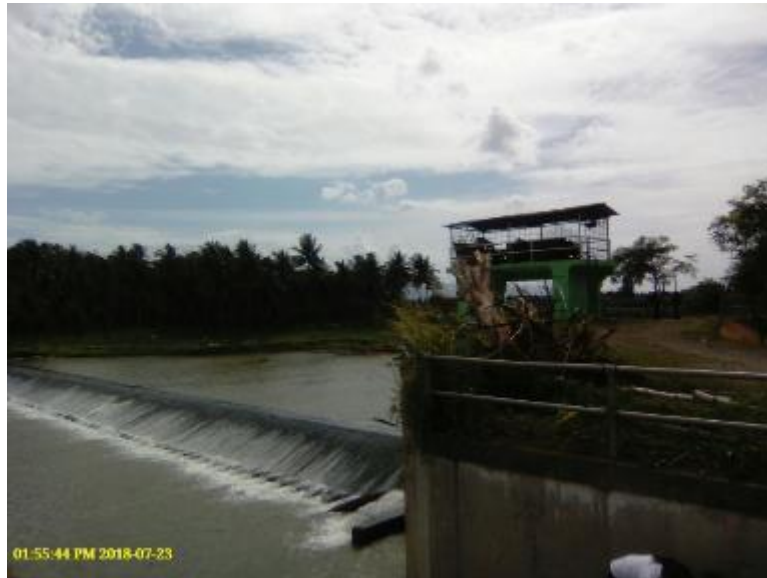
Photo 78. Padada RIS dam.

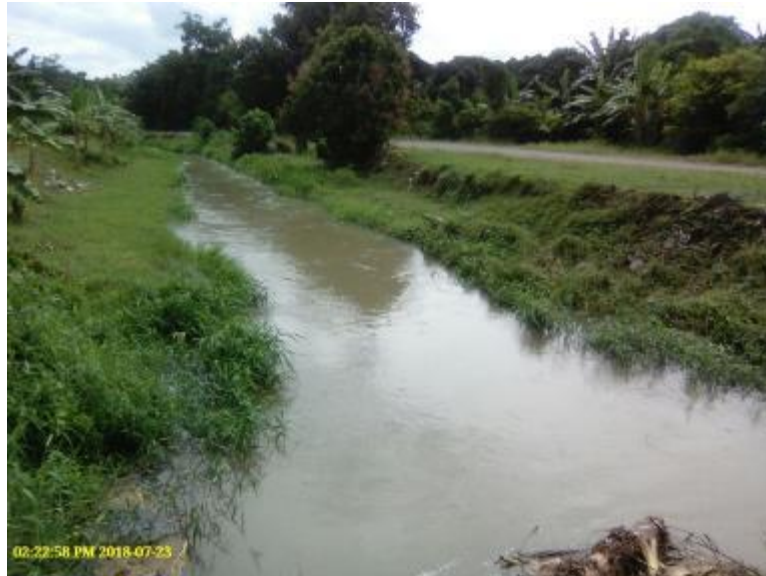
Photo 80. Main canal above designed water level in Padada RIS.

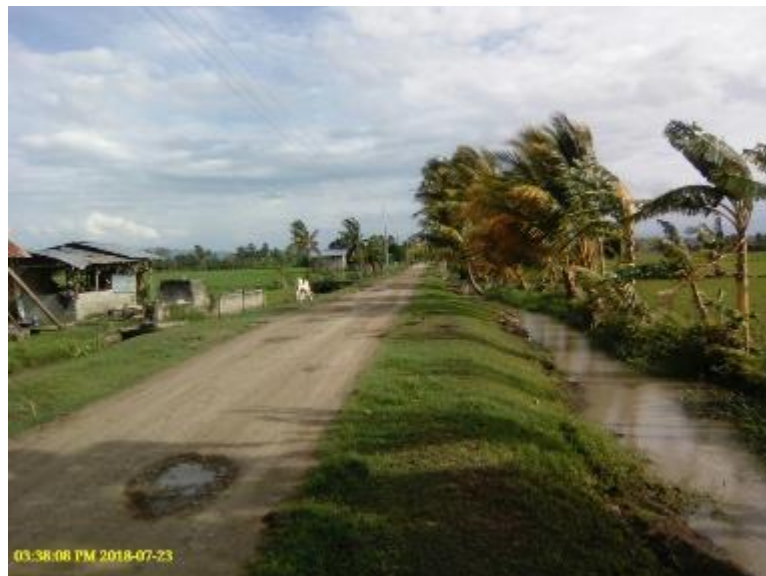
Photo 81. Portion of the Farm to Market Road that was a marshland before.

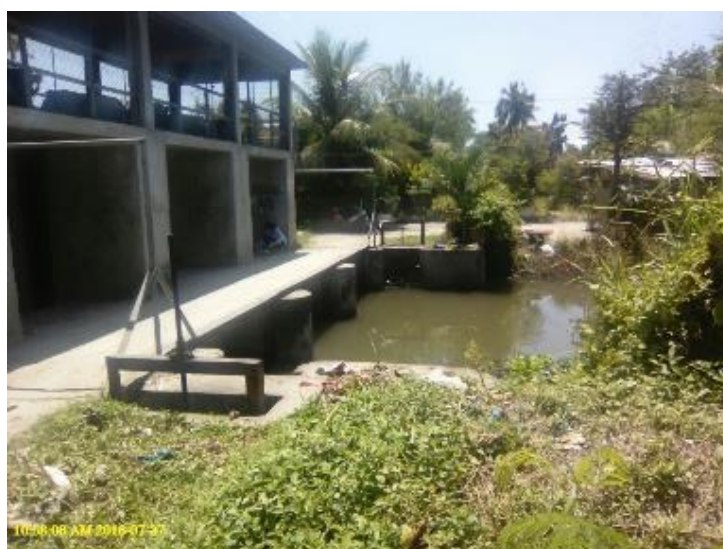
The designed river discharge for Marbel #1 RIS was 5.44 CMS but the river discharge was only about 2.726 CMS (Table 25). The total watershed area is about 203.0 km<sup>2</sup>. Due to low river discharge, supplementary water was being drawn out from Calalima and Bulok Creek as re-use dams. There were about 18 re-use dams that irrigate about 358 has. An example is the Bulok Dam presented in Photo 83.

Photo 83. The Bulok Dam (re-use) of the Marbel #1 RIS.

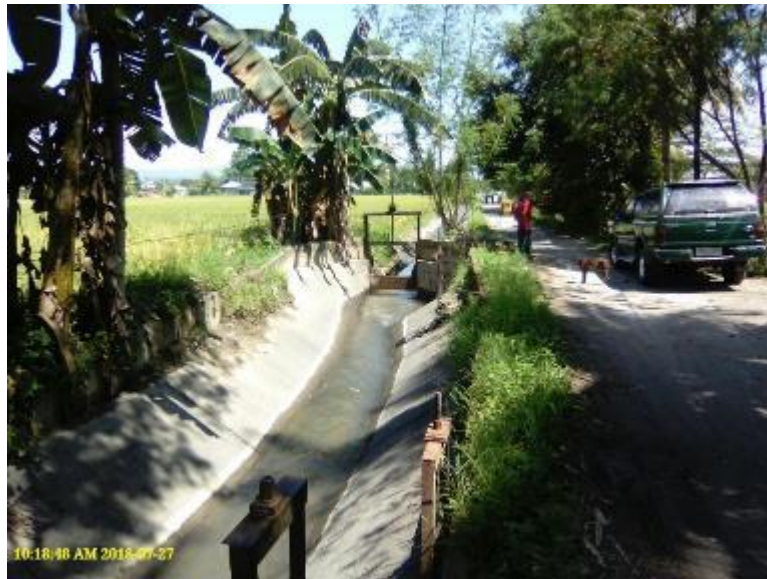
Photo 84. Section of Main Canal of Marbel #1 RIS at the headgate of Lateral E.

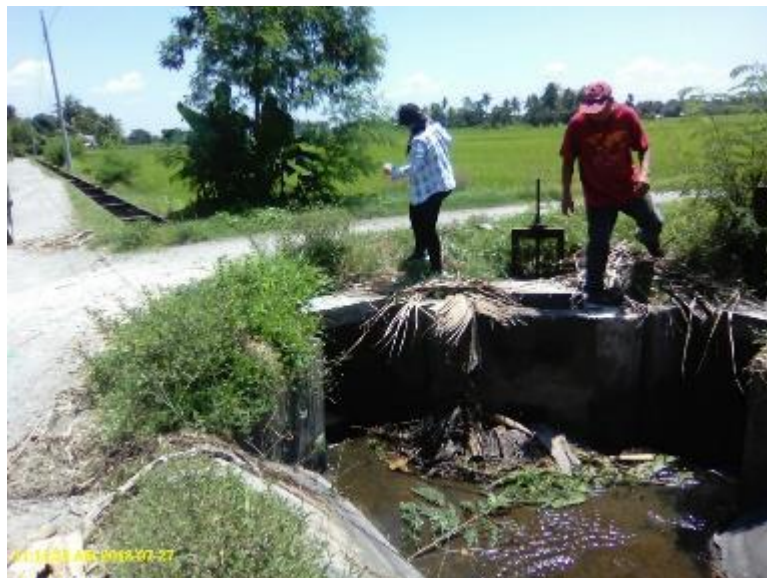
Photo 85. Section of Main Canal of Marbel #1 RIS at the headgate of Lateral H1.

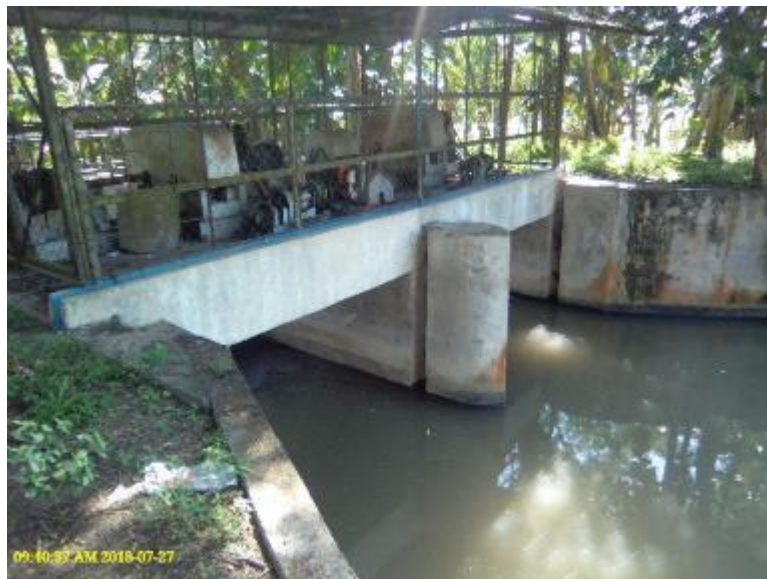
intensity of Marbel #1 RIS is the reduction of silt in the canals. The system is operating the silt ejector (Photo 87) and wasteways (Photo 88) once a month.

Photo 87. Control gates of the silt ejector of Marbel #1 RIS.

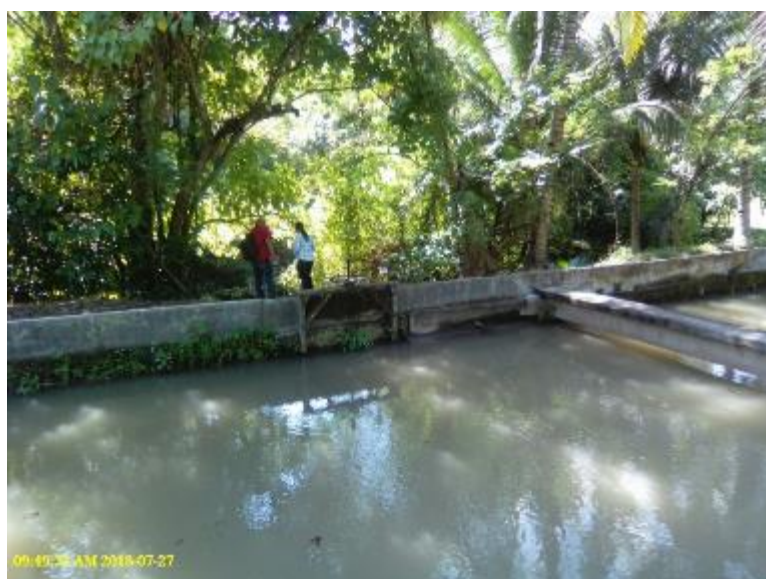
Photo 88. Control gate of one of the wasteways of Marbel #1 RIS.

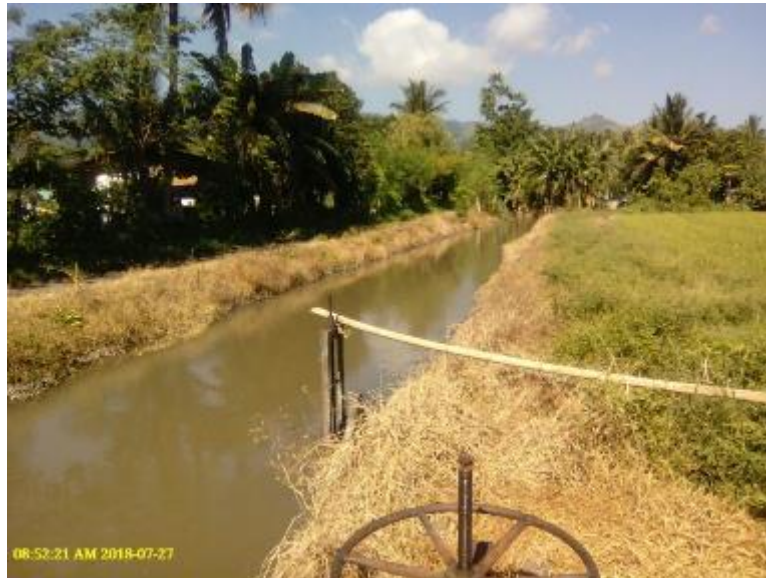
Photo 89. Silted section of Marbel #1 RIS.

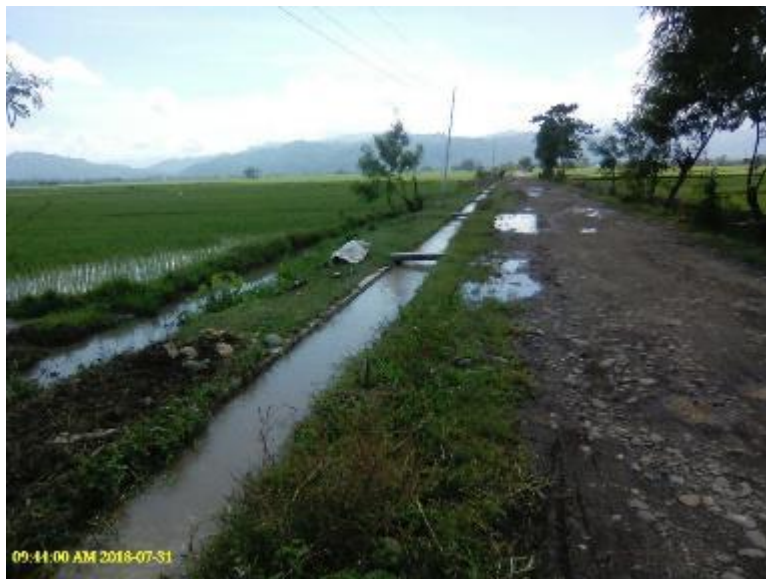
**Bench Flume.** Most of the visited NIS uses bench flume design (rectangular canal) in the lining of Main and Lateral canals (Photos 90 and 91). Compared to the rectangular cross-section design, rectangular section occupies less space and lesser earthworks making it faster to construct and lower in cost. However, the design section of NIA should look or study the bench flume design in terms of hydraulic efficiency. Flow efficiency is very critical during low water supply. The design should consider a canal discharge level that would need the use of bench flume as canal cross-section.

Photo 91. Section of Lateral G6 of Pulangui RIS.

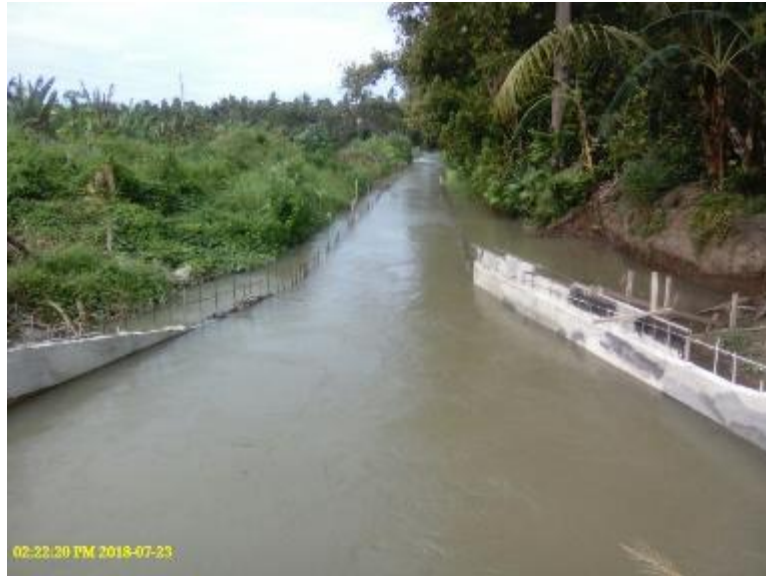
about a year or two to line a significant section of Main Canal of a particular NIS. One could compare this during road repairs of main thorough fares in the Philippines. But, cutting the water supply of a given NIS for one year will affect livelihood of the farmers as well as the target rice yield of the area. For example, if the 21 kms of unlined section of the Main Canal (Photo 92) of Jalaur RIS will be lined, it will affect about 8,200 has of farms in Iloilo. Thorough planning and use of advance construction technology (or methodology) will be needed to properly execute lining of Main Canal. For example, at the time of survey, sections of Main Canal of Padada RIS were being lined (Photo 93). Lining of the Main Canal could pose a problem during operation. A system could only have a water cut off of around two months. In this period, only a small portion could be lined depending on the condition. The lining of the MC of Padada RIS has to be temporarily suspended (Photo 94). However, total system closure for one to two croppings is a bigger problem.

Photo 93. Unfinished construction of Main canal of Padada RIS.

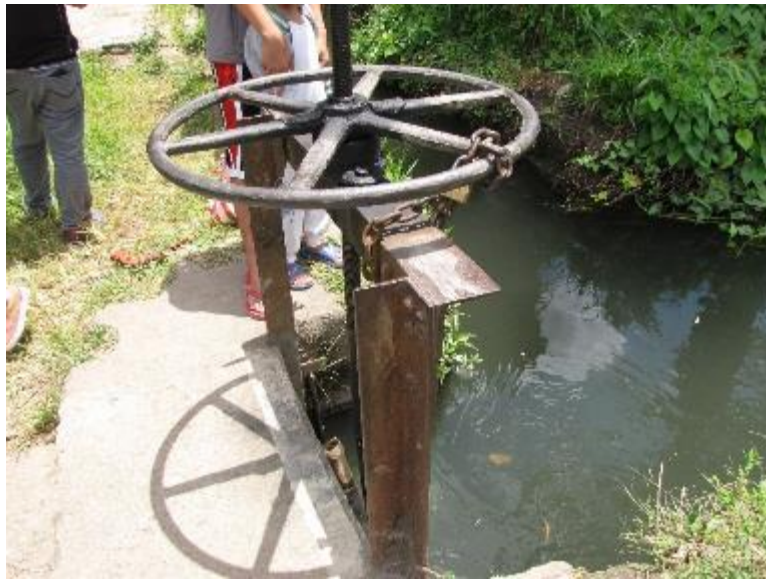
***Lock or Not.*** In all NIS cases covered, one of the most common problem during operation was the illegal opening of gates (Laterals and turnouts). In some of the NIS surveyed, gates were being padlocked (Photo 95) to avoid illegal opening. While some of the gates were confined and protected with padlocked gates (entrance). But only in some of the NIS surveyed in Mindanao (Photo 96) where gates are being welded (permanent). In fact, Bukidnon IMO was planning in procuring more portable welding machine for this purpose. Padlocks are prone to breakdown and sometimes stolen thus, gates were being welded.

Photo 95. Gate in Cavite FLIS.

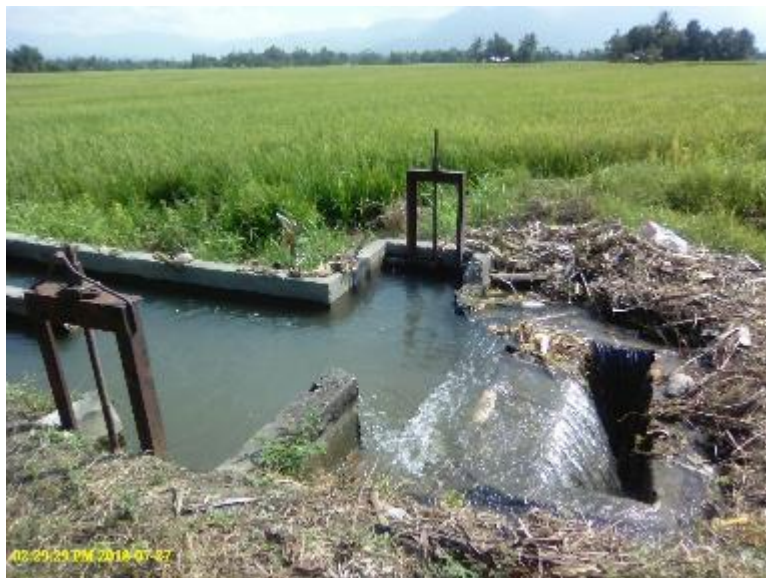
Photo 96. Gates in Banga RIS.

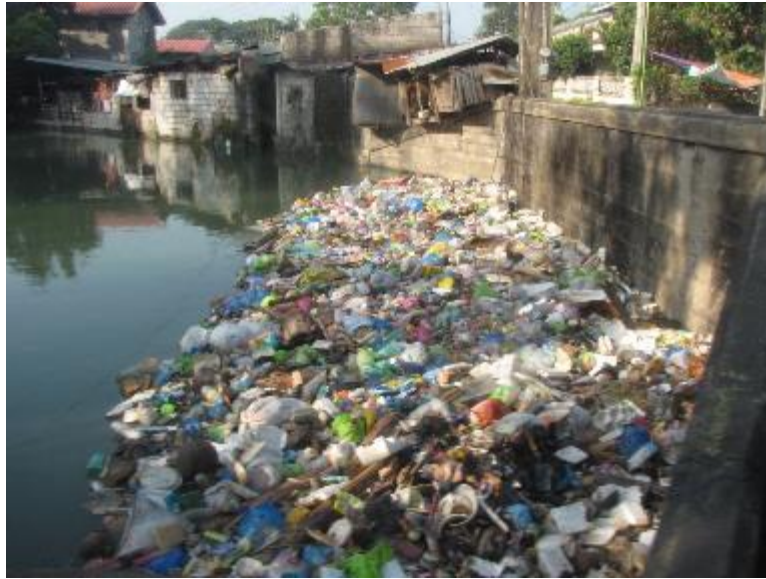
***Trapped!*** Some of the floating debris in the Main and Lateral canals were trapped near the checkgates (Photos 97 and 98). However, removal of debris is a big problem with NIS with wide canals like Angat-Maasim RIS, Pampanga Delta RIS, UPRIIS, MARIIS, Libmanan-Cabusao PIS, Binahaan-Tibak RIS, Jalaur RIS and Malitubog-Maridagao RIS. To remove debris in a wide canal section, one may need long poles, a platform to stand during operation and some NIS even uses back hoe equipment.

Photo 97. Section of Main Canal of Angat-Maasim RIS.

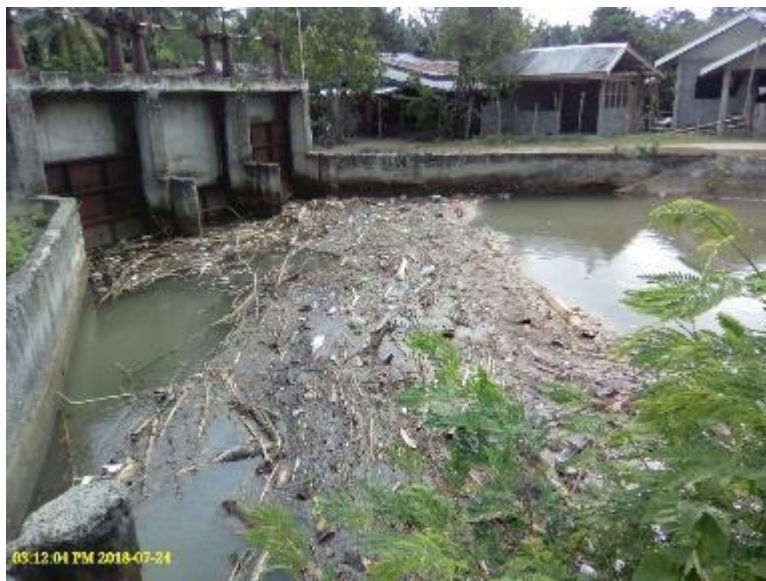
Photo 98. Debris trapped in a check gate along Main Canal of Malitubog-Maridagao RIS.

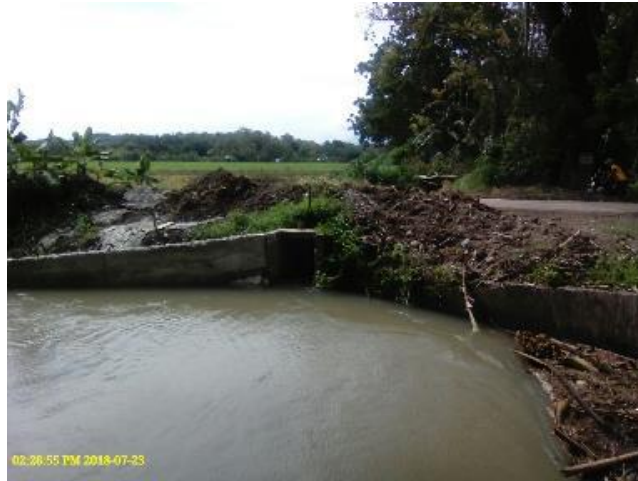
***Innovations?*** Some structures in the NIS in Mindanao looks weird, at least at the technical point of view. But this was the adjustments made by people from ground (operations) to cope up with actual situations. For example, Lateral A of Padada RIS has two headgates (Photo 99). Additional (second headgate, Photo 100) gate was installed because water spills on this section during high flows. On the other hand, additional canal was installed beside the existing lined canal of Lateral F, Banga RIS (Photo 101). Additional areas for expansion was added on the tail-end part of Lateral F. This will require increasing the cross-sectional area of canal to accommodate higher discharge rate. To avoid demolition of a part of the existing canal, additional canal was constructed beside it, making it a double canal.

Photo 99. Second headgate of Lateral A of Padada RIS.

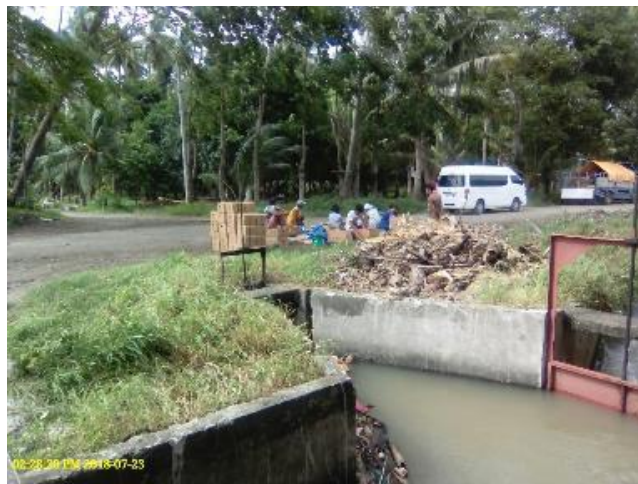
Photo 100. First (original) headgate of Lateral A of Padada RIS.

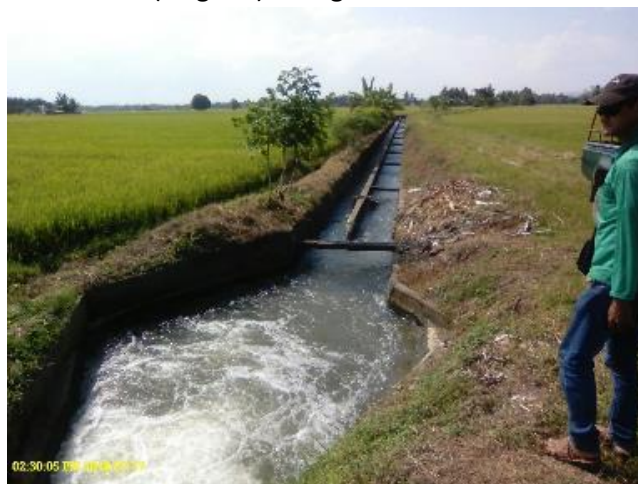
Photo 101. The "double" canal of Lateral F, Banga RIS.
