Assessing the resurgent irrigation development program of the Philippines: Communal irrigation systems component

PIDS Discussion Paper Series, No. 2020-02

Assessing the Resurgent Irrigation Development Program of the Philippines – Communal Irrigation Systems Component

March 2020

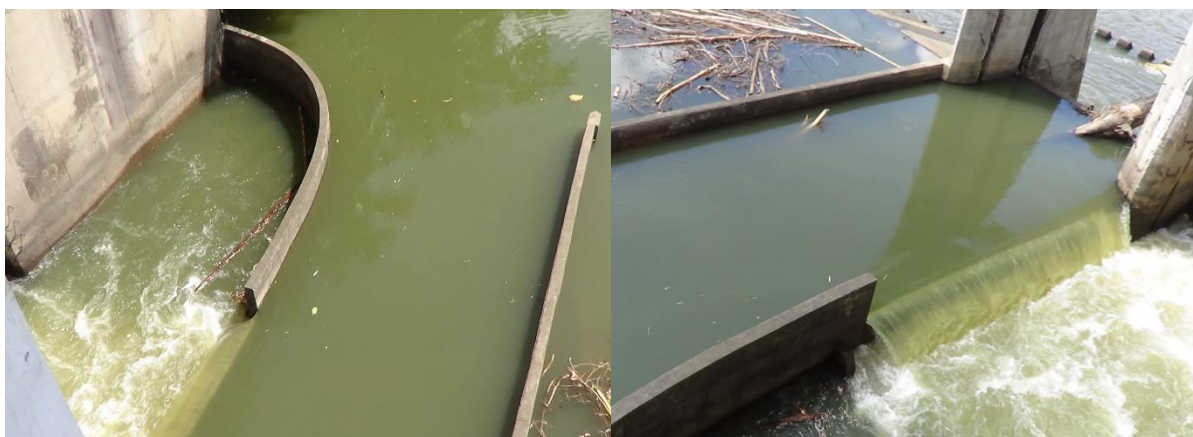
Figure 23. Construction of silt excluder at the MalRIS

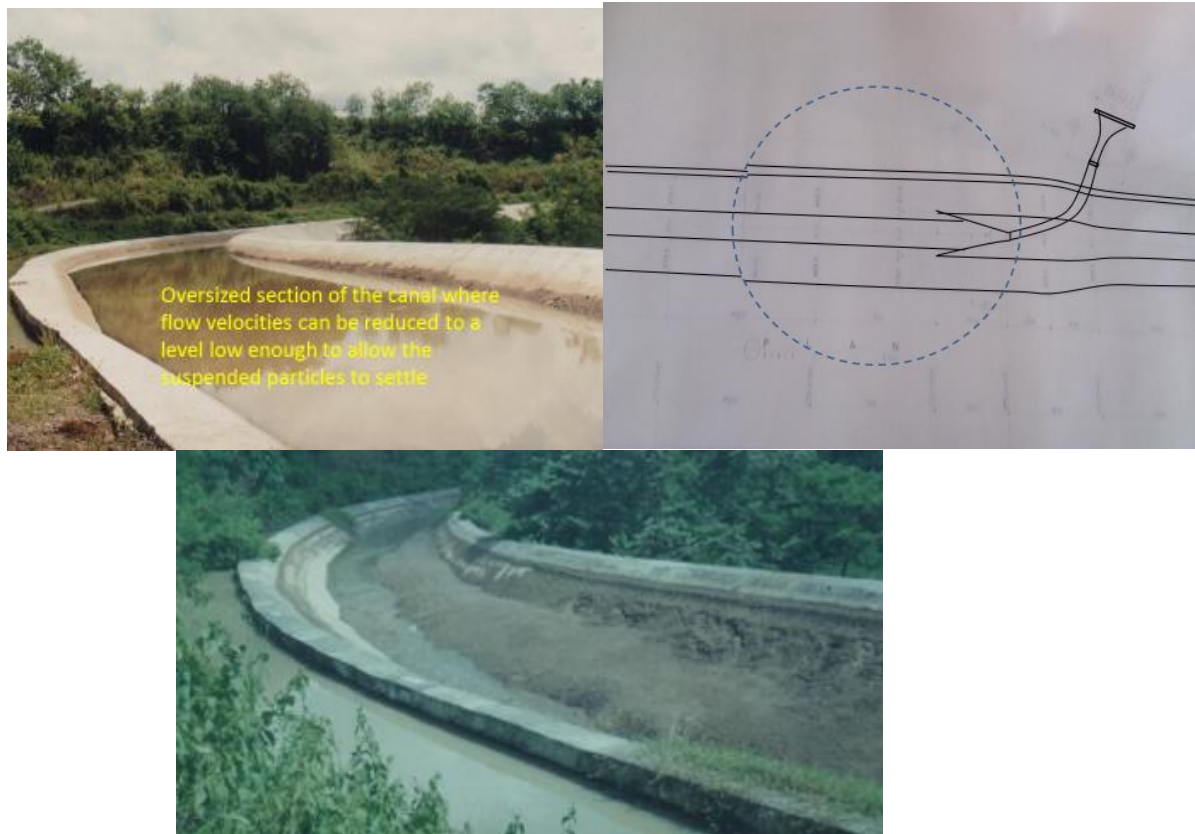
The study at the MALRIS pointed out that silt excluder reduced the intrusion of sediment (sand) in the main canal. The provision of settling basin in the main canal of Mlang RIS reduced the rehabilitation costs on a yearly basis, specifically, on dredging activities or canal de-silting. These silt control devices, and a host of many others (e.g. King's silt vanes, Gibb's groyne, curved wing with silt vanes, silt platforms, vortex tube sand trap and sloping sill sand screen) can be used to reduce or flush out silts from the canal and the river itself. However, if large bed loads, including rocks and boulders are present upstream, the use of Sabo dams may be employed. But the more important measure is to promote a community-based project in cooperation with local DENR (MENRO, PENRO) to protect and conserve the watershed area.

Figure 25. Settling basin at the Mlang RIS

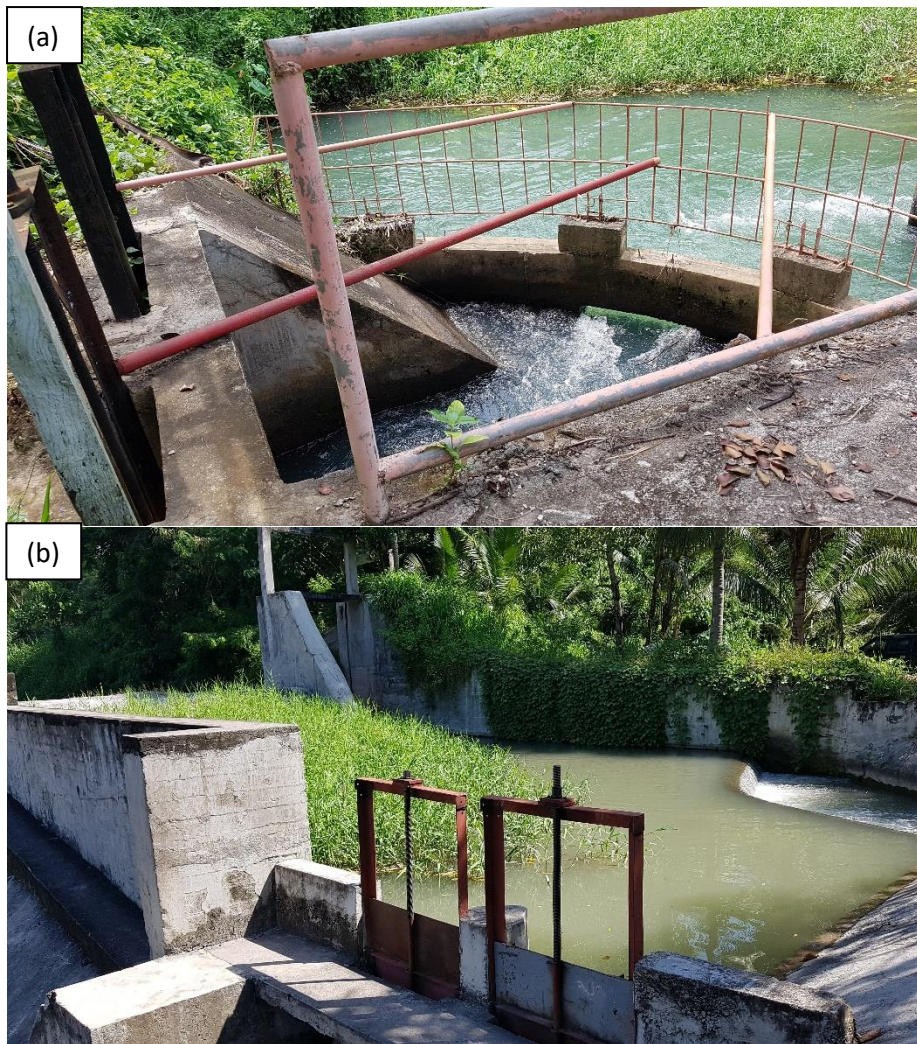
The provision of silt control devices is not included in the CIS design manual of NIA. Estimation of sediment load discharge as a proportion of the total discharge of a river is not even conducted during the project feasibility phase. However, several silt control devices were encountered during the field visits, but all are in Mindanao. This is quite understandable since the catchment management program of the WRDP (1998) was piloted in Mindanao. This project conducted rehabilitation works on several NIS, focusing on modification of diversion works, construction of silt excluder as well as sediment monitoring. An example of rehabilitation works conducted under the WRDP are those at the Malasila River Irrigation System (MaLRIS) in North Cotabato. It was envisioned that with the provision of silt excluder (Figure 23) the settling of sediments in main canal and laterals would be minimized. Sediment sampling and monitoring was also conducted at the Malasila River and the main canal (Figure 24). This include discharge measurement, silt and sand sampling, bed load sampling and silt monitoring at the main canal. Another is the provision of a settling basin and silt ejector at the Mlang RIS also in North Cotabato. A settling basin (Figure 25) is an oversized section of the canal where flow velocities can be reduced to a level low enough to allow the suspended particles to settle. During fallow period, clearing of the settling basin is carried out by combined manual and hydraulic flushing using the silt ejector (Figure 26). Examples of silt control devices in Del Carmen CIS (Marbel River in N. Cotabato) and LMT CIS (Taplan River, N. Cotabato) both in Mindanao are shown in Figure 27. These are installed under the IAs own initiatives with technical help from NIA.

Figure 27. Silt control device in (a) Del Carmen CIS (Marbel River, N. Cotabato) and (b) LMT CIS (Taplan River, S. Cotabato).

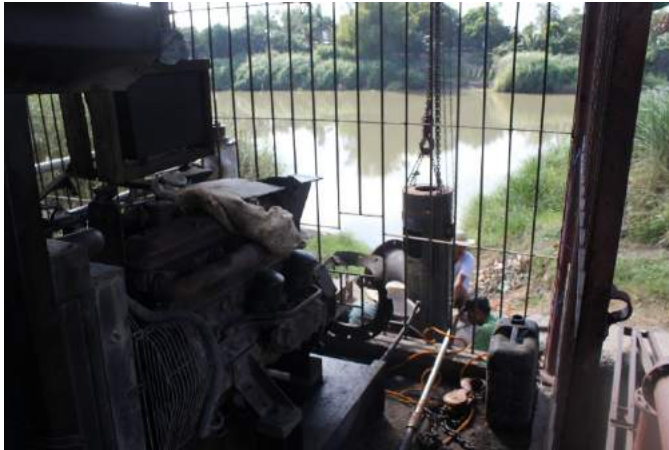
Figure 1A-2. One of 2 Iveco diesel engines for the mixed flow pumps; at the background is the Pampanga River where the PIS derive its waters

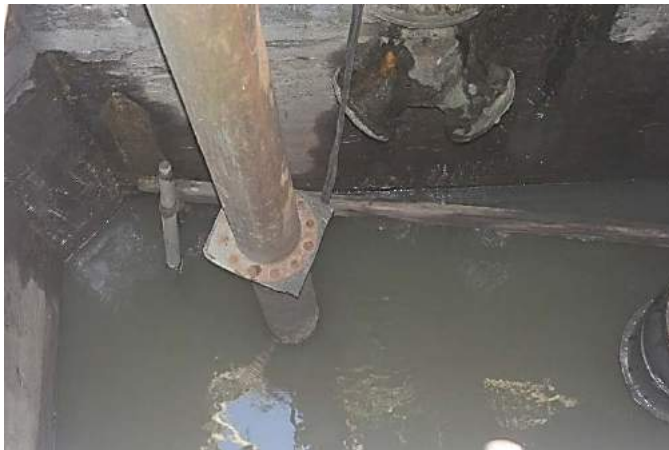
Figure 1A-3. The concrete intake pit for the suction pipes of the Gulap Pump Irrigation System; also shown is the 10-in pipe of the submersible pump

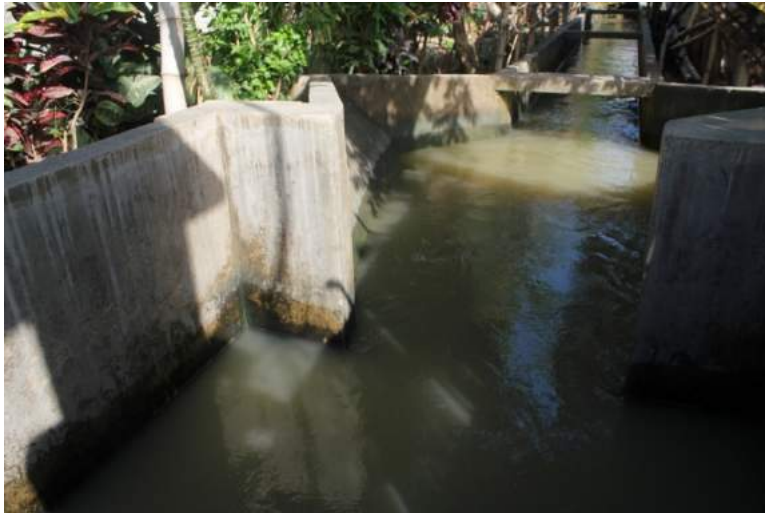
Figure 1A-5. The outlet of the inverted siphon under the road across the concrete sump and pump house; this channels the water into the main canal

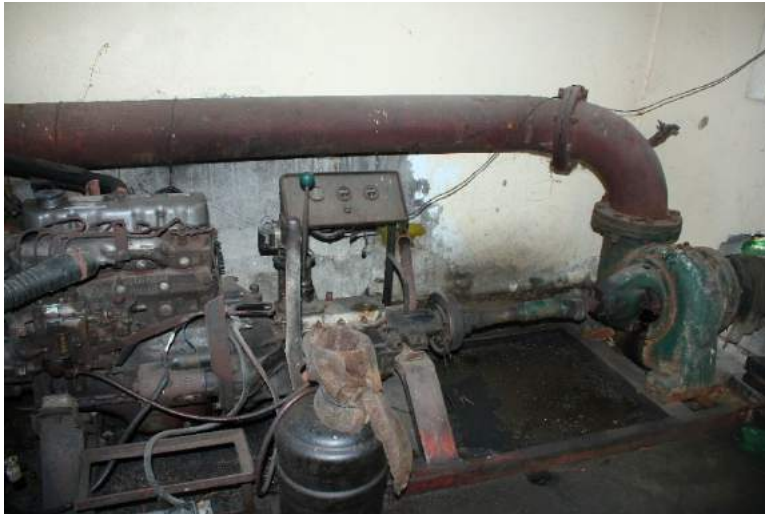
have been done in the pump and engine. The IA officers said that there were instances before when saltwater from the sea intruded into the creek, damaging the crops during those times. The main canal has a 300-m concrete-lined and 100-m unlined sections. Some siltation were observed from the main canal and the turnouts uses wooden slabs. The longer lateral canals are unlined. Some fields in the downstream part of the system get their irrigation directly from the creek using individual centrifugal pumps.

Figure 1A-8. The 8-in dia. centrifugal pump powered by a 4DR5 diesel engine of the Sapa-San Vicente PIS

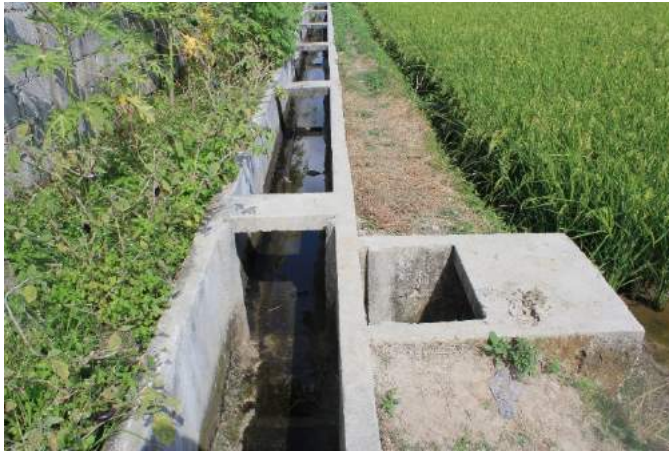
Figure 1A-10. The concrete-lined main canal with a simple turnout gate using slots and wooden slabs as gate

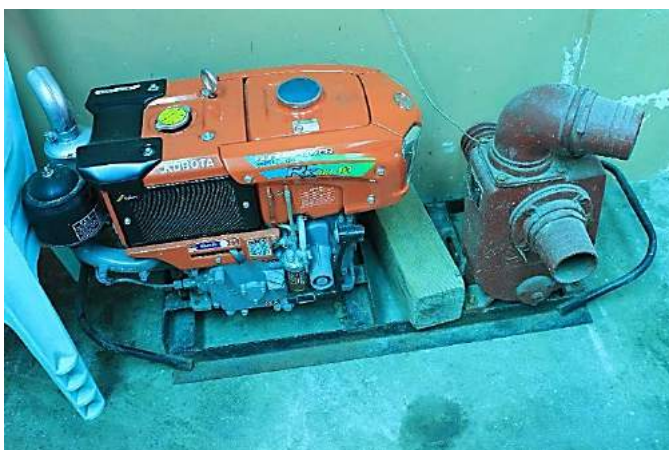
Figure 1A-12. A typical pumpset with a 4x4 self-priming centrifugal pump driven by an 8-Hp Kubota diesel engine (RK80-1S)

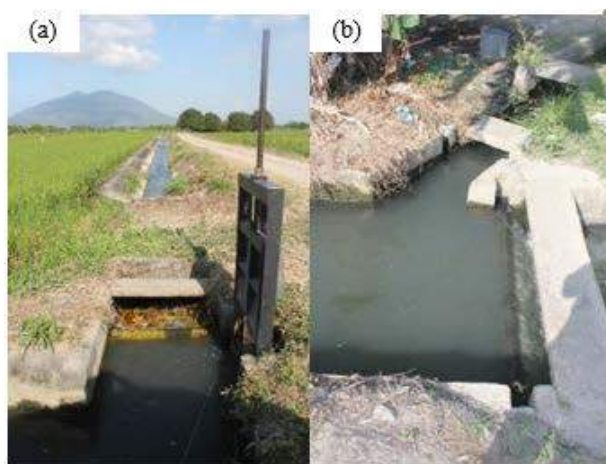
Figure 1A-19. (a) A check gate that serves as a turnout for distributing water to a secondary lateral; (b) a flow dividing structure to a lined lateral; the control has slots for wooden slabs and combined with a shallow drop

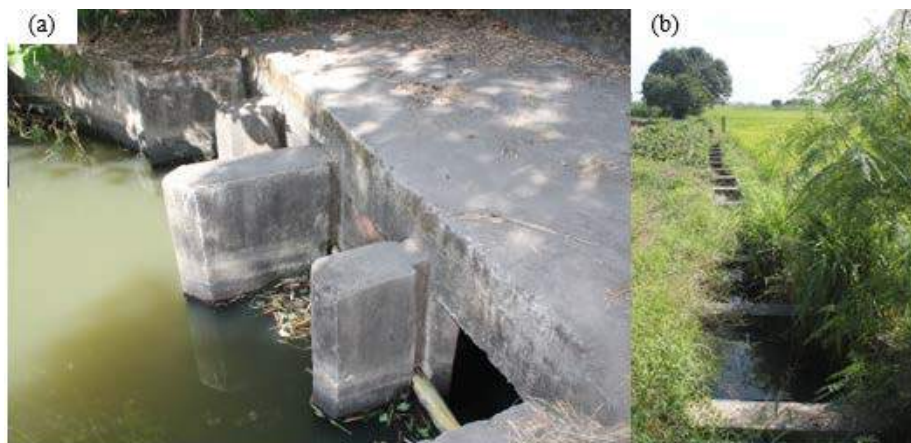
Figure 1A-20. (a) The check gate which the IA refers to as “Dam 2” is used to increase the head at the main canal for distribution to secondary laterals; (b) one of the laterals (concrete-lined) served by the check gate

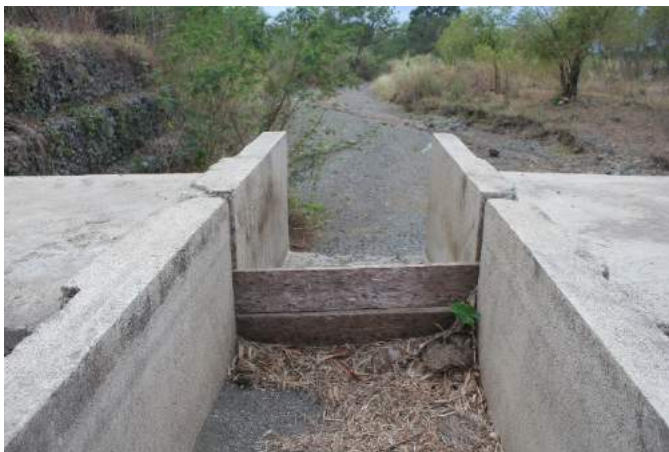
Figure 1A-25. The sluice gate is made of concrete with slots for wooden slabs serving as gates; the background is the downstream portion of the dam

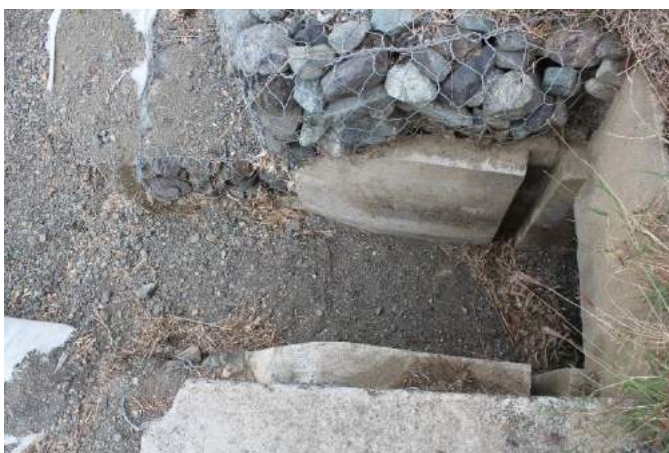
Figure 1A-26. The intake structure with the slots for the wooden gates

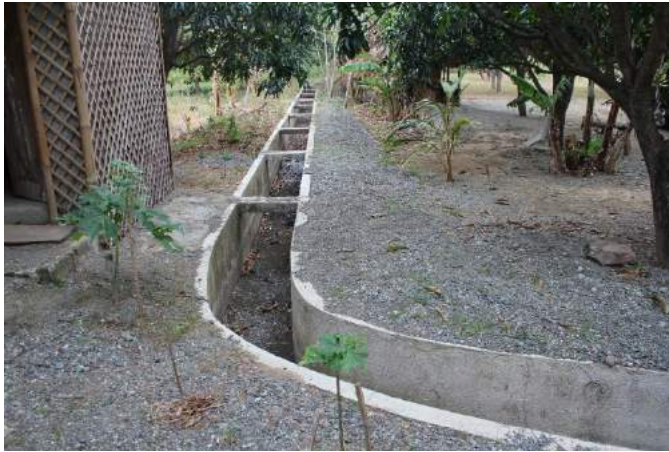
Figure 1A-27. The concrete-lined rectangular main canal

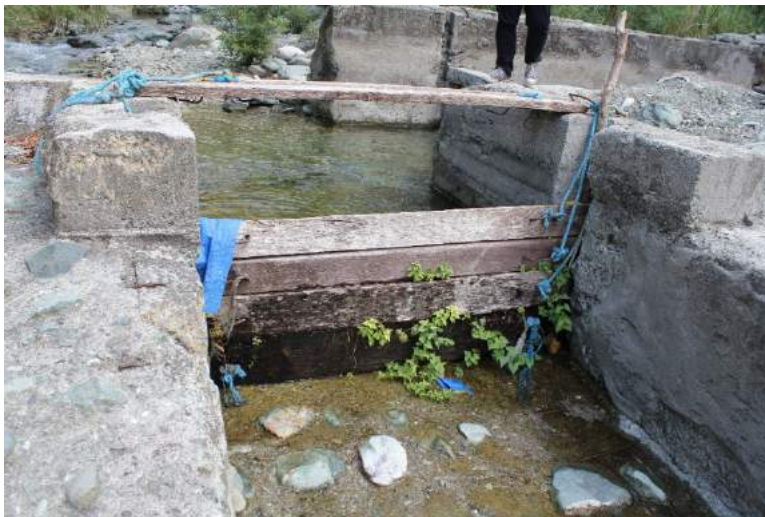
Figure 1A-29. The sluice gate is made of wooden slabs stacked together in a slot serving as water level control gate

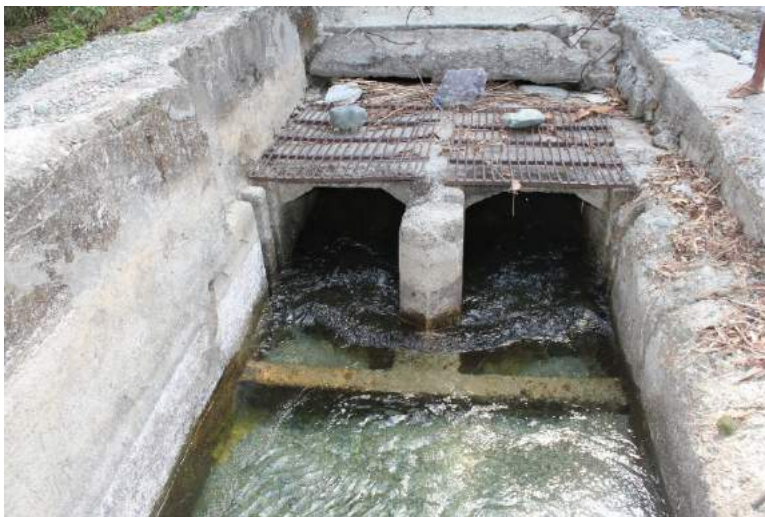
Figure 1A-30. The intake structure leading to the underground tunnel into the main canal

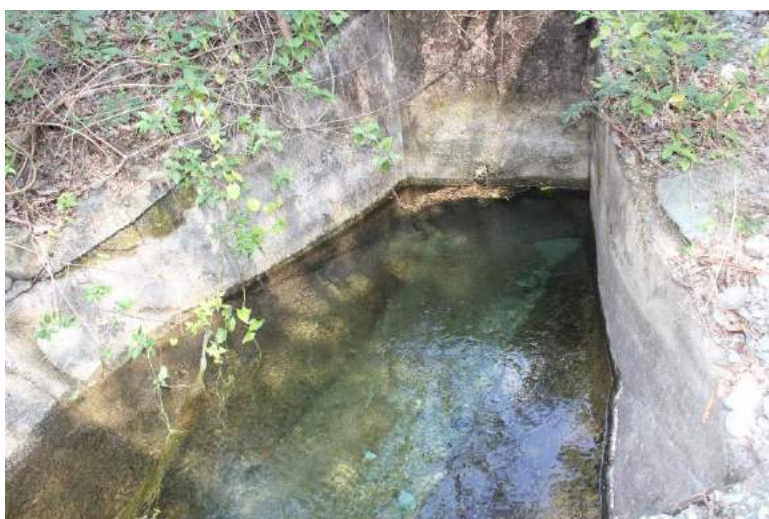
Figure 1A-32. The main canal coming from the underground tunnel from the dam

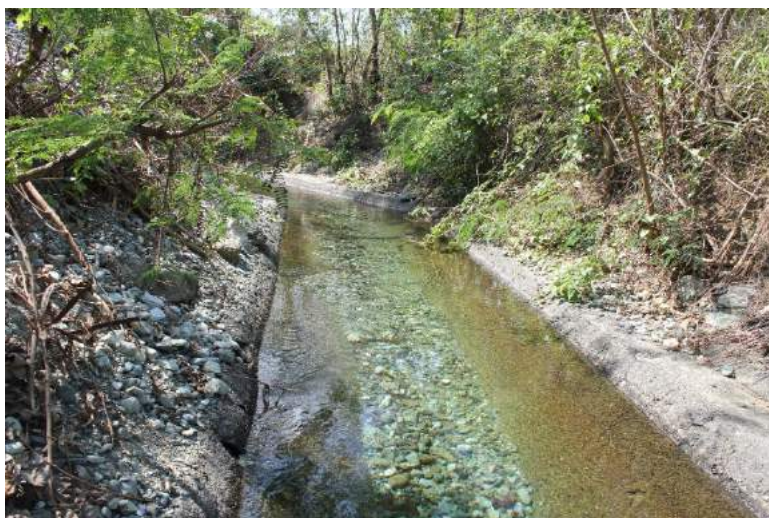
Figure 1A-33. The trapezoidal main canal; the canal bottom is filled with small rocks

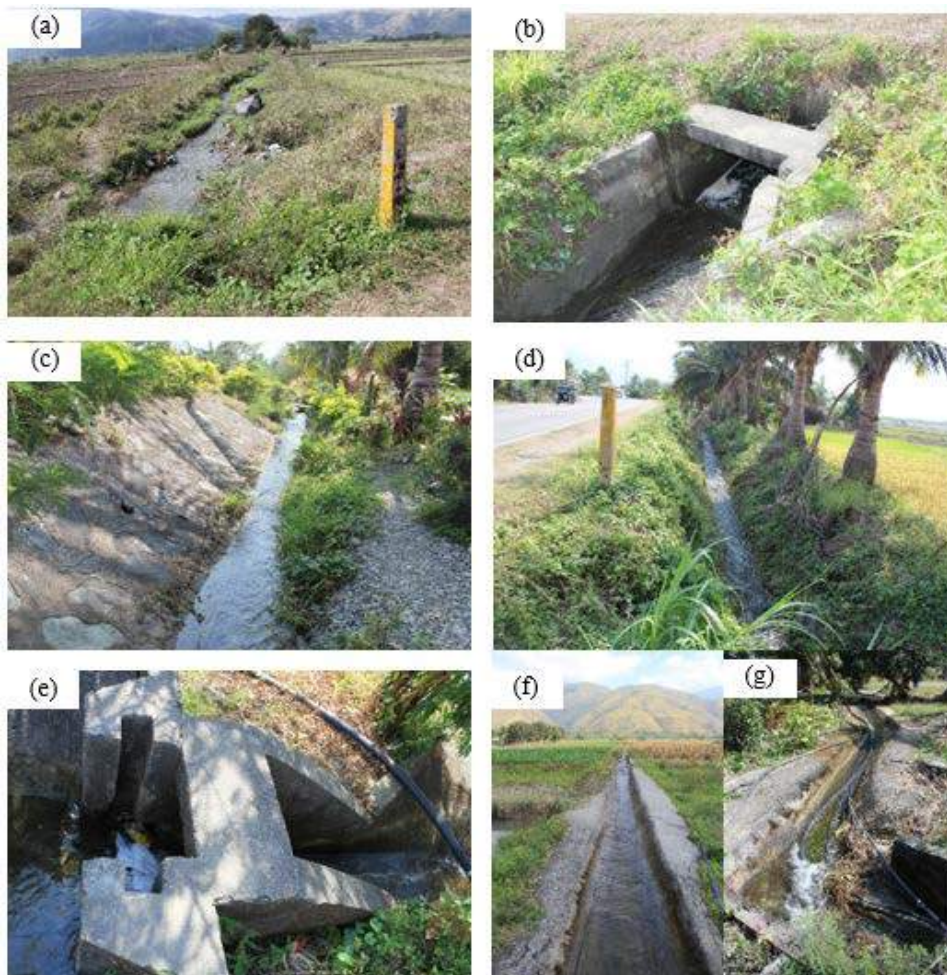
Figure 1A-35. (a) An unlined secondary canal; (b) a concrete check gate and inlet to a road crossing; (c) a lateral at the side of the highway which has a riprap side wall; (d) an unlined lateral at the side of the highway; (e) a concrete check gate in a lateral; (f) a concrete-lined lateral; (g) domestic water supply flexible pipes along a lined lateral

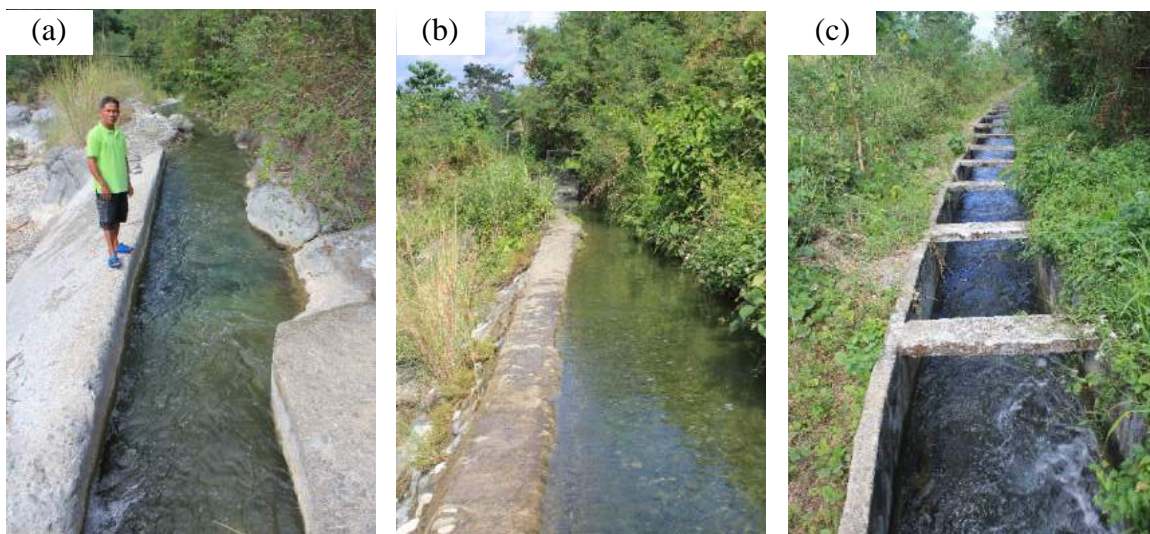
Figure 1A-39. (a) Intake channel at the side of the river just after the dam; (b) continuation of the intake channel; (c) the main canal just after the check gate

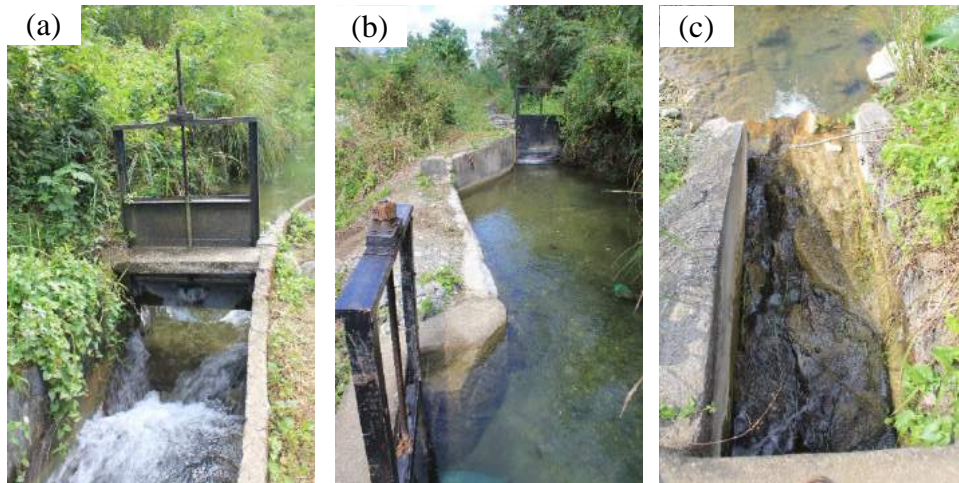
Figure 1A-40. (a) Check gate to control the flow to the main canal; (b) the gate at the top controls the flow to the main canal while the left gate controls return flow to the river; (c) guide chute for excess water reverted back to the river

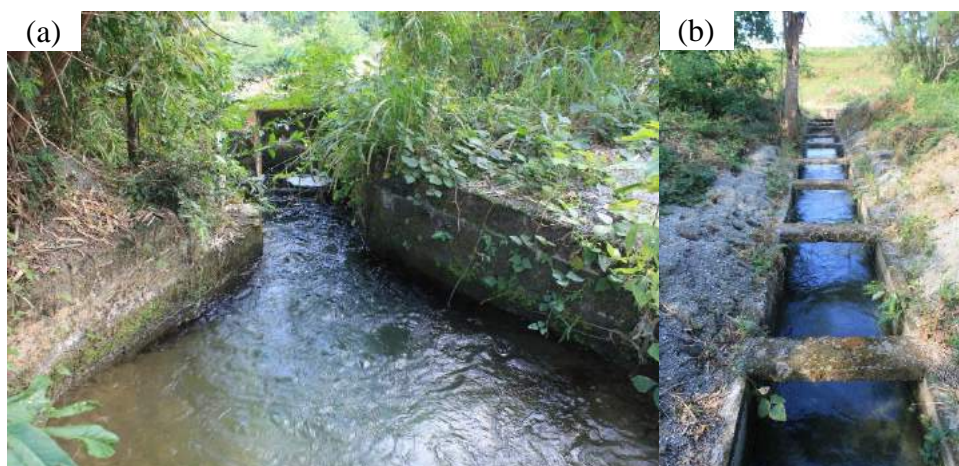
Figure 1A-42. (a) Outlet of the inverted siphon under the river; (b) the concrete-lined lateral canal after the outlet of the inverted siphon used to distribute the water to Parang-Bugnan CIS area across the river

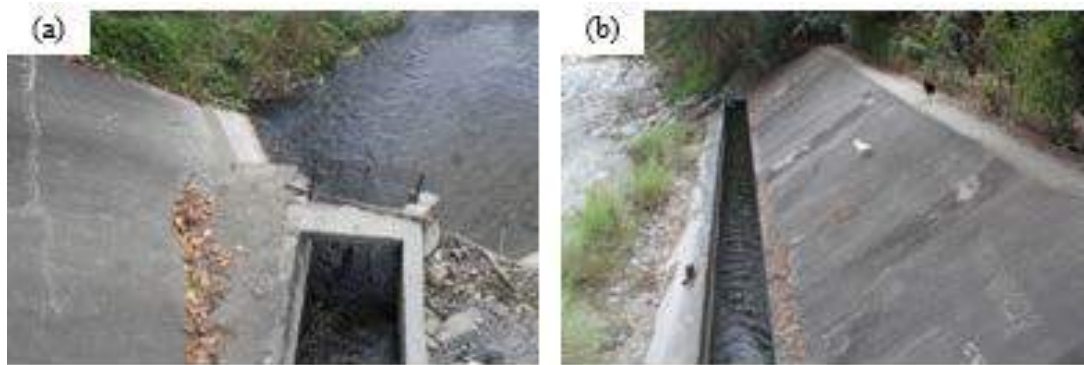
Figure 1A-52. (a) The intake structure with a steel grill to prevent entry of large debris and stones into the main canal; (b) the intake channel at the bottom of the embankment

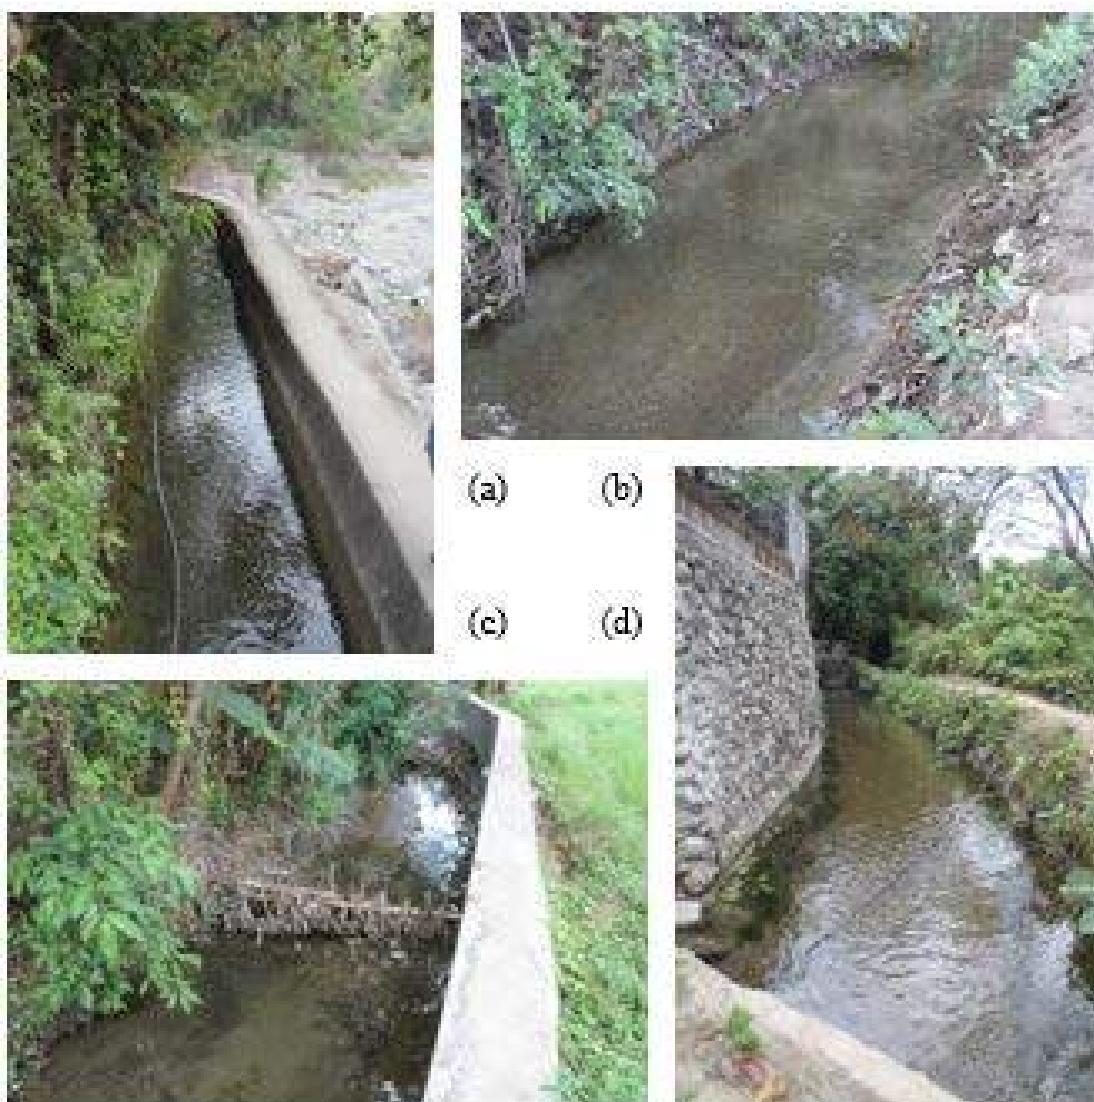
The Ngayao-ngaoan CIS is located at Sison, Pangasinan. It gets water from the Aloragat River. The ogee dam is already damaged and completely filled with sediments (Figure 1A-50), but the concrete embankments and structure for the sluice gate is still in good condition (Figures 1A-50 to 1A-51). The sluice gate however is broken so they use bamboo and sandbags just to divert water into the intake gate. The intake has no check gate, only a steel grill to prevent large debris and stones from entering into the main canal (Figure 1A-52). There are several lined canals and control structures and some have ripraps but most are unlined (Figure 1A-53). The canals are heavily silted and the IA reported several illegal offtakes.

Figure 1A-53. (a-d) Pictures of the canal system with some having concrete lining, some have ripraps and most are unlined; most canals exhibit heavy siltation

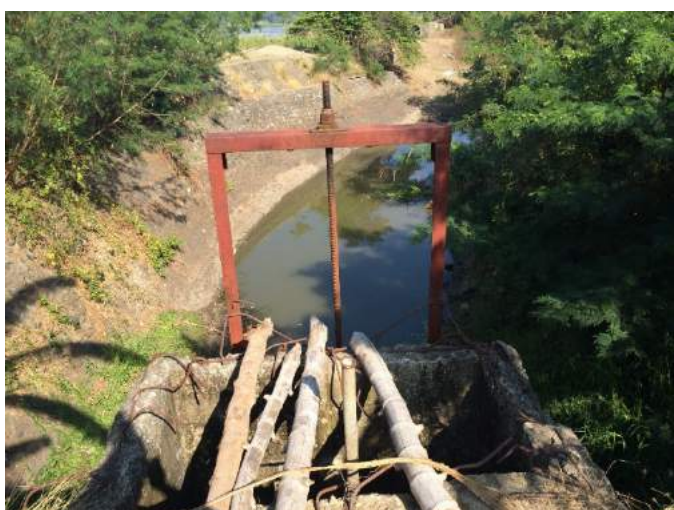
Figure 1A-55. The Baay CIS intake structure

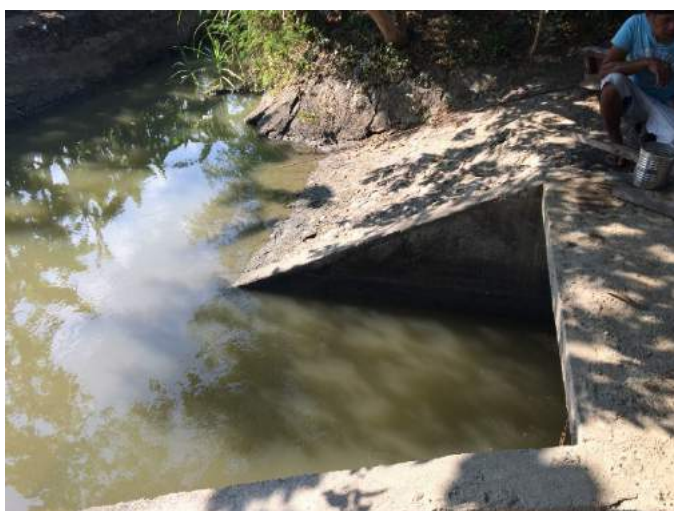
Figure 1A-56. The end of the tunnel connecting the from intake and main canal

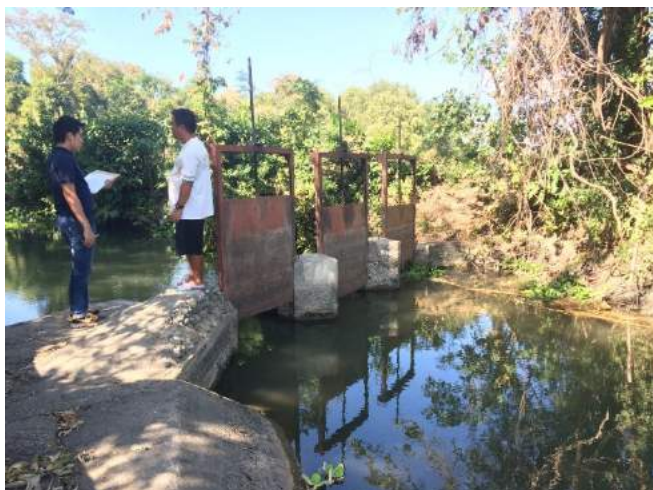
The IA was able to generate PhP 250,000 from LGUs last 2010 for riprapping. They also raised PhP 280,000 in 2013 to install/repair three sets of gates. Heavy siltation occurs on the first set of gates near the intake structure (Figure 1A-59). In the second set of gates (upstream), one of two check gates is broken and a wooden plank is used as replacement (Figure 1A-60). In the third set of gates (midstream), the three gates are damaged and non-operational because a tree fell on it last 2014 during typhoon Mario (Figure 1A-61). It has not been fixed yet though the IA has been requesting for repair since. Since the third set of gates were broken, the IA have experienced water shortage in the downstream portion of the system. There is no water master/tender so the officers just take turns in operating the gates. The IA uses both STW and LLP for other crops (tobacco, garlic, onion). But illegal pumping from the main and lateral canals occurs. Some farmers pumping water are not even members of the IA. Some lateral canals have unwanted grasses growing at the bottom and banks.

Figure 1A-59. The intake structure of the dam

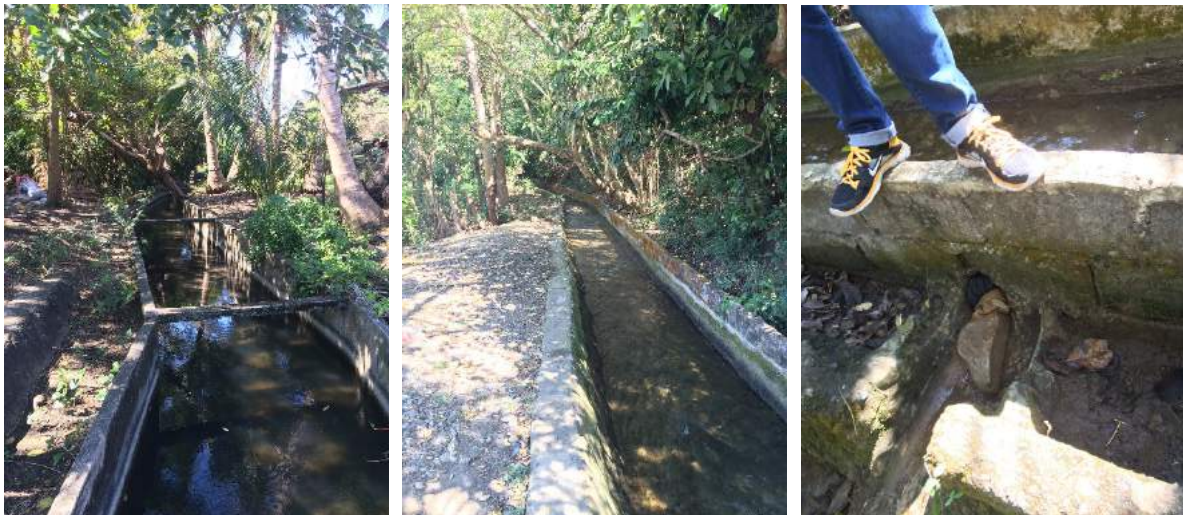
The dam is a simple concrete dike (Figure 1A-63). The intake gate is broken and only wooden planks are used (Figure 1A-64). The main canal have patches of concrete lining (Figure 1A-65). Holes were made in the main canal to serve as turnouts to lateral canals where rocks are used to control the flow of water. A part of the main canal is along the national highway where some rocks from the highway contribute to the canal's sediments. Heavy siltation also occurs in a road crossing especially during the wet season clogging it. The IA spends at least a day to clean the clogged culvert.

Figure 1A-65. Concrete sections of the main canal upstream (left) and midstream (middle); holes in the concrete canal serving as turnouts for distributing water to laterals; rocks are used to control the flow from the canal (right).

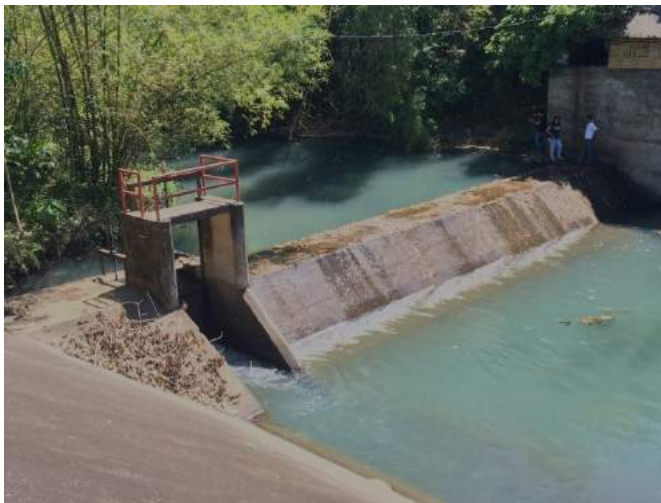
Figure 1A-66. Maybatang Dam

The Maybatang dam (Figure 1A-66) is a run-of-the-river dam originally constructed in 1980. The system was rehabilitated in 2009. Heavy siltation were observed in both the upstream and downstream portion of the dam, with the sediment nearly reaching the level of the crest upstream. The sluice gates of the intakes and spillway are properly maintained and well lubricated for ease of operation, as the Cooperative allots PhP 50,000 per year for the maintenance of irrigation structures. The intake structure and the main canal is connected by a culvert approximately 50 m long. The stretch of the main canal after the culvert has a rectangular cross-section with dimensions of 1m by 1m (Figure 1A-67). However, reductions in dimensions of the main canal were observed as it approaches the downstream portion. The cooperative has a budget of PhP. 110,100 per year for the clearing and desilting of canals.

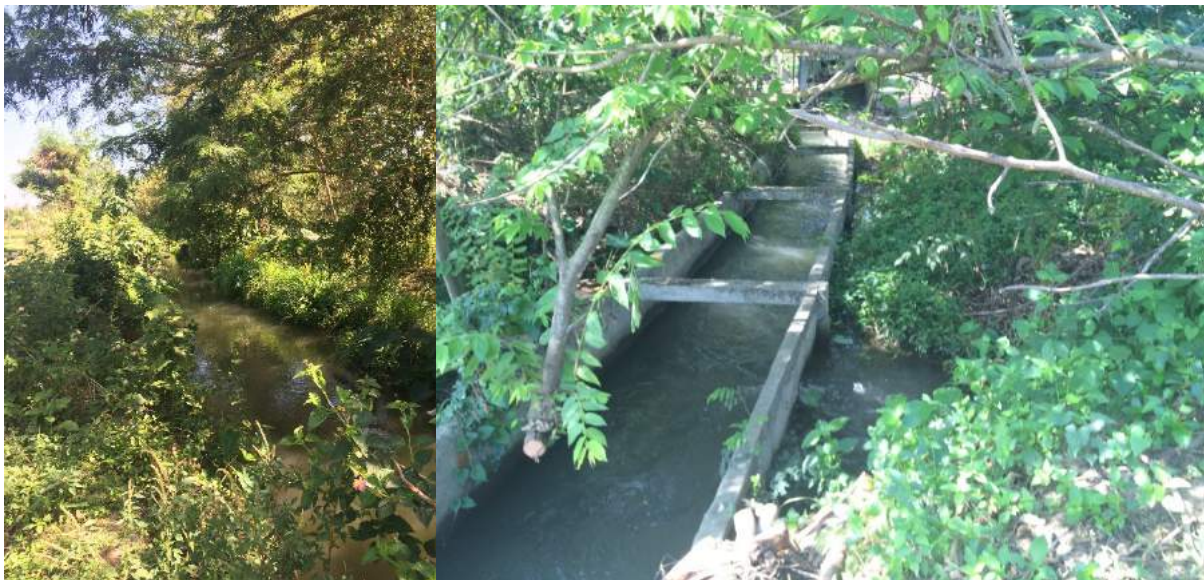
Since the construction of the system in 1960, only a 63-m stretch in the midstream portion of the main canal was lined last 2012 with funding from NIA. After this lining project, the IA have requested for more lining as they experience both heavy siltation and high seepage losses.

Figure 1A-73. Left: unlined portion of the main canal; Right: lined portion of the main canal with illegal turnout

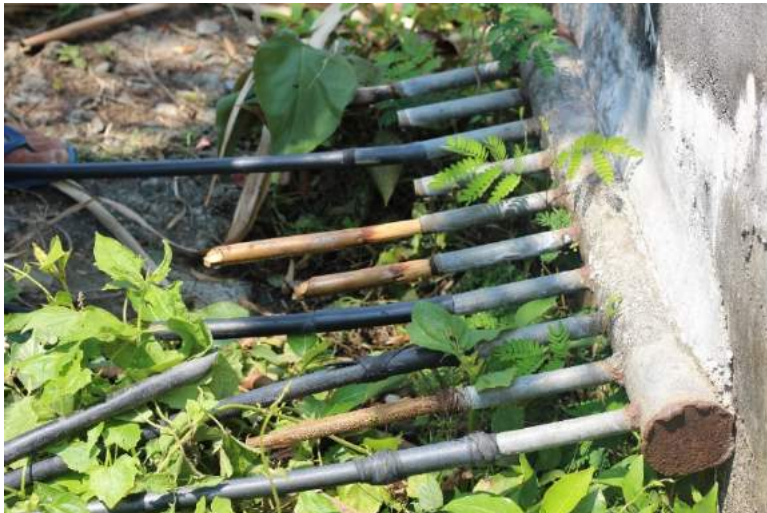
Parasipis CIS is located in Tuba, Benguet. It gets its water primarily from a spring but also taps water from a river during the dry season when the spring flow is low. The spring water was certified as Class A by the DENR. The river flow, on the other hand, gets murky during the rainy season. A small pool is created at the source where water enters a screened inlet and distributed using 119 rolls (60 m/roll) of 2-in dia. HDPs. From this main line, water is diverted to four concrete tanks (three 8x8x8 m and one 4x4x4 m). Each of these tanks (Figure 1A-81), has an overflow pipe for channeling excess water and an opening at the top where a man can enter for tank cleaning. Water is distributed to each farms from a distribution assembly (Figure 1A-82) at the tank and using individual HDPs. They have no gate valves in each distribution pipe so they use wood stems to plug each pipe when not in use.

Figure 1A-82. The distribution pipe assembly showing wooden plugs

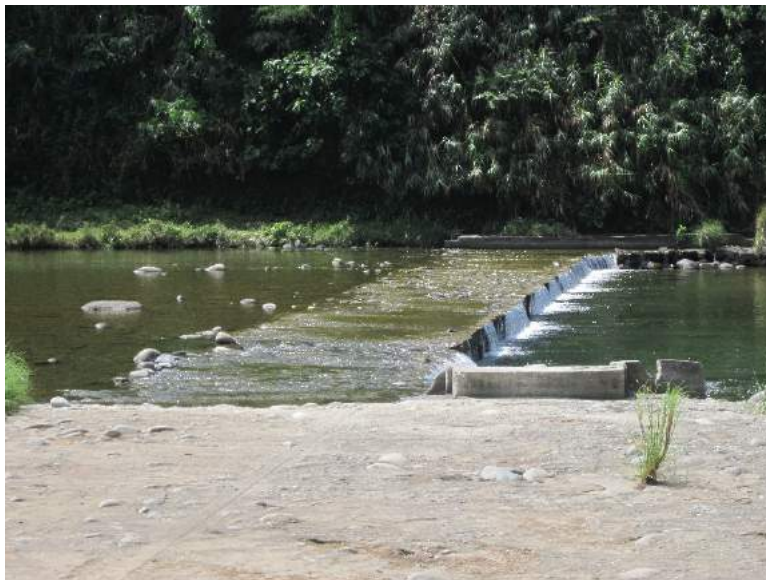
The Casiligan Balacong CIS derives its water from the Bintakan River and has a service area of 175 ha. The old dam (Figure 1A-87) was constructed in 1982 but it was damaged by two typhoons Goring and Iliang. The dam was repaired by NIA in 1996 but this include only the concreting of one side of the dam, construction of a new intake to replace the old one which was a siphon but was fully filled with rocks and sediments during the typhoons, and the dredging and lining of some canals. The dam is filled with sediments and the intake has no screen so the intake canal at the side of the river leading to the main canal is also filled with sediments (Figure 1A-88). The IA guide during the walkthrough said that the original depth of this intake canal may be about 2 man standing on top of another but is now about 3-ft deep. This intake canal was originally covered with concrete slabs but it was removed during one dredging operation and never put back again (Figure 1A-89). The intake canal leads to an intake gate then to a long underground culvert then to the main canal. The gates controlling water flowing to the main canal are still operational but the entry is filled with sediments (Figure 1A-90). The main canal is unlined and the only lateral which runs along the foothills is not only unlined (Figure 1A-91) but is constantly filled with silts from the hills. So the IA are requesting that their canals be lined and the lateral be covered to prevent siltation. There are 6 drops along the main canal.

Figure 1A-87. The old dam (top) and the repaired part (bottom); the old intake can be seen in between the two

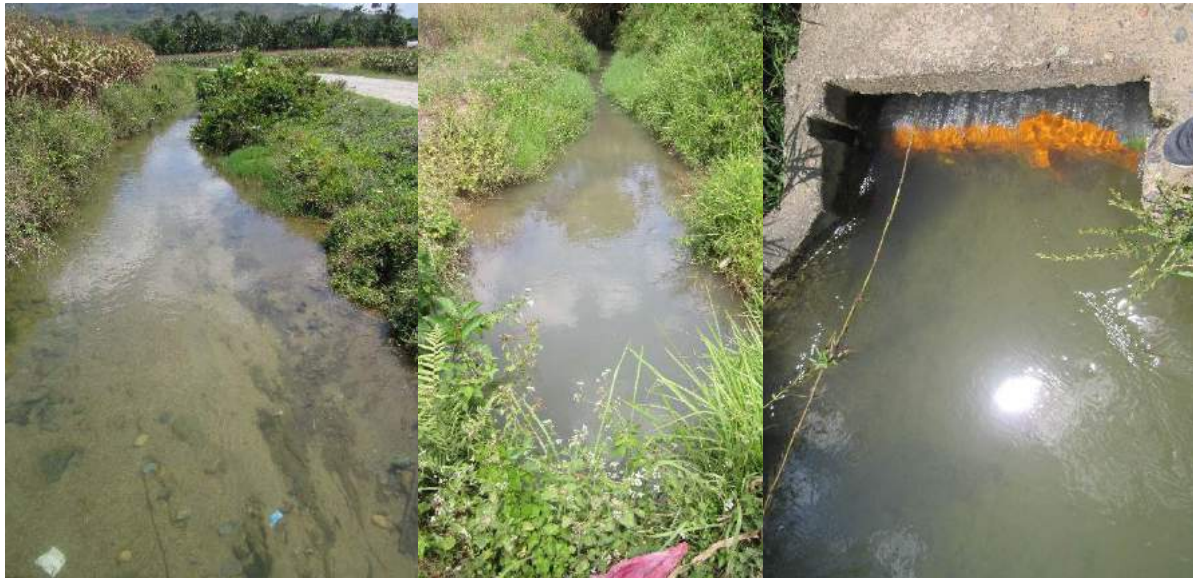
Figure 1A-91. The unlined main and lateral canal and one of the drop structure combined with siphon

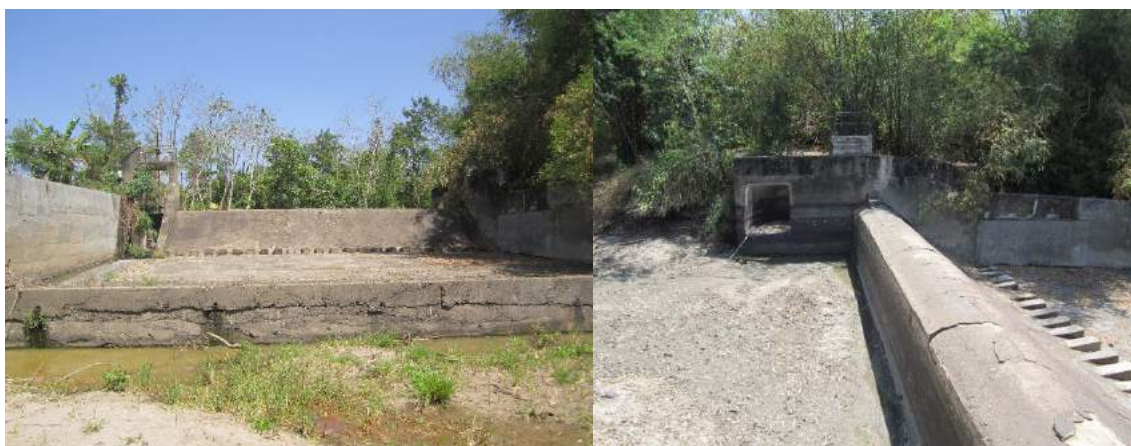
Calusit CIS is located in Enrile, Cagayan and diverts water from Pangul Creek. The creek is the boundary between Cagayan and Kalinga and the watershed is located in Kalinga. The ogee type dam (Figure 1A-94) was constructed on early 1960s and was improved by NIA on 2013. The regulator of the intake is completely broken (Figure 1A-95). The upstream is flooded when there are heavy rains, so another intake was made to divert water and bypass the ogee dam (Figure 1A-94). The IA was granted a water permit to divert 300 lps which good for more or less 200 ha of service area but only about half are being irrigated. The IA suggested to NIA that canal lining will help in increasing the irrigable area of their system. Now the system has 4 km lined trapezoidal canal (Figure 1A-96) and a 0.4 km lined rectangular canal. The IS is amortized for 50 years with payment of 100 kg/ ha during wet and 150 kg/ha during the dry season per member.

Figure 1A-94. The ogee dam exposed because there are no water on Pangul Creek during the visit; also shown is the bypass inlet used to divert water downstream during high flows

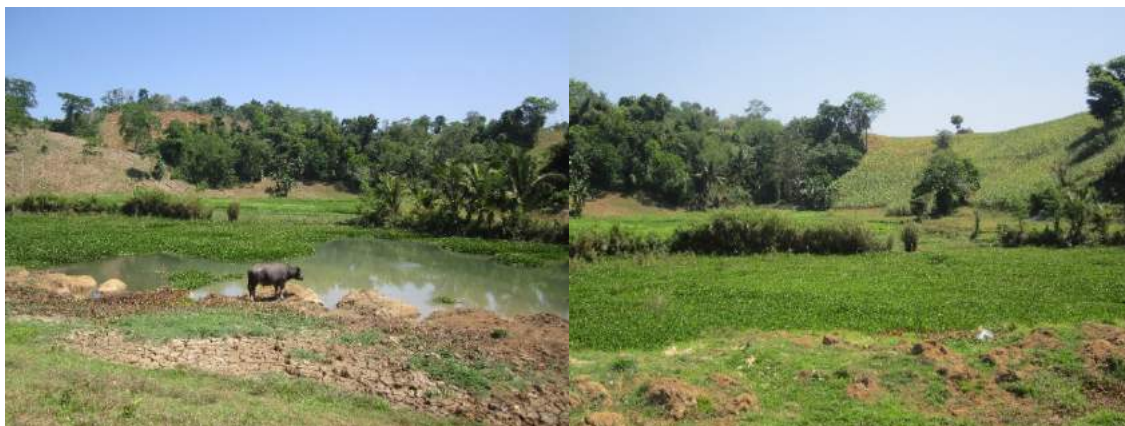
The Naddungan CIS is also located Gattaran, Cagayan. It is an impounding type (Figure 1A-97) which traps runoff from the ephemeral Naddungan Creek. The dam (Figure 1A-98) was constructed in 1986 with a crest of about 25 wide and a service area of 112 ha. There is heavy siltation coming from the watershed due to kaingin and corn planted on steeply sloping lands. It has undergone dredging last 2014. The intake structure (Figure 1A-99) is covered and the gate opens to a 48-in culvert leading to the trapezoidal main canal (Figure 1A-100). The main canal is heavily silted especially in stretches where the canal passes through the foothills. A brush dam (Figure 1A-101) is located downstream of the main dam where it leads to a canal constructed by the IA themselves in 2012 using their own funds. The canal has dimensions of 0.9m wide 1.2m deep and 28m long. Water flow is very low during the visit and a pump set was being used to divert water into the canal. It services about 30 ha. NIA is set to continue the lining project of about 200 m canal and was staking the line during the field visit.

Figure 1A-97. The impounding reservoir filled with water lilies indicating heavy siltation

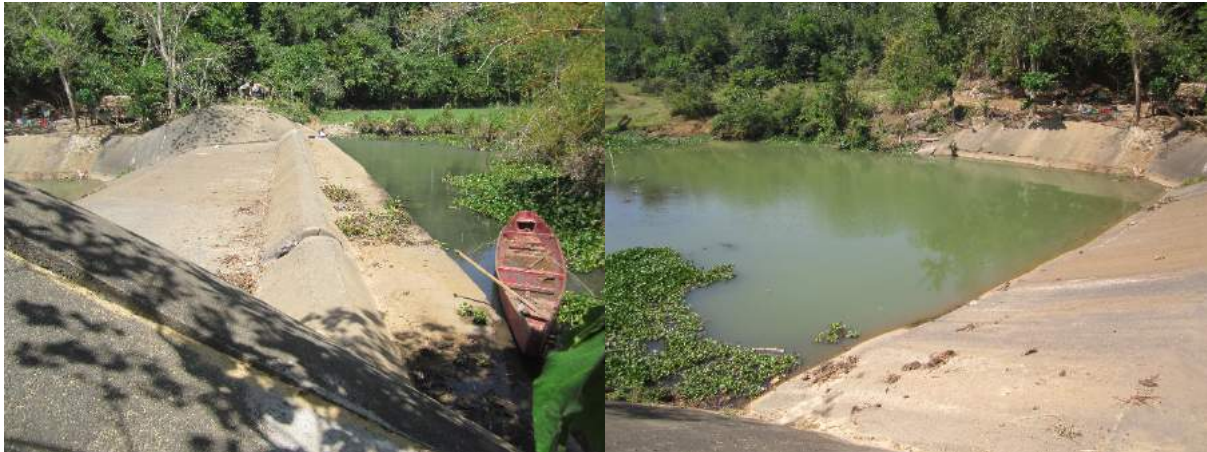
Figure 1A-98. The impounding dam upstream (left) showing crest height increased by a few feet where the overflow water goes downstream (right) to the brush dam

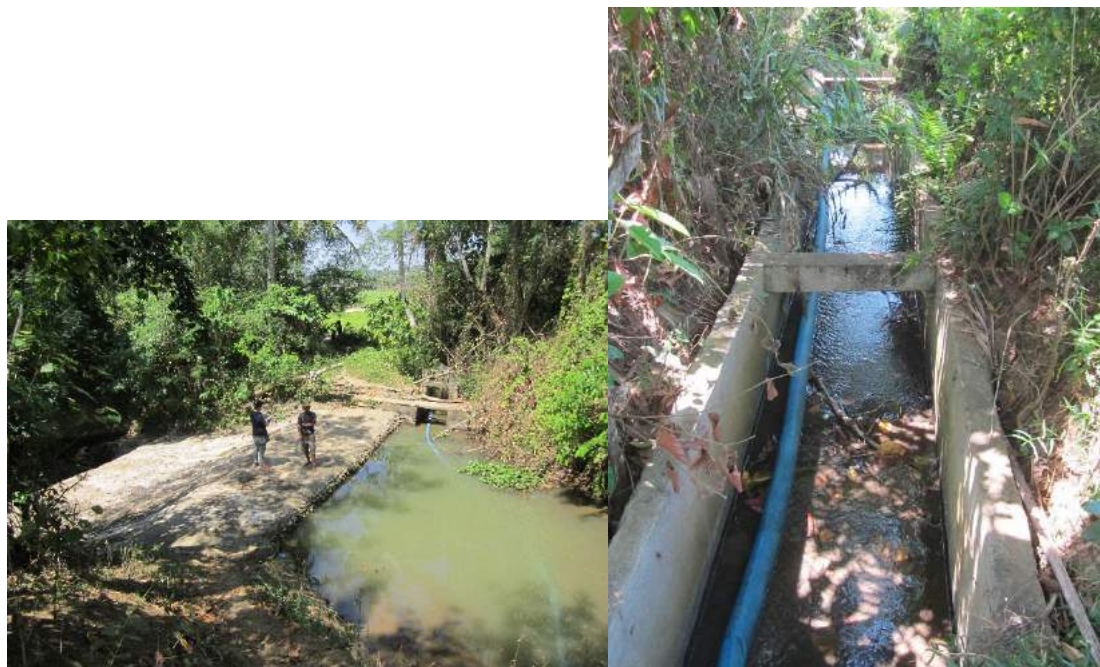
Figure 1A-101. The brush dam now made of concrete and the rectangular lined canal constructed by the IA; water is pumped to the canal due to low flow
