Assessing the resurgent irrigation development program of the Philippines: Communal irrigation systems component

PIDS Discussion Paper Series, No. 2020-02

Assessing the Resurgent Irrigation Development Program of the Philippines – Communal Irrigation Systems Component

March 2020

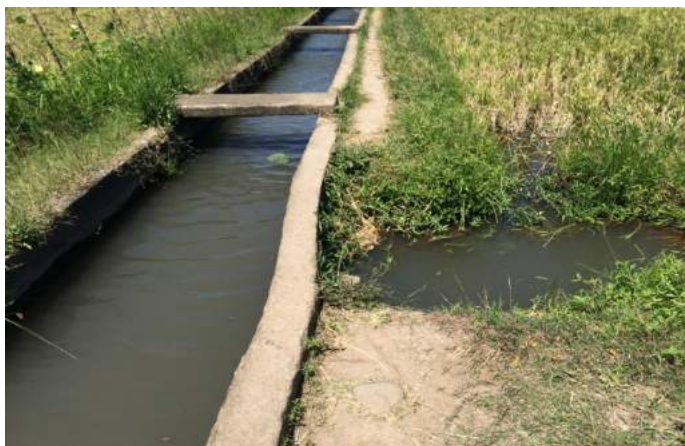
Figure 1A-102. The intake of the Maria Pelaez Communal Irrigation System

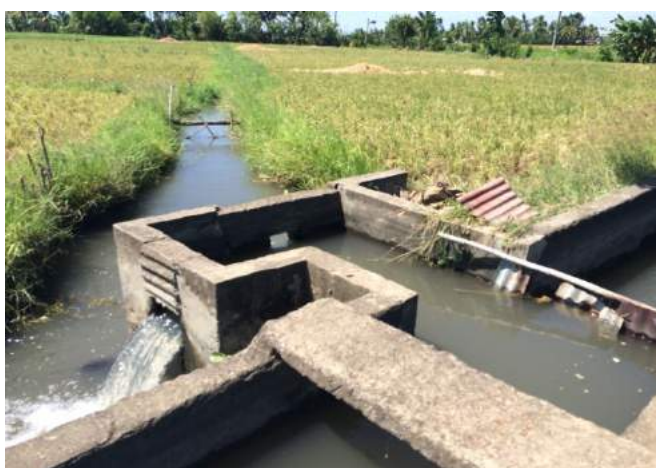
Figure 1A-103. The 1-m wide, 1-m deep concrete-lined main canal of Maria Pelaez CIS
Source: Author's capture

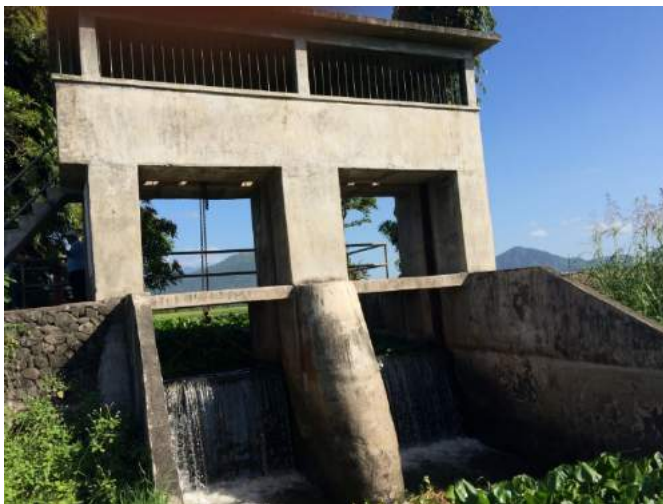
Figure 1A-106. The San Benito CIS Dam

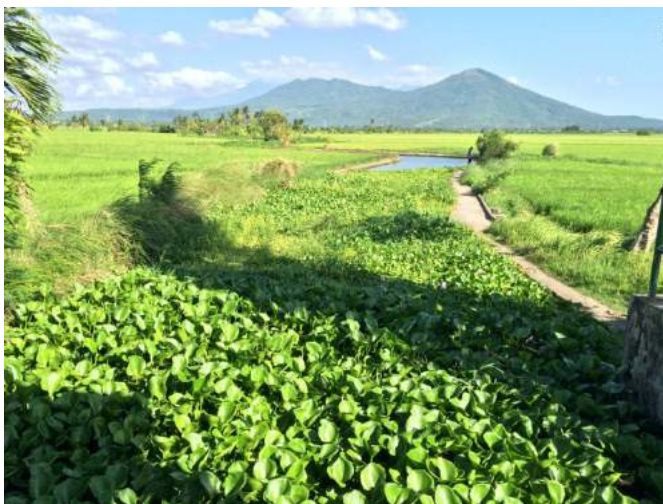
Figure 1A-107. Downstream portion of the dam that is full of water lilies

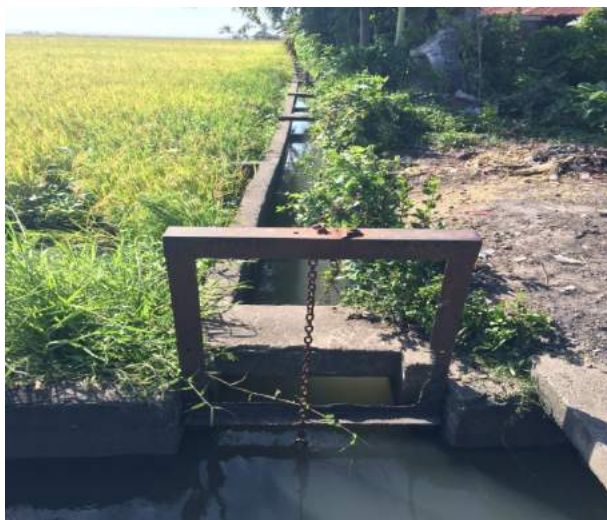
Figure 1A-108. Lateral canal without gate and lock

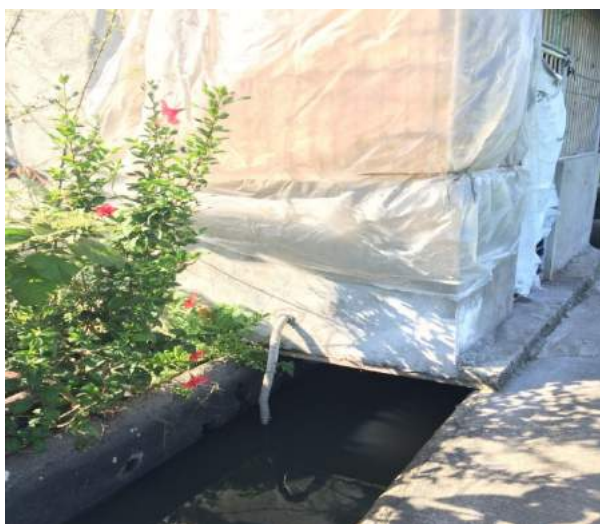
Figure A1-109. A drainage outlet of a house alongside of the main canal

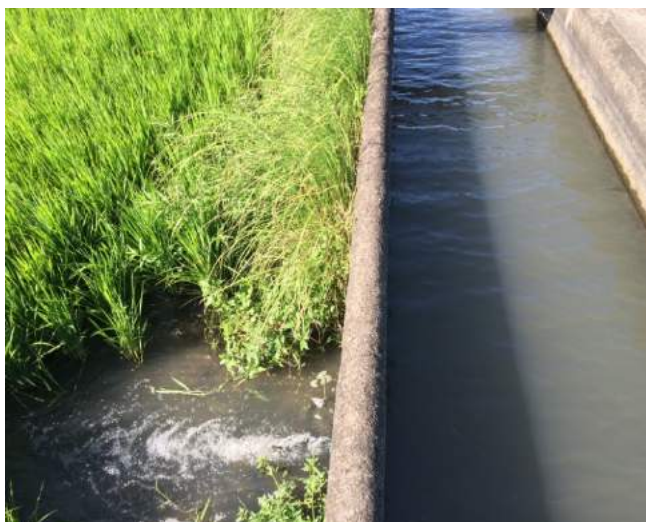
Figure 1A-110. Illegal turnouts directly tapped on main canal

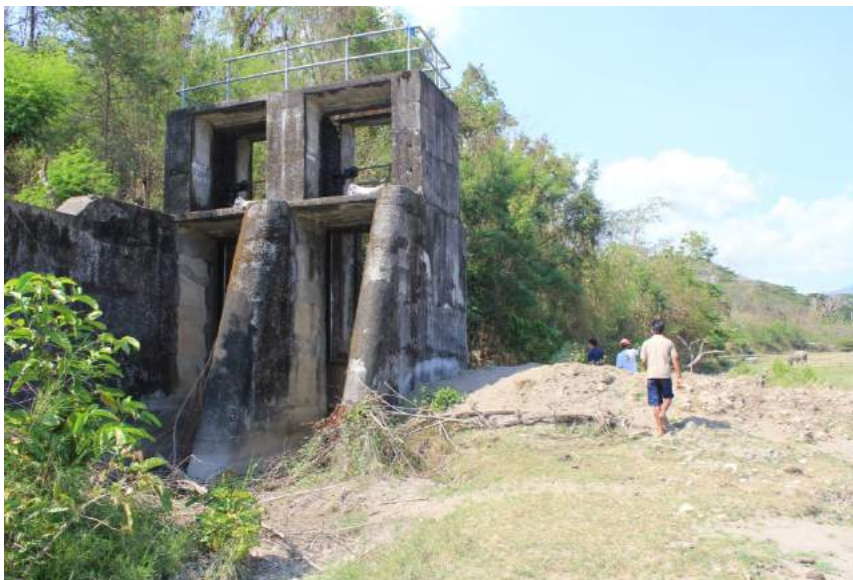
Figure 1A-111. The Bongbongan CIS Dam

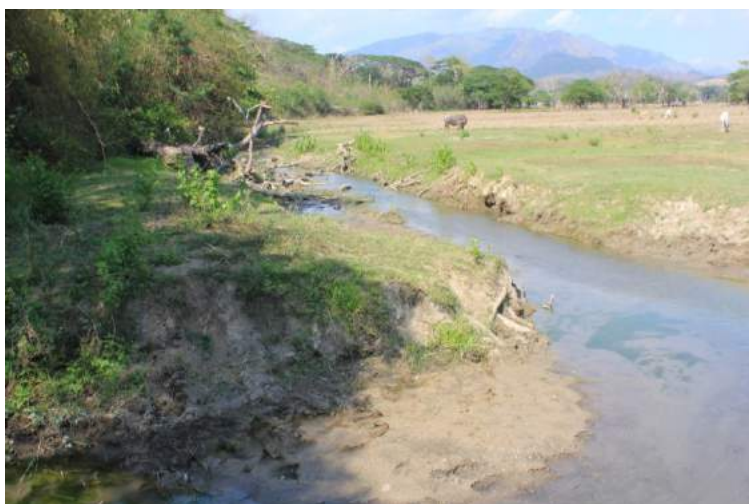
Figure 1A-112. Water diverted from Anahawin River to the intake

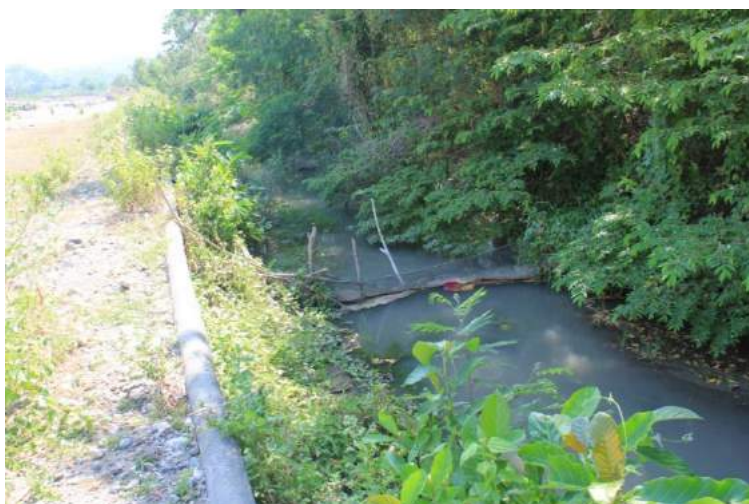
Figure 1A-113. The 2.5-m wide and 3-m deep concrete-lined main canal

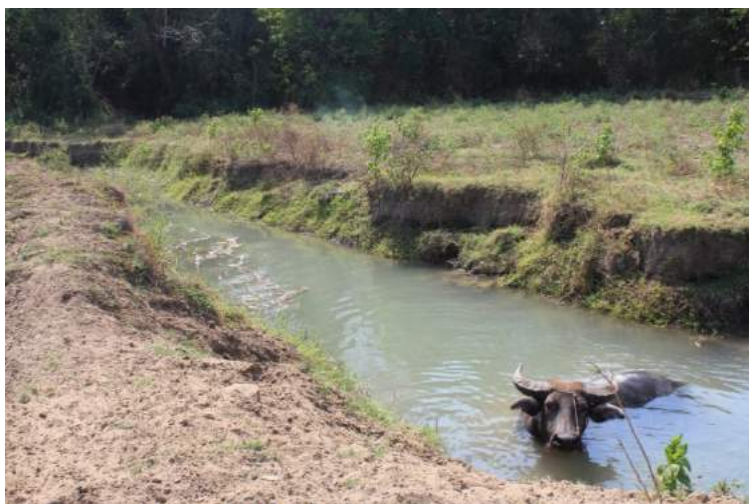
Figure 1A-114. Unlined main canal

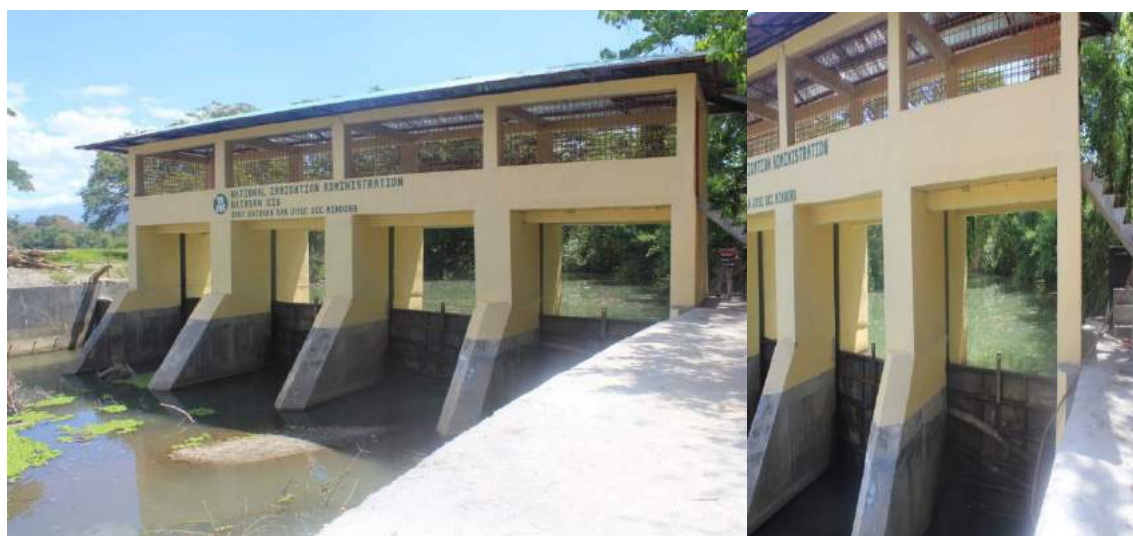
Figure 1A-116. The Batasan CIS dam that was only built last October 2014
Source: Author's capture

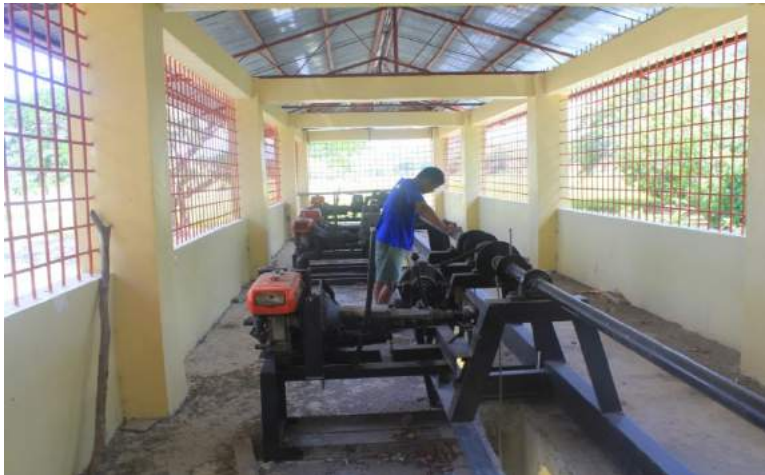
Figure 1A-117. Diesel engines used to control the sluice gates

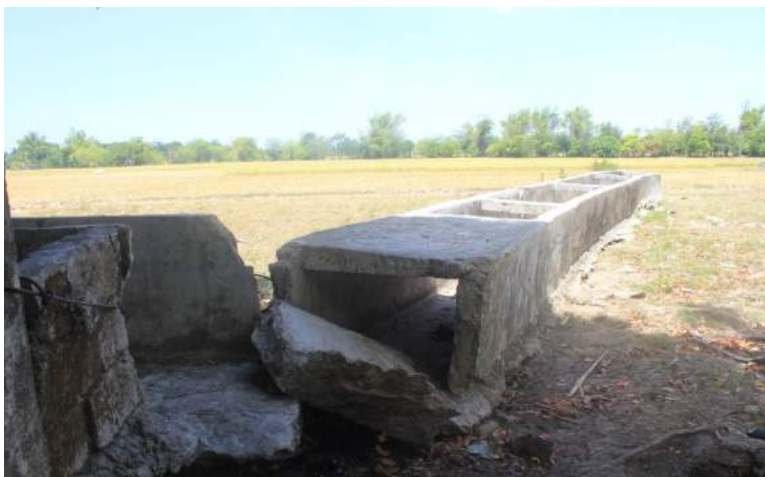
Figure 1A-118. Detached Main canal due to typhoon Glenda

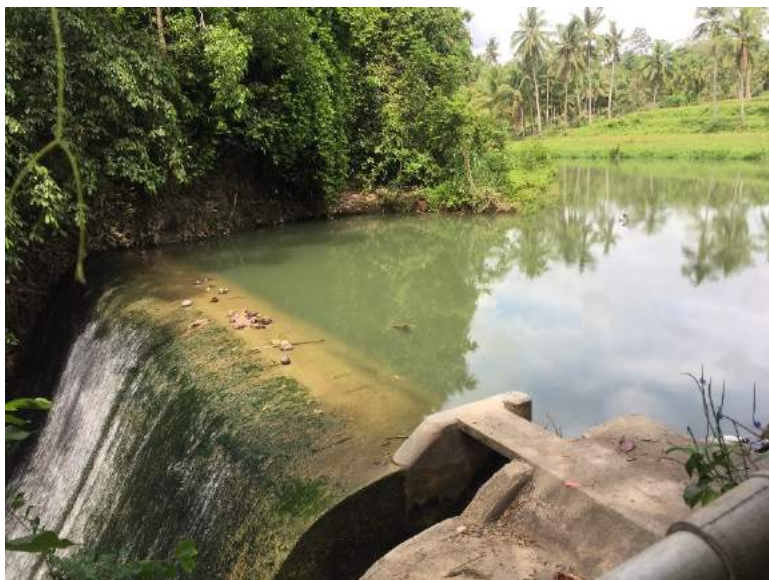
The dam (Figure 1B-1) was built in 1982 and is still fully operational with some rehabilitations done on the intake gate and several turnouts. About 4.5 km of the main canal and some portions of the lateral canals are lined (Figure 1B-2). There is minimal siltation observed although the inverted siphon passing underneath a creek was clogged preventing the conveyance of water from the main canal to about 40 ha downstream. The IAs wants NIA to use GI pipes to convey the water over the bridge instead to continue servicing water in the affected farms. The river has enough water to irrigate all the service area as long as there are no broken or nonoperational canals. Water flowing to Kanumantad falls comes from the dam so when the intake gate is fully opened, no water flows on the falls. Some farmers use pumps to supplement water from the system. Saline intrusion and sedimentation are also problems encountered by the farmers in the downstream sector. The IA suggests to complete concreting of canal lining and desilting of Gabayan river.

Figure 1B-1. The main dam of the Gabayan CIS

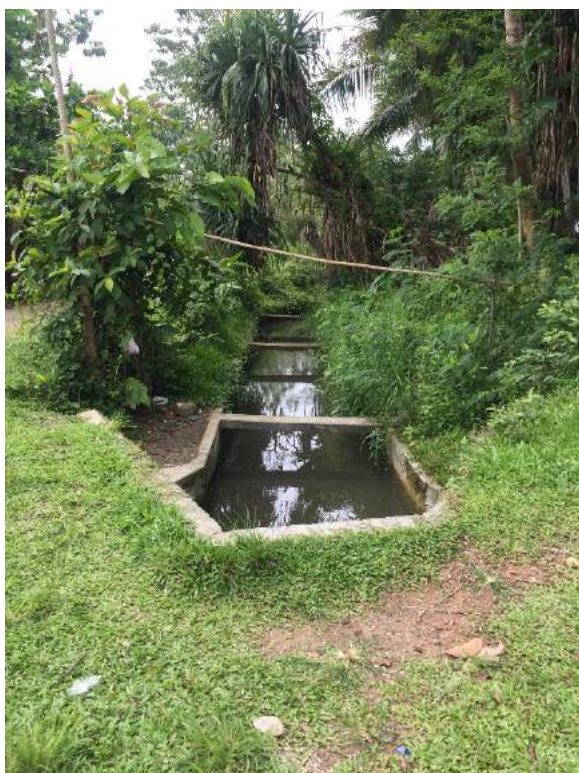
Figure 1B-2. The main canal of the Gabayan CIS

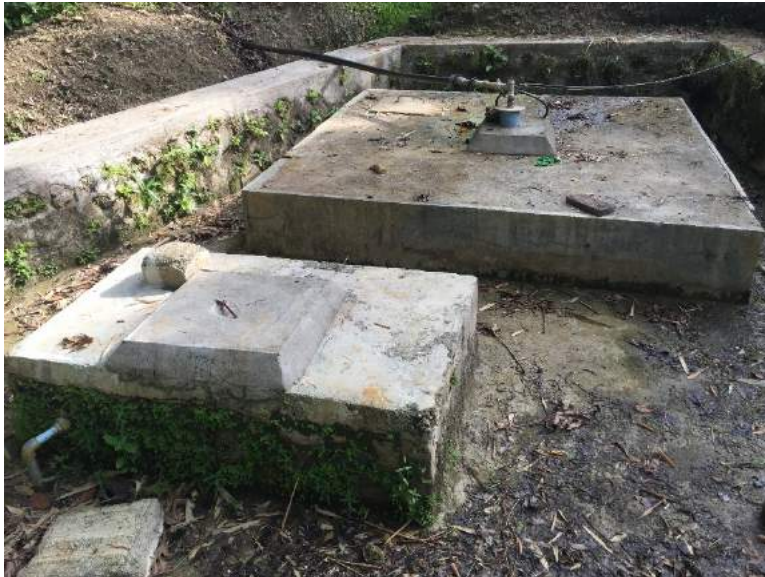
Figure 1B-4. The well source of Loboc Groundwater IP showing the two reservoirs

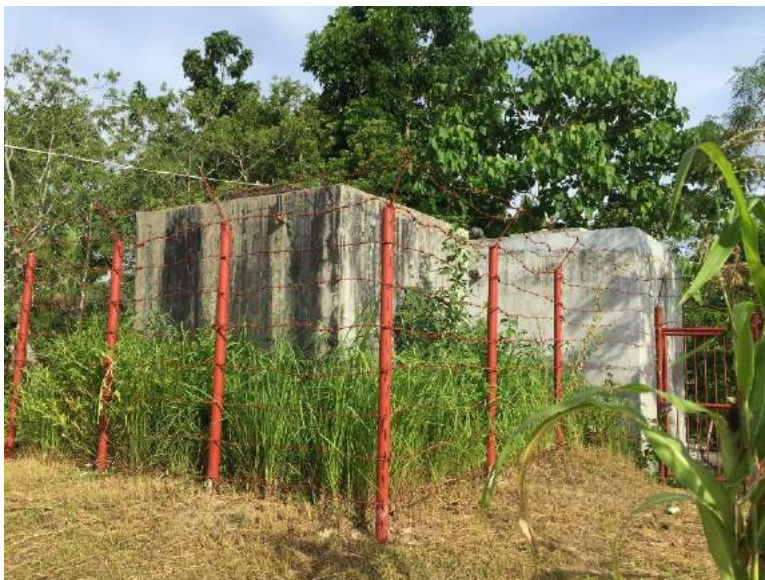
The water from the well is pumped to two concrete reservoirs located on top of a small hill (Figure 1B-5), and water is distributed by gravity to its intended use. The pipeline is 1200 m to the service area. Only one reservoir was originally built but was deemed not enough so another reservoir was built in 2017.

Figure 1B-5. The main (2m x 2m) and additional (2.5m x 2.5m) reservoirs of the system

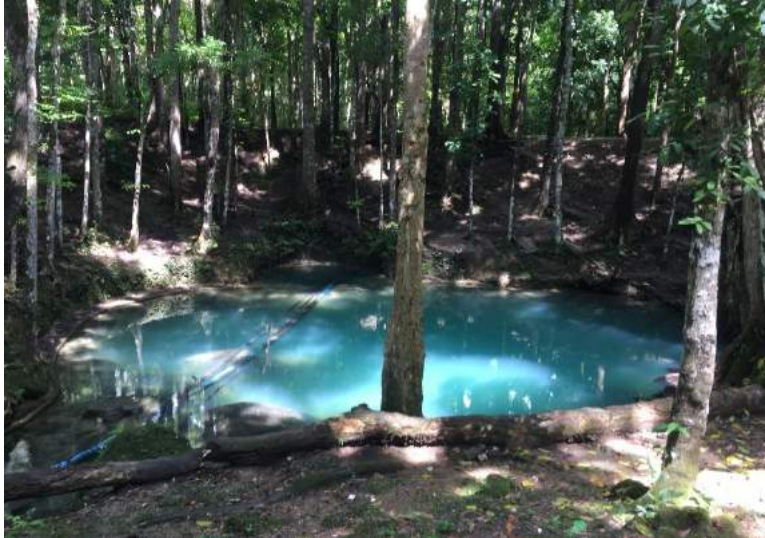
Figure 1B- 6. Ughuban spring, the source of water of Cambuyo CIP. The depth of the pipe in the source is 40 ft

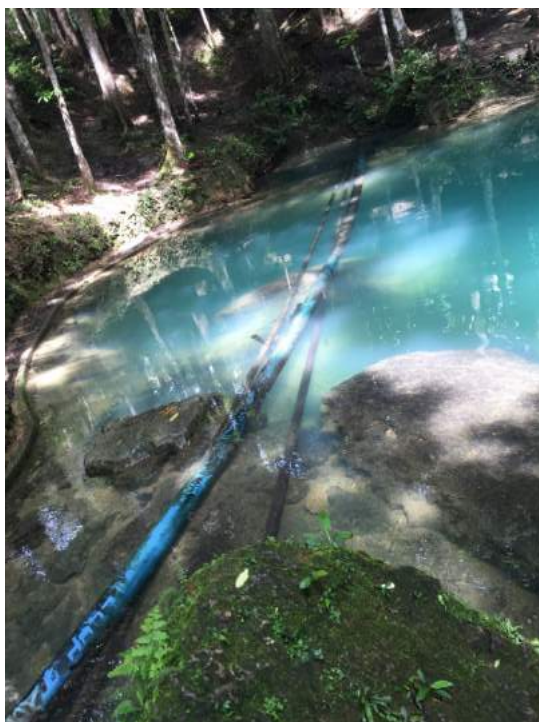
Figure 1B- 7. The three pipes also tapping water from the spring to provide water for the barangay (6"), ram pump for the High School (3"), and a private service area (3")

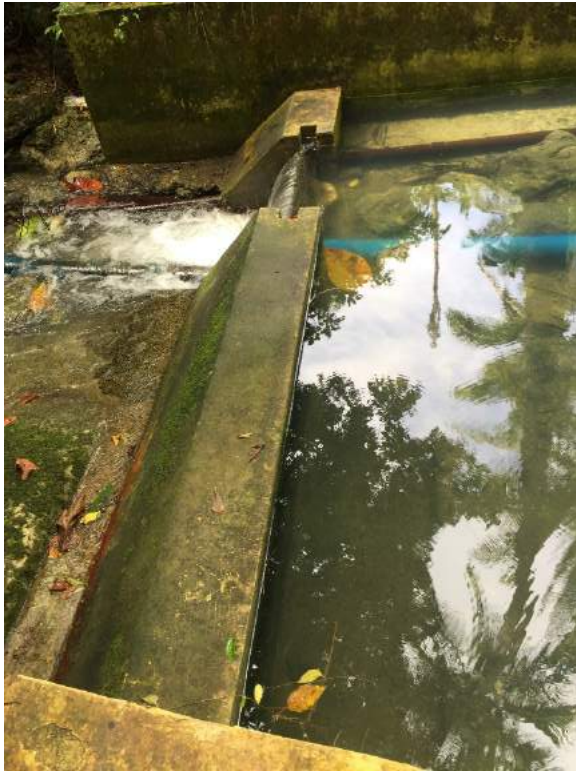
Figure 1B- 8. The diversion dam of the Cambuyo CIP

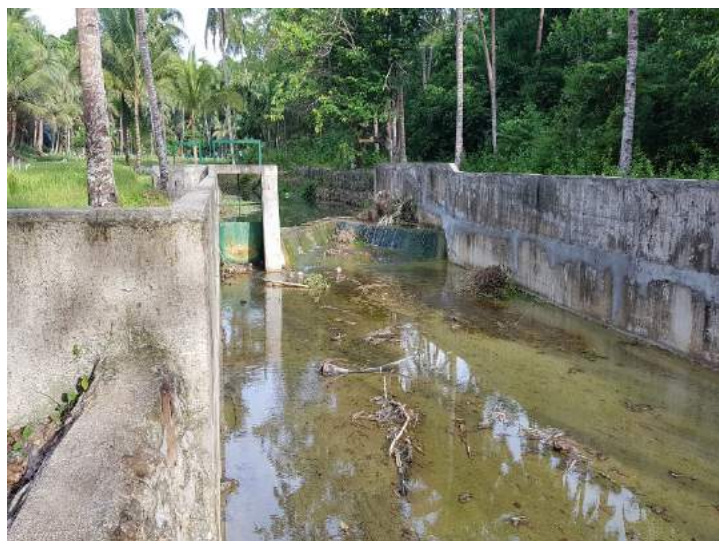
The current dam was constructed in 2012 (Figure 1B- 9) upstream of the original dam and the new main canal was constructed along the original main canal, using the old concreted side walls as support. The dam has a duckbill-type weir to increase crest length and reduce backwater flow effect with increase in flow. This is necessary to prevent flooding in nearby farms during high water flows which frequently occur in the area.

Figure 1B- 9. The new dam of the Maljo CIS constructed in 2012. It is a run-of-the-river type dam with a duckbill crest

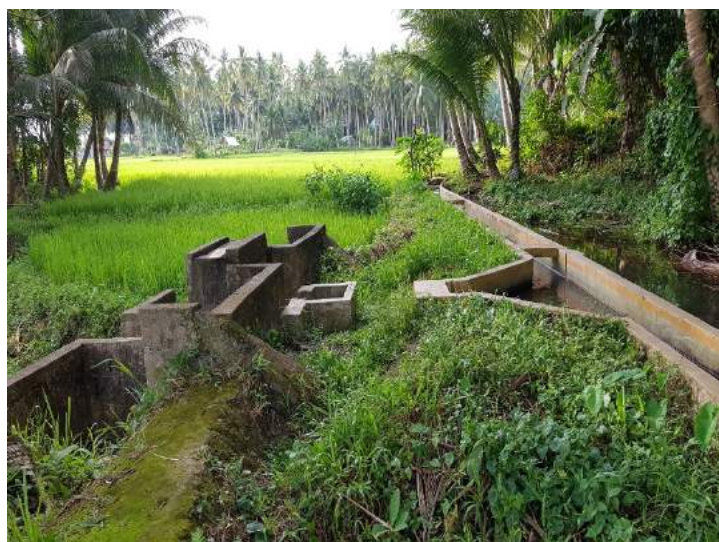
Figure 1B- 10. The original dam constructed in 1960 downstream of the new site. The main canal of the new dam is seen on the right side

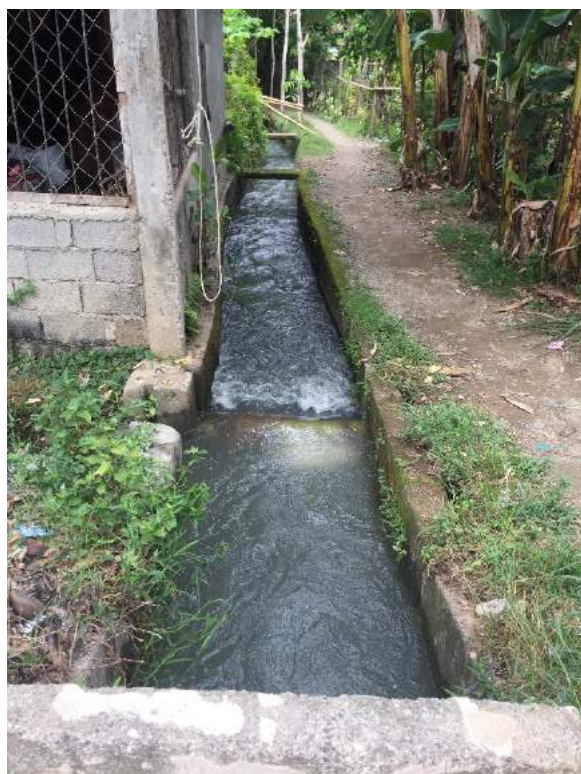
Figure 1B- 11. Main canal of Tagbawto CIS with width of 100 cm and height of 80 cm

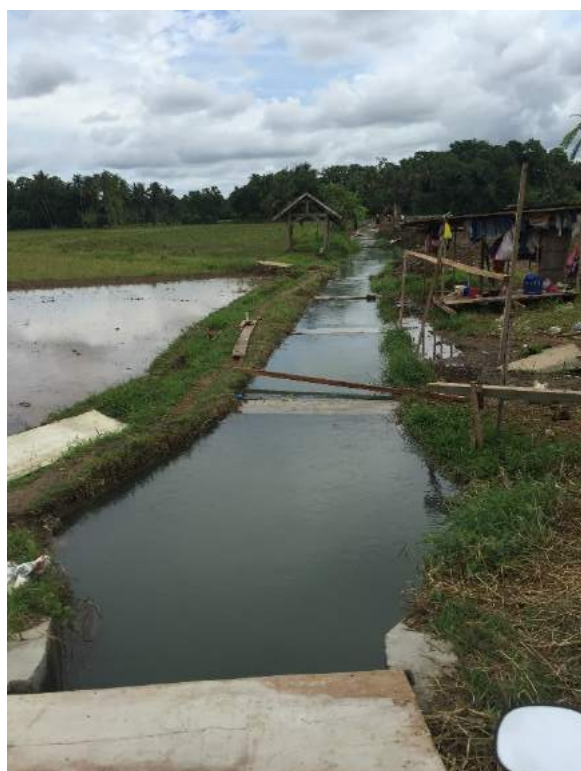
Figure 1B- 12. Ongoing canal construction with width of 2 m and depth of 1.25 m

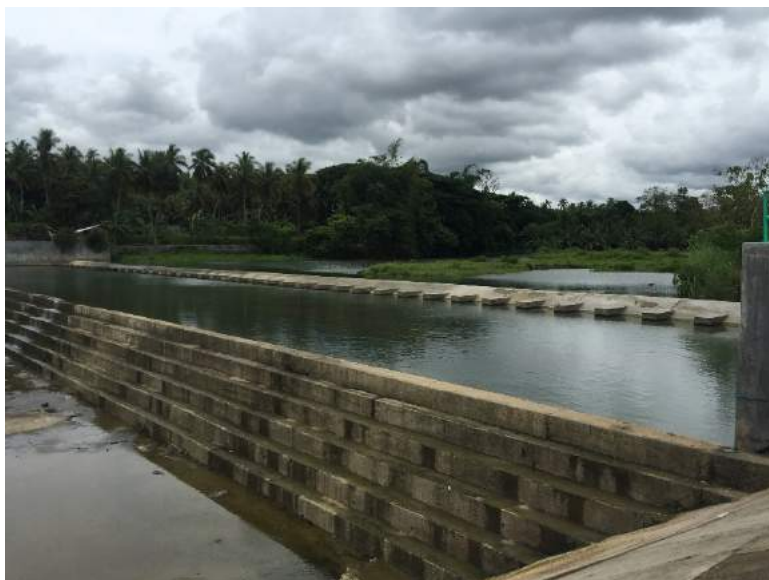
The CIS has two dams, one of which is already operational (Figures 1B-13 and 1B-14) while the other is under-construction. The diversion dam spillway, aprons, sidewalls and sluice gates are all properly maintained and in good conditions. There is visible sedimentation in the storage area of the dam but since the water is still enough to service the required water of the CIS, no dredging is being done by the IA (Figure 1B- 15).

Figure 1B- 13. The diversion dam of Tagbawto CIS with a width of 100 m
Source: Author's capture

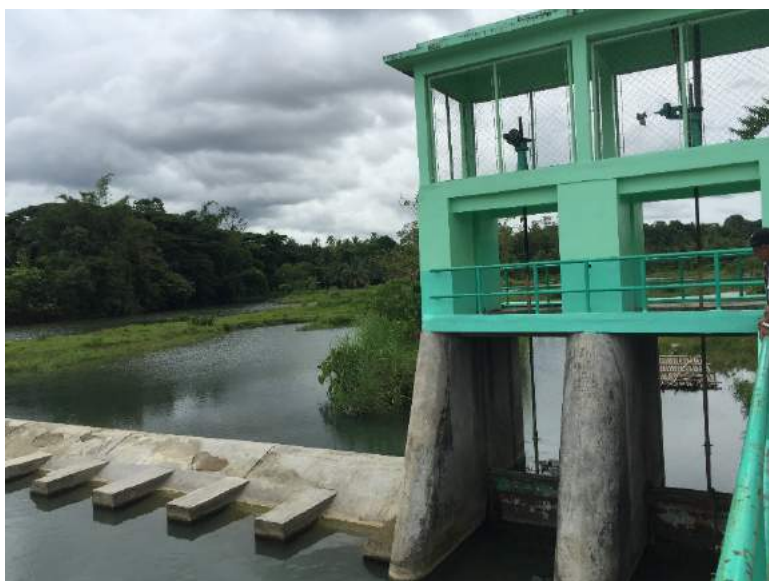
Figure 1B- 14. Two steel gates of the dam which measured 1.5 m each
Source: Author's capture

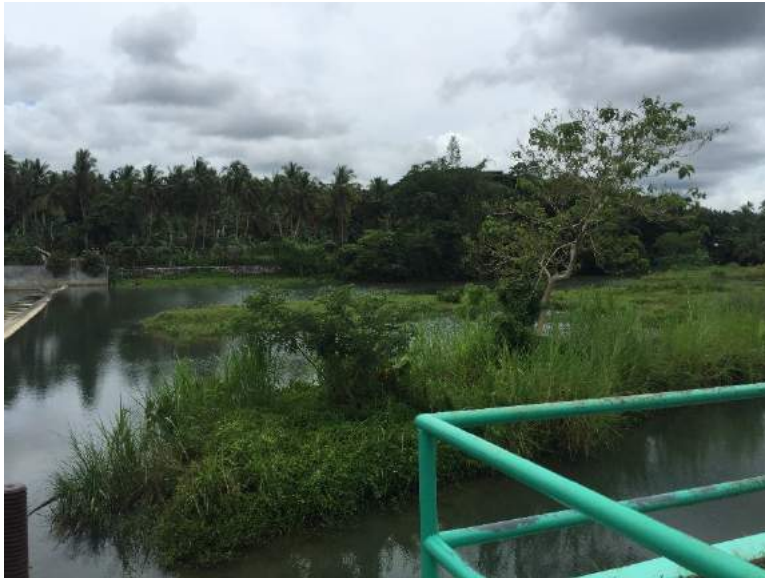
Figure 1B- 15. Dam site showing that dredging is not practiced

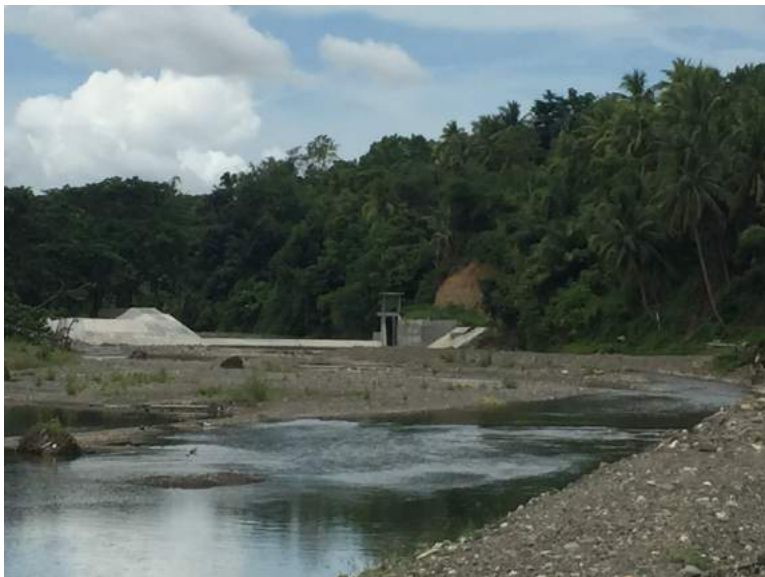
Another dam is being constructed downstream to service an additional 100 ha. The construction of the dam started September 2017 and the expected date of completion was May 2018 (Figure 1B- 16). However, the construction was stopped since there is no more budget allotted. The association also have to negotiate for the right of way during the construction of canal. The start of dry cropping season was already delayed due to the dam construction.

Figure 1B- 16. Construction of the new dam

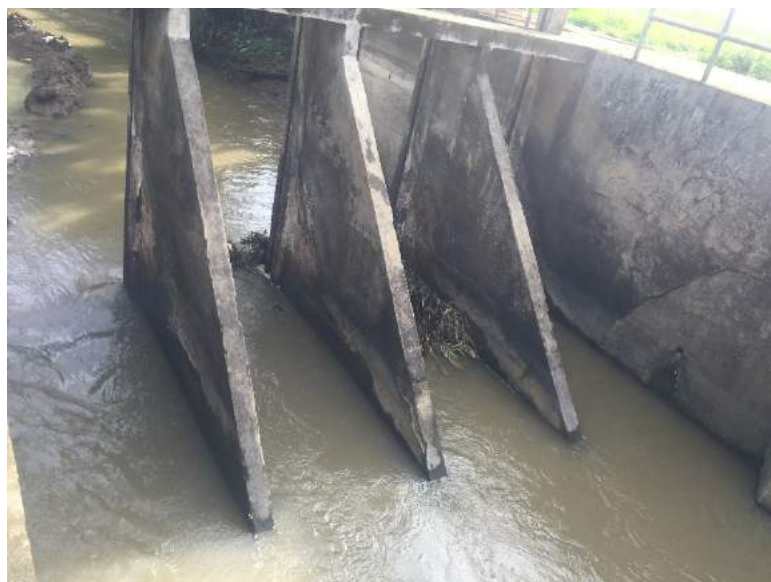
Figure 1B- 17. The buttress dam of Sta. Elena CIS. The IAs use wooden planks since no steel gates were installed

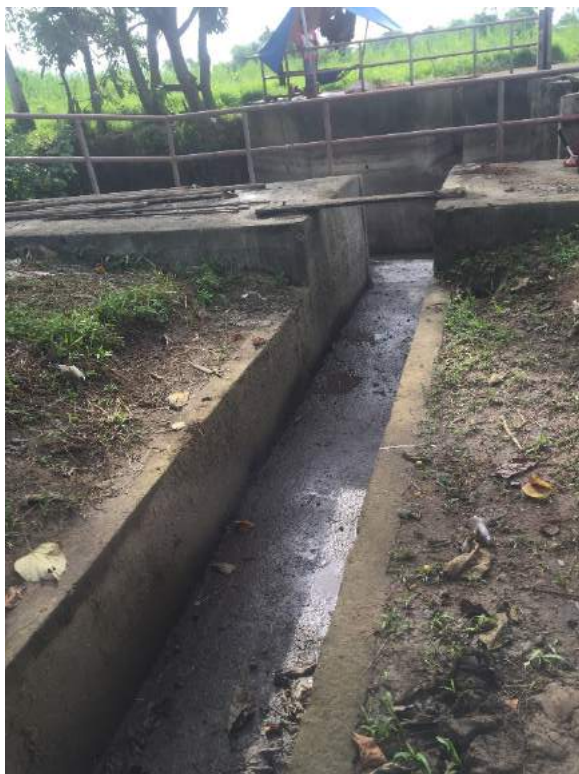
Figure 1B- 18. Intake of Sta. Elena CIS going to the main canal

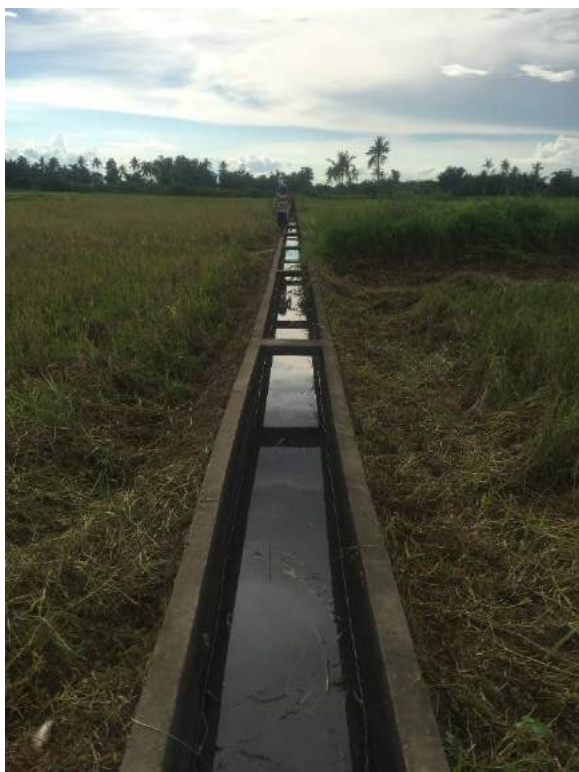
the dam is being repaired when the team visited. Main canals are lined and cemented (Figure 1B- 19).

Figure 1B- 19. Main canal of Sta. Elena CIS

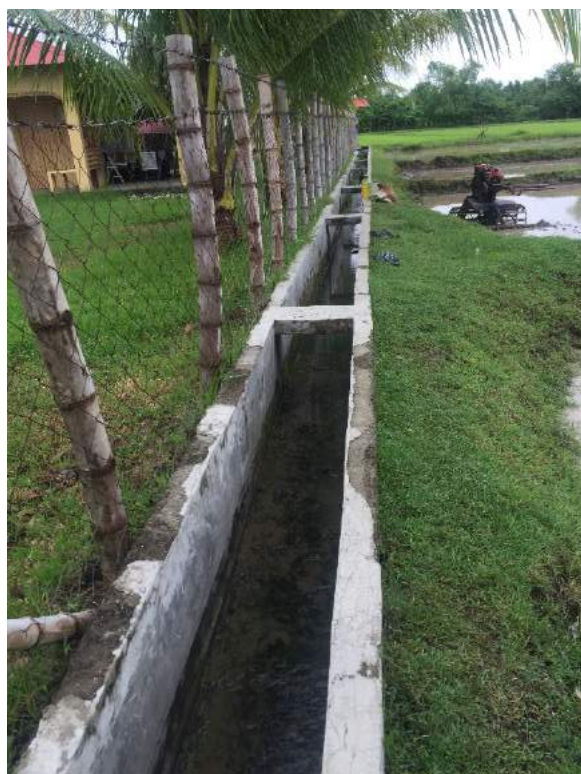
Figure 1B- 20. Main canal of the CIS

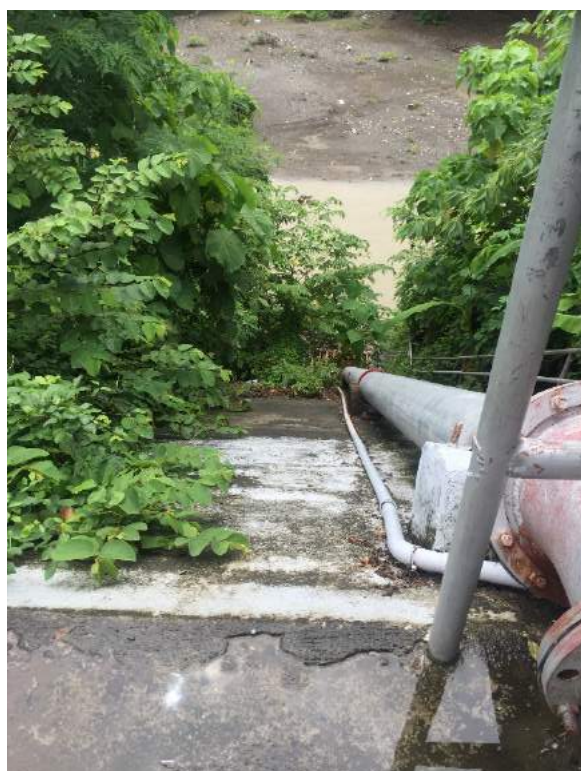
**Figure 1B- 21. The 10" pipe connected to the original pump that delivers water to the
main canal**

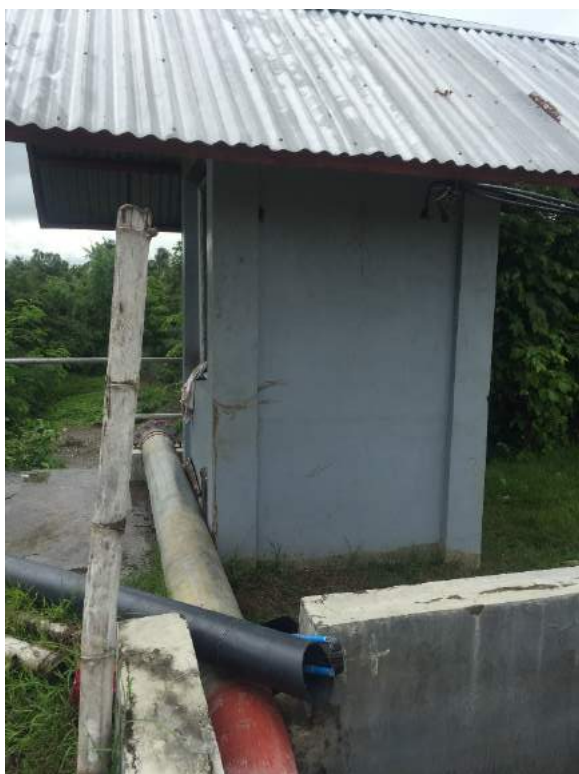
Figure 1B- 22. The 10" pipe (a) connected to the original pump and the 6" pipe (b) connected to the alternative pump

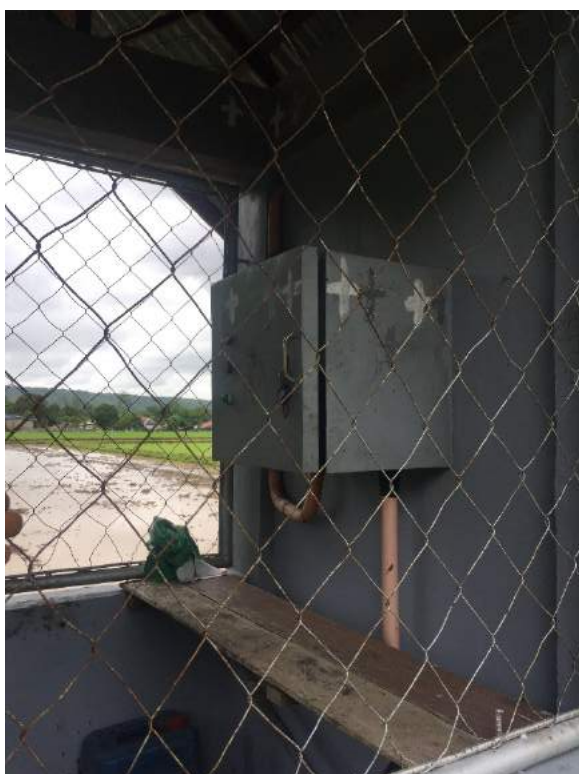
Figure 1B- 23. The transformer for the submersible pump of the CIS

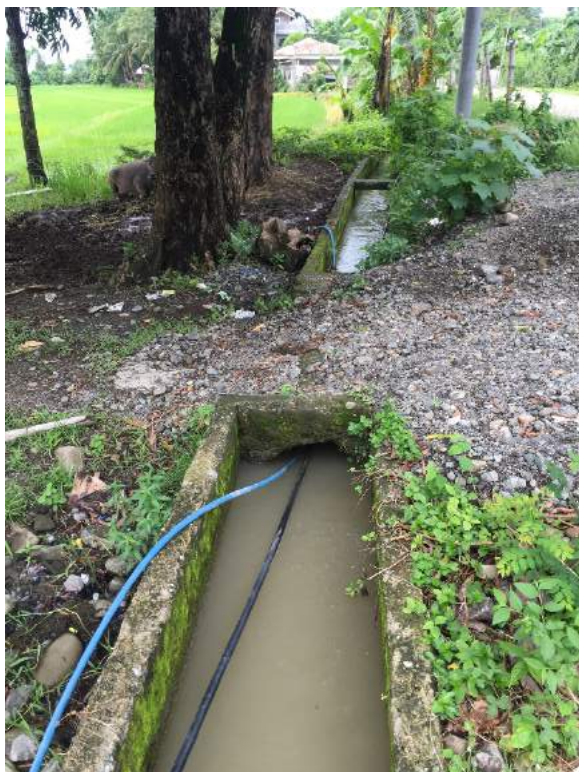
Figure 1B- 25. Main canal of Tumagboc CIS with width of 60 cm and depth of 60 cm

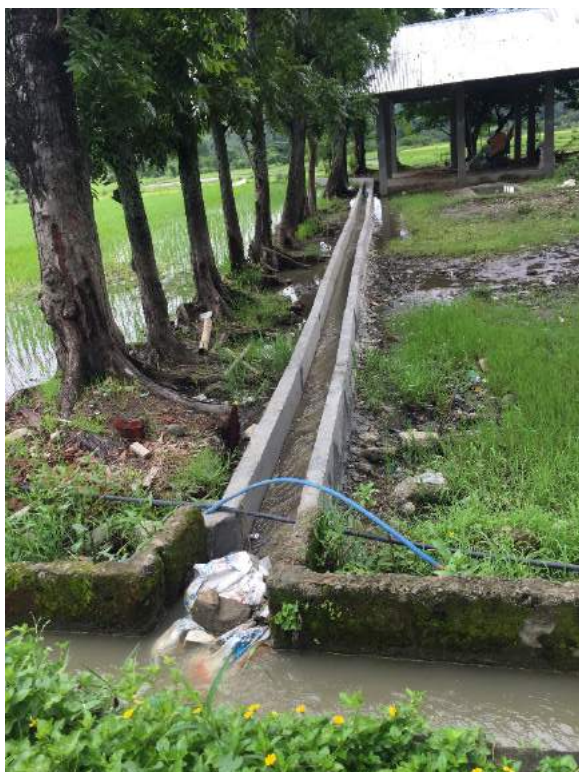
Figure 1B- 26. The newly built lateral canal of the system

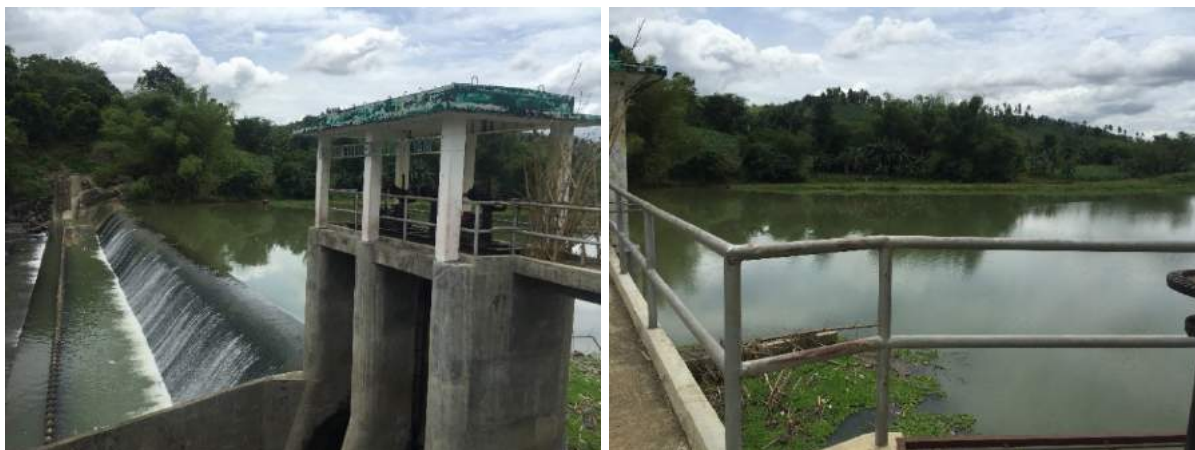
Figure 1B- 29. The dam of Maayon CIS

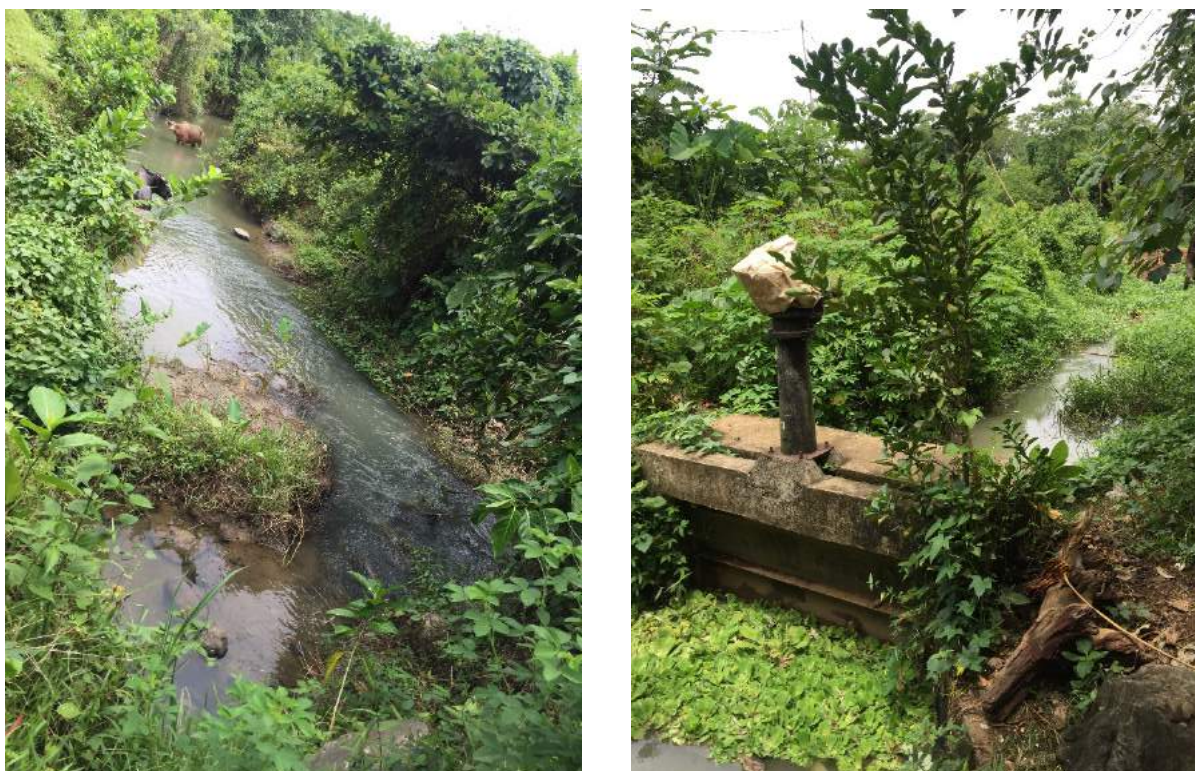
The CIP has a 12-km main canal and all but a few stretches are not lined yet, although there are several concrete control gates within the system (Figure 1B- 30). The design service area was 780 ha and the IA is working out for the right of way on Poblacion Ilaya to allow the construction of line canal to traverse it to Poblacion Ilawod and Fernandez. There are also some parts where the main and lateral canals are not connected yet. The system still has sufficient water even during summer. Since the main and lateral canals are unlined, they are easily damaged by strong flows. There are also two sluice gates on the dam but only one machine is fully functioning to operate them. The dam is not silted, and dredging is not needed.

Figure 1B- 30. The unlined main (left) and lateral (right) canal with some control structure

The association will request to NIA the concreting of the main and lateral canals. Officials of the association admitted lack of support from the local government unit.

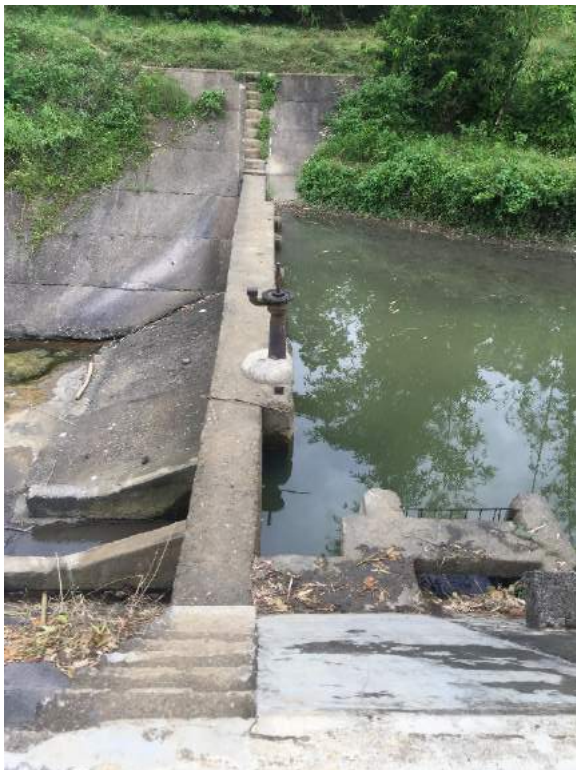
Figure 1B- 31. Dam of Salcedo CIS

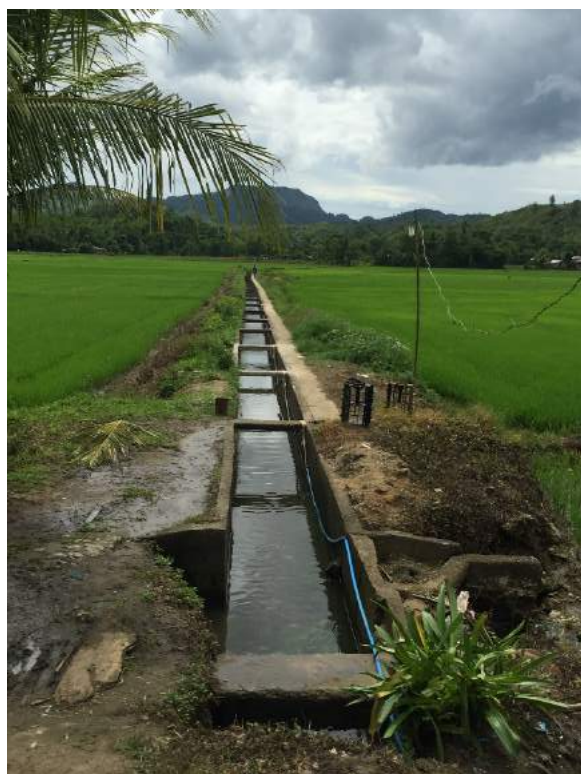
Figure 1B- 32. Main canal of Salcedo CIS

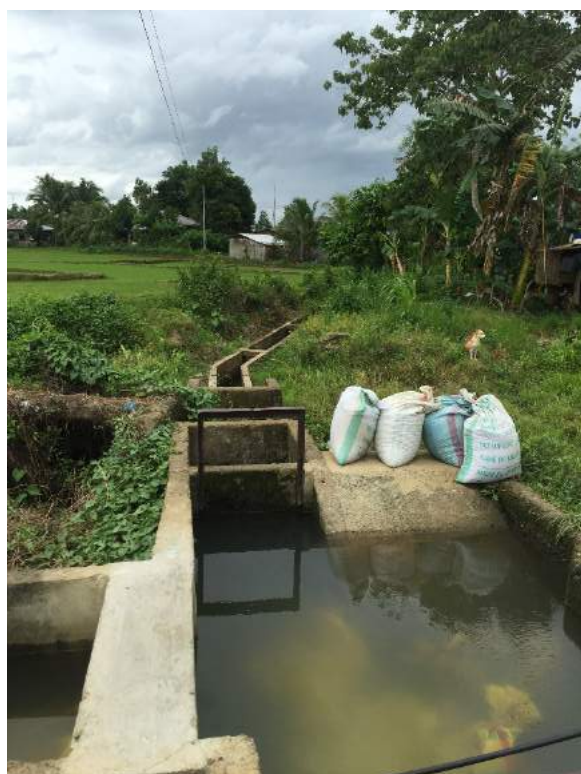
Figure 1B- 33. Lateral canal A and division box of the system

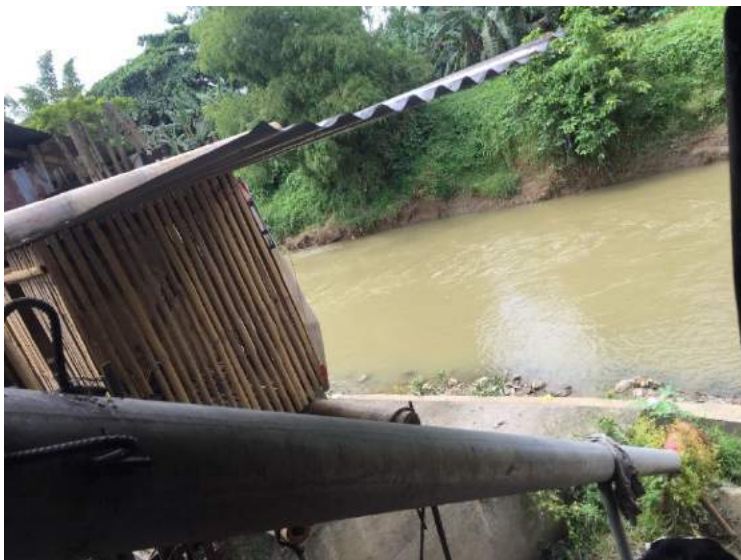
Figure 1B- 34. The 6" suction pipe used in drawing water from the Mambusao River

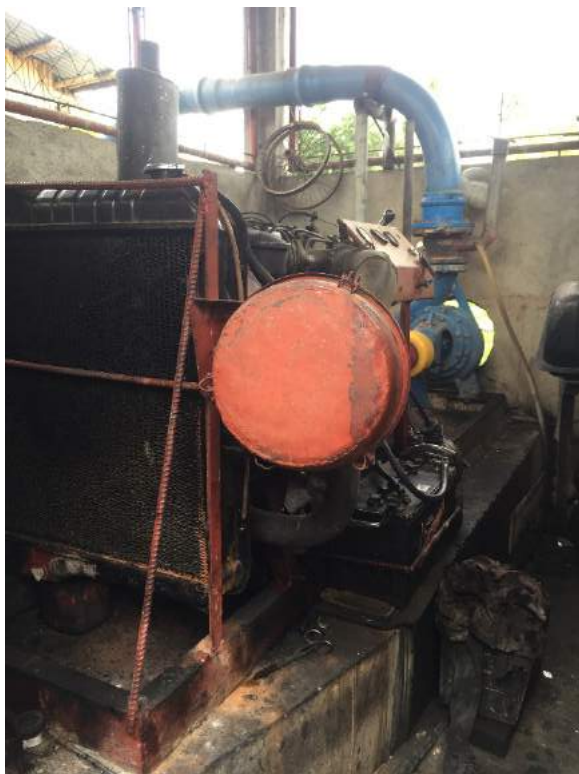
Figure 1B- 35. The centrifugal pump and the diesel engine of the Sigma Sur PCIS

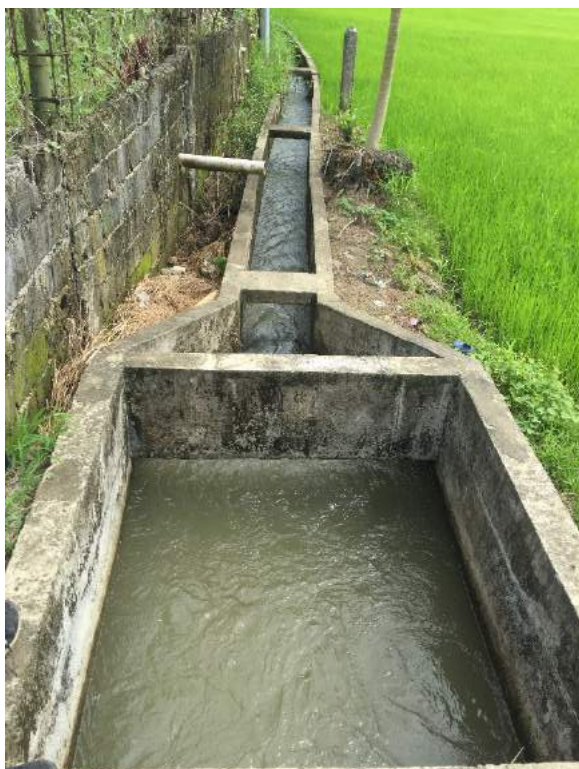
**Figure 1B- 36. The main canal of the system as the canal emerged from an inverted siphon
across a road**

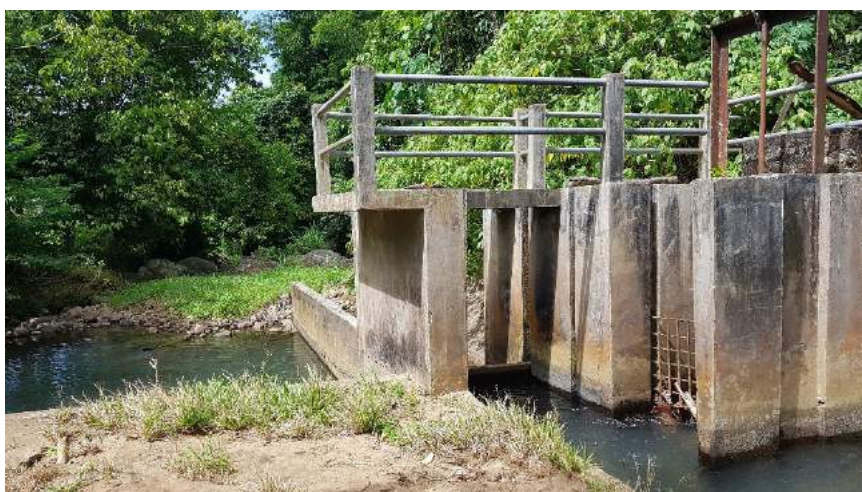
Figure 1C-2. Matanao Dam of Unifarm CIS

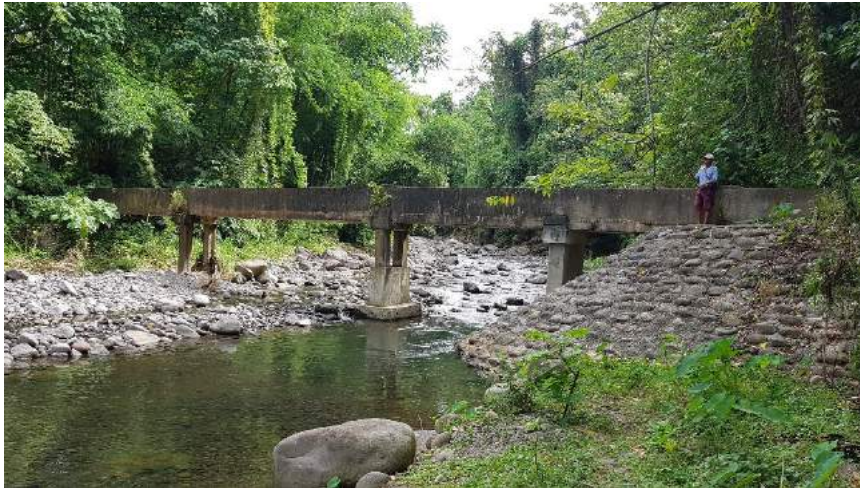
Figure 1C-3. Elevated flume from Matanao dam
