Assessing the resurgent irrigation development program of the Philippines: Communal irrigation systems component

PIDS Discussion Paper Series, No. 2020-02

Assessing the Resurgent Irrigation Development Program of the Philippines – Communal Irrigation Systems Component

March 2020

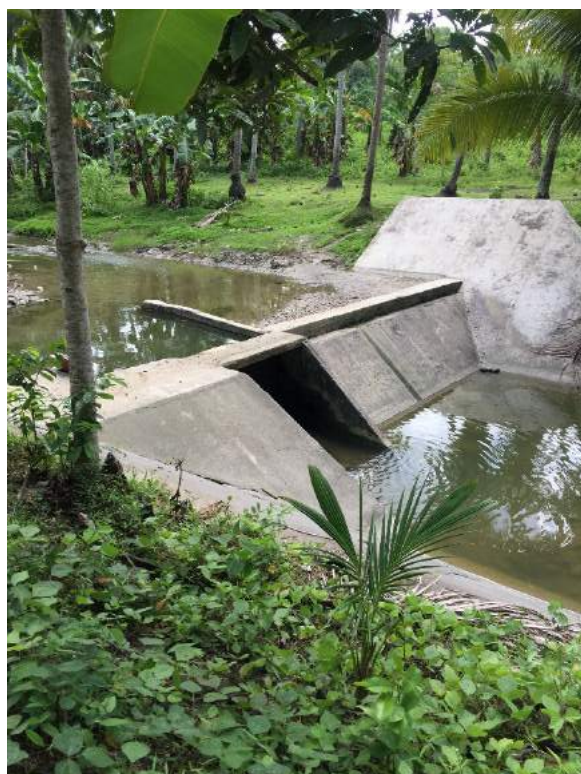
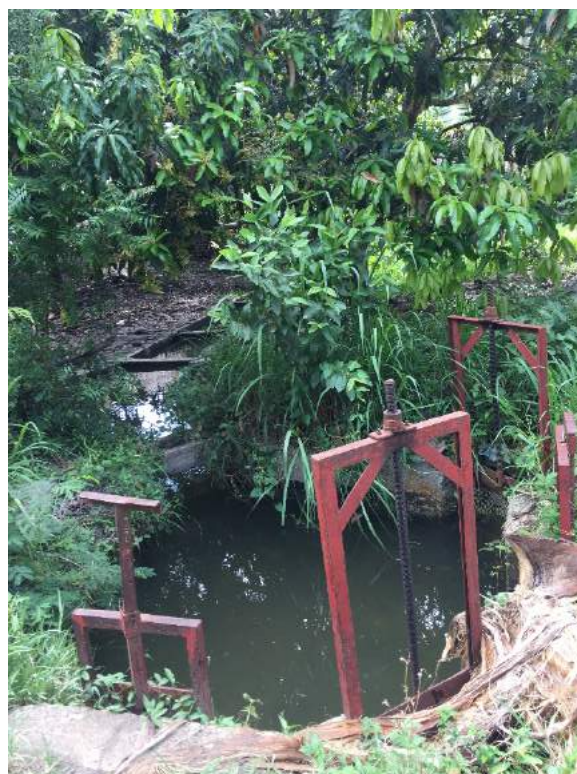
The dam (Figure 1C-5) was built in 1979 and started operation a year after. After completion of the project, however, problems emerged including no steels and unstable trapezoidal canals. Many parts of the main canal are still unlined and there is a broken section in the lined part (Figure 1C-6). The system was turned over to the IA in 1990. It is managed by Latale New Katipunan IA and at present have 81 rice farmer-beneficiaries.

Figure 1C-5. The dam of New Katipunan CIS with the head gates

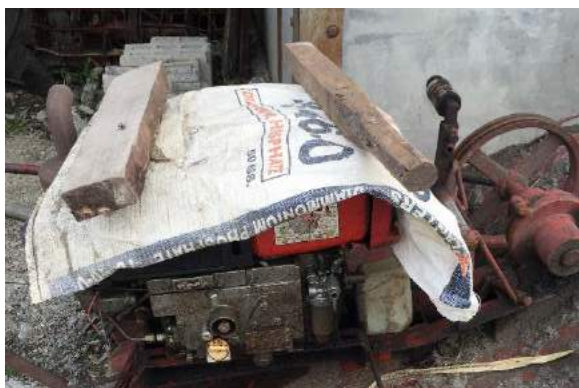
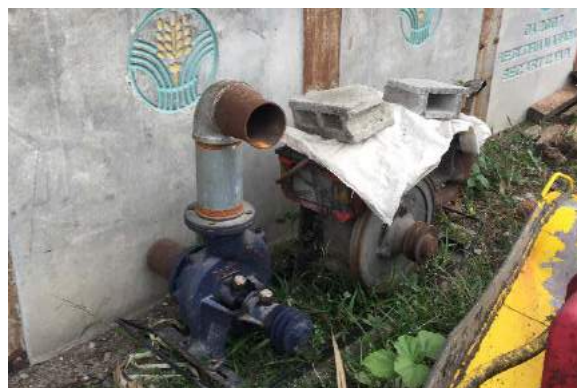
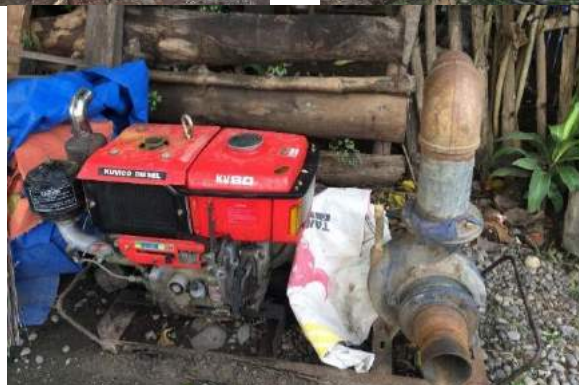
Figure 1C-7. The pumps of the New Katipunan Irrigator's Association

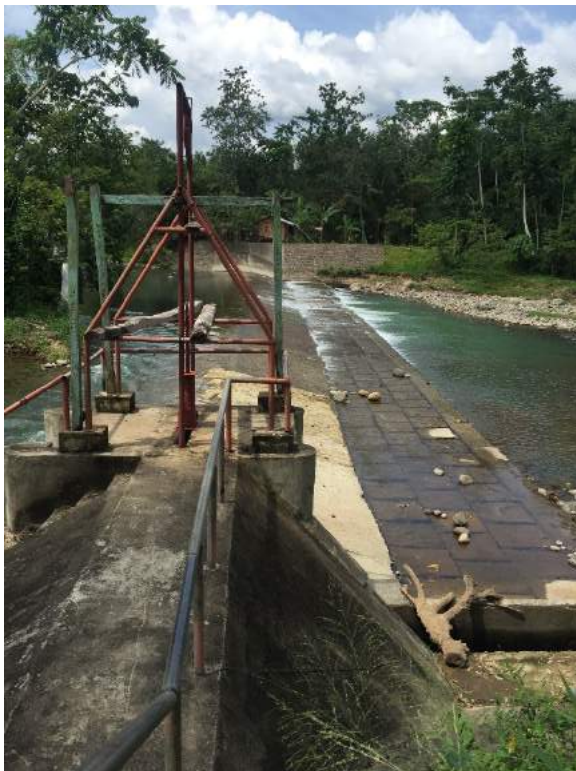
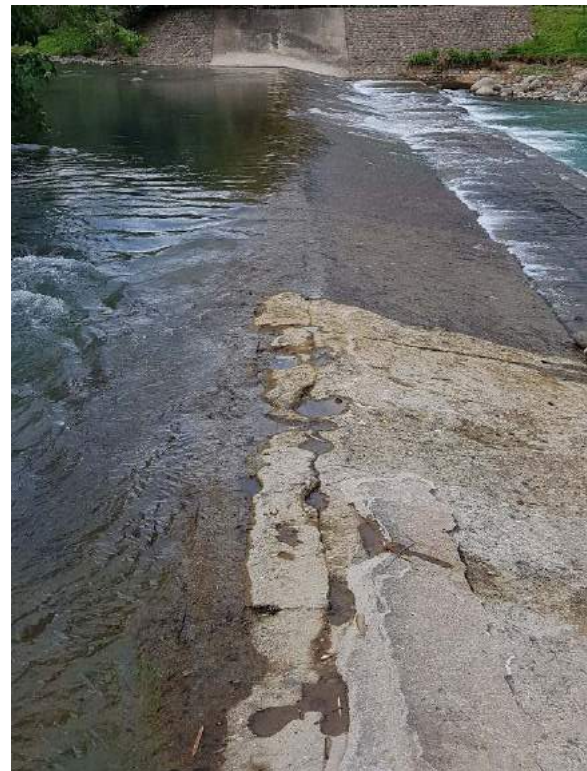
The current dam (Figure 1C-10), including the steel sluice gates and intake gates (Figure 1C-), were constructed by NIA in the 1990's. There were problems of sediments and debris flow so the IA added a silt control structure (Figure 1C-11) costing the IA about ₱50,000. The same problem caused damaged to the sluice gate and the IA repaired it at a cost of a little less than ₱30,000. The dam structure and lining require some repair due to debris and boulder laden flow and the IA conduct regular dam cleaning and desilting. The single gated sluice gate was deemed insufficient and the direction of the training wall is causing more sediments to flow to the intake gates than be flushed through the sluice gates. Most of the main canal is lined although some parts, particularly near the dam, are submerged while some are damaged causing leakages (Figure 1C-12). Sands that accumulate in the main canals are collected and sold by farmers.

Figure 1C-10. The dam of Del Carmen CIS

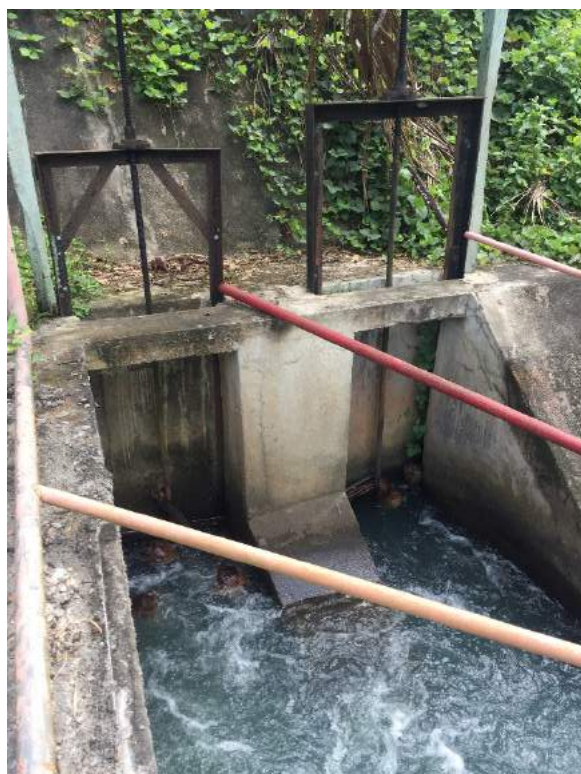
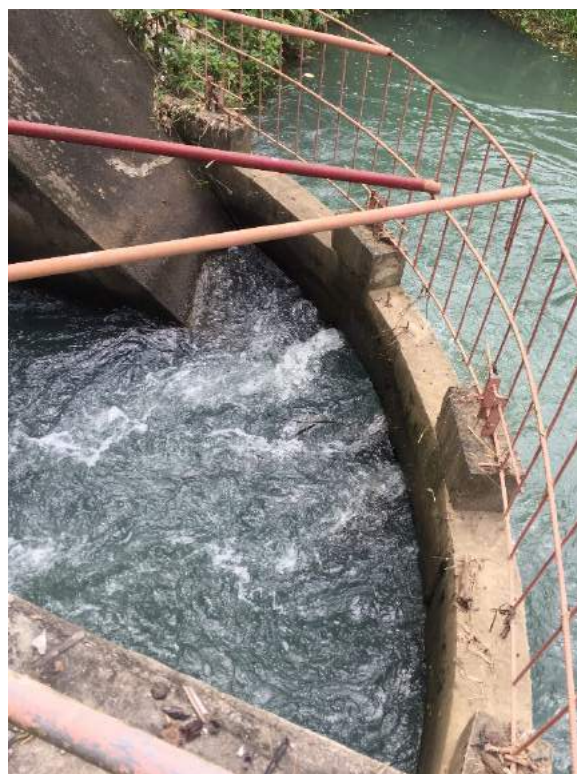
Figure 1C-11. The intake gates with the silt control structure funded by the IA

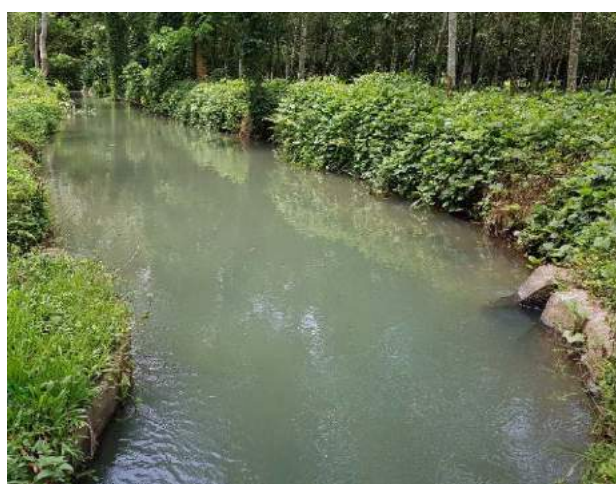
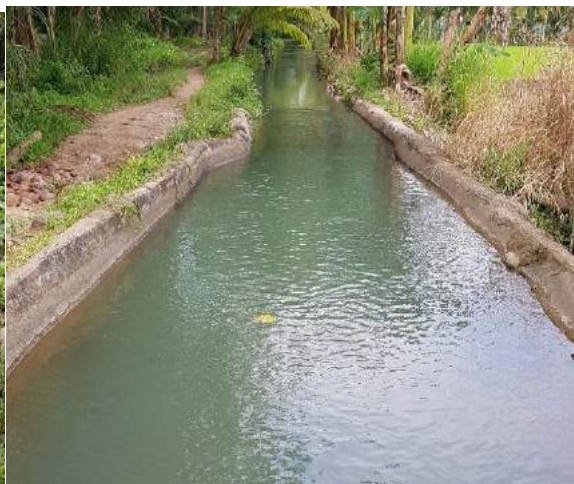
Figure 1C-12. Main canal of the system

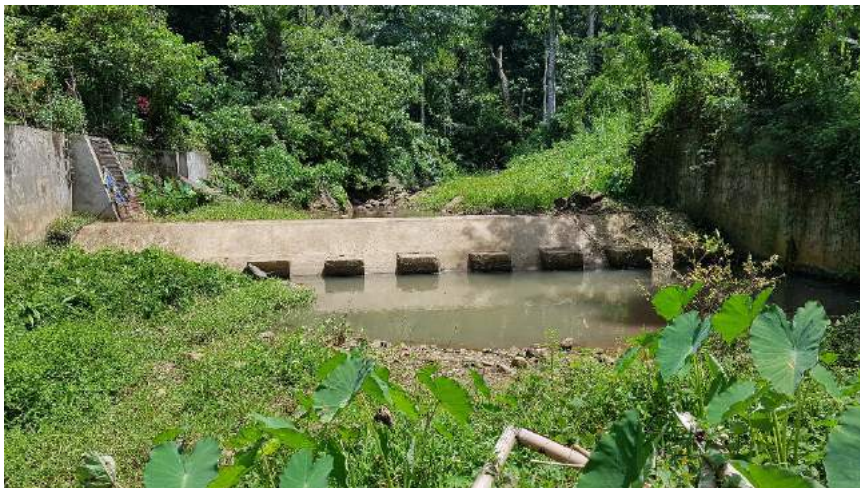
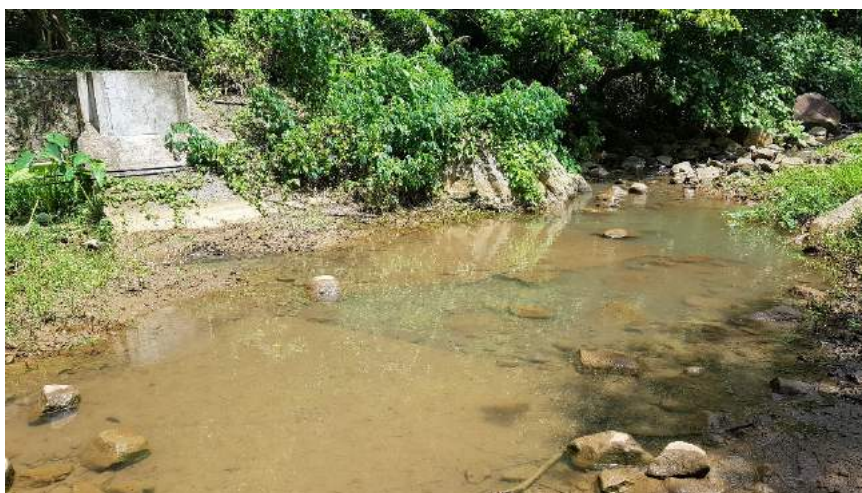
Figure 1C-13. The dam of Sta. Maria – Minamaeng CIS

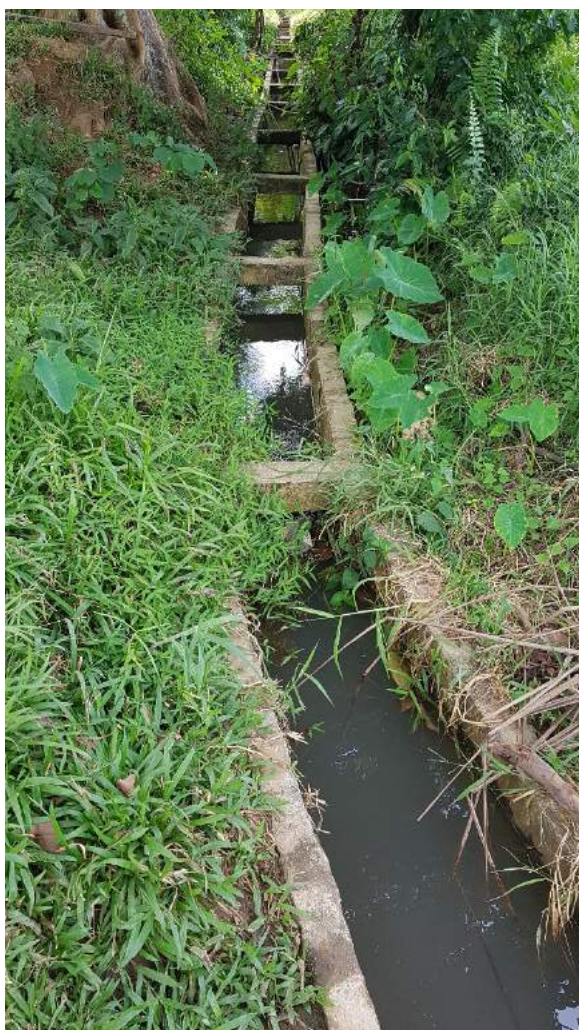
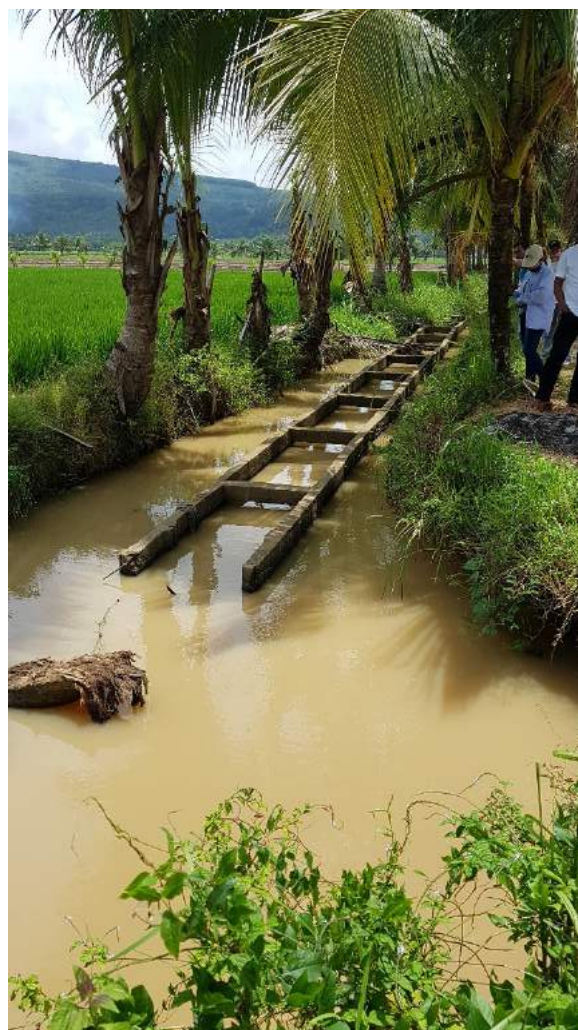
Figure 1C-14. The main canal near the dam and at the end of concrete lining

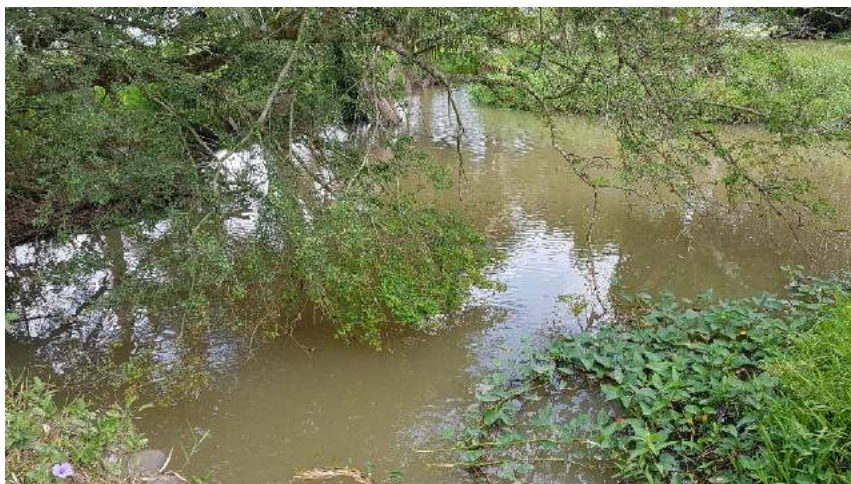
Figure 1C-15. One of several spring sources downstream

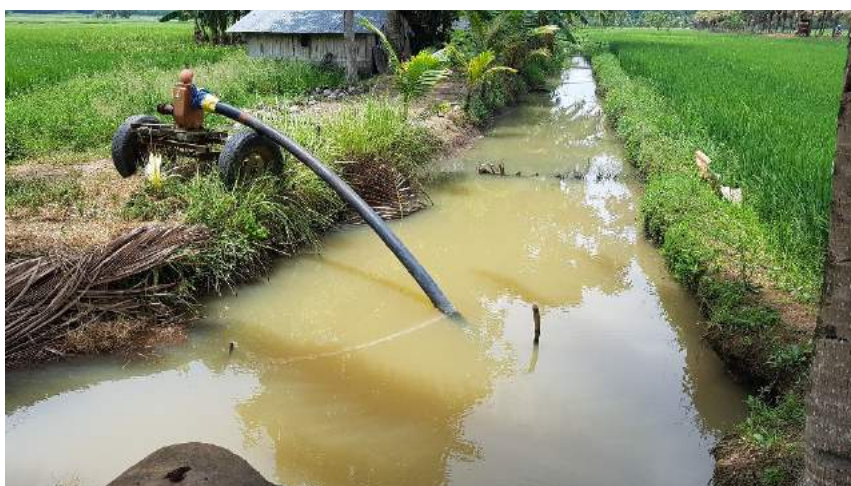
Figure 1C-16. Where the IA pumps water to reach the other side of the field

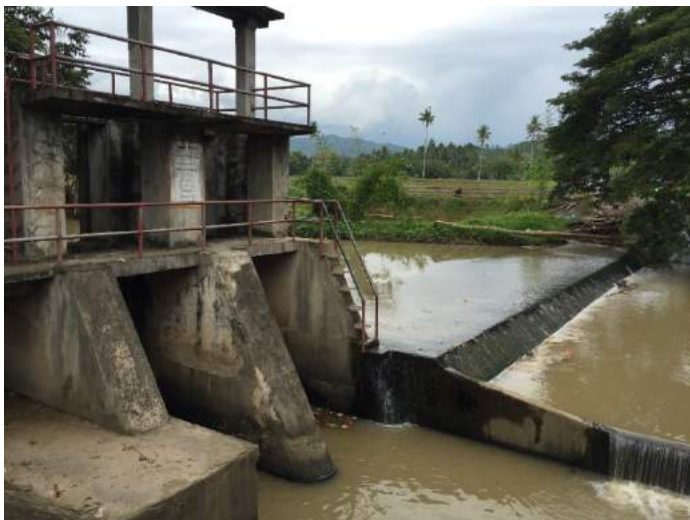
While the dam (Figure 1C-18) is still in good condition and the control gates are still working properly, the river is sediment laden and usually carry floating debris and rubbish (Figure 1C-19). The IA regularly conducts cleaning operation. The IA was granted a loan amounting to ₱13,622,922.22 in 1983, the equity being the labor of the farmers. Source of funds for equity payment mainly comes from IA-owned funds. The Hervilla CIS is already fully paid with their share in the construction of the IS. When asked regarding the FISA, the members interviewed said that there might be possible dissolution of IAs if collection rate of O&M fees will continue to decrease.

Figure 1C-18. The dam of Hervilla CIS

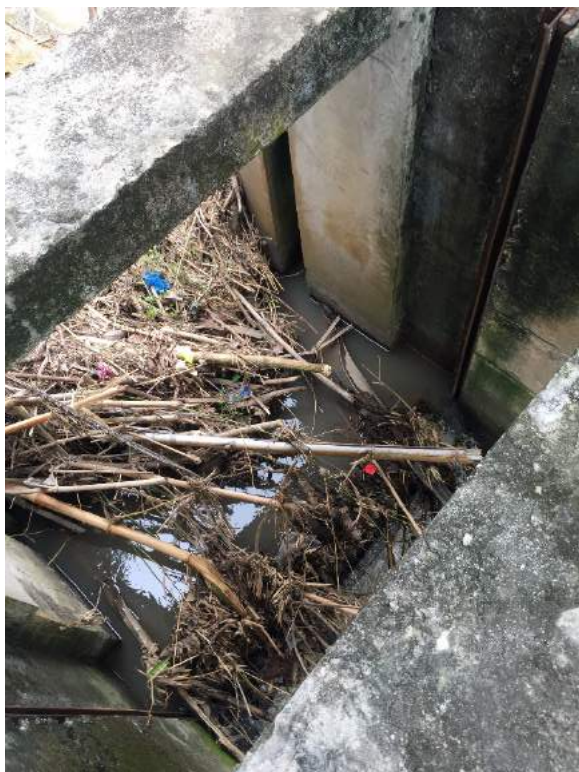
Figure 1C-19. The sluice gate of the dam

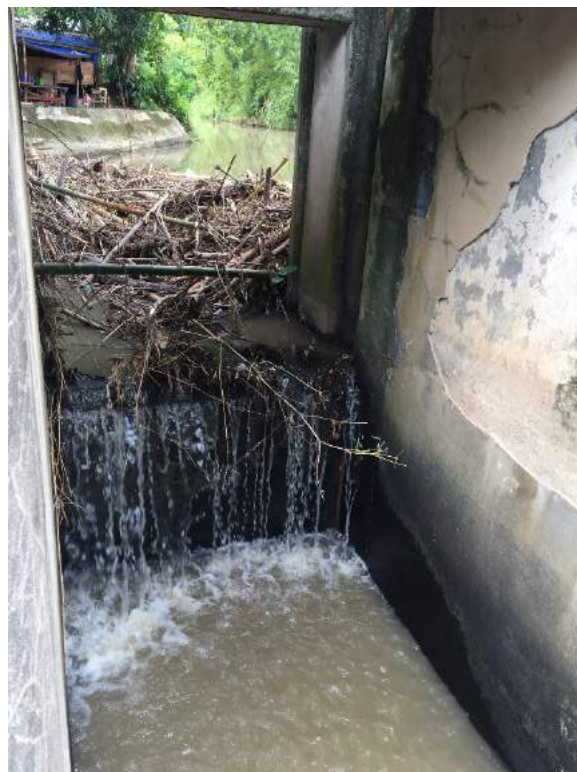
Figure 1C-20. The main canal and division box to divide flow from to different zones

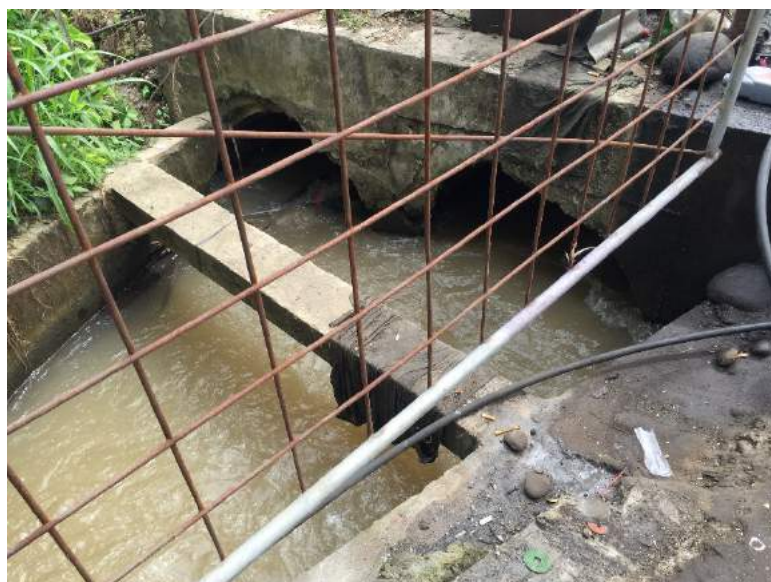
Figure 1C-21. Main canal of the system after the culvert road crossing

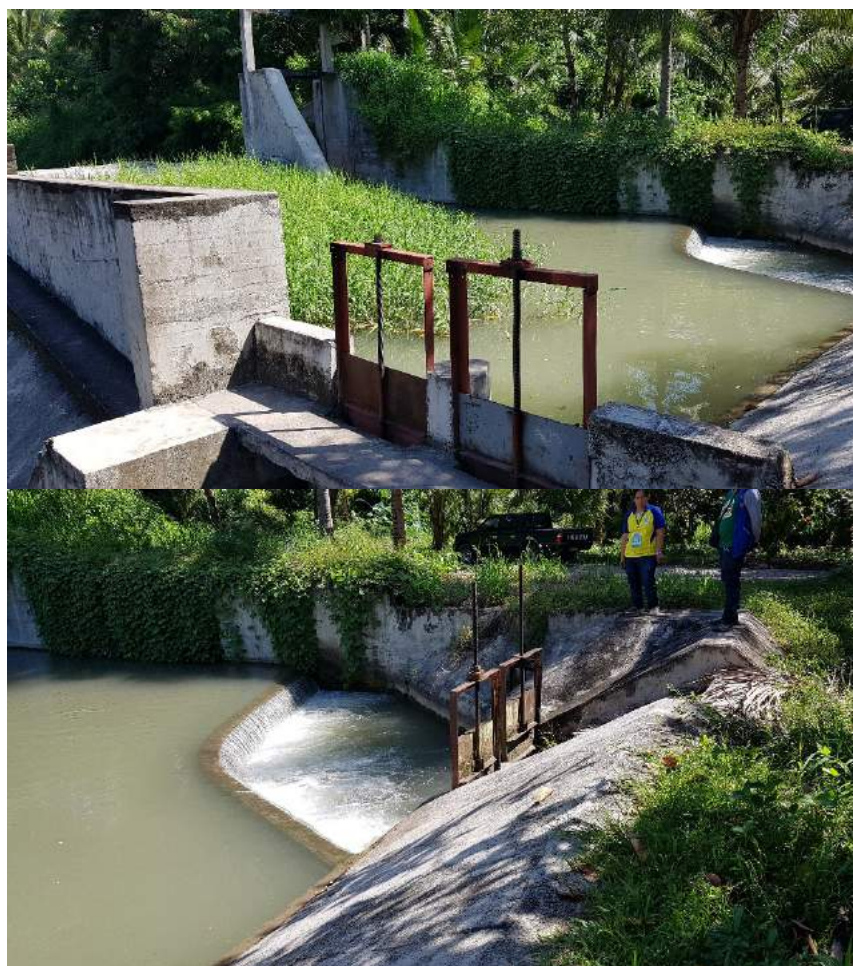
Figure 1C-23. The silt control structure and intake gate

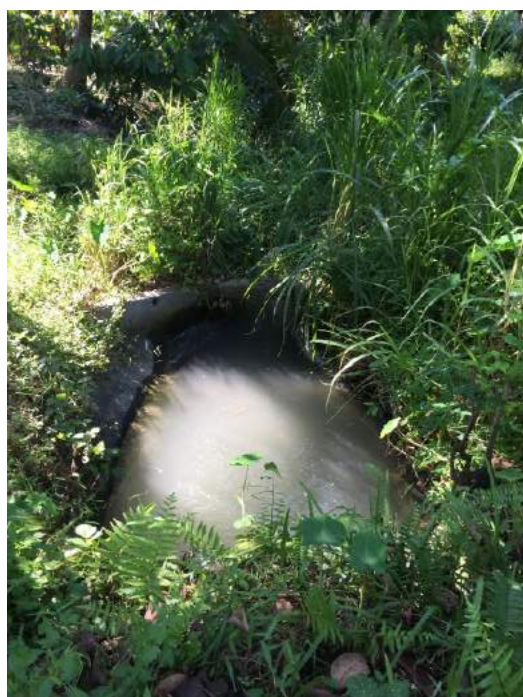
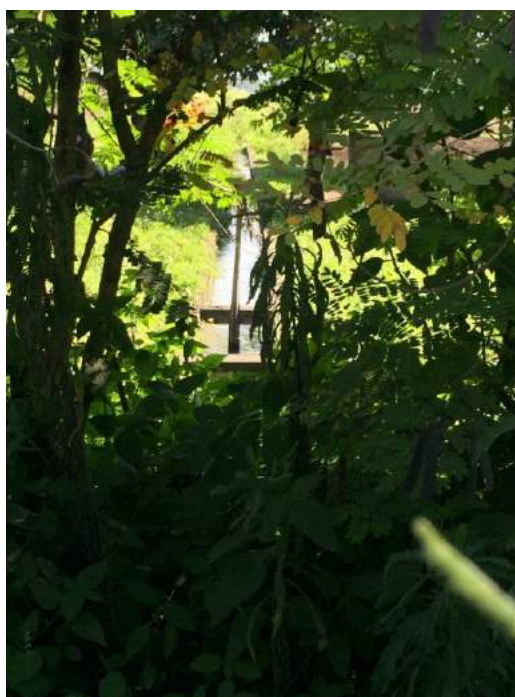
Figure 1C-24. Main canal of the system

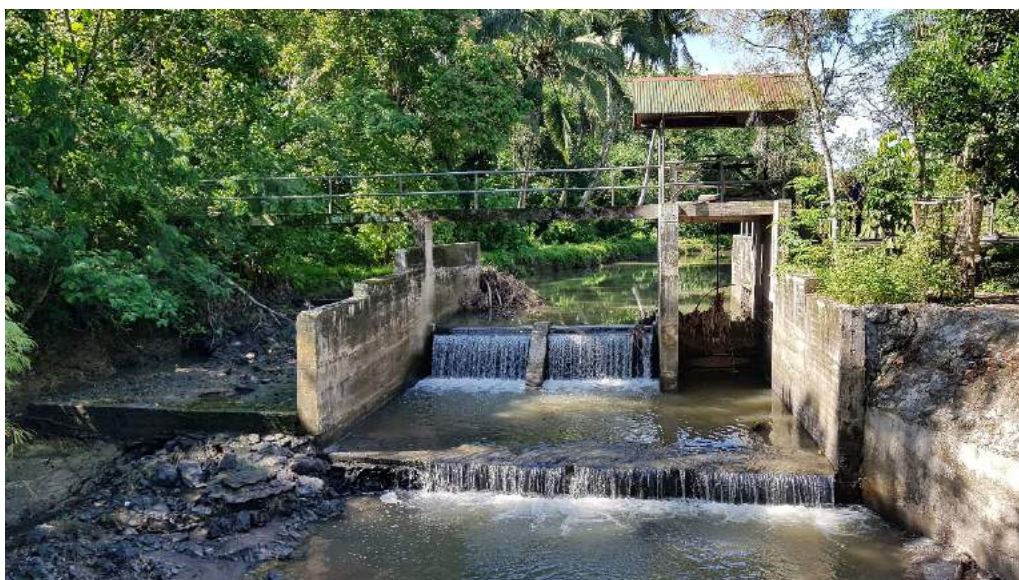
Figure 1C-25. The dam of Mani CIS with a sluice gate of 2 m width

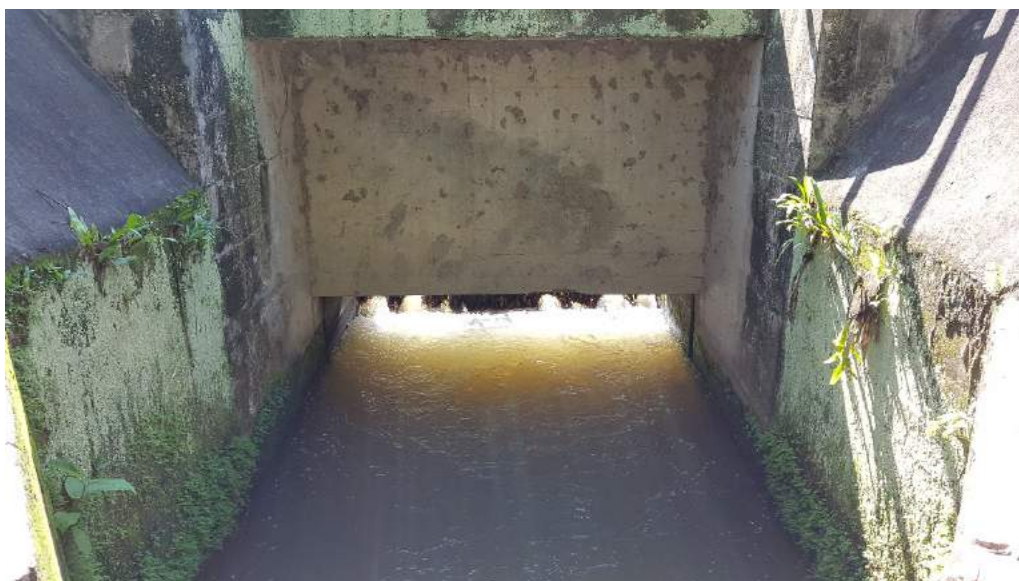
Figure 1C-26. The intake gate that is permanently open

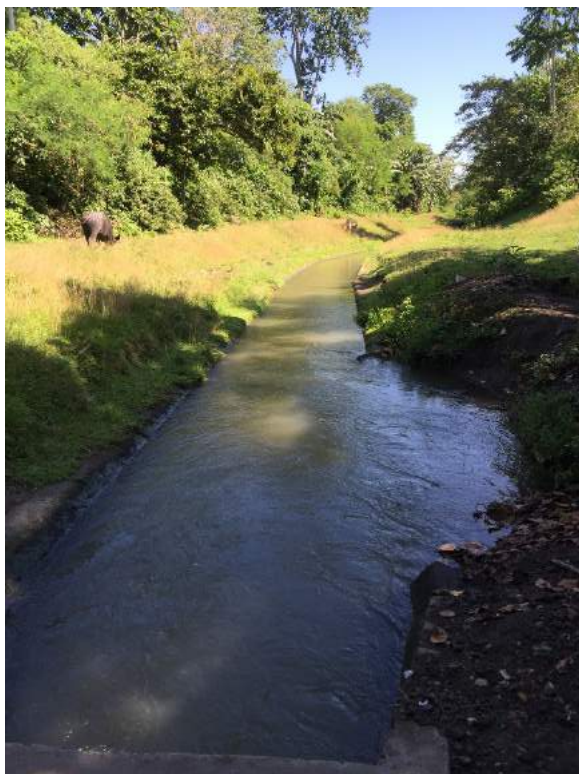
Around 3.5 km of the main canals are lined but the laterals of the system are still unlined. There was one main problem where the main canal narrowed causing the water to overflow. There are also some damaged portions of the main canal causing water leakage. There are no illegal turnouts for the system but some farmers do not follow the imposed schedule when there is not enough water.

Figure 1C-27. The main canal of Mani CIS from the dam

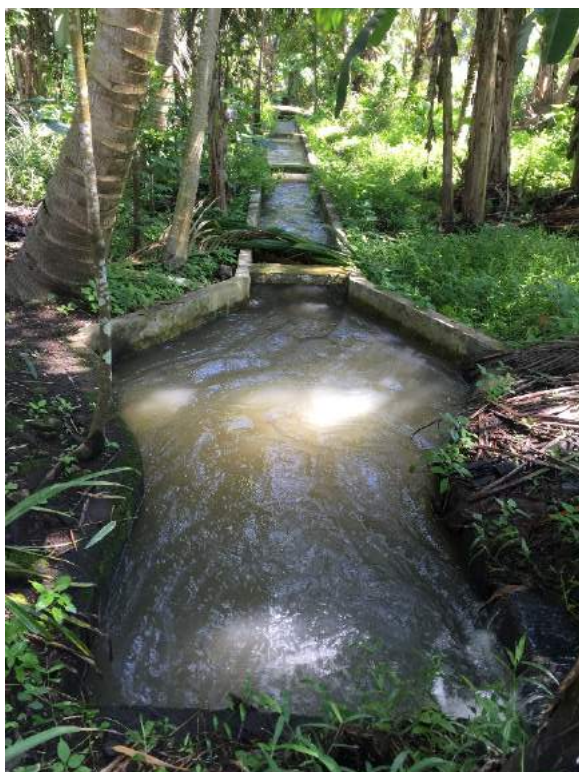
Figure 1C-28. Division box to several laterals

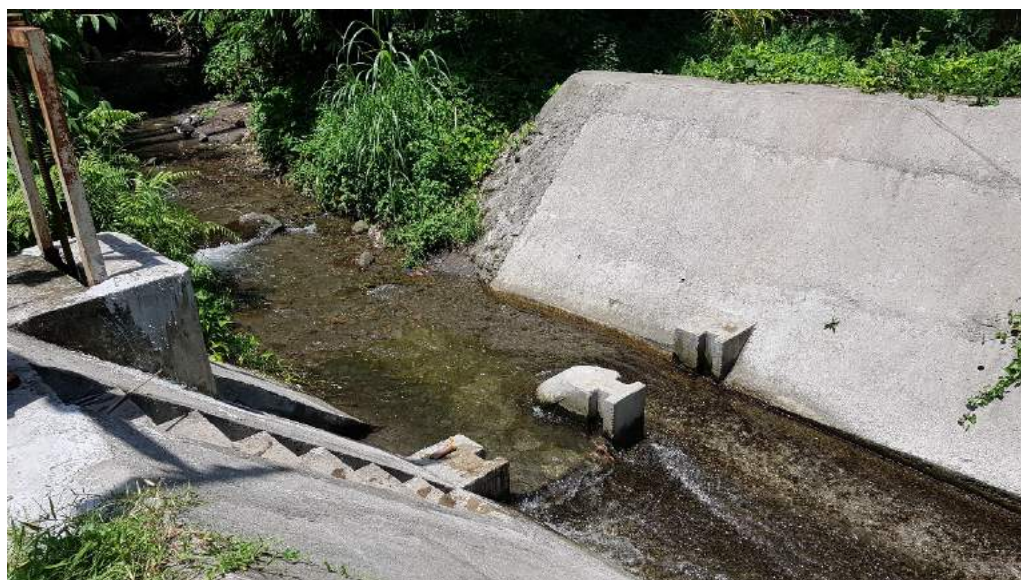
Figure 1C-29. The simple gated dam of Bunao CIS

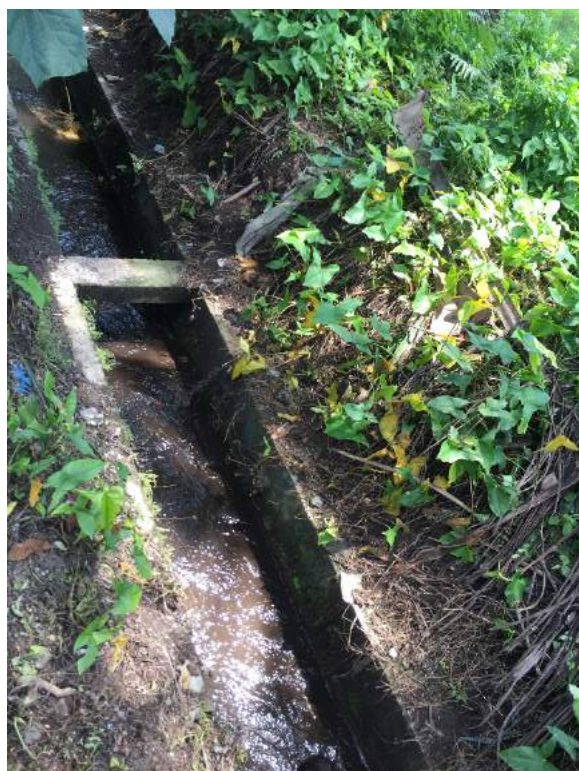
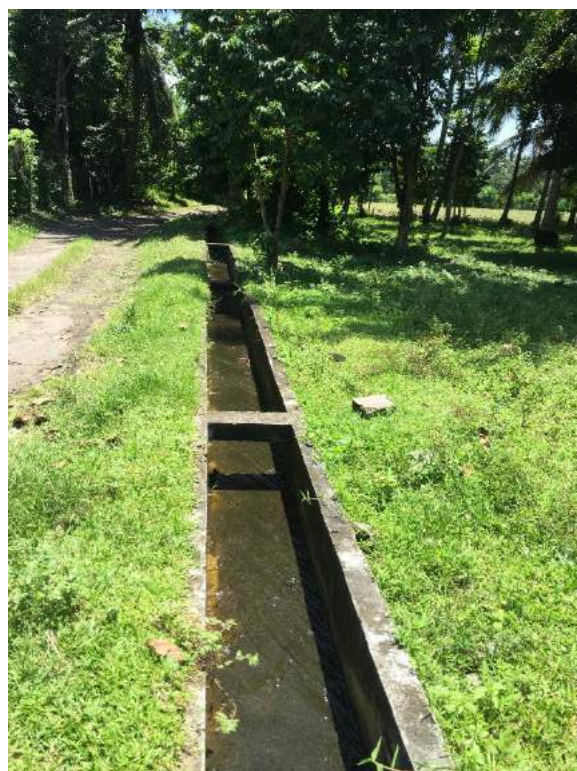
Figure 1C-30. The lined main canal of the system

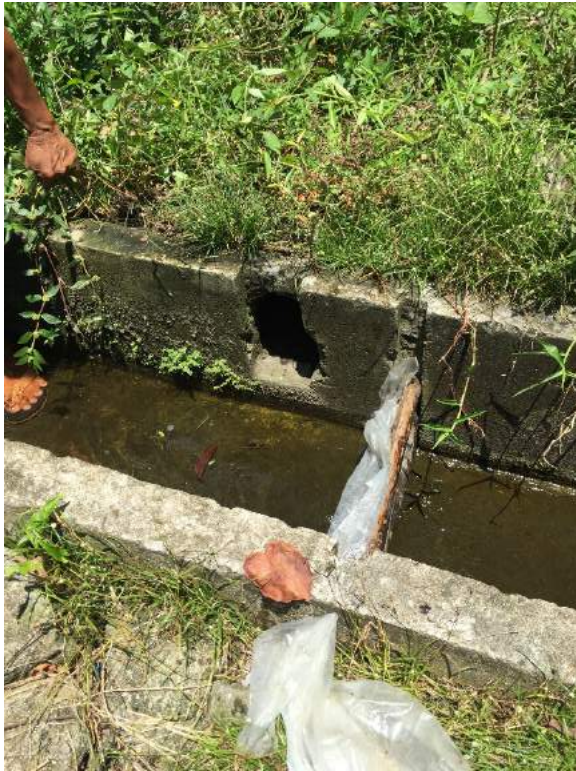
Figure 1C-31. Simple hole turnout and improvised gate

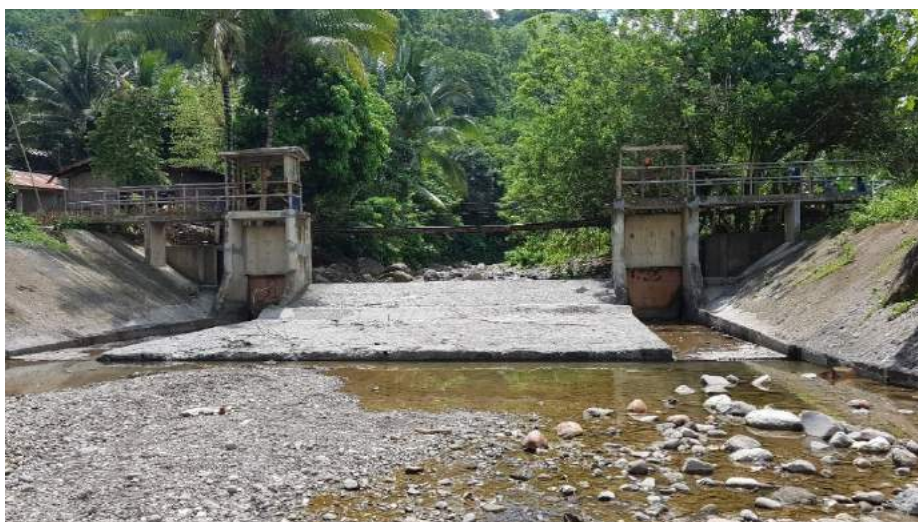
The original dam was built in 1975 through the FSDC and the previous gates were made of wood. The dam was 4-ft deep before but was filled with rocks and boulders starting 2003. It was replaced by NIA in 2013 with a new dam (Figure 1C-32), including steel sluice gates and intake gates on both sides, and lined canals. Last 2017, the dam was damaged due to typhoon Vinta and the dam storage is again filled with rocks and boulders. The downstream apron of the dam is also damaged with scoured concrete lining and exposed steel frames (Figure 1C-33). The lifting mechanisms of the gates were replaced with secondhand chain blocks bought by the IA at ₱6,000 for the 5-ton capacity and ₱5,000 for the 3 tonners.

Figure 1C-32. The dam of Delapa CIS

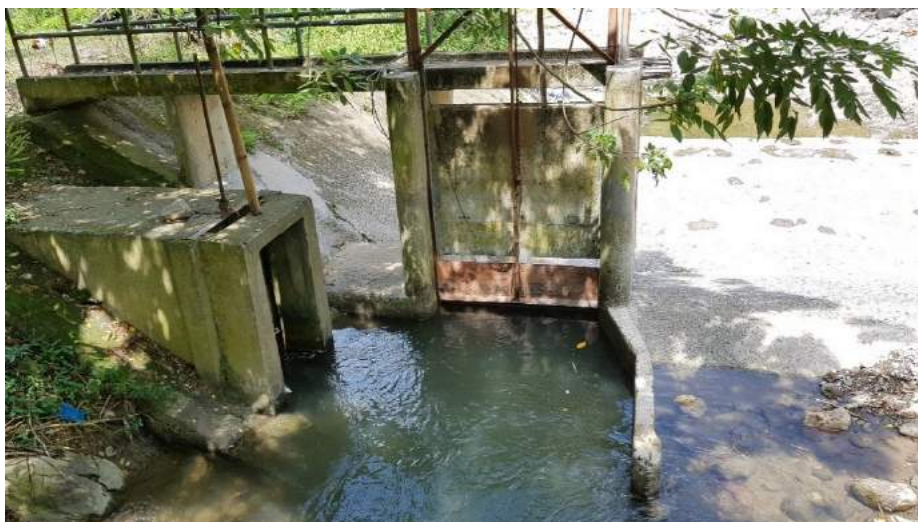
Figure 1C-34. The left sluice gate and intake gate of the dam

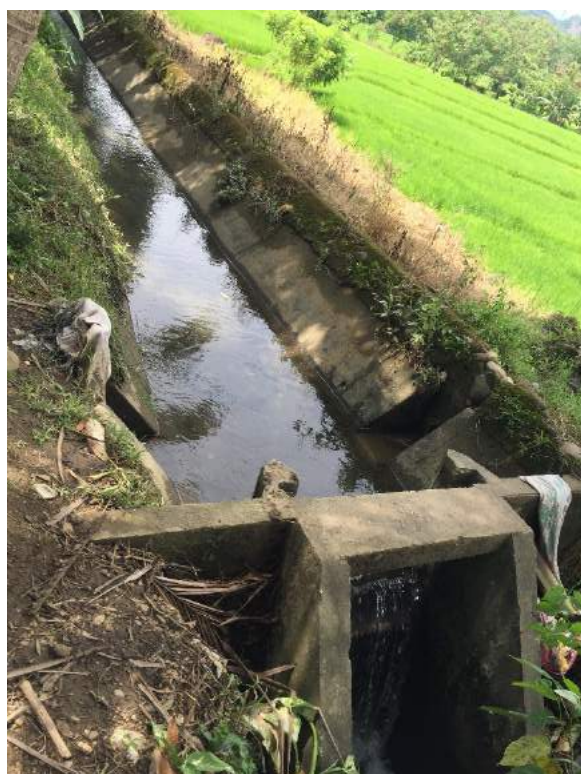
Figure 1C-35. Trapezoidal main canal of the system

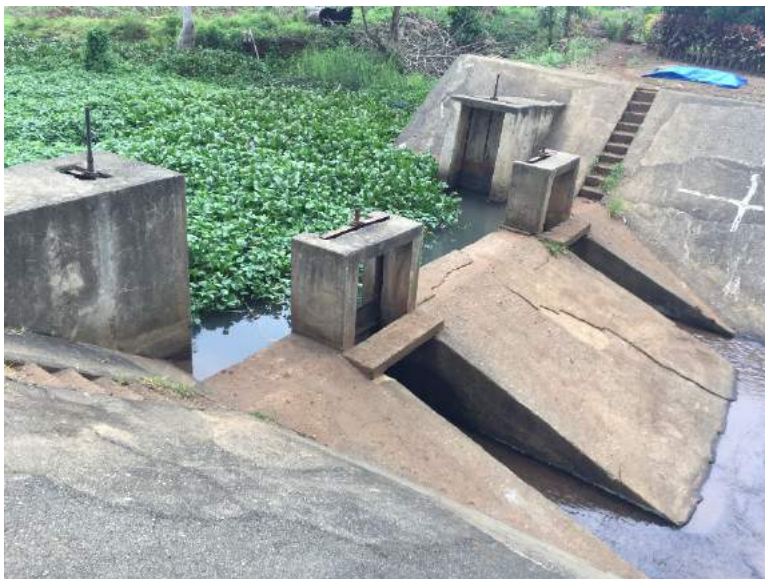
Figure 1C-37. The dam of the system

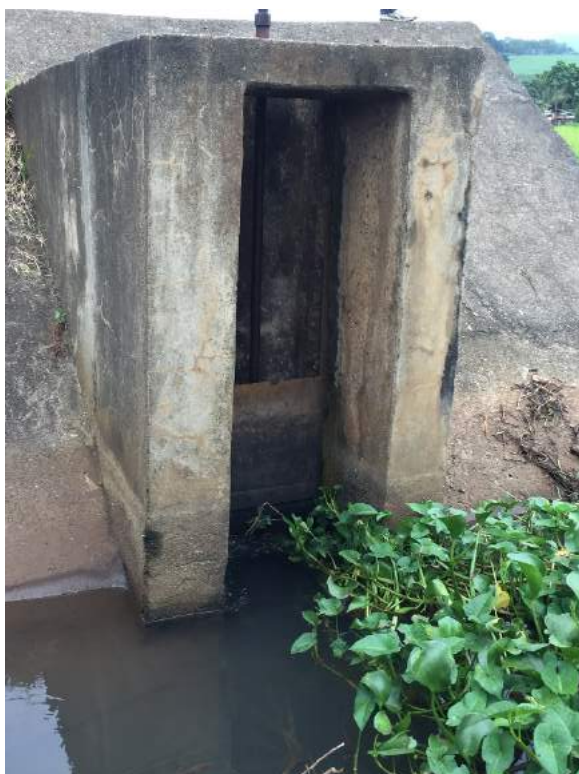
Figure 1C-38. Right main canal intake with 0.5 m width

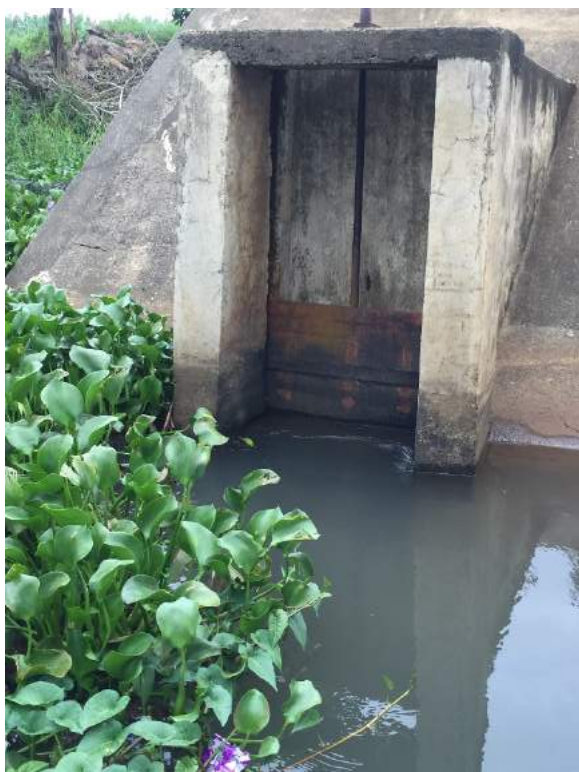
Figure 1C-39. Left main canal intake with 1 m width

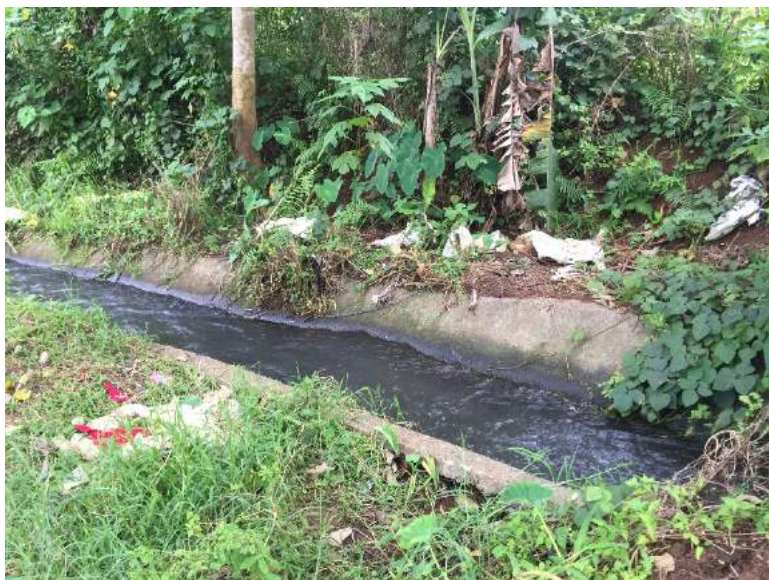
Figure 1C-40. Right main canal of Magsaysay CIS

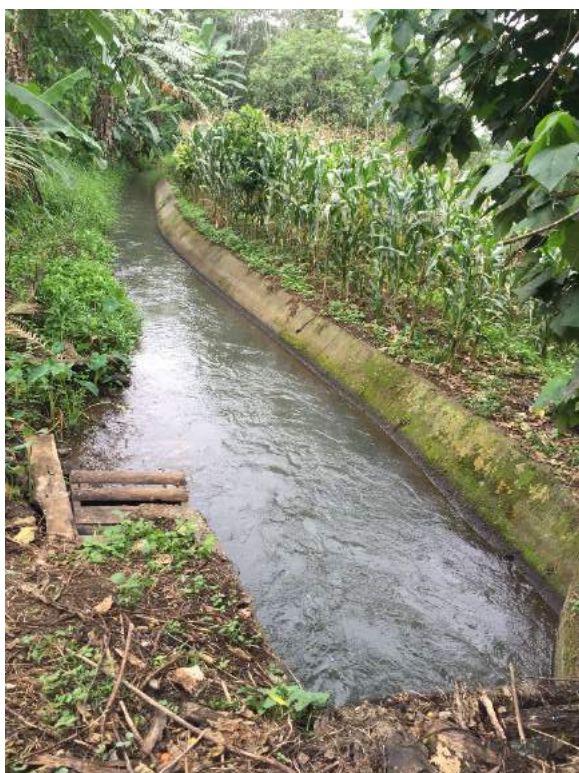
Figure 1C-41. Left main canal of the CIS

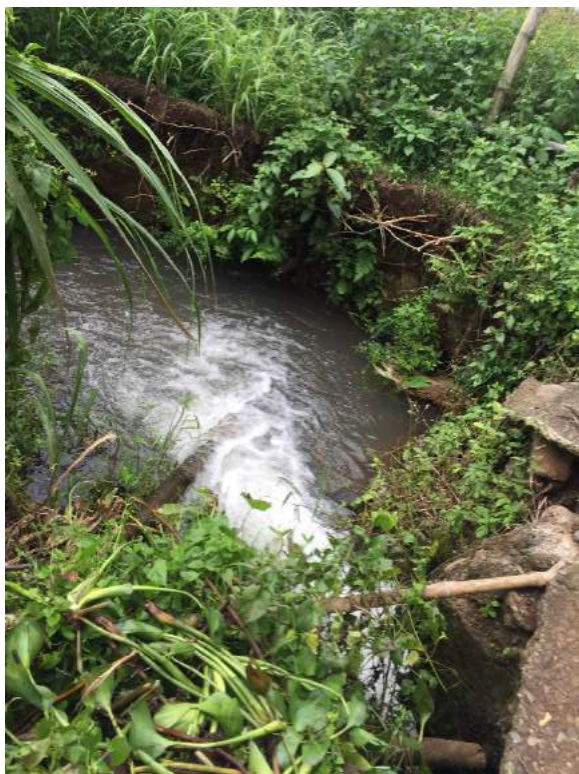
Figure 1C-42. Lateral canal which waters only 10 ha of field

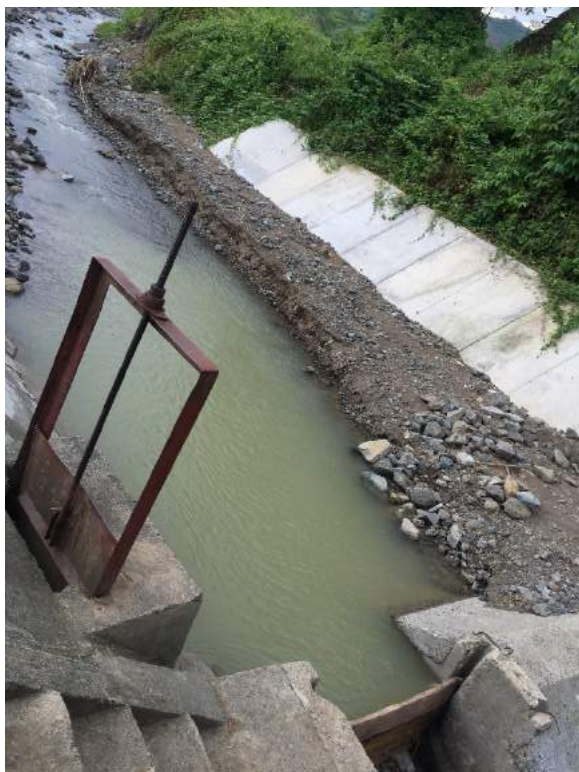
Figure 1C-44. Dam 1 of Miglamin CIS

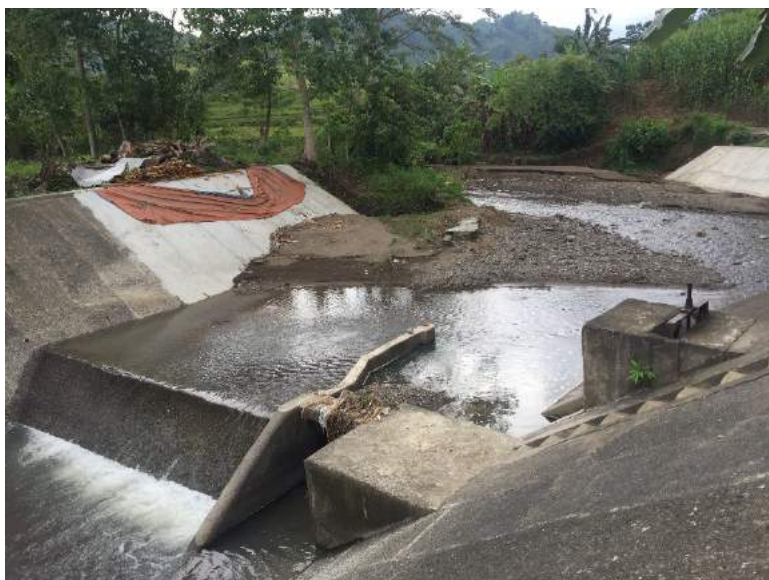
Figure 1C-45. Dam 2 of the system wherein the sand also enters the intake gate

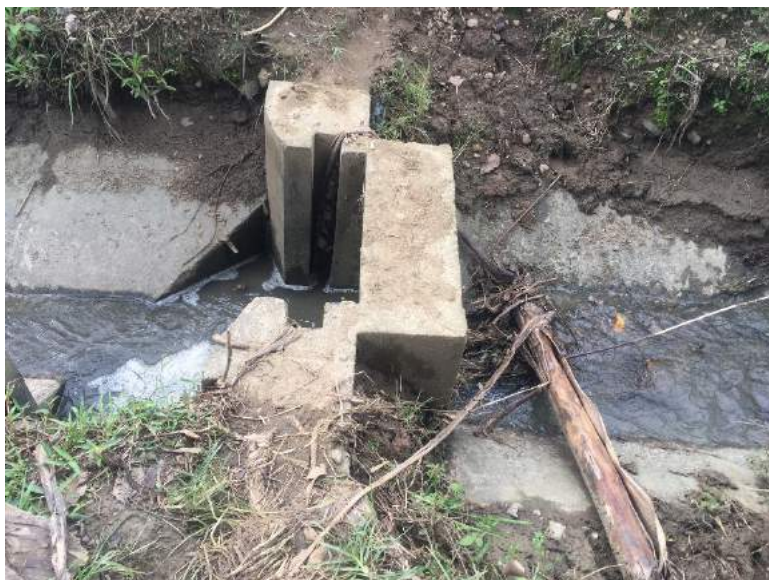
Figure 1C-48. Ejector for silts in main canal connected in Dam 2

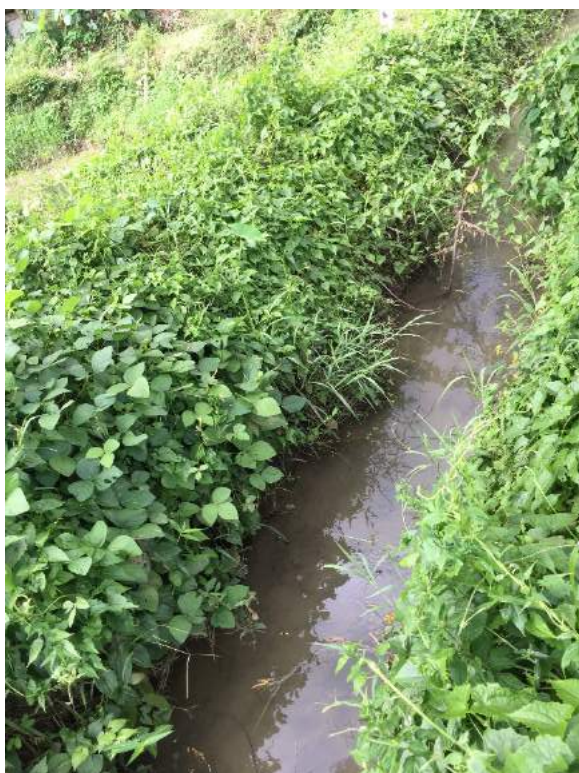
Figure 1C-49. Silted main canal connected to Dam 2
