Assessing the resurgent irrigation development program of the Philippines: Communal irrigation systems component

PIDS Discussion Paper Series, No. 2020-02

Assessing the Resurgent Irrigation Development Program of the Philippines – Communal Irrigation Systems Component

Roger A. Luyun Jr. and Dulce D. Elazegui

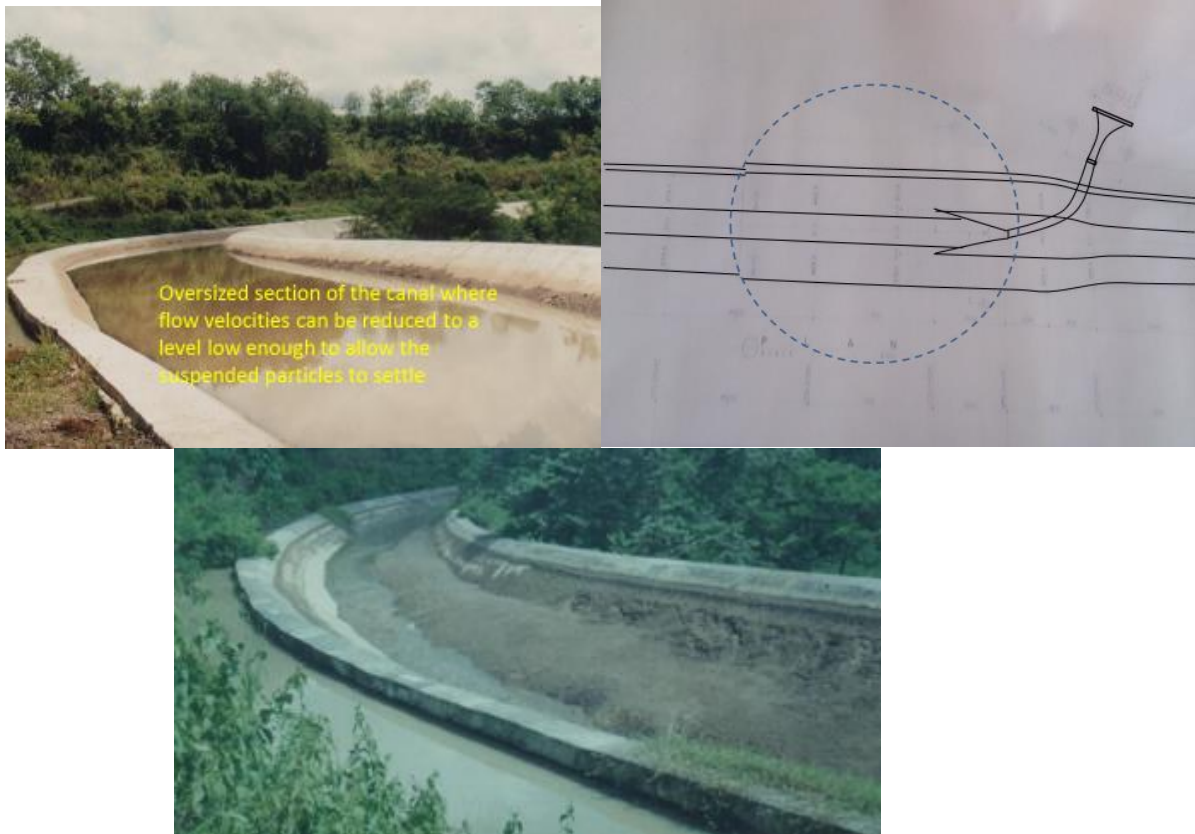
The study at the MALRIS pointed out that silt excluder reduced the intrusion of sediment (sand) in the main canal. The provision of settling basin in the main canal of Mlang RIS reduced the rehabilitation costs on a yearly basis, specifically, on dredging activities or canal de-silting. These silt control devices, and a host of many others (e.g. King's silt vanes, Gibb's groyne, curved wing with silt vanes, silt platforms, vortex tube sand trap and sloping sill sand screen) can be used to reduce or flush out silts from the canal and the river itself. However, if large bed loads, including rocks and boulders are present upstream, the use of Sabo dams may be employed. But the more important measure is to promote a community-based project in cooperation with local DENR (MENRO, PENRO) to protect and conserve the watershed area.

Figure 25. Settling basin at the Mlang RIS

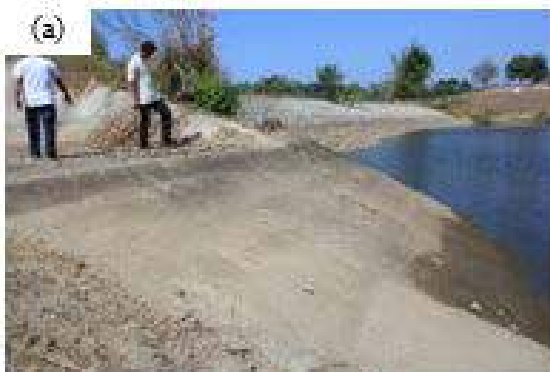
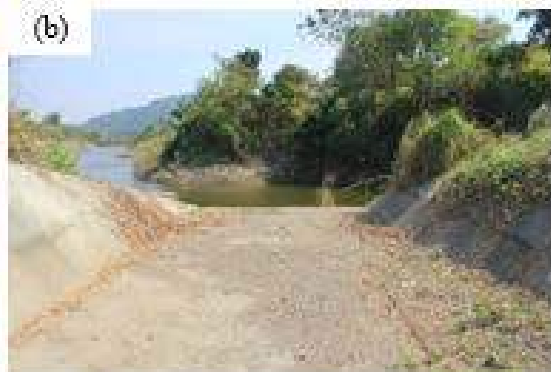
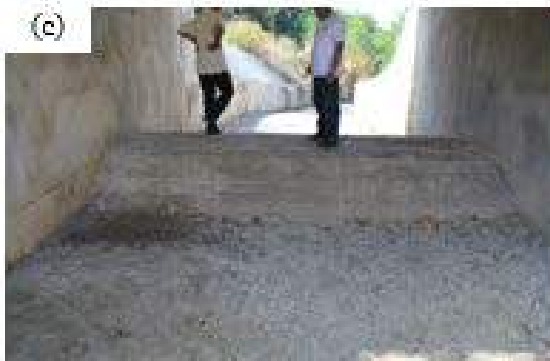
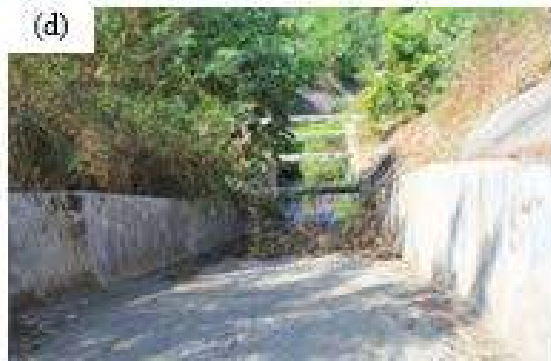
Figure 1A-47. (a) The entranceway to the concrete spillway; (b) the level spillway channel; (c) the hump along the spillway channel to increase storage capacity of the dam; (d) the spillway chute to channel excess water from the dam to a creek

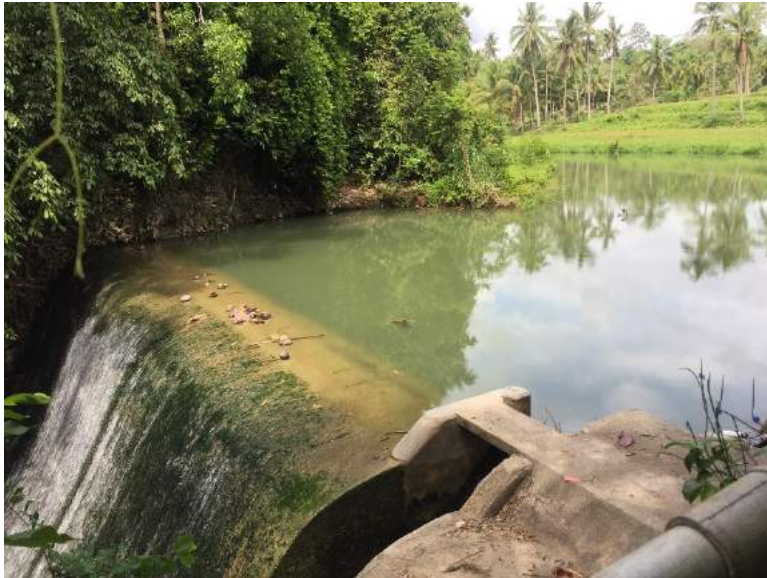
The dam (Figure 1B-1) was built in 1982 and is still fully operational with some rehabilitations done on the intake gate and several turnouts. About 4.5 km of the main canal and some portions of the lateral canals are lined (Figure 1B-2). There is minimal siltation observed although the inverted siphon passing underneath a creek was clogged preventing the conveyance of water from the main canal to about 40 ha downstream. The IAs wants NIA to use GI pipes to convey the water over the bridge instead to continue servicing water in the affected farms. The river has enough water to irrigate all the service area as long as there are no broken or nonoperational canals. Water flowing to Kanumantad falls comes from the dam so when the intake gate is fully opened, no water flows on the falls. Some farmers use pumps to supplement water from the system. Saline intrusion and sedimentation are also problems encountered by the farmers in the downstream sector. The IA suggests to complete concreting of canal lining and desilting of Gabayan river.

Figure 1B-1. The main dam of the Gabayan CIS
Source: Author's capture

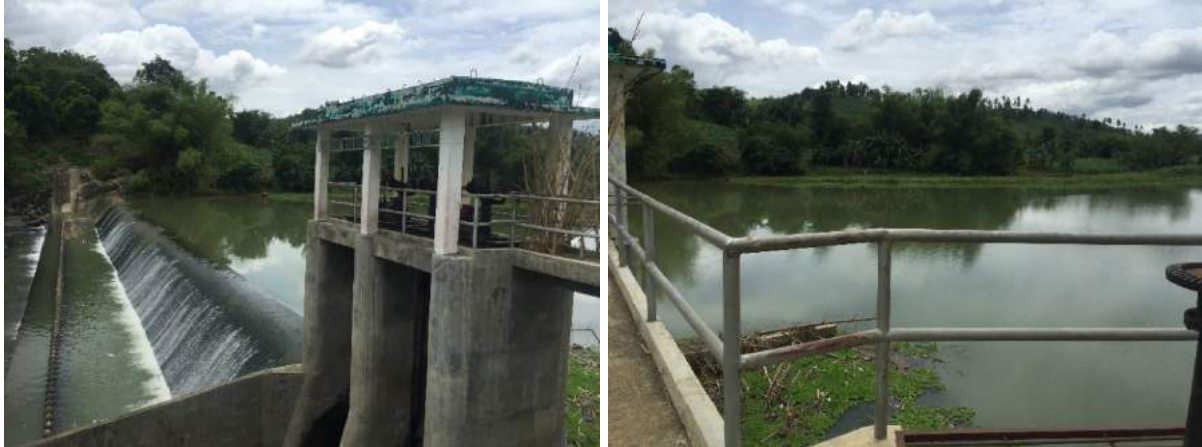
Figure 1B- 29. The dam of Maayon CIS

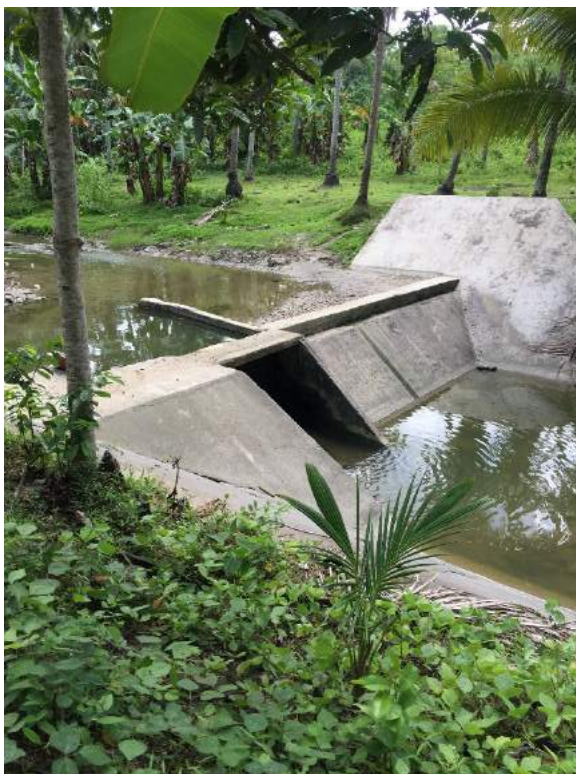
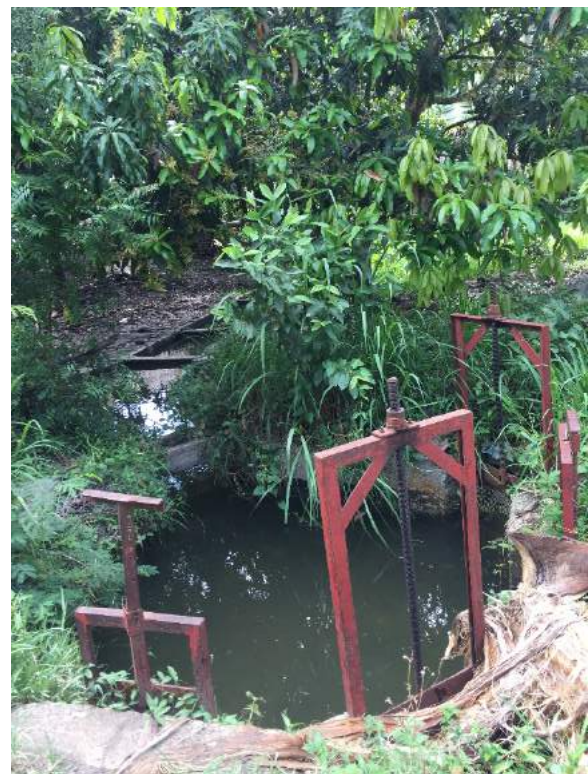
The dam (Figure 1C-5) was built in 1979 and started operation a year after. After completion of the project, however, problems emerged including no steels and unstable trapezoidal canals. Many parts of the main canal are still unlined and there is a broken section in the lined part (Figure 1C-6). The system was turned over to the IA in 1990. It is managed by Latale New Katipunan IA and at present have 81 rice farmer-beneficiaries.

Figure 1C-5. The dam of New Katipunan CIS with the head gates

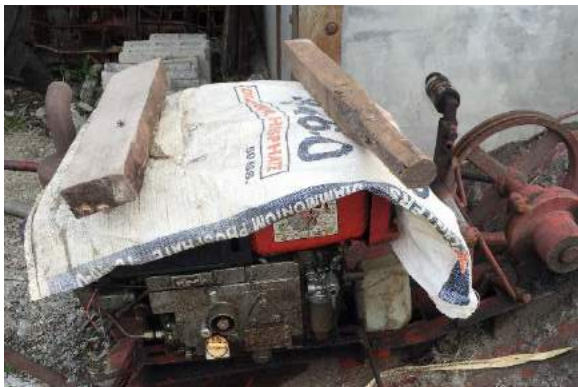
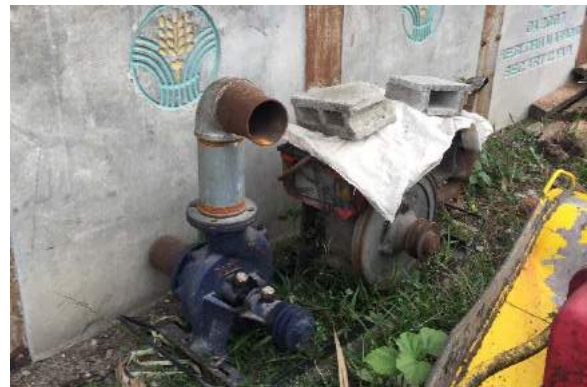
Figure 1C-7. The pumps of the New Katipunan Irrigator's Association

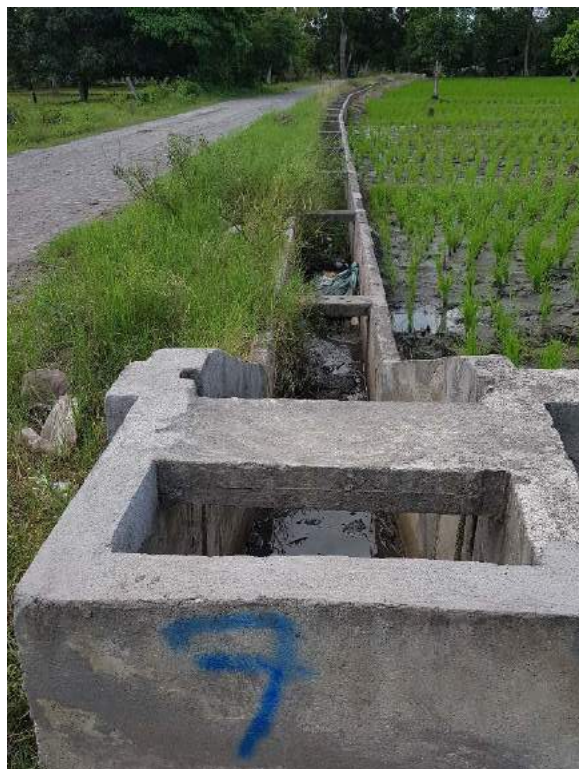
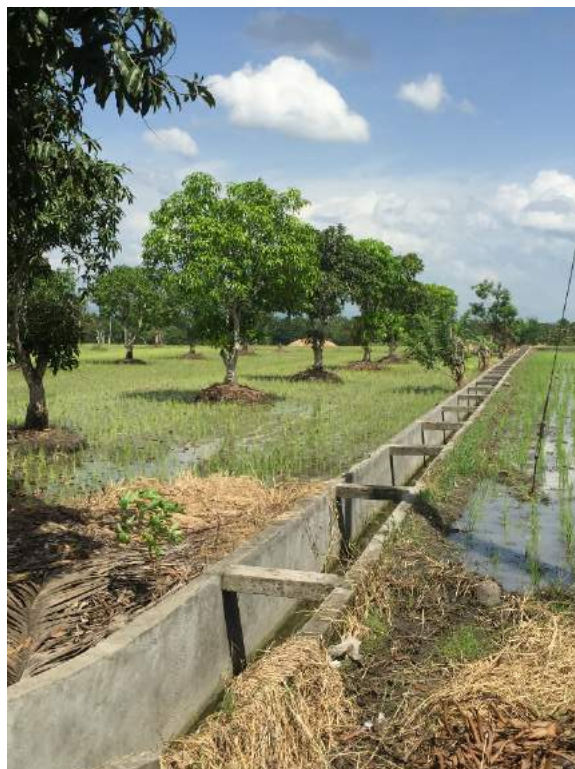
Figure 1C-9. Lined main canal of the Butilon CIS

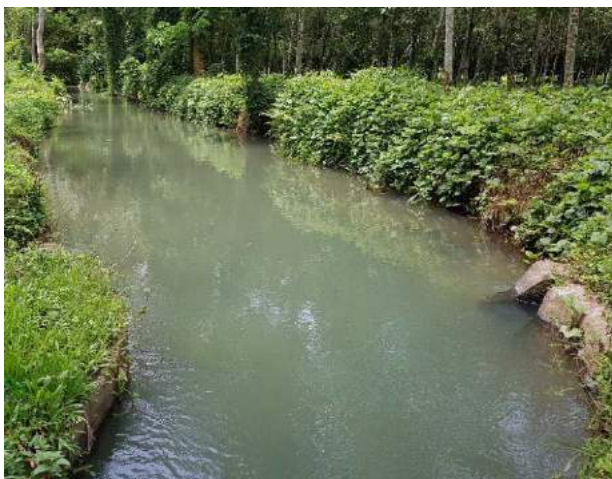
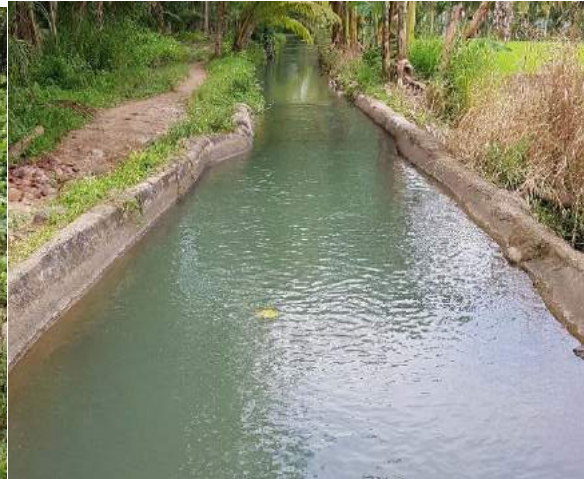
Figure 1C-12. Main canal of the system

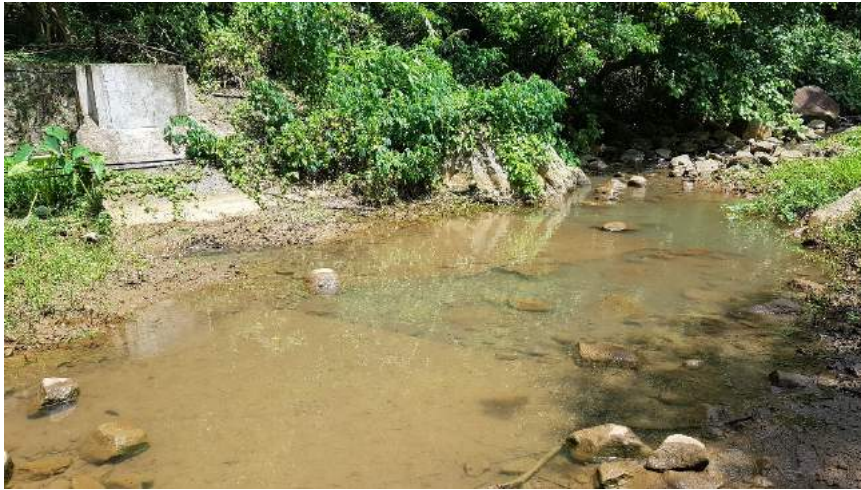
The IA President have served since 2011 and said people appoint whoever they want and there are no term limits. Officers stay in position as long as members of the IA wants them. Members of the body are not compensated but nonetheless, officers still do their best to serve the IA. So far there had not been any issues with the members. IA officials said that they do not have conflicts with regards to the maintenance of the IS. There are no conflicts among members too. All members attend the General Assembly every year and structures of the IS are well-maintained.

Figure 1C-13. The dam of Sta. Maria – Minamaeng CIS

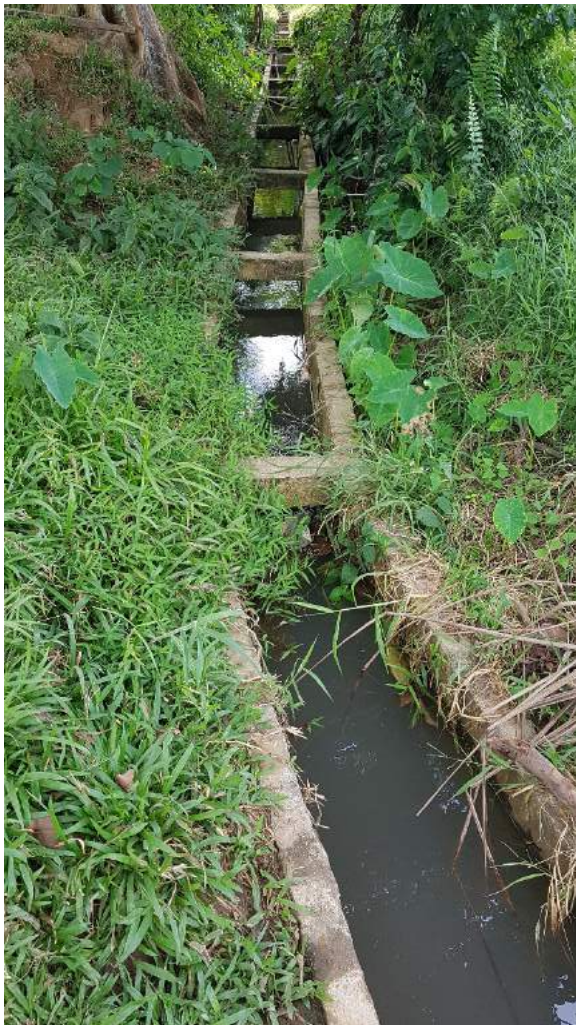
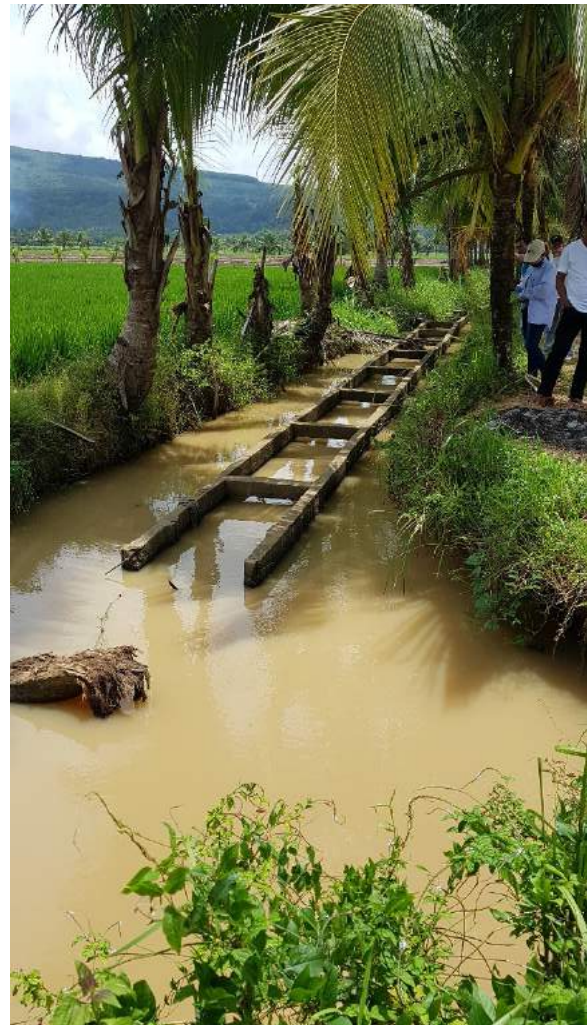
Figure 1C-14. The main canal near the dam and at the end of concrete lining

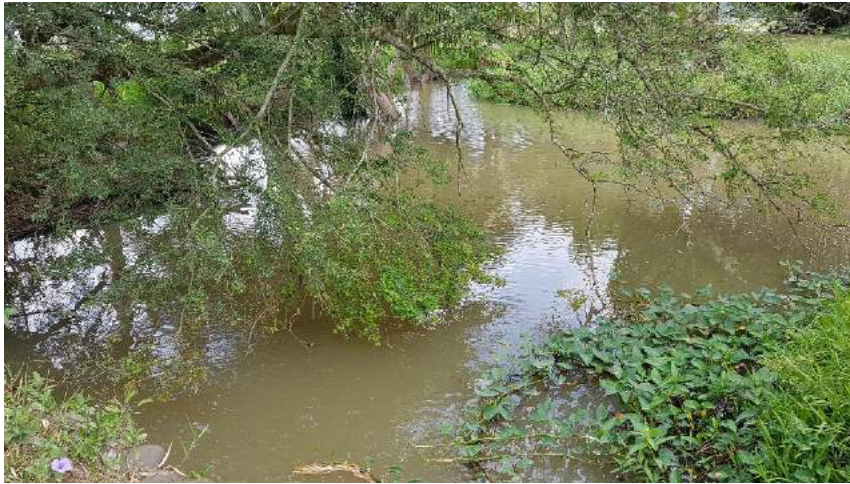
Figure 1C-15. One of several spring sources downstream

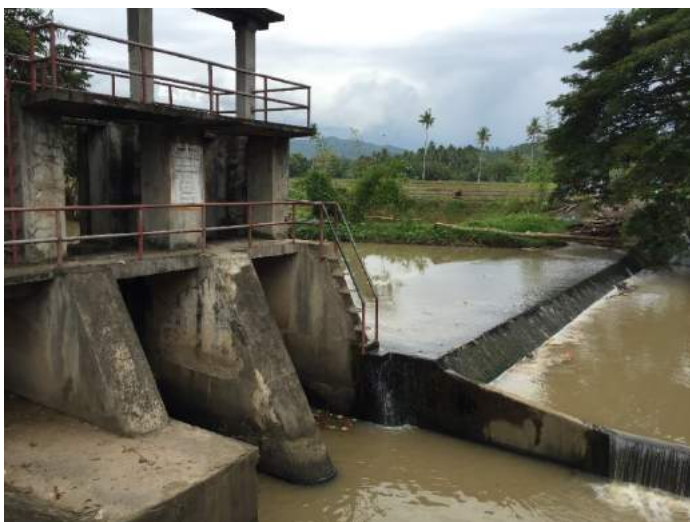
While the dam (Figure 1C-18) is still in good condition and the control gates are still working properly, the river is sediment laden and usually carry floating debris and rubbish (Figure 1C-19). The IA regularly conducts cleaning operation. The IA was granted a loan amounting to ₱13,622,922.22 in 1983, the equity being the labor of the farmers. Source of funds for equity payment mainly comes from IA-owned funds. The Hervilla CIS is already fully paid with their share in the construction of the IS. When asked regarding the FISA, the members interviewed said that there might be possible dissolution of IAs if collection rate of O&M fees will continue to decrease.

Figure 1C-18. The dam of Hervilla CIS

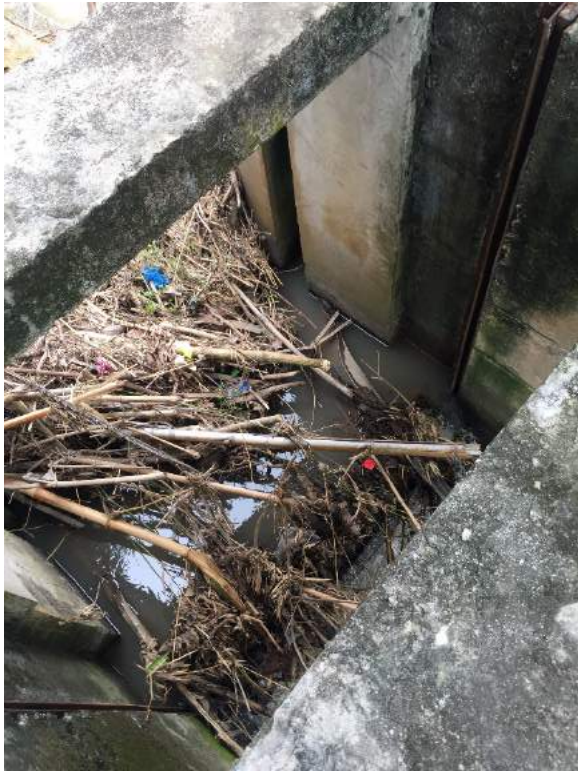
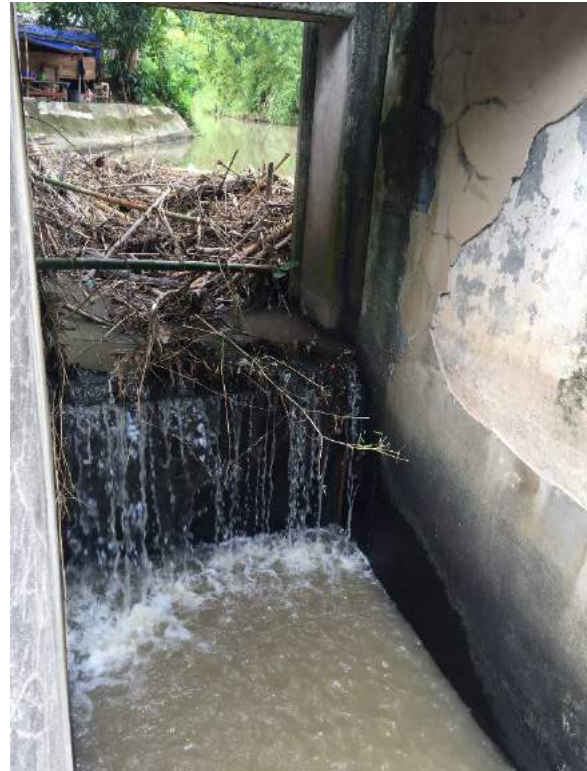
Figure 1C-19. The sluice gate of the dam

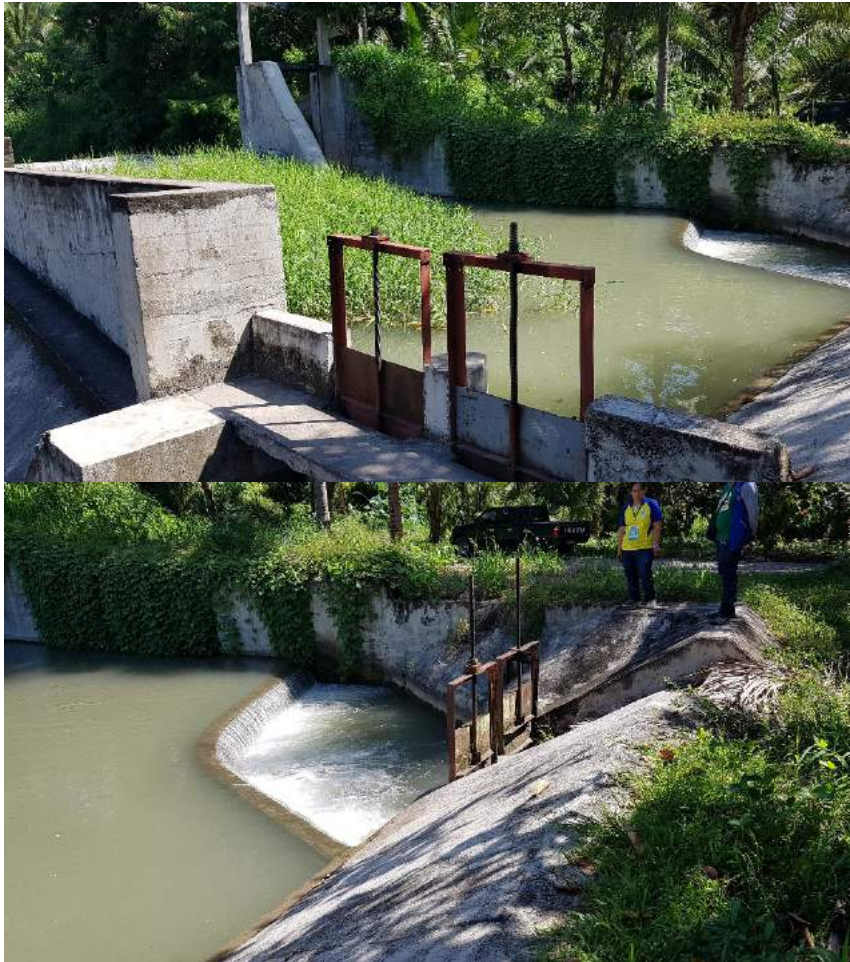
Figure 1C-23. The silt control structure and intake gate

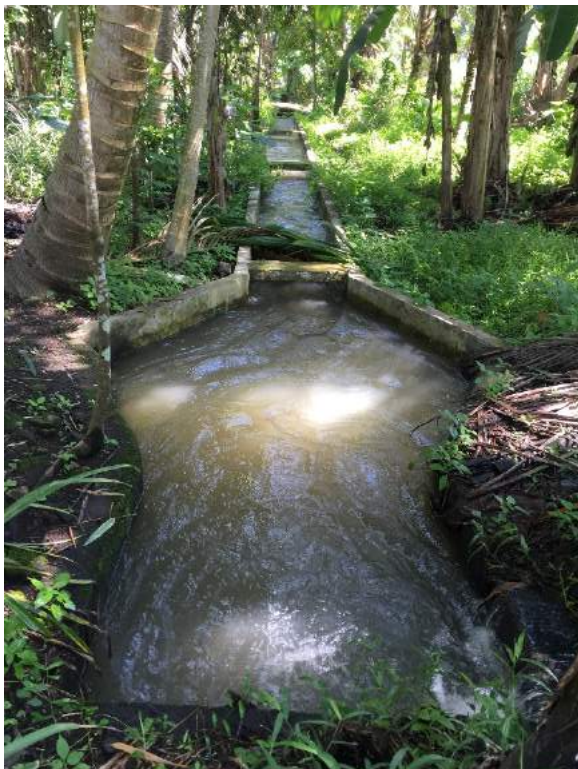
Figure 1C-28. Division box to several laterals

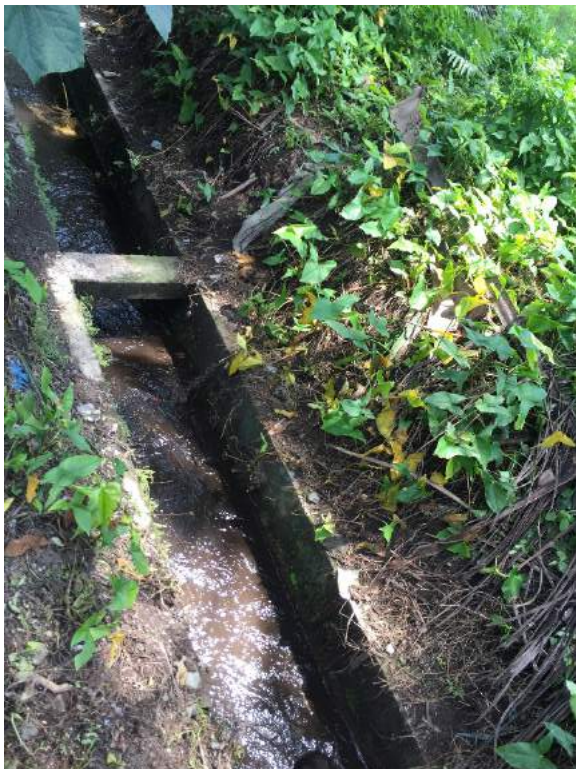
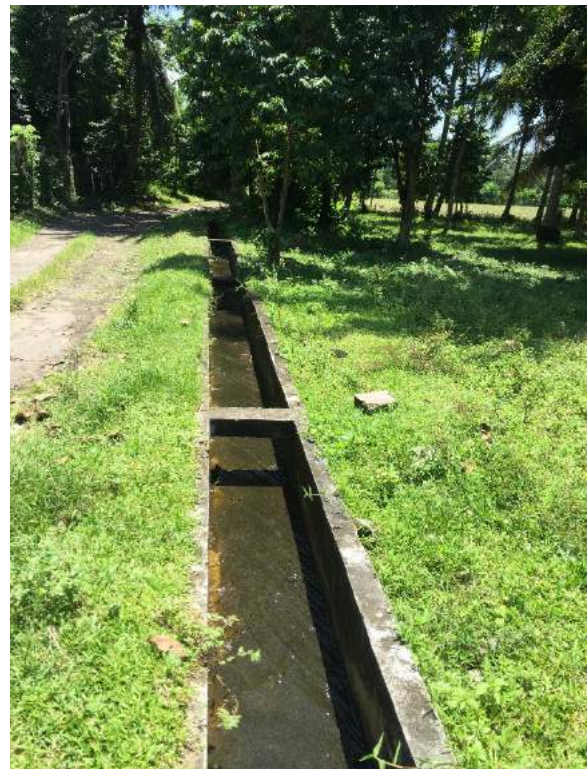
Figure 1C-30. The lined main canal of the system

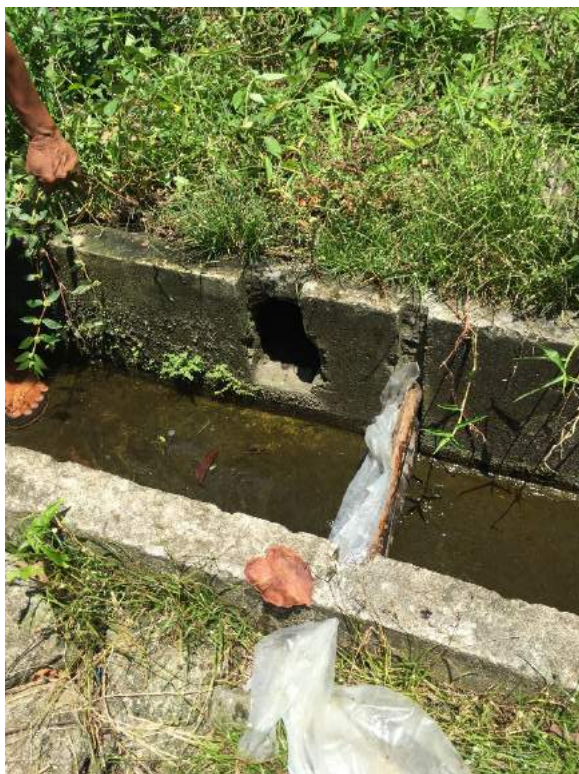
Figure 1C-31. Simple hole turnout and improvised gate

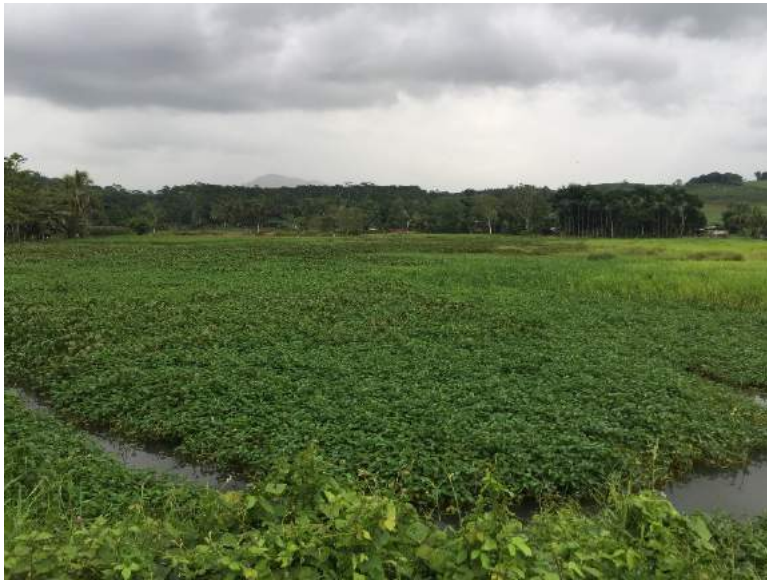
Figure 1C-36. The reservoir of Magsaysay CIS

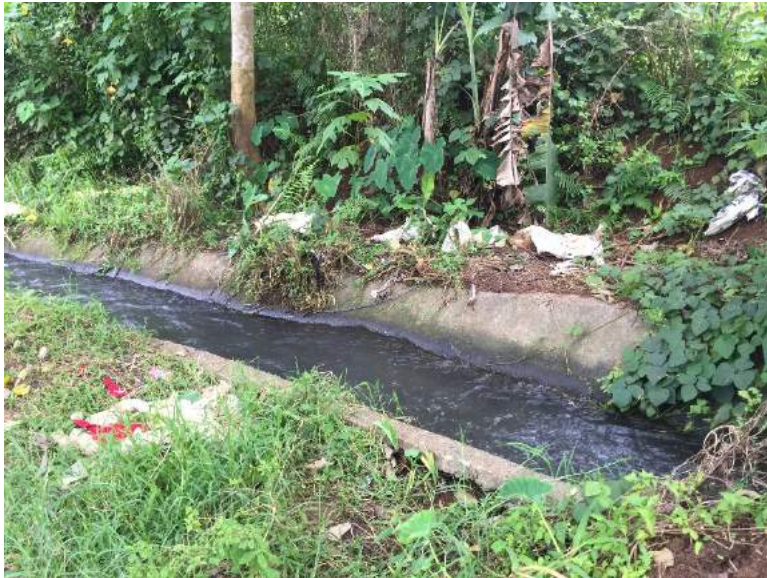
Figure 1C-40. Right main canal of Magsaysay CIS
Source: Author's capture
